Advanced 208-Compliant Investigation/ Vehicle to Object
Dynamic Science, Inc. / Case Number: DS03034
2004 Toyota Corolla S Four-Door Sedan
California
August, 2003

1. Report No. DS03-034	2. Government Accession No.		3. Recipient Catalog No.	
4. Title and Subtitle Advanced 208-Compliant Investigation			5. Report Date September 9, 2005

**Dynamic Science, Inc.
Crash Investigation
Case Number:DS03034**

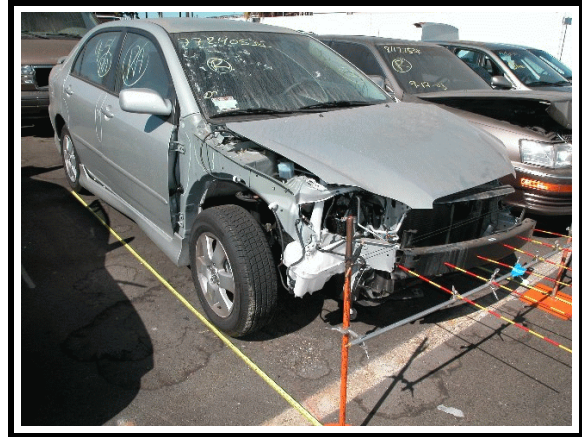
Figure 1. Front right, three-quarter view showing corner impact with continuous right plane sideswipe

The initial front, right corner impact resulted in an insignificant amount of front bumper bar engagement. Maximum front bumper crush was calculated to be 1.2 cm and was located at the front, right corner. The left frame rail end was deformed to the left which resulted as the vehicle rotated counterclockwise into the concrete barrier wall. Direct contact damage extended along the right side plane 346 cm (136.2 in.). The left side sideswipe damage was 314 cm (123.6 in.) in length and initiated 315 cm (124 in.) rearward of the left front wheel.

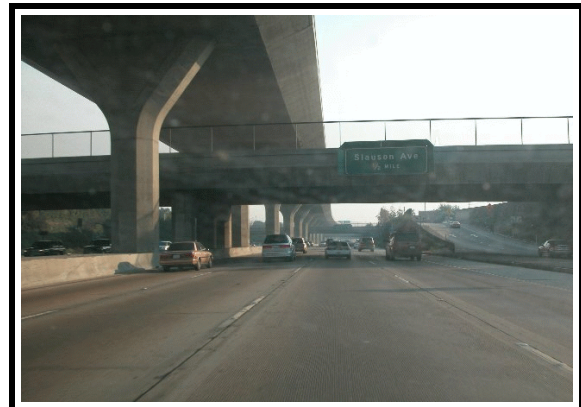
Figure 2. View showing the overhead, elevated HOV/bus northbound travel lanes.

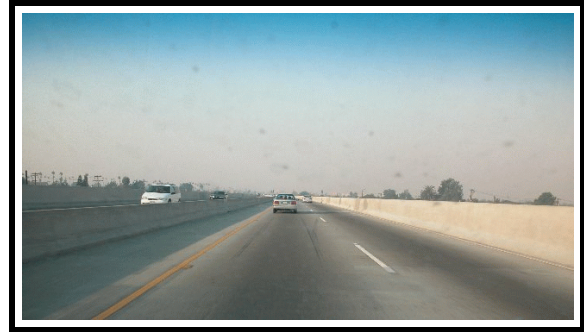
Figure 3. View showing pre-impact trajectory and approximate barrier wall impacts.

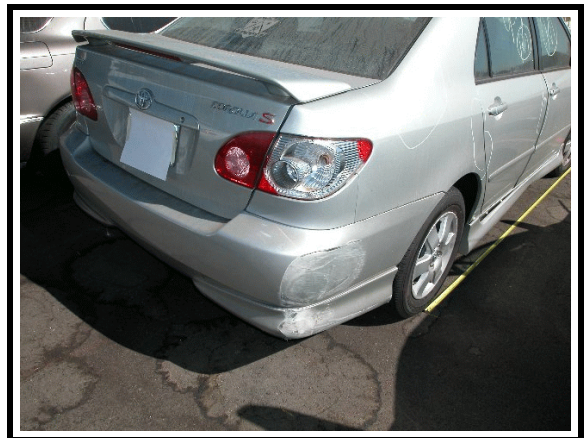
Figure 4. View showing wall contact damage to the right rear bumper fascia

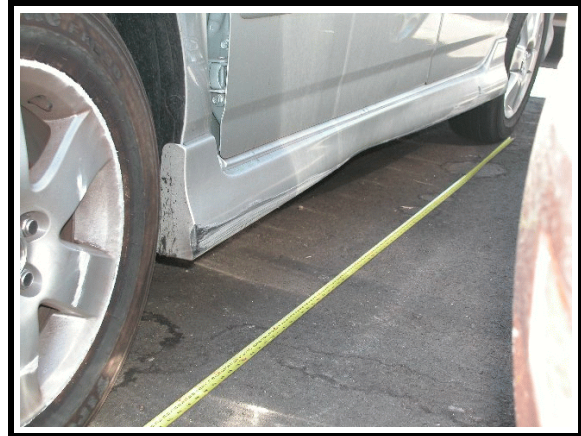
Figure 5. Left side sideswipe damage to left front rim and sill

Minor/ Secondary Left Side Sideswipe Impact: Surface scraping extending along the left side plane. Damaged components include the left side tire rims, left sill and left bumper fascia.

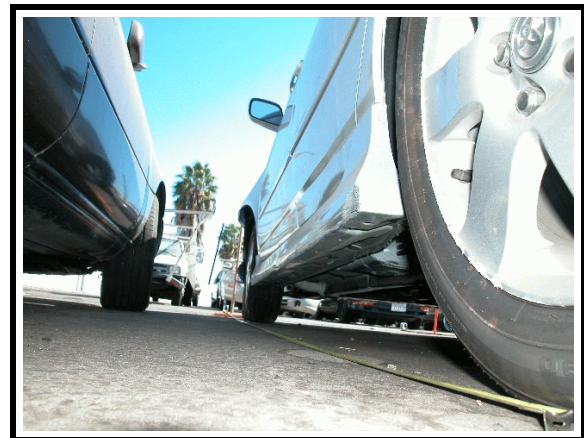
Figure 6. Left side sideswipe damage to left rear rim and sill

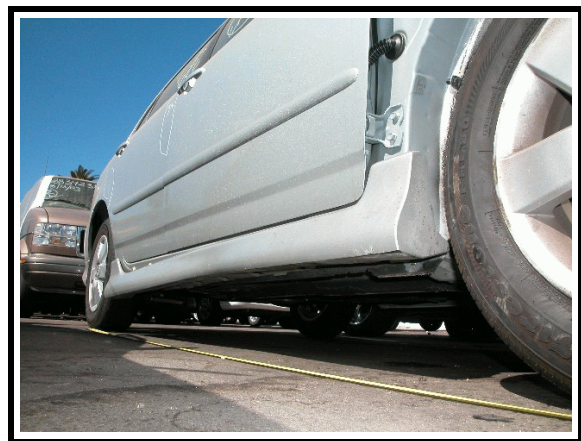
Figure 7. View showing direct contact to wheel rim and right sill area

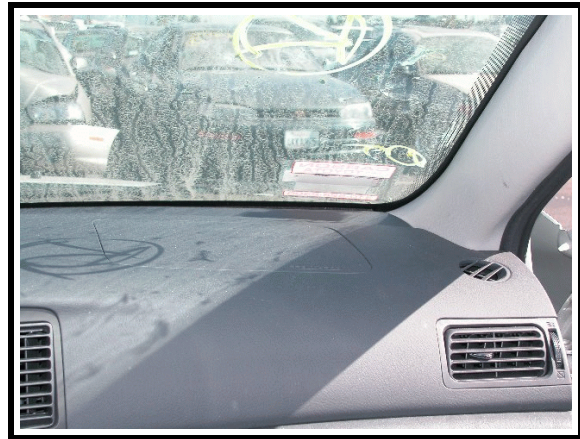
Both the right side and left side collisions resulted in sidwiper type impacts that resulted in low deceleration potential and assumed lower than the threshold necessary for air bag deployment.

Figure 8. Non-deployed front, right air bag

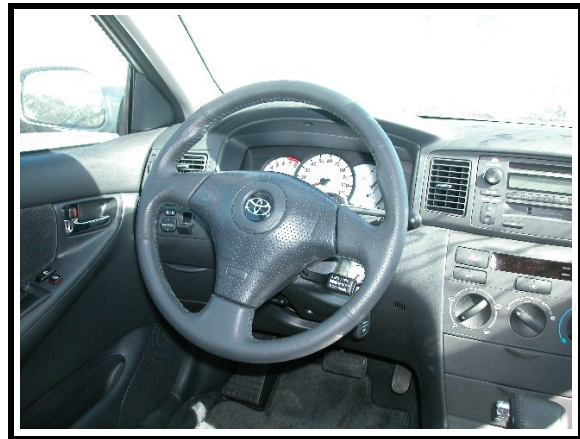
Figure 9. View of non-deployed drivers air bag
