INDIANA UNIVERSITY

TRANSPORTATION RESEARCH CENTER

ON-SITE CERTIFIED ADVANCED 208- COMPLIANT VEHICLE INVESTIGATION

CASE NUMBER - IN-03-036
LOCATION - TEXAS
VEHICLE - 2003 CHEVROLET TAHOE
CRASH DATE - June 2003

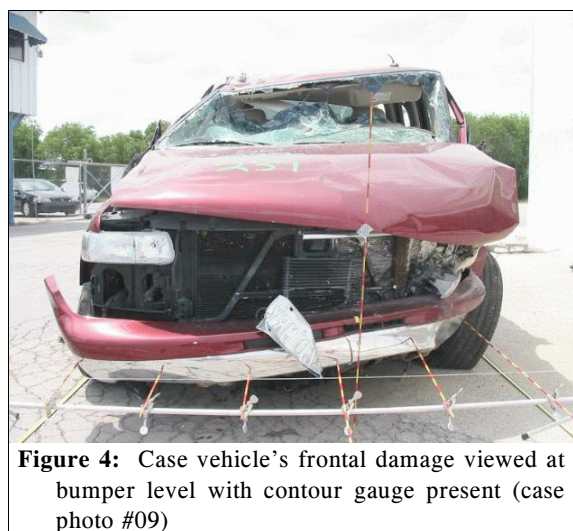
Crash: The front left corner (**Figure 4** and **Figure 5** below) of the case vehicle impacted the front of the Hyundai, causing the case vehicle's driver and front right passenger supplemental restraints (air bags) to deploy. Based on the downloaded **EDR** data, only one stage of the multi-stage air bags was activated. The case vehicle was not equipped with a cutoff switch for the front right passenger supplemental restraint (air bag).

Figure 4: Case vehicle's frontal damage viewed at bumper level with contour gauge present (case photo #09)

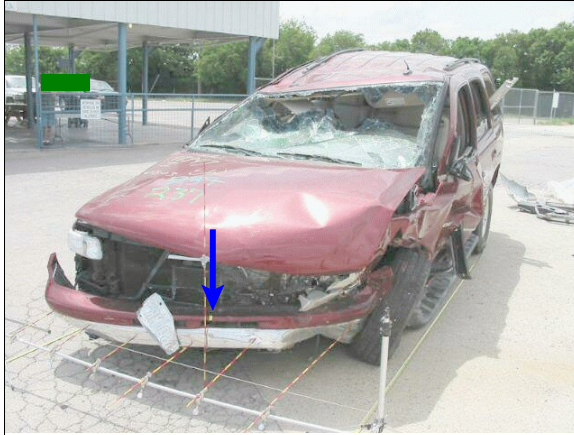
Figure 5: Case vehicle's front and rollover damage viewed from left of front; Note: contour gauge present at bumper level and yellow tape (arrow) indicates end of direct damage area along bumper from impact with Hyundai (case photo #11)

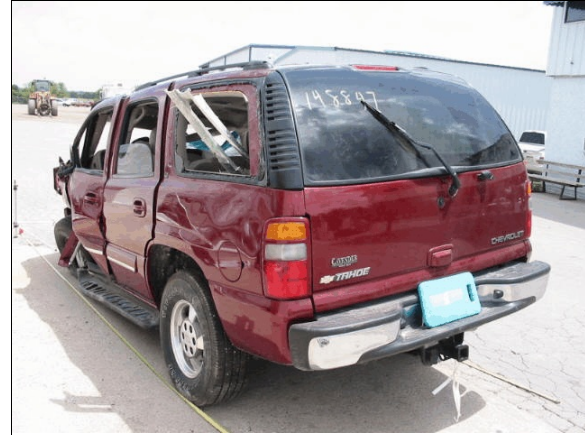
Figure 6: Side slap damage to case vehicle's left quarter panel viewed from left of back; Note: disintegrated glazing (case photo #17)

Post-Crash: After the initial impact, the case vehicle sustained a minor side slap impact to its left back as it continued forward (**Figures 6** and **7**), while being redirected rightward, and traveled off the right edge of the road. In addition, the case vehicle most likely rotated counterclockwise as it traveled westward onto the northern roadside (**Figure 8**). When the case vehicle encountered the soft dirt of the northern roadside's surface, it began to roll onto its right side. In this contractor's opinion, the case vehicle had most likely rolled between one and two quarter turns to its right when the case vehicle encountered an earthen embankment which caused the case vehicle to roll back to its left where it came to rest on its right side heading southwestward (**Figure 9** below). The Hyundai was most likely redirected southwestward and rotated counterclockwise as a result of its impact with the case vehicle. The Hyundai most likely came to rest on the roadway, but its exact location and heading angle are unknown. According to the Police Crash Report, the driver of the Ford steered sharply to the right and avoided contacting both the case vehicle and the Hyundai, but as a result of his steering maneuver, the right outside rearview mirror of the Ford contacted a **STOP** sign on the western corner of the intersection. The final rest position of the Ford is unknown. Please note, the **STOP** sign allegedly contacted by the Ford can be

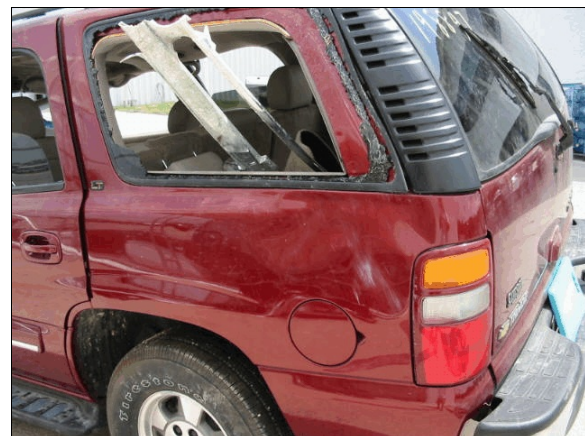
Figure 7: Close-up of case vehicle's left quarter panel showing side slap damage approximately between gas tank filler cap and window sill; Note: disintegrated glazing (case photo #16)

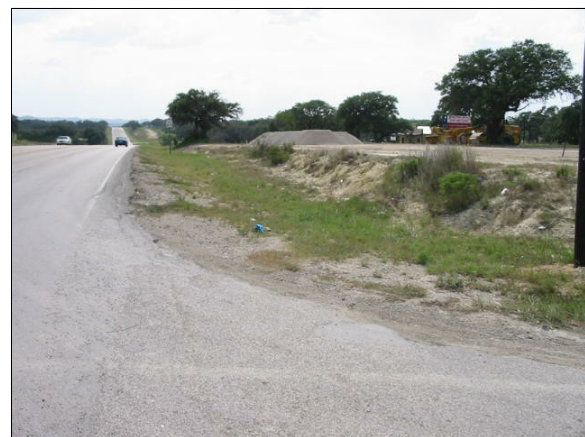
Figure 8: Case vehicle's final rest area on northwest roadside (case photo #03)

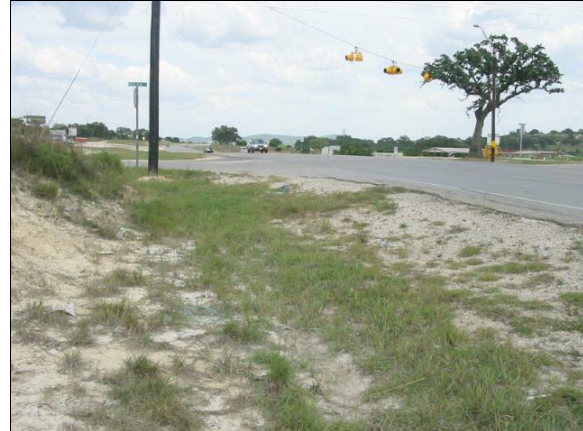
observed near a wooden street light pole (i.e., see **Figures 1** and **2** above, and **Figure 9**). In this contractor's opinion, the reported contact to the regulatory sign is unlikely, but a contact to the wooden utility pole cannot be ruled out.

Figure 9: Eastward view of case vehicle's off-road travel path from beyond final rest position (case photo #04)

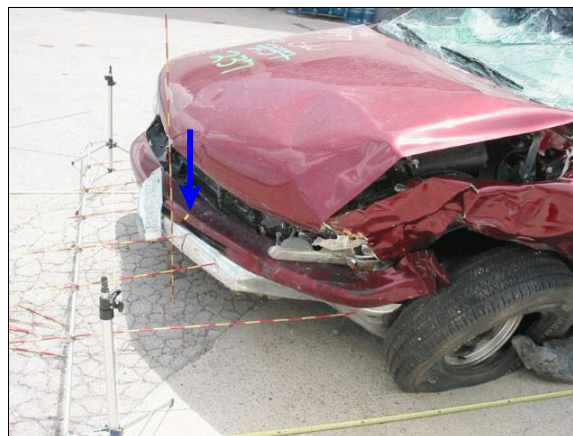
Figure 10: Elevated reference line view from left of case vehicle’s front bumper damage with contour gauge present at bumper level; Note: yellow tape (arrow) indicates length of direct damage along bumper and deformation to left front wheel assembly (case photo #12)

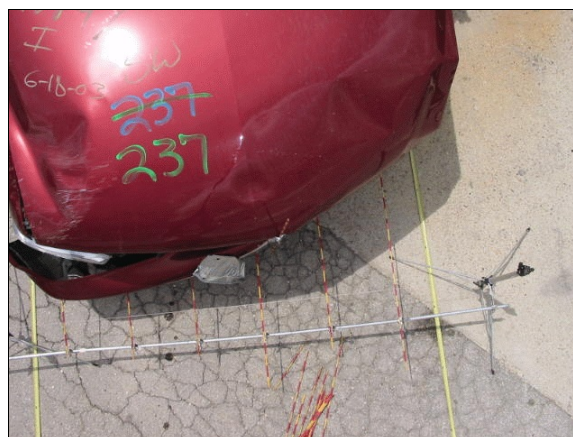
Figure 11: Overhead view of case vehicle’s frontal damage with contour gauge set at bumper level (case photo #27)

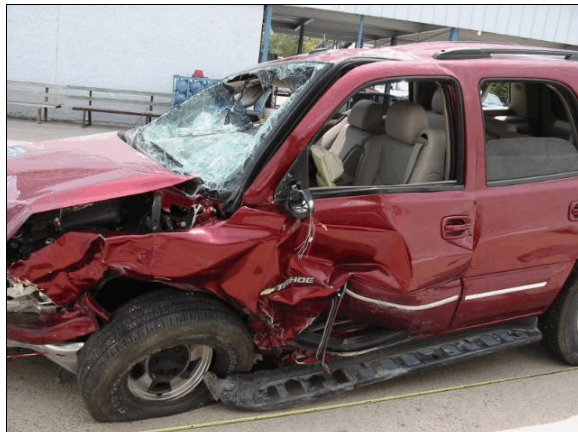
left front door were crushed inward as well (Figure 12). The side slap impact resulted in minor direct damage to the left quarter panel (Figures 6 and 7 above). As a result of the rollover, there was direct damage to the right fender, right front door, right quarter panel, right “A”-pillar, and right roof side rail (Figure 13). The right “A”-pillar, in particular, was crushed both vertically downward and laterally inward. There was induced damage to the right headlight and turn signal assemblies, the left front and rear doors, the hood, roof, and right rear door. The windshield was holed and the left and right front and second left and right back windows were disintegrated.

Figure 12: Inward crush to case vehicle’s left fender and left front door which occurred when Hyundai wrapped around during initial impact; Note: driver’s integrated, lap-and-shoulder safety belt system (case photo #15)

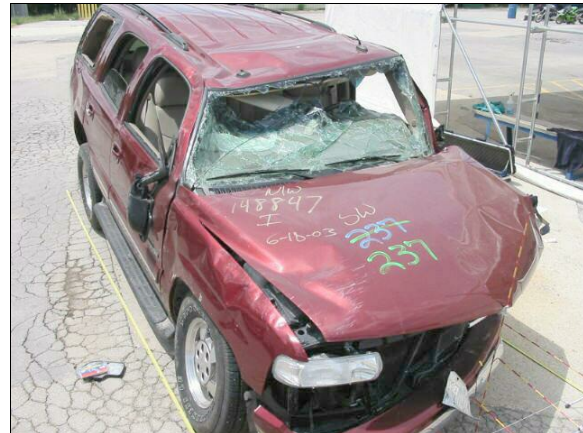
Figure 13: Elevated view from right of front showing case vehicle’s right side and top rollover damage (case photo #25)

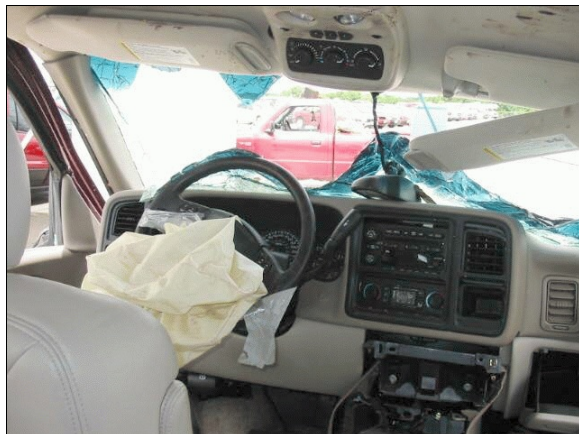
Figure 14: Case vehicle's driver seating area showing deployed driver air bag, collapsed windshield's glazing, and blood splatter on driver's sun visor and across roof (case photo #31)

Interior Damage: Inspection of the case vehicle's interior (**Figures 14** and **15**) revealed a scuff on the left side of the driver's knee bolster, near the driver's door (**Figure 16**) and a major blood stain/smear starting from the driver's visor (**Figure 17**) and continuing along the ceiling toward the right roof side rail (**Figure 18**). In addition, there was blood on the kernels of the case vehicle's collapsed windshield glazing (**Figure 19** below).

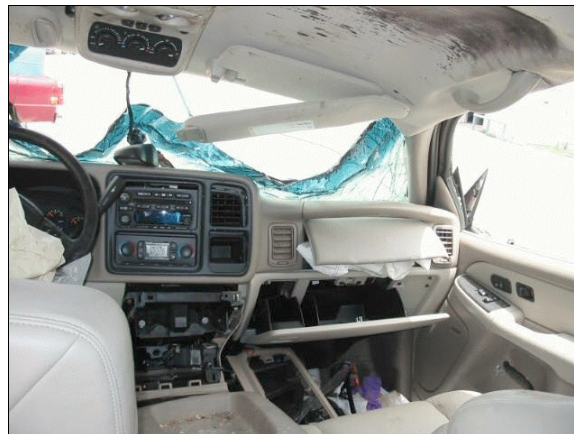
Figure 15: Case vehicle's front right passenger seating area showing deployed front right passenger air bag, distorted front right sun visor, opened glove box door, and blood splatter across roof (case photo #33)

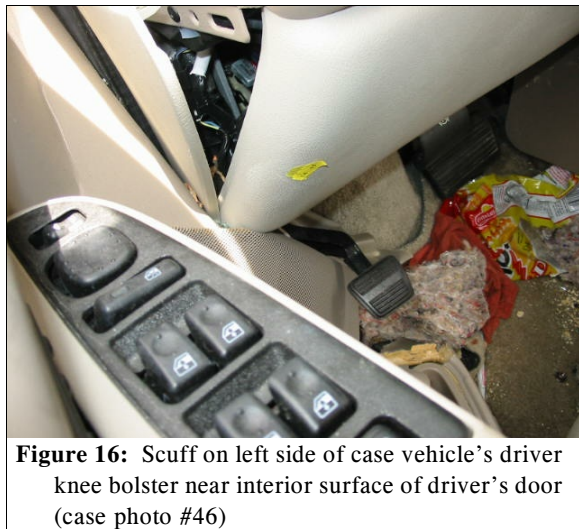
Figure 16: Scuff on left side of case vehicle's driver knee bolster near interior surface of driver's door (case photo #46)

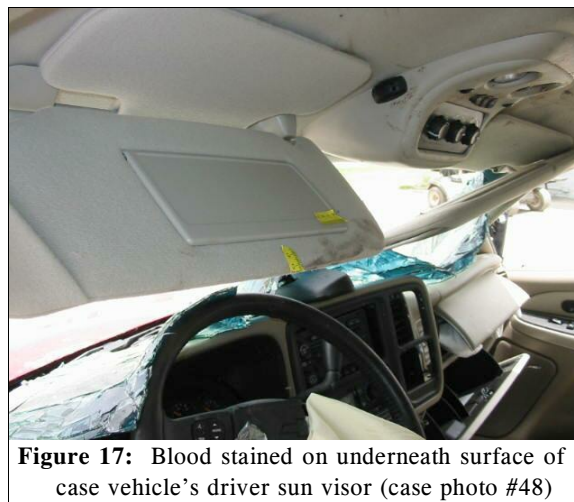
Figure 17: Blood stained on underneath surface of case vehicle's driver sun visor (case photo #48)

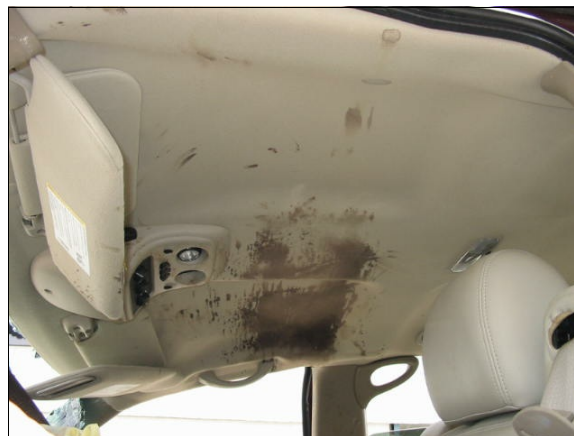
Figure 18: Blood splatter and significant area of blood stain transversely oriented across case vehicle's ceiling; Note: stain primarily over front right seating position (case photo #28a)

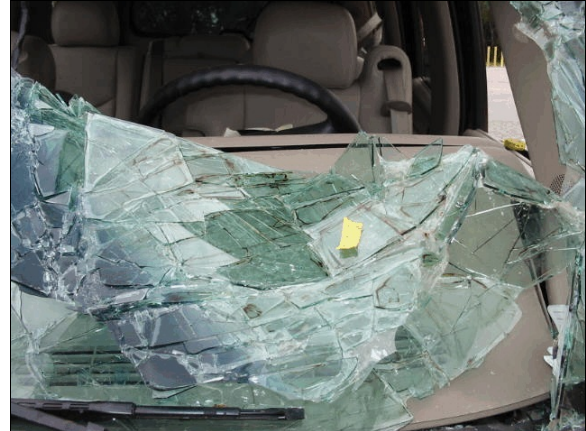
Figure 19: Case vehicle's collapsed windshield glazing showing (yellow tape) blood stains on glazing (case photo #49)

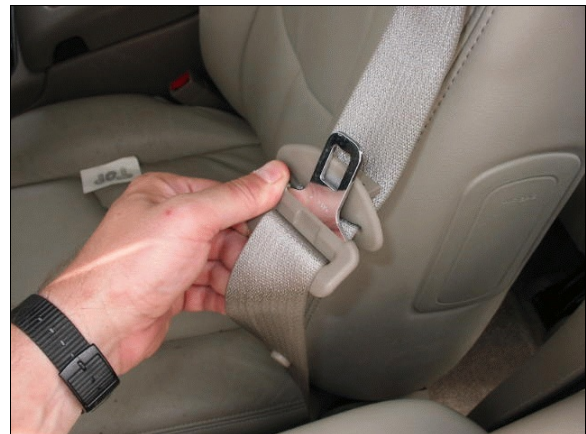
Figure 20: Latch plate for case vehicle's driver safety belt and location of driver's non-deployed seat back-mounted side impact air bag (case photo #45)

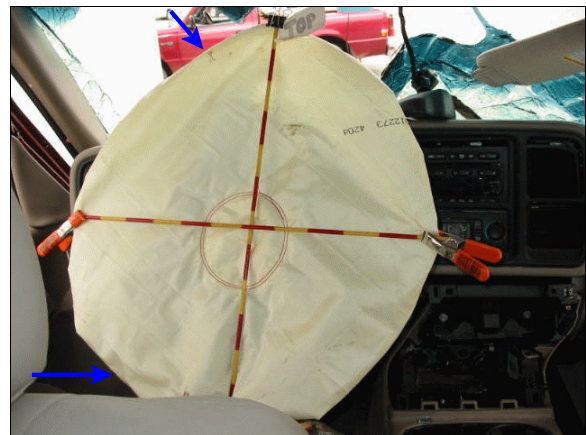
Figure 21: Case vehicle's deployed driver air bag showing blood spots scattered around the right perimeter of the bag's front surface between the 11 and 7 o'clock positions (case photo #37)

driver's air bag was round with a diameter of 61 centimeters (24.0 inches). The distance between the mid-center of the driver's seat back, as positioned at the time of the vehicle inspection, and the front surface of the air bag's fabric at full excursion was 32 centimeters (12.6 inches). An inspection of the driver's air bag fabric revealed minor circumferential blood stains scattered on the front surface of the air bag's fabric (**Figure 21** above).

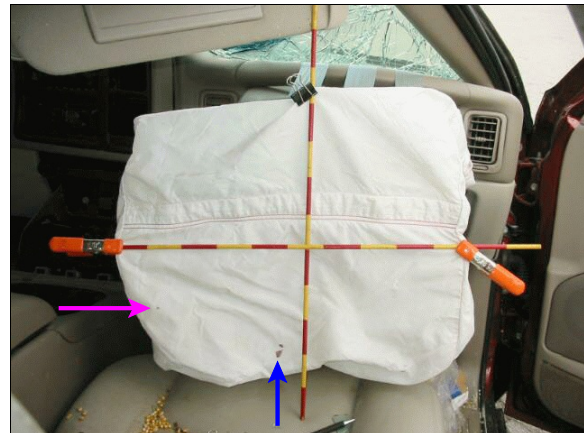
Figure 22: Case vehicle's deployed front right passenger air bag showing two blood spots (arrows) on left lower quadrant of bag's front surface (case photo #50)

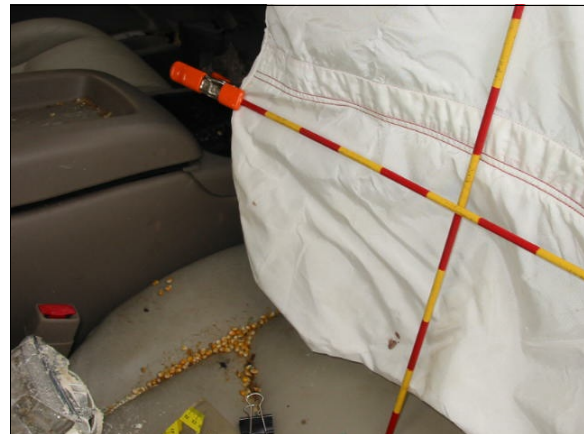
Figure 23: Close-up of blood spot at 6 o'clock position on front surface of case vehicle's deployed front right passenger bag (case photo #51)

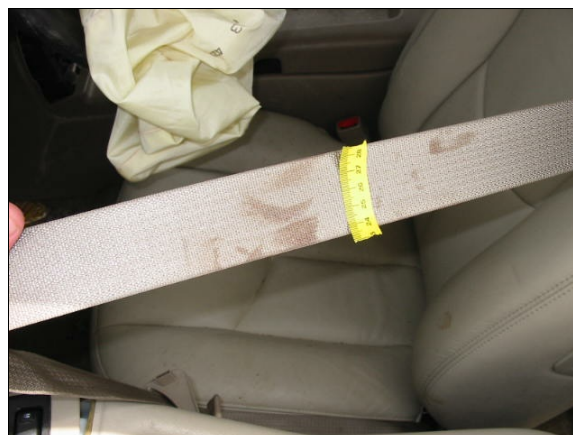
Based on this contractor's vehicle inspection and supported by the EDR data, the case vehicle's driver was restrained by his available, active, three-point, integral lap-and-shoulder, safety belt system; the belt system was not equipped with a pretensioner. Furthermore, there was reported belt pattern bruising to the driver's left neck area, and the inspection of the driver's seat belt webbing and latch plate showed blood stains on the shoulder portion of his safety belt providing strong indications of usage (**Figure 24**).

Figure 24: Blood stains on shoulder portion of case vehicle's driver safety belt (case photo #43)

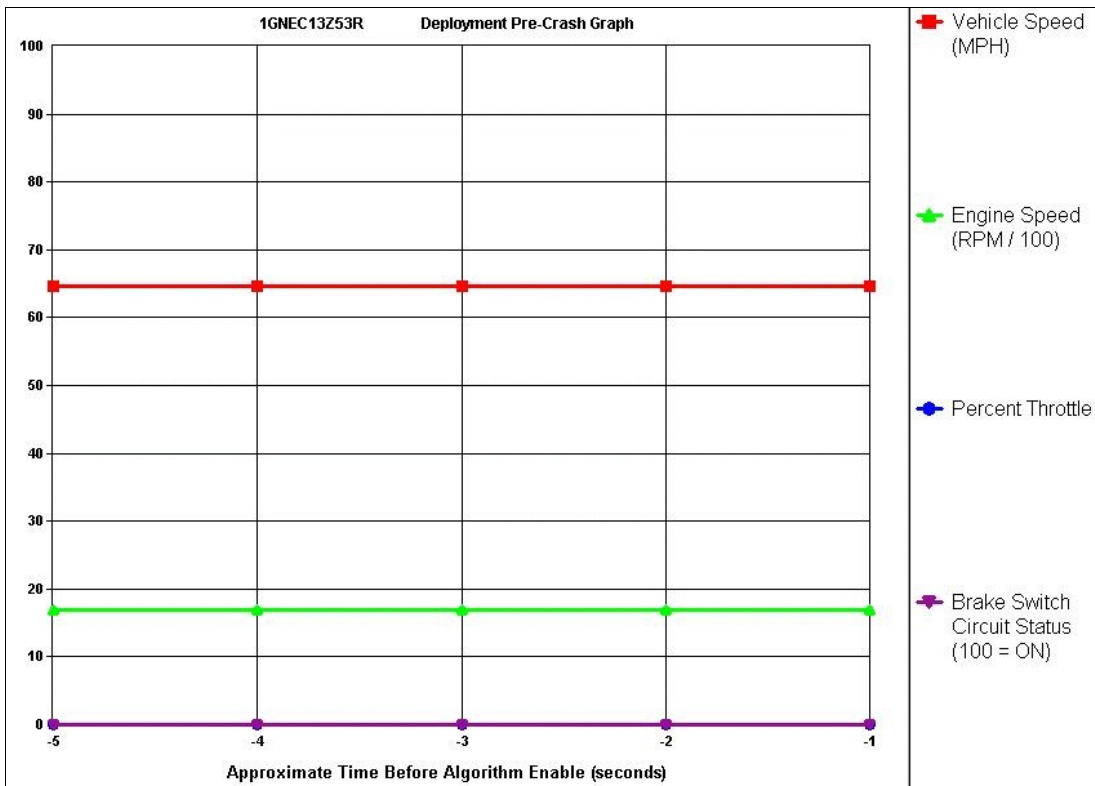
Figure 26: Case vehicle’s pre-crash speed and throttle and brake switch circuit status showing that the vehicle’s speed was recorded at 105 km.p.h. (65 m.p.h.) and that there was 0% throttle and the brake switch was OFF at the five recorded sample periods.

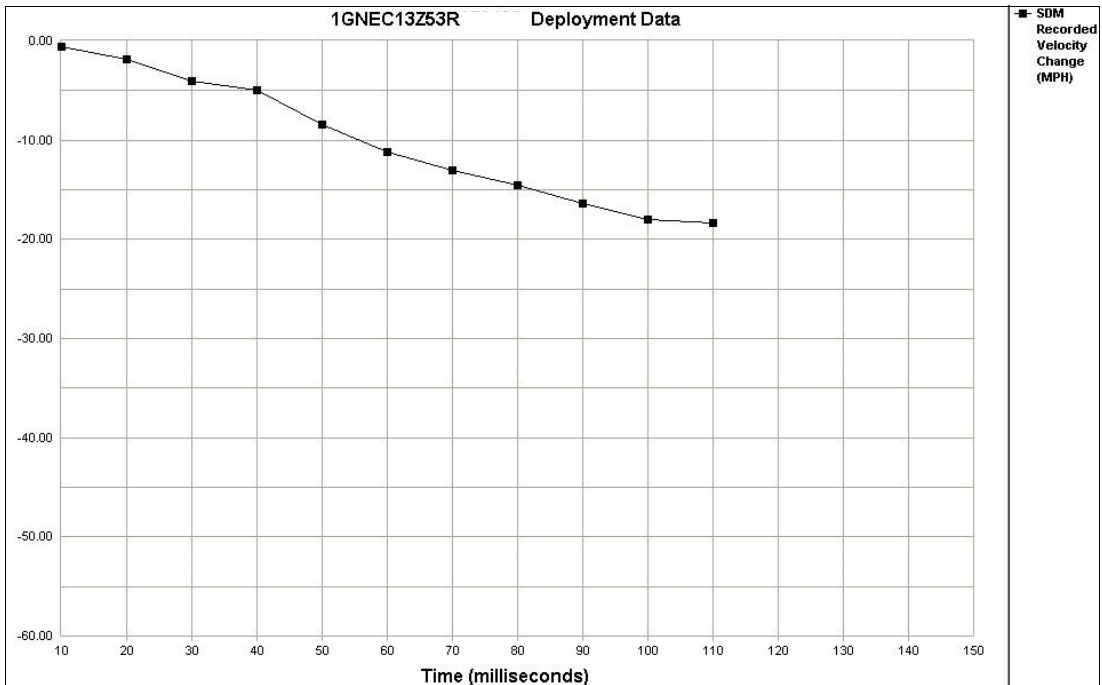
Figure 27: The case vehicle sustained a velocity change of approximately 29.4 km.p.h. (18.3 m.p.h.) during the first 110 milliseconds after the crash was detected
