INDIANA UNIVERSITY

ON-SITE CERTIFIED ADVANCED 208- COMPLIANT VEHICLE INVESTIGATION

CASE NUMBER - IN-03-037
LOCATION - OKLAHOMA
VEHICLE - 2003 GMC YUKON XL
CRASH DATE - July 2001

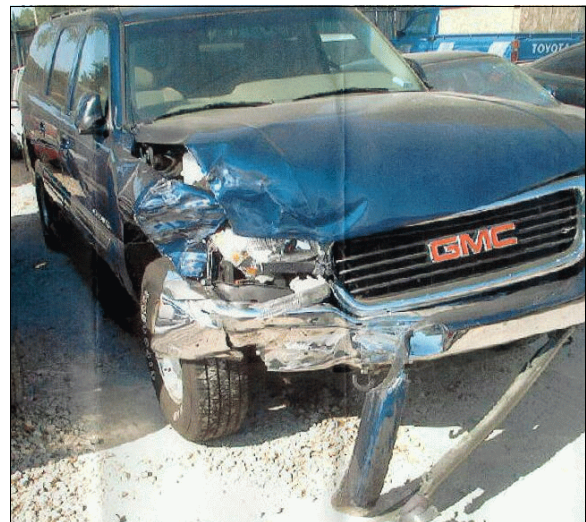
Figure 5: Insurance company photo of case vehicle's front right and corner damage (case photo #14)

Exterior Damage: The case vehicle's contact with the Kia involved the front with the damage distributed on approximately the right half (**Figure 5** above). Direct damage began at the front right bumper corner and, based on the available photographs, extended approximately 60 centimeters (23.6 inches) inward toward the driver's side. Residual crush measurements were not obtained because the bumper fascia, bumper,

grille, hood, and right fender were removed prior to this contractor inspection but, based on the available photographs, maximum crush occurred at C₆. The case vehicle’s wheelbase was unaltered from the crash. The case vehicle’s front bumper, bumper fascia, grille, hood, right fender, and right headlight and turn signal assemblies were directly damaged and crushed rearward. The left and right fenders, left headlight and turn signal assemblies (**Figure 7** above), right outside rear view mirror, right front door, right “A”-pillar, and the right side of the windshield’s glazing sustained induced damage (**Figure 8**). No obvious induced damage or remote buckling was noted to the remainder of the case vehicle’s exterior.

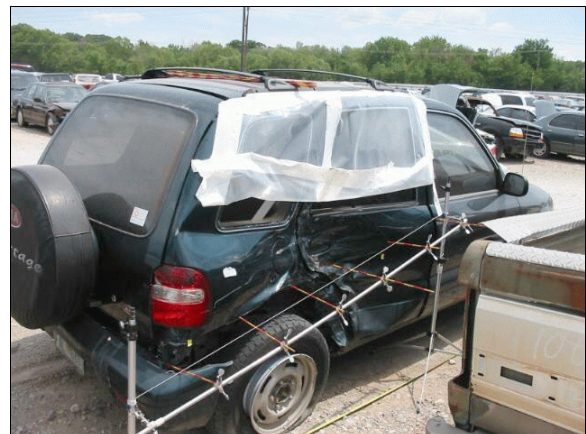
Figure 6: Damage to rear portion of Kia's right side with contour gauge present (case photo #43)

Exterior Damage: The Kia’s contact with the case vehicle involved its right side with the damage distributed on approximately the back half (**Figure 6** above and **Figure 17**). Direct damage began 202 centimeters (79.5 inches) rearward of the front right axle and extended 122 centimeters (48.0 inches) rearward along the right side. The field L began 166 centimeters (65.4 inches) rearward of the front right axle and extended 165 centimeters (65.0 inches) rearward as well. Residual maximum crush was measured as 17 centimeters (6.7 inches) at C₄ (**Figure 18**). The table below shows the case vehicle’s crush profile.

The wheelbase on the Kia’s left side was shortened 4 centimeters (1.6 inches) while the right side was extended 4 centimeters (1.6 inches). The Kia’s right rear door and right quarter panel were directly damaged and crushed inward. There was induced damage to the right front door, right “C” and “D”-pillars, and the back right stop/tail light and turn signal assemblies. In addition, both the right rear glazing and the second right glazing were disintegrated.

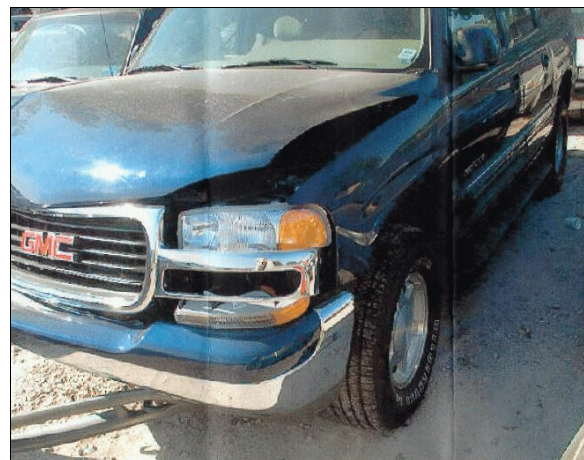
Figure 7: Insurance company photo of induced damage to case vehicle's left front corner (case photo #13)

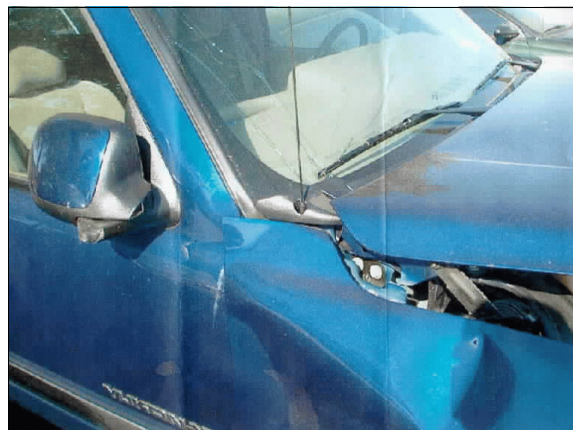
Figure 8: Close-up of induced damage to case vehicle’s right fender, right outside rearview mirror, right “A”-pillar, and the right side of the windshield’s glazing (case photo #08)

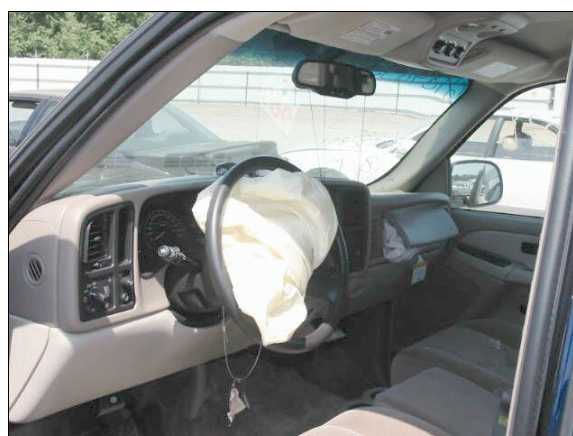
Vehicle Interior: Inspection of the case vehicle’s interior revealed that there was no evidence of occupant contact on the interior surfaces of the case vehicle (**Figure 9** and **Figures 10** through **13** below). Finally, there was no evidence of intrusion to the case vehicle’s interior, no evidence of compression to the energy absorbing shear capsules in the steering column, and no deformation to the steering wheel rim.

Figure 9: Case vehicle’s front seating area viewed from outside driver’s door showing deployed front air bags and no contact evidence on driver’s knee bolster or instrumental panel or left “A”-pillar (case photo #16)

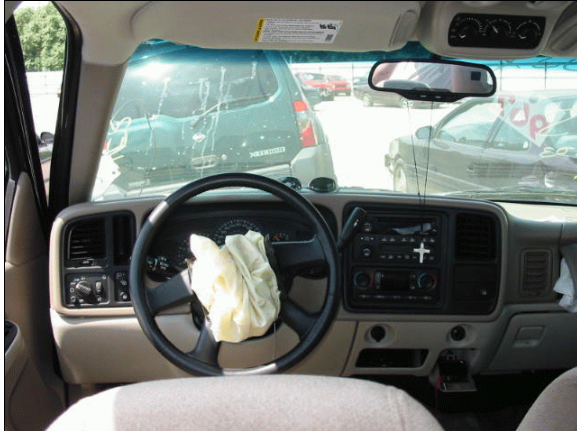
Figure 10: Case vehicle's driver seating area showing deployed driver air bag and no apparent evidence of occupant contact to left or center instrument panels or greenhouse area (case photo #19)

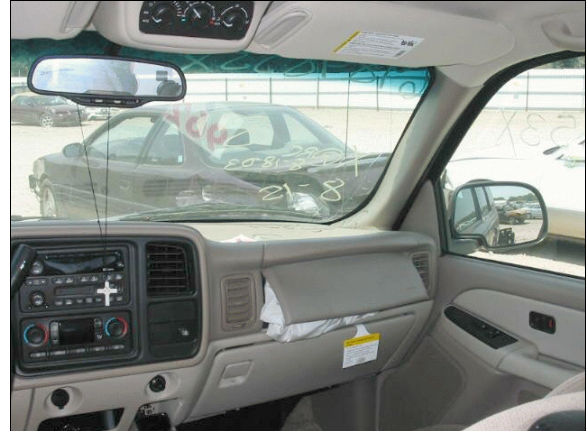
Figure 11: Case vehicle's front right passenger seating area showing deployed front right passenger air bag and no apparent evidence of occupant contact to either center or right instrument panel or greenhouse area (case photo #21)

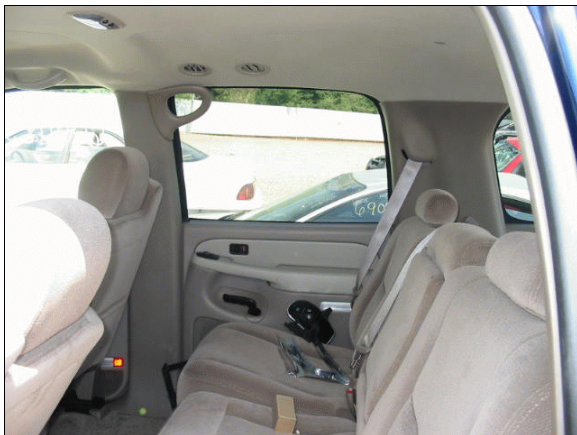
Figure 12: Case vehicle's second seating area viewed from left showing no obvious occupant contact evidence (case photo #35)

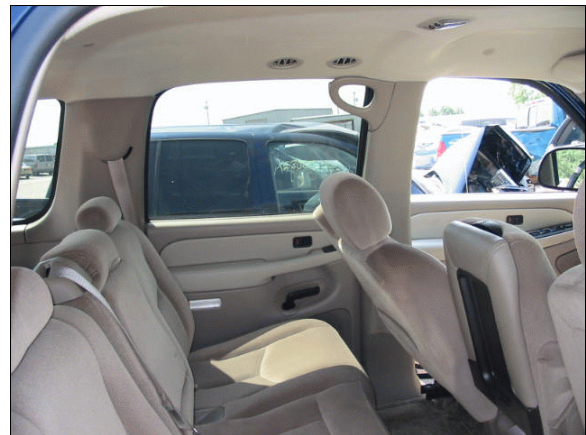
Figure 13: Case vehicle's second seating area viewed from right showing no obvious occupant contact evidence (case photo #36)

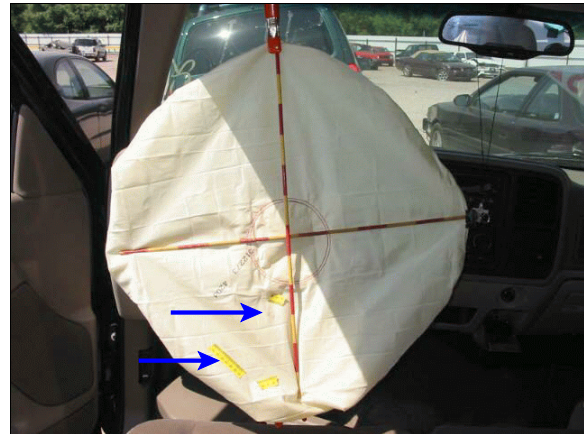
deployed as a result of the frontal impact with the Kia. Only one stage of the multi-stage air bags was activated. The case vehicle's driver air bag was located in the steering wheel hub. The module cover consisted of asymmetrical, essentially, "I"-configuration cover flaps made of medium thickness vinyl. Both the left and right flaps were trapezoidal in shape with overall dimensions of 15 centimeters (5.9 inches) at the top horizontal seam, 10.5 centimeters (4.1 inches) at the bottom horizontal seam, and 12 centimeters (4.7 inches) vertically along the seam that separated the two flaps. An inspection of the air bag module's cover flaps and the air bag's fabric revealed that the cover flaps opened at the designated tear points, and there was no evidence of damage during the deployment to the air bag or the cover flaps. The driver's air bag was designed with two tethers, each approximately 13 centimeters (5.1 inches) in width. The driver's air bag had two vent ports, approximately 3 centimeters (1.2 inches) in diameter, located at the 11 and 1 o'clock positions. The deployed driver's air bag was round with a diameter of 63 centimeters (24.8 inches). An inspection of the driver's air bag fabric revealed very slight smudges, possibly makeup, on the fabric of the air bag's front surface in the lower left quadrant toward the 7 o'clock position (**Figures 14 and 15**).

Figure 14: Case vehicle's deployed driver air bag showing occupant contact evidence (i.e., arrows) on air bag's front surface in lower left quadrant near 7 o'clock position (case photo #25)

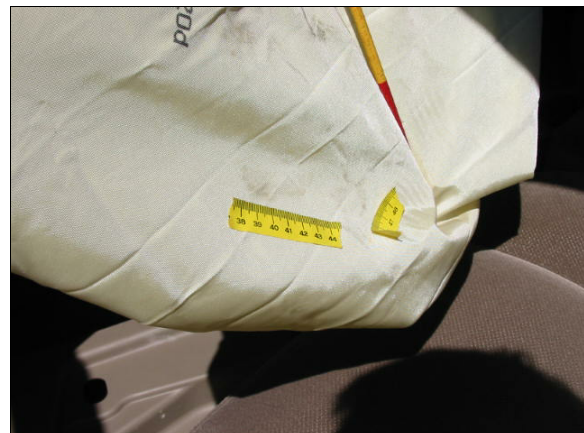
Figure 15: Close-up of contact evidence (i.e., smudges) near 7 o'clock position of case vehicle's deployed driver air bag (case photo #26)

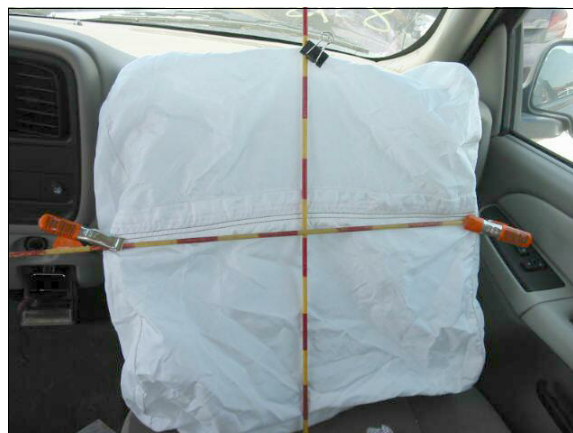
The front right passenger's air bag was located in the middle of the instrument panel. There was a single, essentially rectangular, modular cover flap. The cover flap was made of a thick semi-pliable vinyl, thicker than the vinyl on the driver's module. The flap's dimensions were 39 centimeters (15.4 inches) at the lower horizontal seam and 15 centimeters (5.9 inches) along both vertical seams. The profile of the case vehicle's instrument panel was flush with the leading edge of the cover flap. An inspection of the front right air bag module's cover flap and the air bag's fabric revealed that the cover flap opened at the designated tear points, and there was no evidence of damage during the deployment to the air bag or the cover flaps. The front right passenger's air bag was designed with one tether, approximately 46 centimeters (18.1 inches) in width. The front right air bag had two vent ports, approximately 3.5 centimeters (1.4 inches) in diameter, located at the 2:30 and 9:30 clock positions. The deployed front right air bag was rectangular with a height of approximately 53 centimeters (20.9 inches) and a width of approximately 50 centimeters (19.7 inches). An inspection of the front right passenger's air bag fabric revealed no contact evidence readily apparent on the air bag's fabric (**Figure 16** below).

Figure 16: Case vehicle's deployed front right passenger bag showing no apparent contact evidence on air bag's front surface (case photo #30)

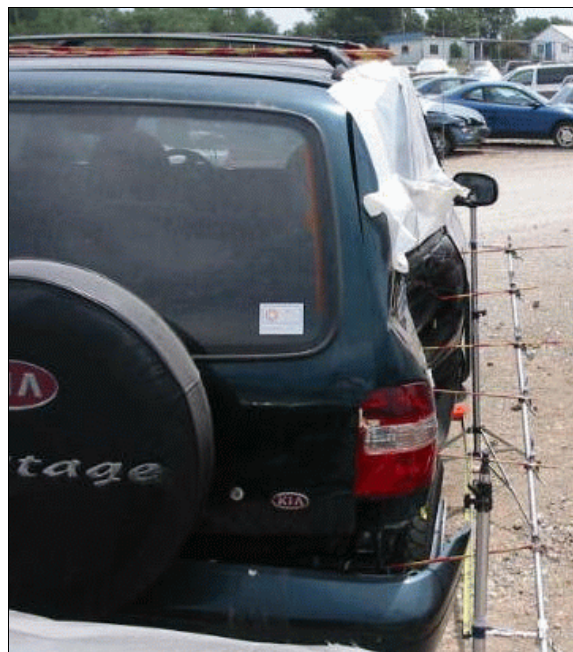
Figure 17: Reference line view from back showing Kia’s right side damage with contour gauge positioned above sill level (case photo #40)

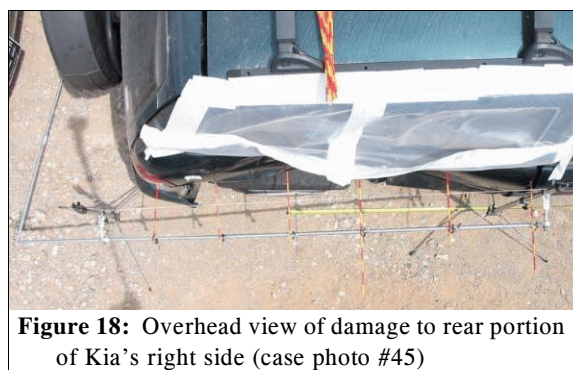
Figure 18: Overhead view of damage to rear portion of Kia’s right side (case photo #45)

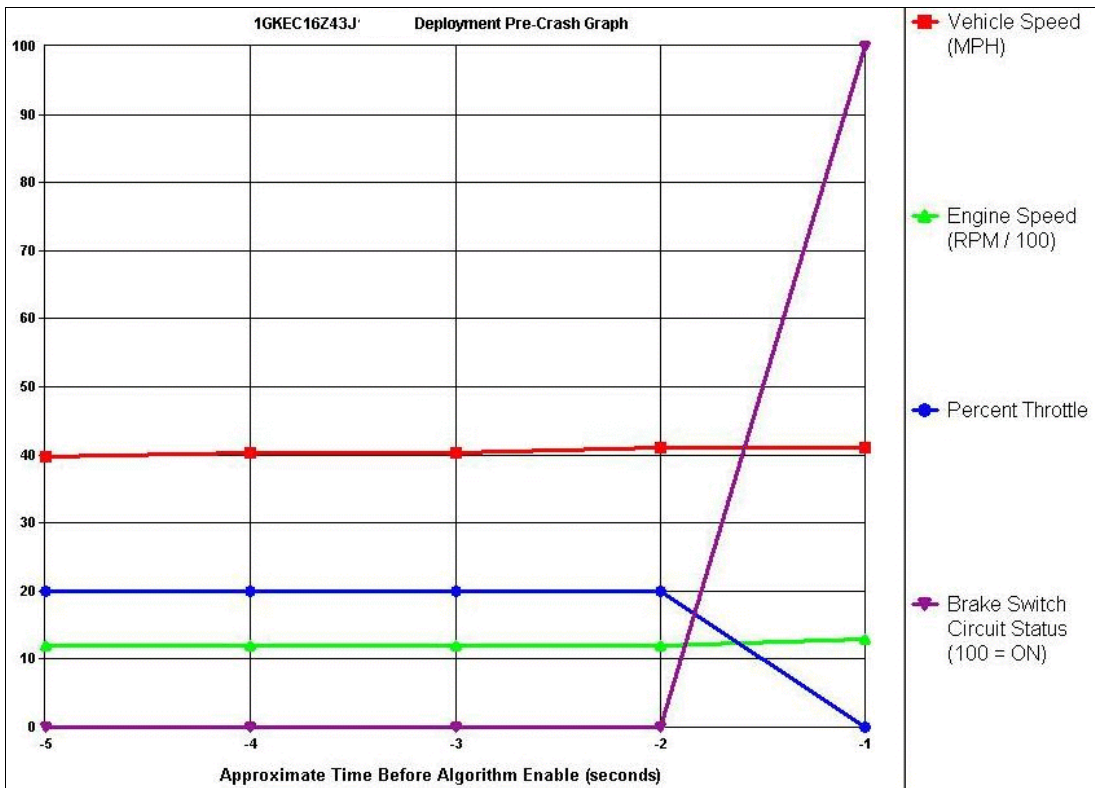
Figure 20: Case vehicle’s pre-crash speed and brake switch circuit status showing that the vehicle’s speed was recorded at 66 km.p.h. (41 m.p.h.) when the brake was activated approximately 2 seconds prior to algorithm enable.

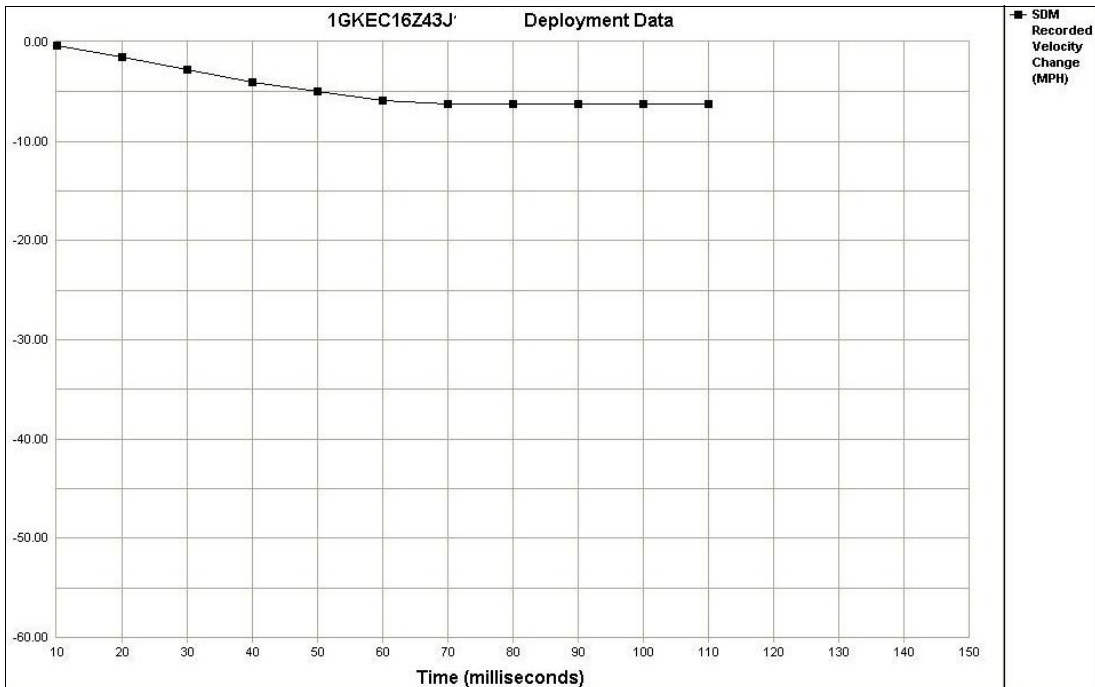
Figure 21: The case vehicle sustained a velocity change of approximately 10.0 km.p.h. (6.2 m.p.h.) during the first 110 milliseconds after the algorithm was enabled
