**GENERAL DYNAMICS ON-SITE CHILD SAFETY SEAT INVESTIGATION
SCI TECHNICAL SUMMARY REPORT**

CASE NO. CA03-037

VEHICLE – 1992 FORD TEMPO

CRASH DATE – JUNE 2003

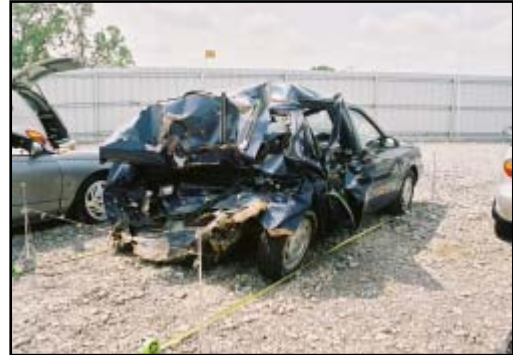
This on-site investigation focused on the performance of a forward-facing child safety seat (CSS) that was installed in a 1992 Ford Tempo (**Figure 1**). The Tempo was occupied by a 20-year-old female driver and a 10-month-old female child passenger who was restrained in a forward-facing convertible CSS. The Tempo was stopped in the eastbound travel lane of a two-lane roadway waiting to initiate a left turn onto a local roadway. The stationary Tempo was struck in the rear by a 1999 Ford F-350 Super-Duty utility/flat-bed truck that was traveling in the same lane and did not detect the vehicle stopped in the roadway. The severe impact accelerated the Tempo across the intersection in a

Figure 1. Damaged 1992 Ford Tempo

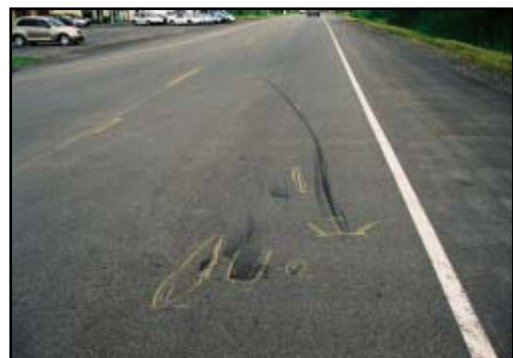
Figure 5. Close-up of point of impact and right rear tire mark

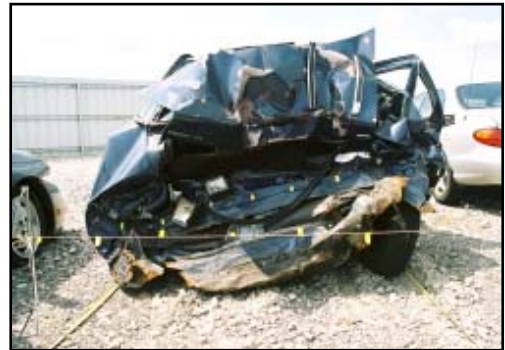
The 1992 Ford Tempo sustained severe damage as a result of the rear impact with the Ford F-350. The direct damage began 91.4 cm (36.0”) right of the centerline and extended 185.4 cm (73.0”) to the right across the back plane. It should be noted that this measurement was documented along the damage profile. The maximum crush was located at the rear right corner and measured 85.7 cm (33.8”). The rear bumper fascia was abraded, fractured, and completely separated as a result of direct contact. The entire width of the bumper and trunk rear trunk wall were crushed forward from the impact (**Figure 6**). The left rear Energy Absorption Device (EAD) stroke measured 6.4 cm (2.5”) and the right rear EAD stroke measured 5.1 cm (2.0”). The bumper was completely separated from the mounting brackets of both EAD’s. The sheet metal on the forward aspect the left EAD was completely torn in a vertical fashion and the left EAD face was rotated outward to the left. The entire right EAD was rotated upward and inward and separated completely from the vehicle’s structure (**Figure 7**).

Figure 6. View of the rear damage to the Tempo

The roof was buckled forward of the C-pillars. Six crush measurements were documented along the rear trunk lip and were as follows: C1 = 65.4 cm (25.8"), C2 = 74.9 cm (29.5"), C3 = 75.6 cm (29.8"), C4 = 74.3 cm (29.3"), C5 = 78.1 cm (30.8"), C6 = 85.7 cm (33.8"). The Collision Deformation Classification for the rear impact with the Ford F-350 was 06-BDEW-6.

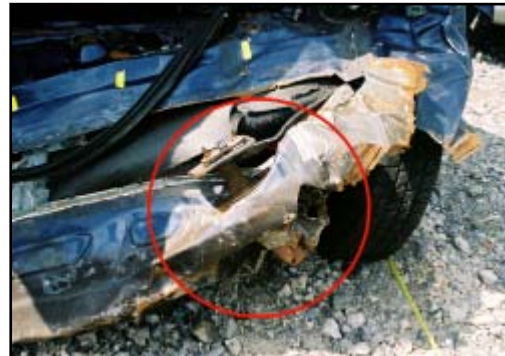
The rear face of the right EAD was facing upward. The trunk lid was crushed rearward, buckled upward, and disengaged from the latch. The forward displacement of the trunk lid allowed the forward edge of the trunk lid to contact the backlight header (**Figure 8**). The abrasion from the trunk lid contact began 16.5 cm (6.5”) right of the centerline, extended 29.2 cm (11.5”)

Figure 7. Close up of the right side EAD

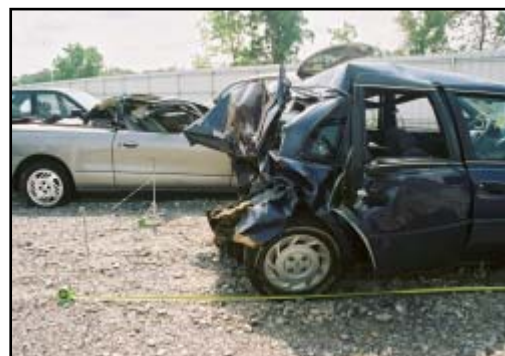
Figure 8. Lateral view showing the severe crush and trunk lid contact with the backlight header

to the right, and continued onto the roof. Matching abrasions were present on the right interior aspect of the trunk lid. The backlight header was crushed forward 24.3 cm (9.5") at the right aspect. The combined direct and induced damage measured 116.8 cm (46.0") across the back plane. Both quarter panels were crushed forward and buckled outward. The severe rear crush resulted in the reduction of the left wheelbase by 14.0 cm (5.5") and the reduction of the right wheelbase by 6.0 cm (2.4"). Both rear wheels were restricted due to the forward displacement. The fuel filler neck was crushed and abraded from engagement between the right rear quarter panel and the vehicle frame. The exhaust pipe was crushed and buckled, and was protruding outboard of the left rear sill. Both rear doors were displaced forward and were jammed shut.

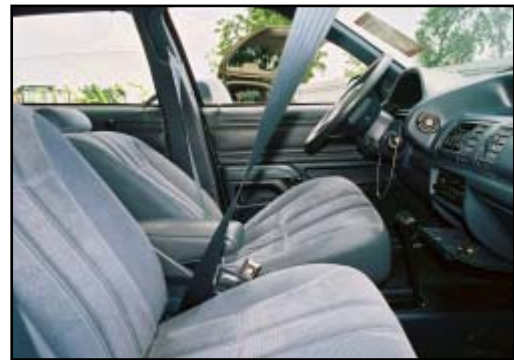
The Tempo sustained moderate interior damage as a result of passenger compartment intrusion. Both rear door windows and the backlight disintegrated as a result of the initial impact. The driver's seat was deflected rearward as a result of occupant loading (**Figure 9**). At the time of the inspection, the seat back was reclined 60 degrees from vertical and the recline adjustment mechanism was jammed. The driver's seat cushion was displaced upward, and the outboard side measured 7.0 cm (2.8") above the inboard aspect of the cushion. The center armrest was displaced 1.9 cm (0.8") to the right. The right sun visor was displaced rearward, disengaged from the bracket.

Figure 9. View of driver's seat and displaced arm rest

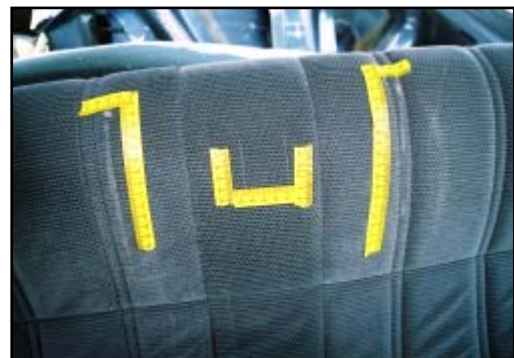
Vertical linear scuffs were present 3.8 cm (1.5") below the top of the rear seat back on the forward aspect from engagement with the plastic shell of the CSS (**Figure 10**). The left scuff was located 14.0 cm (5.5") right of the centerline and measured 17.8 cm (7.0") in length. The right scuff was located 11.4 cm (4.5") right of the centerline and measured 12.7 cm (5.0") in length. Two

Figure 10. View of scuffs on rear seat back

smaller linear scuffs that measured 3.2 cm (1.3”) were located 7.6 cm (3.0”) below the top aspect of the seat back and 0.6 cm (0.3”) and 1.9 cm (0.8”) left and right of the centerline, respectfully. There was no contact evidence on the rear aspects of the front seat backs.

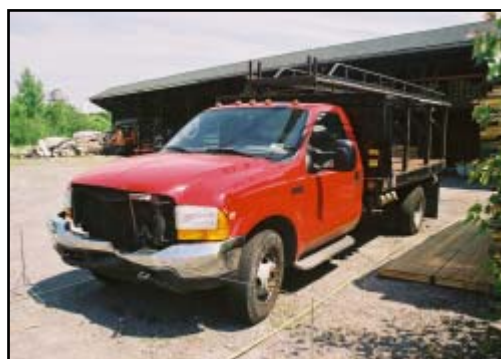
The 1999 Ford F-350 (**Figure 11**) sustained minor frontal damage as a result of the impact with the Tempo. The vehicle was a Ford F-350 Super-Duty chassis with a steel flat-bed that measured 365.8 cm (144.0”) in length and 243.8 cm (96.0”) in width. The direct damage began at the front left corner and extended 161.3 cm (63.5”) to 67.3 cm (26.5”) right of the centerline. Paint transfers began at the left front corner and extended 98.4 cm (38.8”) to the right from direct contact with the Tempo. The front bumper was displaced slightly to the right and the plastic grille was fractured and separated. The combined direct and induced damage involved the entire frontal width of the

Figure 11. Damaged 1999 Ford F-350 truck

F-350 and measured 190.5 cm (75.0"). The left front fender sustained minor induced buckling. Six crush measurements were documented along the front bumper and were as follows: C1 = 18.4 cm (7.3"), C2 = 7.6 cm (3.0"), C3 = 7.6 cm (3.0"), C4 = 5.1 cm (2.0"), C5 = 0.0 cm, C6 = 0.0 cm. The CDC for the frontal impact with the Ford Tempo was 12-FDEW-1.

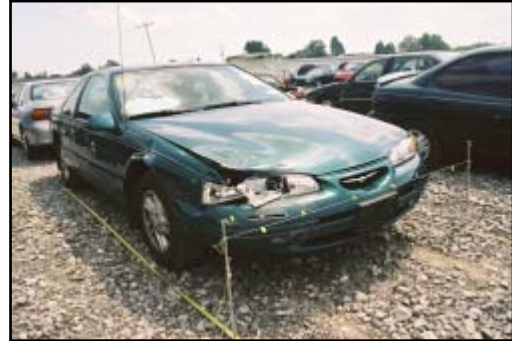
The 1996 Ford Thunderbird (**Figure 12**) sustained minor frontal damage as a result of the secondary impact with the Tempo. The direct damage began 17.8 cm (7.0") right of the centerline and extended 78.7 cm (31.0") to the front right corner. Paint transfers and abrasions were present on the front right aspect of the bumper fascia and on the front right aspect of the hood. The right headlamp was fractured and the bumper fascia was fractured on the right aspect. The combined direct and induced damage involved the entire frontal width of the vehicle and measured 154.9 cm (61.0"). The right front fender sustained induced buckling. Six crush measurements were documented along the front bumper and were as follows: C1 = 0.0 cm, C2 = 0.0 cm, C3 = 0.0 cm, C4 = 0.0 cm, C5 = 1.3 cm (0.5"), C6 = 10.2 cm (4.0"). The CDC for the secondary frontal impact with the Ford Tempo was 12-FZEW-1.

Figure 12. Damaged 1996 Ford Thunderbird

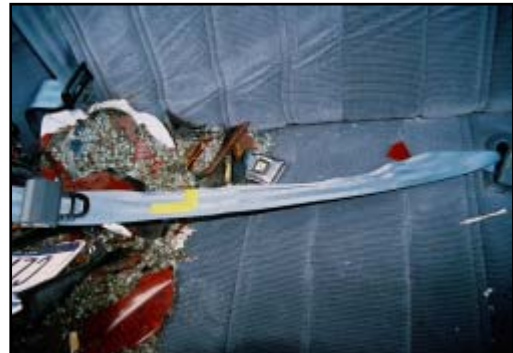
The 1992 Ford Tempo was configured with automatic shoulder belts and manual lap belts for both front seat positions. The lap belts were configured with sewn latch plates which yielded minor abrasions consistent with minimal historical use. The rear outboard seating positions were configured with three-point lap and shoulder belts with sliding latch plates and Emergency Locking Retractors (ELR's). The rear center position was configured with a lap belt with a locking latch plate (**Figure 13**). At the time of the vehicle inspection, the center of the latch plate was located 62.2 cm (24.5") from the anchor and the excess webbing from the latch plate measured 57.2 cm (22.5"). The belt webbing was cupped as a result of the loading of the CSS against the webbing due to the intrusion of the rear seat back. The cupping on the webbing began 16.5 cm (6.5") from the anchor and extended 35.6 cm (14.0") along the webbing. A faint plastic transfer was present on the bottom aspect of the webbing (exposed to the rear of the CSS belt path) from CSS loading that measured 3.2 cm (1.3") in length, 1.9 cm (0.8") in width, and was located 33.0 cm (13.0") from the anchor.

Figure 13. Rear center lap belt

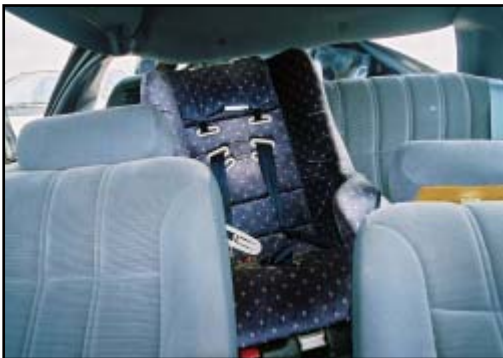
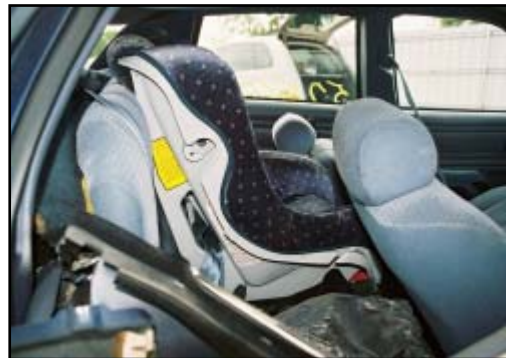
At the time of the vehicle inspection, the CSS was found installed in the rear-center position of the Tempo (**Figures 14 and 15**), secured by the lap belt and locking latch plate. Due to the rear seat back intrusion and rearward deflection of the driver's seat back, the CSS was projected forward and wedged between the rear seat back and the front seat backs. The distance between the CSS seat back and the front left and front right seat backs measured 20.3 cm (8.0") and 27.9 cm (11.0"), respectively. The CSS was rotated slightly CCW and leaned slightly toward the right side. The top of the CSS was located 2.5 cm (1.0") below the intruded backlight header. During the SCI inspection, the investigator was able to pull the top of the CSS forward 3.8 cm (1.5") away from the vehicle seat back.

Figure 14. View of CSS as found in the Tempo

Figure 15. Lateral view of CSS as found in the Tempo

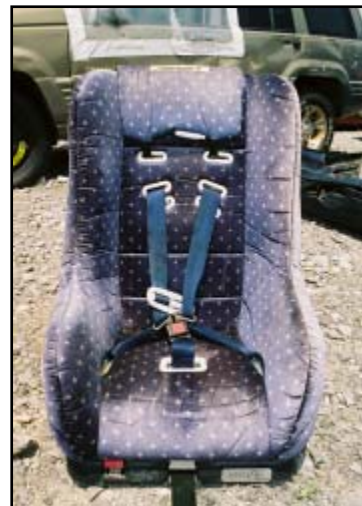
The CSS recline adjustment was found in the upright position and the shoulder harness straps were positioned through the second set of harness slots (**Figure 16**). The harness slots in use provided no forward-facing reinforcement at that level. The harness adjustment tab extended 35.6 cm (14.0") from the forward aspect of the seat and the plastic harness retainer clip was positioned on the right shoulder harness 22.9 cm (9.0") below the right harness slot. At the time of the CSS inspection, the retainer clip was not engaged with the left shoulder harness strap. The left shoulder harness strap was folded in half starting 35.6 cm (14.0) below the right harness slot and 5.1 cm (2.0") below the right latch plate loop. Both latch plates had abrasions consistent with frequent usage. The vehicle belt locking clip was found on the harness adjustment webbing 7.6 cm (3.0") forward of the splitter plate on the bottom aspect of the CSS. There was no loading evidence present on the CSS shoulder harnesses or the harness slots due to the rear impact and subsequent rebound.

Figure 16. Evenflo Convertible CSS

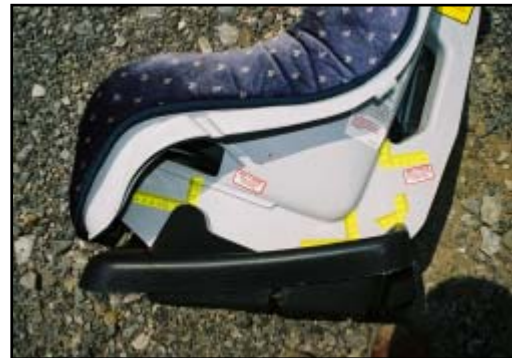
Minor abrasions were present on the bottom aspects of the forward-facing belt path from engagement with the vehicle's lap belt. In the forward-facing orientation, a triangular fracture on the left outboard aspect of the plastic shell was present under the rear facing belt path (**Figure 17**). The fracture began 0.6 cm (0.3") rear of the leading edge of the rear-facing belt path and extended 3.8 cm (1.5") rearward. The plastic shell also exhibited stress marks on the left side of the shell. The first stress mark measured 4.4 cm (1.8") in length and was located 10.2 cm (4.0") forward of the rear edge and 2.5 cm (1.0") above the base of the CSS. A second stress mark that measured 2.5 cm (1.0") in length was present on the left side of the CSS and located 4.4 cm (1.8") forward of the rear aspect and 4.4 cm (1.8") above the base of the CSS. Two longitudinal stress marks were located on the bottom aspect of the plastic CSS base. The first measured 3.8 cm (1.5") in width and was located 21.6 cm (8.5") rear of the forward aspect of the base and 9.5 cm (3.8") left of the centerline. The second measured 5.7 cm (2.3") in width and was located 24.1 cm (9.5") rear of the forward aspect and 14.0 cm (5.5") left of the centerline. Minor abrasions were present on the front and rear outboard corners of the plastic shell.

Figure 17. Left side view showing fracture and stress marks
