### ON-SITE CERTIFIED ADVANCED 208- COMPLIANT VEHICLE INVESTIGATION

CASE NUMBER - IN-03-038  
LOCATION - TEXAS  
VEHICLE - 2003 CHEVROLET K1500 SILVERADO Z71  
CRASH DATE - July 2003

1. <i>Report No.</i> IN-03-038		2. <i>Government Accession No.</i>		3. <i>Recipient's Catalog No.</i>	
4. <i>Title and Subtitle</i> On-Site Certified Advanced 208-Compliant Vehicle Investigation Vehicle - 2003 Chevrolet K1500 Silverado Z71 Location - Texas			5. <i>Report Date:</i> May 21, 2007

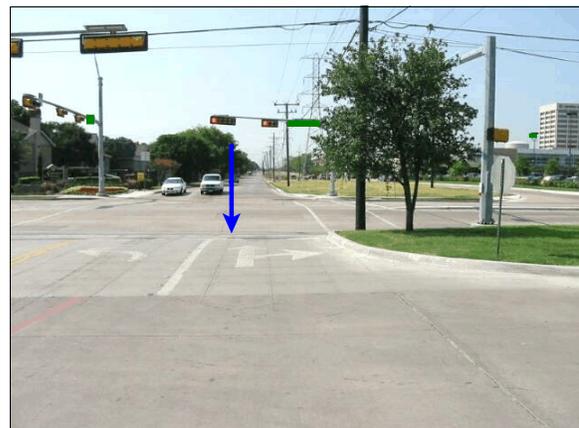
**Figure 1:** Case vehicle's southward travel path in southbound through lane; case vehicle accelerated forward into intersection from a stop; Note arrow indicates approximate impact location with Honda (case photo #01)

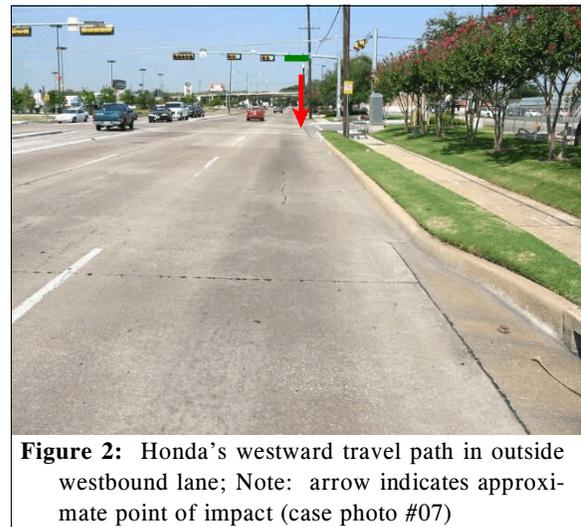
**Figure 2:** Honda's westward travel path in outside westbound lane; Note: arrow indicates approximate point of impact (case photo #07)

The other vehicle's city roadway was straight and level at the area of impact (**Figure 2**). The pavement was concrete, and the width of the outside westbound through lane was 3.5 meters (11.5 feet). The east-west trafficway's shoulders were not improved (i.e., grass), and the westbound roadway was bordered by barrier curbs with the curb on the north associated with a 1.5 meter (4.9 foot) raised paved median. No centerline was present for the westbound roadway. Pavement markings consisted of dashed white lines that separated the through lanes. Furthermore, the left-hand turn lane was separated from the through lanes by solid white lane line. In addition, no edge lines were present. The estimated coefficient of friction was 0.75. Traffic controls consisted of three on-colors, pre-timed, horizontal mounted traffic control signals that were located on the northwest quadrant of the four-leg intersection. The statutory speed limit was 72 km.p.h. (45 m.p.h.). No regulatory speed limit sign was posted near the crash site.

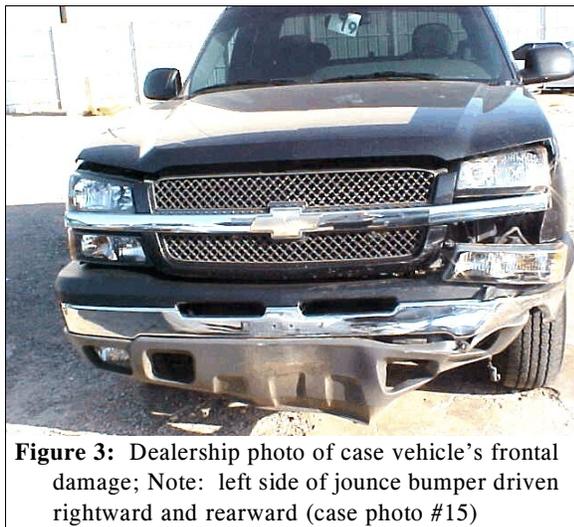
**Figure 3:** Dealership photo of case vehicle's frontal damage; Note: left side of jounce bumper driven rightward and rearward (case photo #15)

**Crash:** The front left (**Figure 3**) of the case vehicle impacted the right front (**Figure 4**) of the Honda. Although the case vehicle was equipped with driver and front right passenger supplemental restraints (air bags), the driver's air bag did not deploy. Furthermore, the case vehicle was equipped with a switchable (i.e., a cutoff switch) front right passenger supplemental restraint (air bag) that was set to the "auto" position. This air bag also did not deploy during the crash sequence.

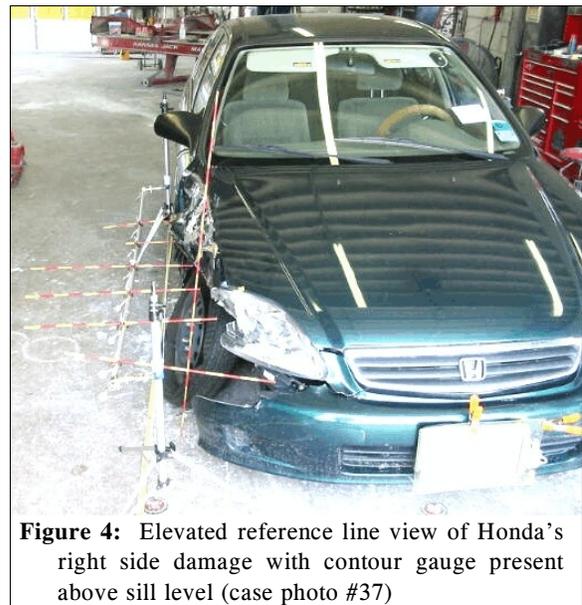
**Figure 4:** Elevated reference line view of Honda's right side damage with contour gauge present above sill level (case photo #37)

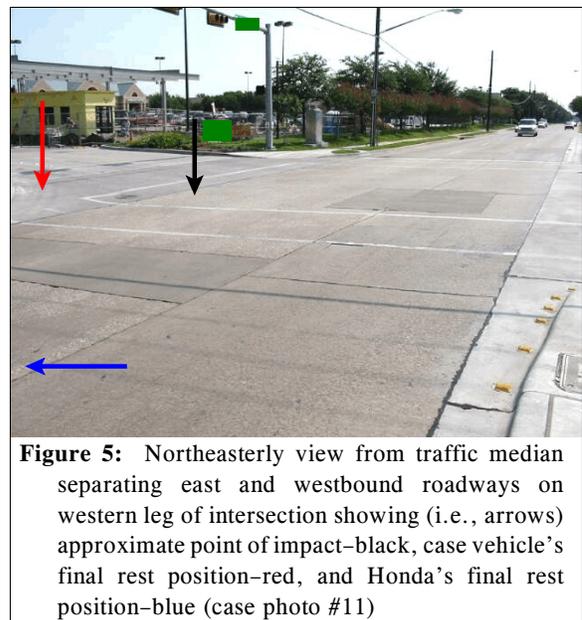
**Figure 5:** Northeastery view from traffic median separating east and westbound roadways on western leg of intersection showing (i.e., arrows) approximate point of impact—black, case vehicle's final rest position—red, and Honda's final rest position—blue (case photo #11)

coming to rest, obliquely oriented, in the center westbound through lane of the western leg of the intersection, heading in a west-southwesterly direction (**Figure 5** above).

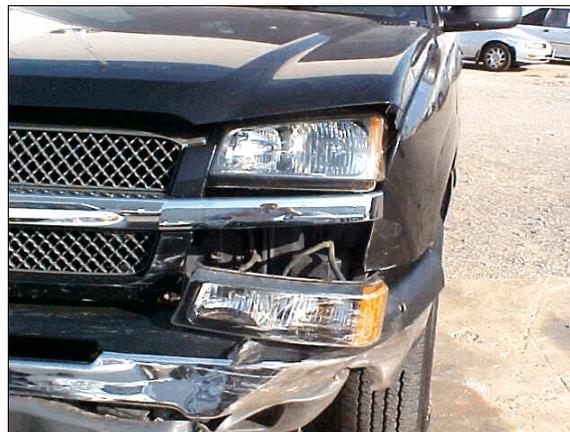
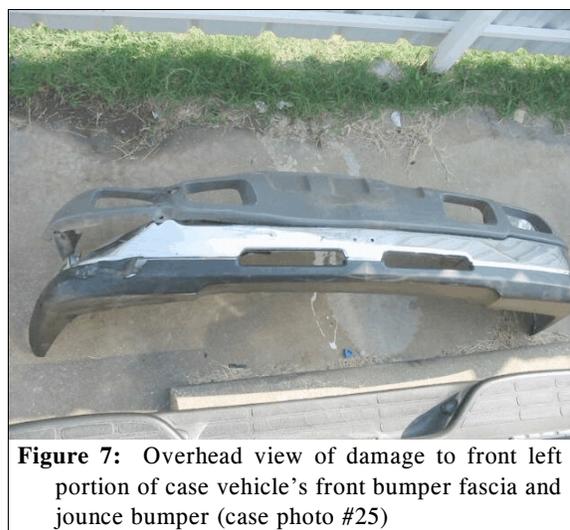
**Figure 6:** Dealership close-up photo of damage to case vehicle's front left bumper and left headlight and turn signal assemblies (case photo #18)

**Figure 7:** Overhead view of damage to front left portion of case vehicle's front bumper fascia and jounce bumper (case photo #25)

inches) inward along the front bumper (**Figures 6 and 7** above). Crush measurements as well as maximum crush could not be determined. Because the vehicle was partially repaired at the time of inspection, it is unknown if the case vehicle’s wheel base was altered as a result of the crash. The case vehicle’s front bumper, bumper fascia, jounce bumper, portions of the left headlight and turn signal assemblies, and the left fog lamp were directly damaged and crushed rearward. There was induced damage to the remainder of the left headlight assembly, and remote buckling (i.e., an increased separation) was also found between the right portion of the case vehicle’s extended cab behind the right rear door and in front of the regular truck bed (**Figure 8**). No obvious induced damage or remote buckling was noted to the remainder of the case vehicle’s exterior.

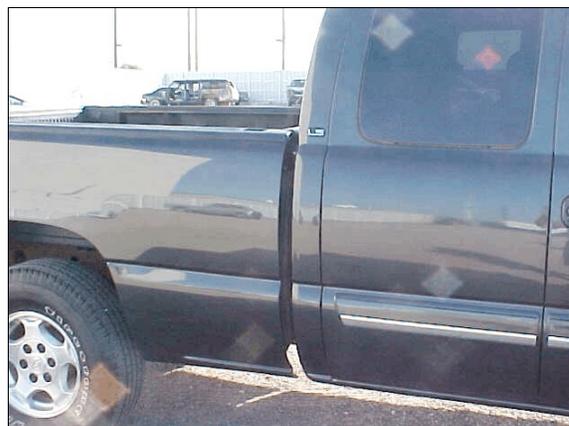
**Figure 8:** Dealership photo of remote buckling to case vehicle’s right truck bed (case photo #24)

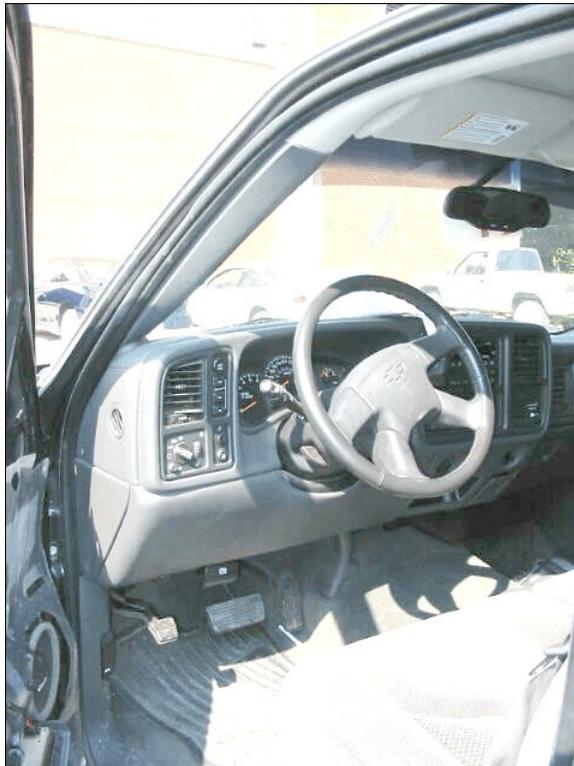
**Vehicle Interior:** Inspection of the case vehicle’s interior revealed no evidence of occupant contact on the interior surfaces of the case vehicle (**Figures 9 and 10** below). Furthermore, there was no evidence of intrusion to the case vehicle’s interior, no evidence of compression to the energy absorbing shear capsules in the steering column, and no deformation to the steering wheel rim.

**Figure 9:** Case vehicle's driver seating area showing non-deployed driver air bag and foot well and no apparent evidence of occupant contact to left instrument panel, driver's knee bolster, and left "A"-pillar, windshield glazing, or sun visor (case photo #27)

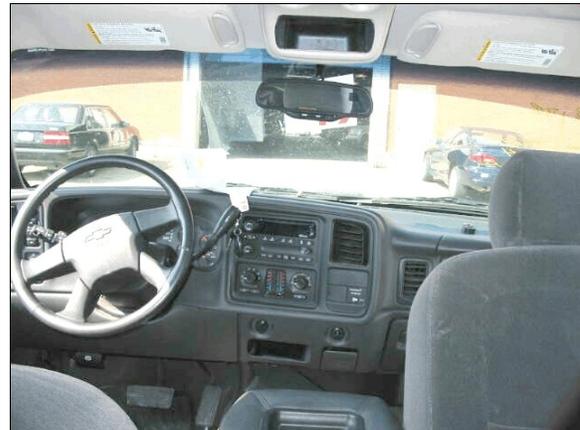
**Figure 10:** Case vehicle's driver seating area and center instrument panel showing non-deployed driver air bag and no apparent evidence of occupant contact to steering wheel, center instrument panel, or greenhouse areas (case photo #29)

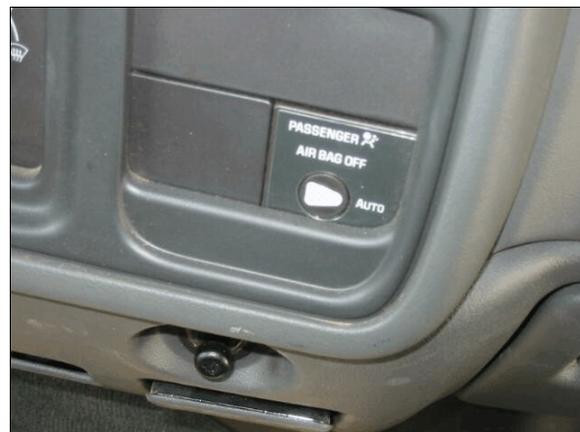
**Figure 11:** Close-up of case vehicle's center instrument panel showing front right air bag control switch in "auto" position (case photo #30)

The case vehicle was equipped with a Supplemental Restraint System (SRS) that contained dual stage frontal air bags at the driver and front right passenger positions. Neither frontal air bag deployed as a result of the oblique frontal impact with the Honda. The case vehicle's driver air bag was located in the steering wheel hub, and the front right passenger's air bag was located in the middle of the instrument panel. The front right passenger air bag was controlled by an On/Off switch, which was positioned in the On (i.e., "AUTO"matic) position at the time of the crash (Figures 11 and 12).

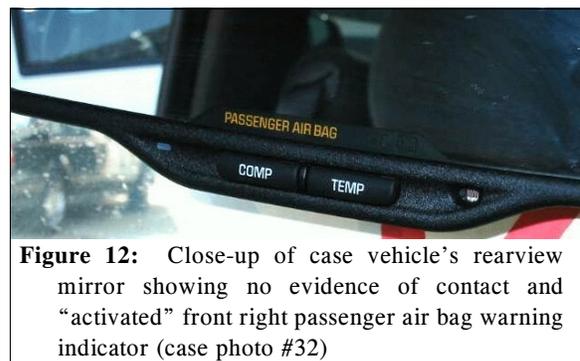
**Figure 12:** Close-up of case vehicle's rearview mirror showing no evidence of contact and "activated" front right passenger air bag warning indicator (case photo #32)

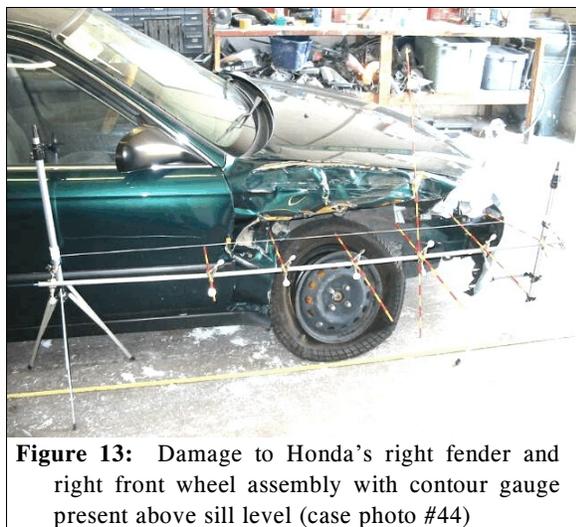
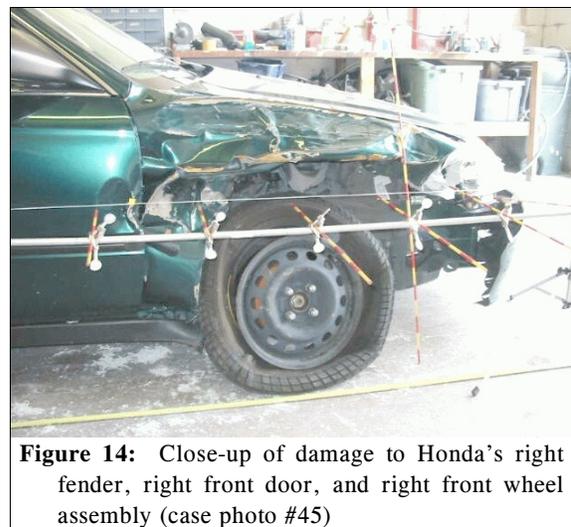
**Figure 13:** Damage to Honda’s right fender and right front wheel assembly with contour gauge present above sill level (case photo #44)

**Figure 14:** Close-up of damage to Honda’s right fender, right front door, and right front wheel assembly (case photo #45)

**Exterior Damage:** The Honda’s contact with the case vehicle primarily involved its right front (Figures 13 and 14). Direct damage began 208 centimeters (81.9 inches) forward of the right rear axle and extended, a measured distance of 120 centimeters (47.2 inches), along the right front door and fender. The Field L began 200 centimeters forward of the right rear axle and extended 128 centimeters (50.4 inches) to the right front bumper corner. Residual maximum crush was measured as 9 centimeters (3.5 inches) at C<sub>2</sub>. The table below shows the case vehicle’s crush profile.

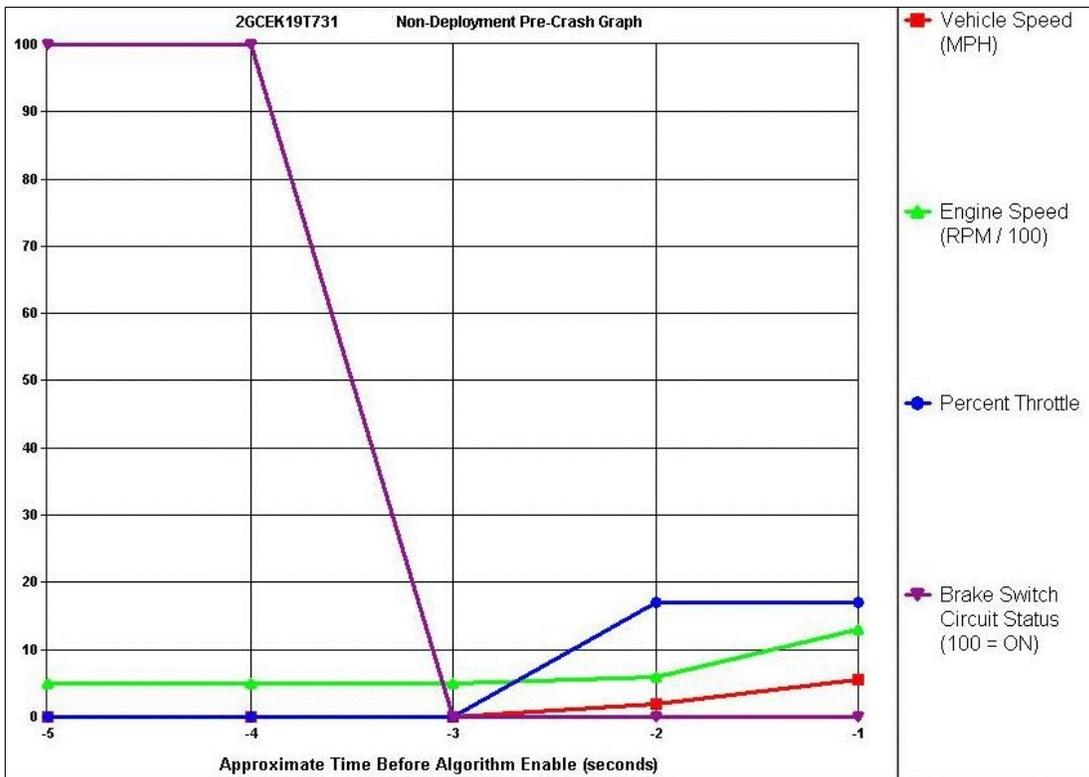
**Figure 16:** Case vehicle's pre-crash speed and brake switch circuit status showing that the vehicle had accelerated to approximately 10 km.p.h. (6 m.p.h.) and that the brake switch had been deactivated approximately 3 seconds prior to algorithm enable.

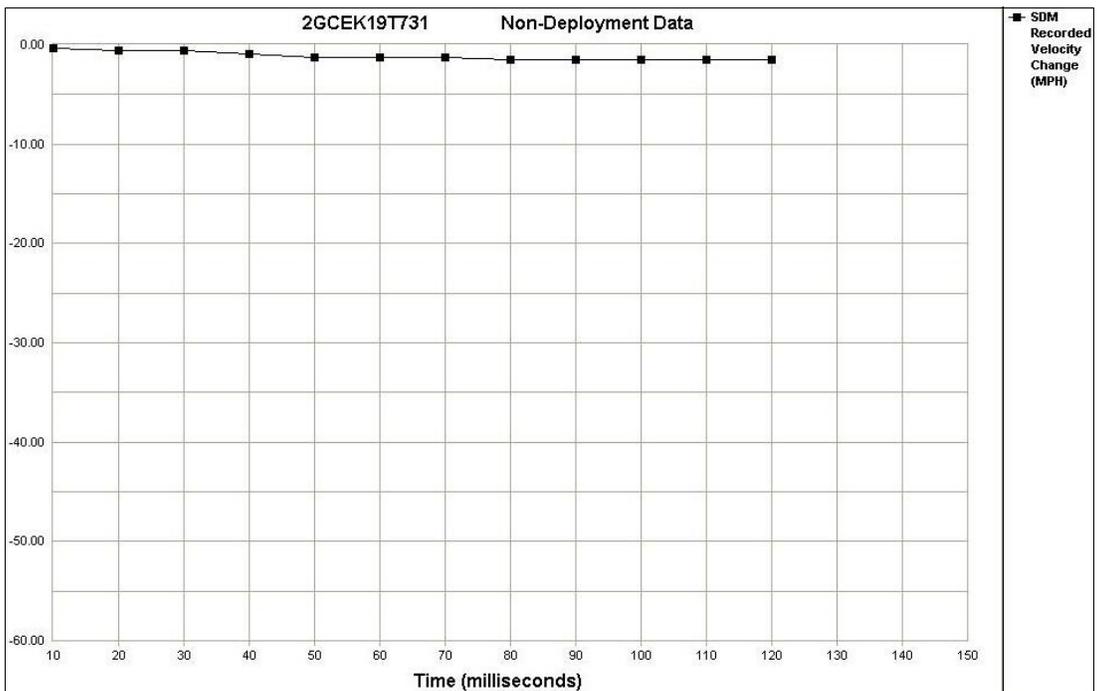
**Figure 17:** The case vehicle sustained a velocity change of approximately 2.6 km.p.h. (1.6 m.p.h.) during the first 120 milliseconds after the crash was detected
