CALSPAN ON-SITE CHILD SAFETY SEAT CRASH INVESTIGATION

CALSPAN CASE NO: CA03-038

VEHICLE: 1994 CHEVROLET CAVALIER

CRASH DATE: JUNE 2003

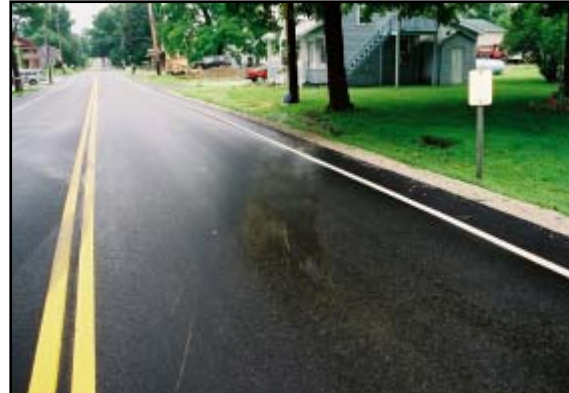
Figure 3. POI from the Chevrolet's northbound approach.

The front right area of the Chevrolet struck the front right of the Ford in a head-on off-set configuration (**Figure 3**). The resultant directions of force were 1 o'clock for the Chevrolet and 12 o'clock for the Ford. The WINSMASH damage algorithm was used to calculate a delta-V for this impact. The total delta-V for the Chevrolet was 99 km/h (61.5 mph) and the Ford was 52 km/h (32.3 mph). The longitudinal and lateral components for the Chevrolet were -93 km/h (-57.8 mph) and -33.9 km/h (-21.0 mph), respectively. The longitudinal and lateral components for the Ford were -52 km/h (-32.3 mph) and 0 km/h, respectively.

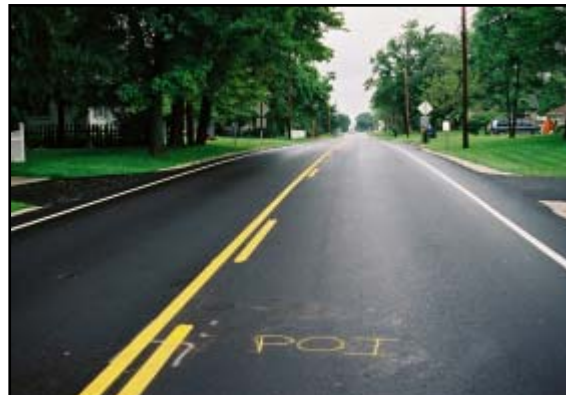
As a result of the off-set frontal impact, the Cavalier's forward momentum was arrested as the vehicle was redirected rearward. Thus, the Chevrolet began to travel in a southwest direction while initiating a counterclockwise rotation. The travel path of the Chevrolet was evidenced by gouging and fluid on the asphalt road surface. These witness marks were approximately 6 meters (19.7 feet) in length and extended to the west curb on a diagonal path. The Chevrolet entered the roadside where the left side tires rolled under the steel rims and gouged the grass surface. The ground contact was evidenced by a 2 meter (6.6 feet) gouge in the grass surface. This contact tripped the Chevrolet into a left side leading rollover event. The greenhouse area of the Cavalier impacted and sheared a utility pole as it rolled to final rest on its roof. The Cavalier was displaced approximately 20 meters (65.6 feet) from the point of impact with the Ford. **Figure 4** is an overall view of the Cavaliers approach to the rollover event, the pole impact, and final rest.

Figure 4. Cavalier's approach to rollover event, pole impact, and final rest.

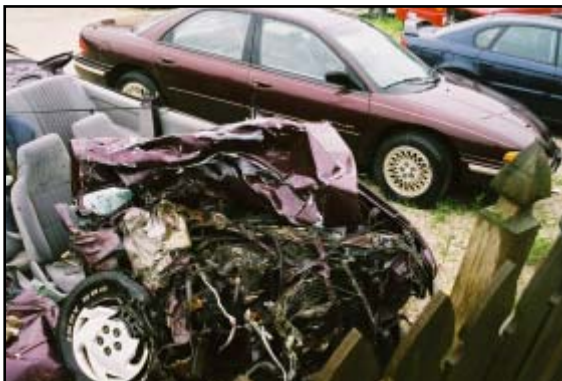
The 1994 Chevrolet Cavalier sustained severe frontal damage as a result of the impact with the Ford (**Figures 5 and 6**). Maximum crush was 151 cm (59.4”), located 8 cm (3.1”) right of the centerline. The direct contact damage measured 117 cm (46”) and extended from bumper corner to bumper corner. The bumper beam was separated during the crash; therefore, the residual crush was measured along the full width of the deformed upper radiator support (Field L) of 80 cm (31.5”). Six equidistant crush measurements were documented at this level and were as follows: C1 = 48 cm (18.9”), C2 = 109 cm (42.9”), C3 = 141 cm (55.5”), C4 = 151 cm (59.4”), C5 = 145 cm (57.0”), C6 = 137 cm (53.9”). The Collision Deformation Classification (CDC) for this impact was 01-FDEW-6. The right front door was jammed closed and was cut from the vehicle by rescue personnel. The roof was cut from the vehicle and was not located; therefore the severity of damage to the roof of the Cavalier is unknown. The CDC for the rollover event was 00-T990-9 and the pole impact was 00-T999-9 (9’s = represent unknown).

Figure 5. Overhead view of the frontal damage.

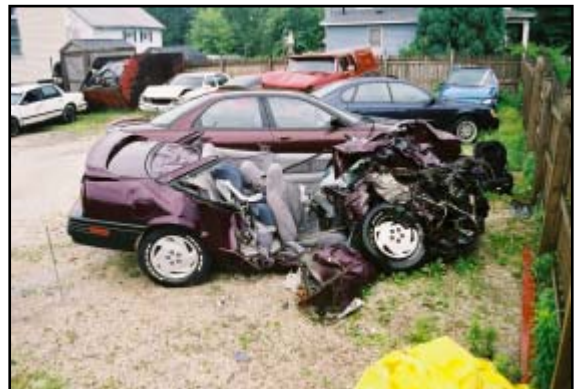
Figure 6. Overall view of the resultant damage.

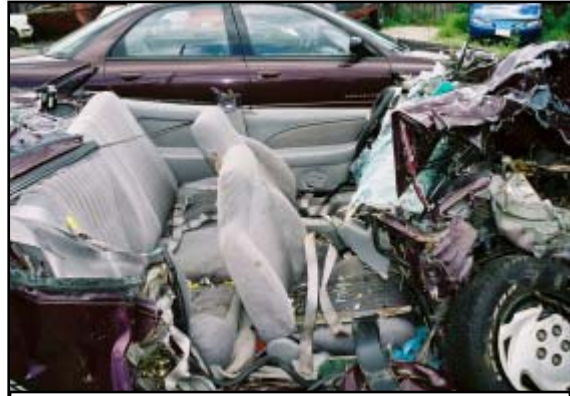
The interior of the Chevrolet sustained moderate severity damage from occupant contact points. The driver’s occupant contact points consisted of contact and loading to the steering components. The steering wheel rim was bent 10 cm (4.0”) forward and the shear capsules were completely separated from loading. The tilt steering lever was fractured from its mounting point. A right knee contact was noted to the knee bolster which was evidenced by a 5 cm (2”) dent that penetrated into the heater core and sub panel. Additionally, a scuff mark was noted on the bottom aspect of the steering column shroud.

Figure 7. Overall view of the passenger compartment.

The front right passenger contact points consisted of fractures to the glove box door from contact with her knees. The intruding front right instrument panel contacted the passenger, which resulted in scuffing and fracturing of the instrument panel. A scuff mark was noted to the rear of the front right seatback from contact with the child safety seat. However, no occupant contact points from the rear seat passengers were present in the vehicle. **Figure 7** is an overall view of the passenger compartment. The passenger compartment intrusions were as follows:

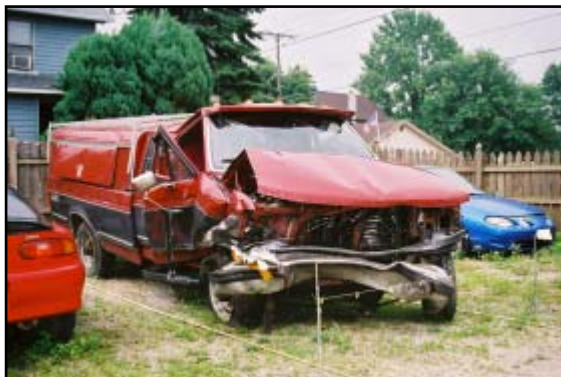
The 1993 Ford F-250 sustained severe frontal damage as a result of the impact with the Chevrolet (**Figure 8**). The maximum crush measured 82 cm (32.3”) and was located at the front right bumper corner. The direct contact damage measured 150 cm (59.0”) and extended from the front left bumper corner to the front right bumper corner. A crush profile was documented along the front bumper to capture the residual crush. The profile was as follows: C1 = 0 cm, C2 = 2 cm (0.8”), C3 = 45 cm (17.7”), C4 = 47 cm (18.5”), C5 = 51 cm (20.0”), C6 = 82 cm (32.3”). The CDC for this impact was 12-FDEW-3.

Figure 8. Resultant damage to the front of the 1993 Ford F-250.

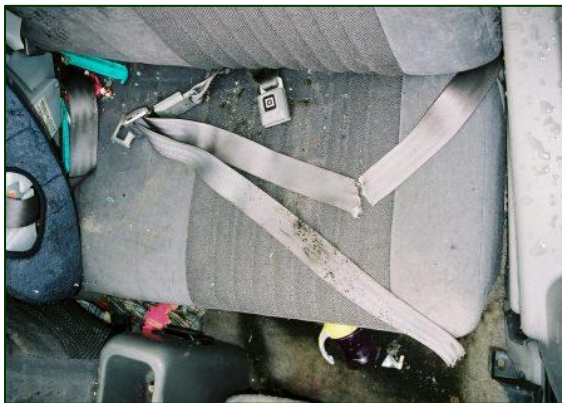
rear buckle and the belt webbing was cut by rescue personnel (**Figure 9**). The shoulder belt webbing was cut 61 cm (24.0”) above the latch plate and lap belt was cut 32 cm (12.75”) above of the anchor. Additional damage to the belt system consisted of a fractured plastic buckle sleeve. The SCI investigator noted the portion of lap belt that was exposed measured 75 cm (29.5”). The child safety seat was repositioned in the vehicle and it was determined that to obtain a snug fit installation, the exposed length of lap belt length would be approximately 56 cm (22.0”). Therefore, it appears that the child safety seat was loosely installed prior to the crash.

Figure 9. Cut left rear safety belt.

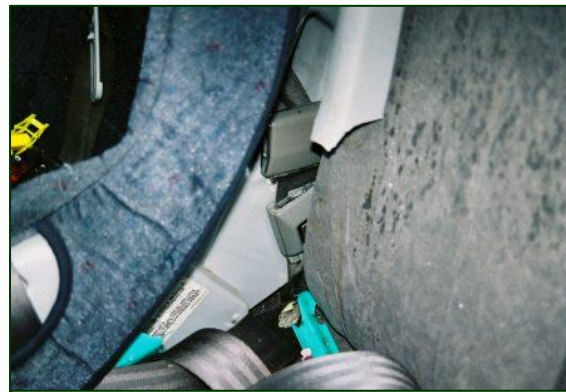
The right rear safety belt exhibited a vinyl transfer from the loading with the belt path of the child safety seat. This transfer measured 6 cm (2.25”) and was located 59 cm (23.25”) below the rear deck. The trunk contents, which consisted of a stroller, two bags of clothing, and two diaper bags were displaced forward and loaded the rear of the seatback deforming the center section forward. Due to this displacement, the side mounted release button for the rear right safety belt buckle was compressed and consequently released (**Figure 10**). The rear center belt was a lap belt only with a locking latch plate and no retractor.

Figure 10. Released right rear safety belt buckle.

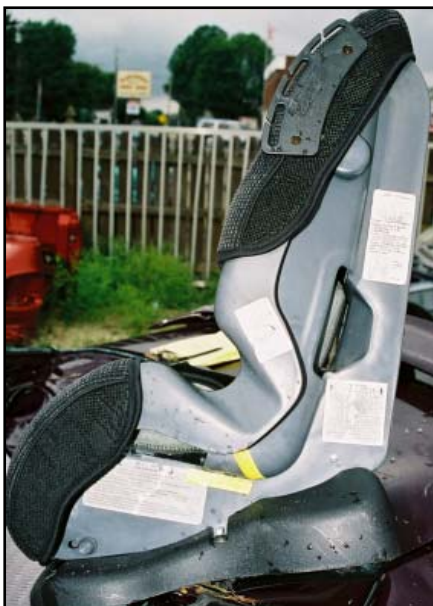
The history of the CSS was unknown. The CSS was located by the SCI investigator outside the vehicle exposed to weather. It was determined that the CSS was installed forward facing using the vehicle's lap and shoulder belt incorrectly routed through the rear facing belt paths. This was supported by loading evidence at the rear facing belt path. The left rear facing belt path of the CSS exhibited a 5 cm (1.875") tear from loading by the lap belt. And the right rear facing belt of the CSS contained a 3 cm (1.125") tear from the lap belt loading. The plastic shell at the tear location was deformed rearward and exhibited a white color at the deformation areas. **Figure 11** is of the left side of the CSS, the damage to belt path is highlighted with calibrated tape.

Figure 11. Loading damage to the belt path.

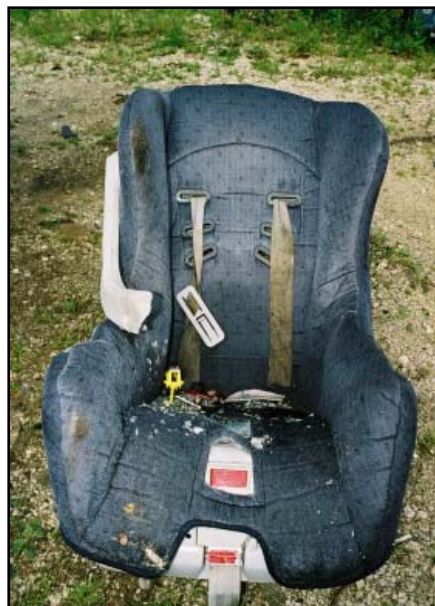
Figure 12. Century convertible CSS.

The harness straps were cut to remove the child from the CSS. The left strap was cut 32 cm (12.5”) below the top slots and the right strap was cut 34 cm (13.25”) below the top slot. The right harness strap was also twisted in the retainer clip. Damage to the CSS consisted of fractures to the tray shield. The right side of the tray shield was fractured at the junction of the arm and shield 36 cm (14”) below the pivot point. The left side of the tray shield was fractured 18 cm (7”) below the pivot point. The tray shield damage was attributed to the intruding B-pillar and the side panel rear of the B-pillar. Additional damage was noted to the shell of the CSS which was fractured at the rear facing belt path. This fracture measured 8 x 6 cm (3.25 x 2.25”) and resulted from contact with the intruding side panel rear of the B-pillar. Stress marks were noted across the full frontal width of the CSS from contact with the back of the front right seat.
