ON-SITE REDESIGNED AIR BAG INVESTIGATION

CASE NUMBER - IN-03-040
LOCATION - MISSOURI
VEHICLE - 2002 KIA SPECTRA
CRASH DATE - September 2003

1. <i>Report No.</i> IN-03-040		2. <i>Government Accession No.</i>		3. <i>Recipient's Catalog No.</i>	
4. <i>Title and Subtitle</i> On-Site Redesigned Air Bag Investigation Vehicle - 2002 Kia Spectra Location - Missouri			5. <i>Report Date:</i> May 17, 2007

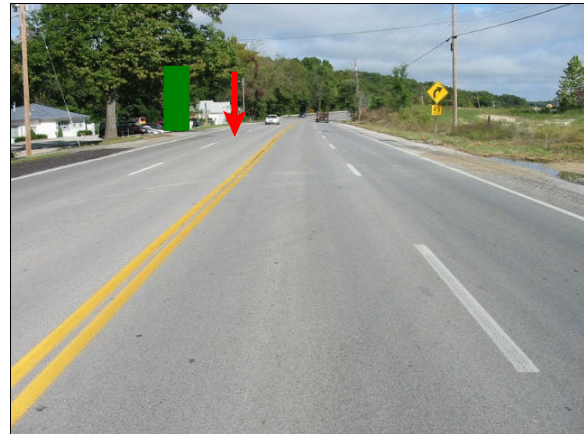
Figure 1: Case vehicle's north-northwestward travel path in inside northern lane; Note: arrow shows approximate point of impact (case photo #02)

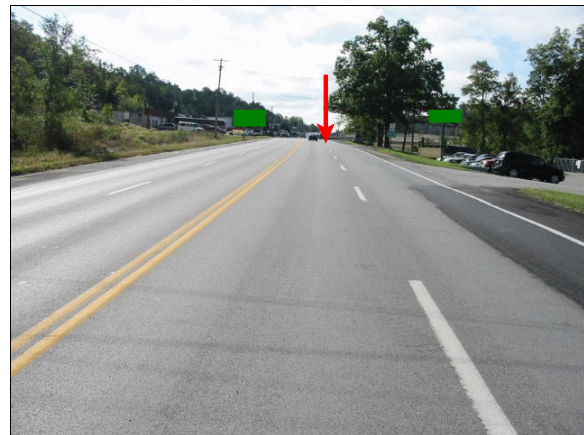
Figure 2: Chevrolet's south-southwestward travel path, exiting slight left-hand curve, in inside southern lane; Note: arrow indicates approximate location of impact near driveway junction (case photo #09)

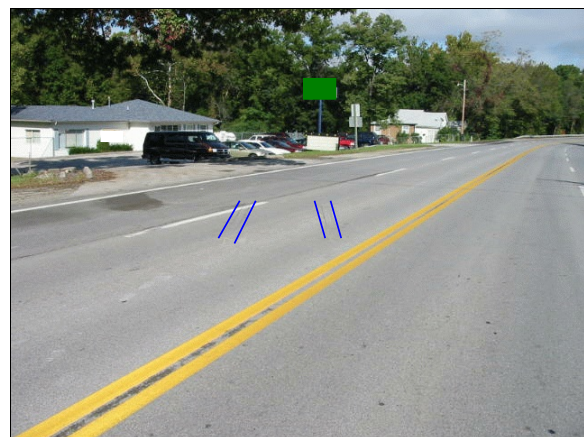
Figure 3: Case vehicle's pre-impact skid marks {highlighted} in inside southern lane deposited during case vehicle's left-hand turn toward commercial driveway on western roadside (case photo #04)

scene, the case vehicle left approximately 3 meters (9.8 feet) of skid marks in an attempt to avoid the crash (**Figure 3** above). The driver of the Chevrolet steered to the right and braked, depositing approximately 12 meters (39.4 feet) of pre-impact skid marks, attempting to avoid the crash (**Figure 4**). The crash occurred in the inside southern lane of the roadway, within or near the driveway junction.

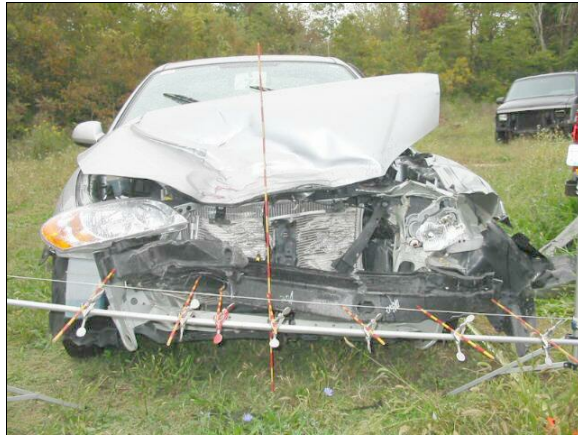
Figure 5: Case vehicle's frontal damage with contour gauge set at bumper level (case photo #17)

Crash: The front (**Figure 5**) of the case vehicle impacted the front left corner (**Figure 6**) of the Chevrolet, causing the case vehicle's driver and front right passenger supplemental restraints (air bags) to deploy. The Chevrolet's driver only air bag also deployed as a result of this crash.

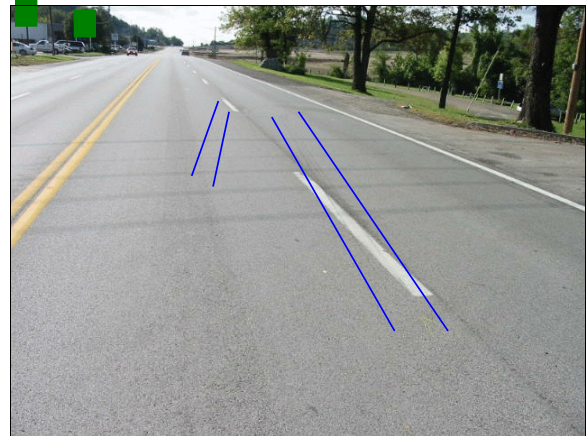
Figure 4: Chevrolet's rightward steering and pre-impact skid marks {highlighted} beginning in inside southern lane (case photo #12)

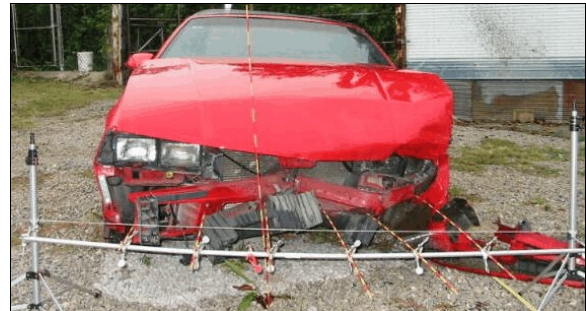
Figure 6: Chevrolet's frontal damage with contour gauge set at bumper level (case photo #58)

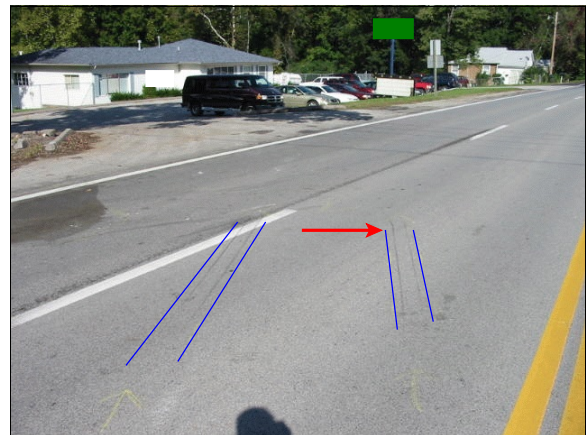
Post-Crash: As a result of this impact, the case vehicle was driven backwards (i.e., towards the south-**Figure 7**) and rotated approximately 125 degrees counterclockwise before coming to rest, obliquely oriented in the outside southern lane, heading in a south-southwesterly direction. Post-impact, the Chevrolet continued in a southward path but was redirected approximately 30 degrees clockwise (**Figure 8** below) before it came to rest obliquely oriented, straddling the outside southern lane, heading in a south-southwesterly direction (**Figure 9** below).

Figure 7: Close-up of case vehicle's pre-impact skid marks in inside southern lane, deposited during case vehicle's left-hand turn; Note: arrow shows deflection point of right front tire (case photo #05)

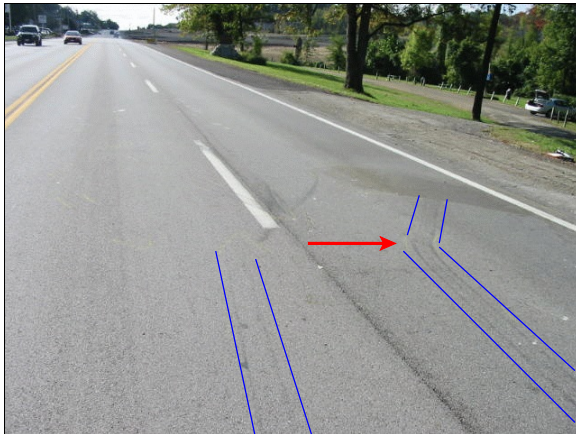
Figure 8: Chevrolet’s southwestward post-impact trajectory from impact (i.e., deflection points) position, straddling southern lanes, to final rest (i.e., fluid run off) position obliquely oriented in outside southern lane (case photo #06)

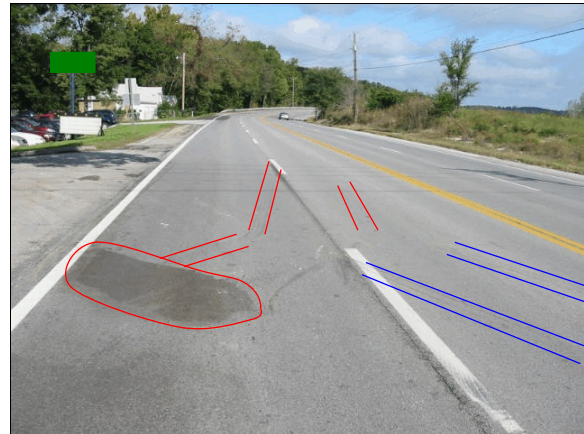
Figure 9: North-northwestward view in outside southern lane showing case vehicle’s pre-impact skid marks (blue lines) and Chevrolet’s pre-impact skid marks, deflection marks, and final rest position (i.e., fluid run off-red lines), obliquely oriented in outside lane (case photo #16)

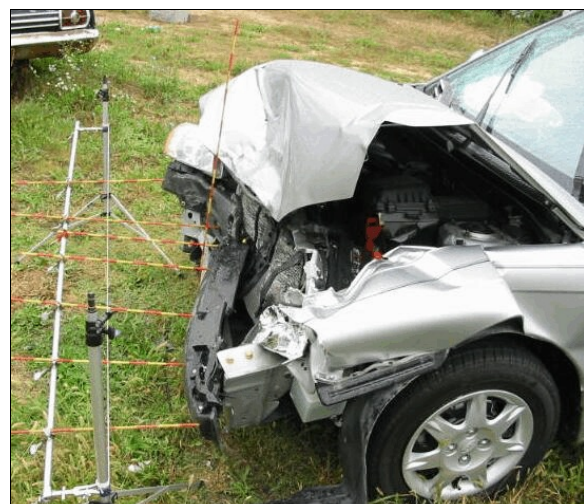
Figure 10: Reference line view from left showing case vehicle’s frontal damage with contour gauge set at bumper level (case photo #20)

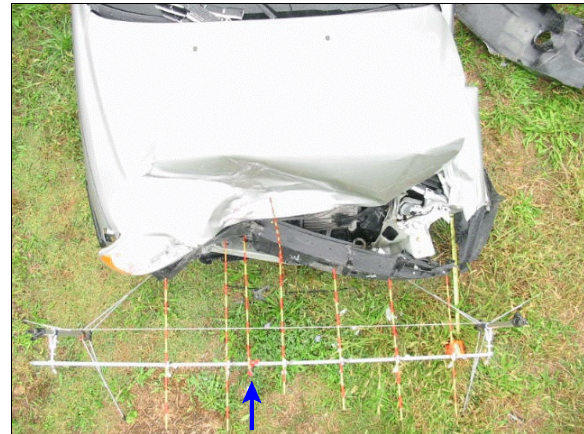
Exterior Damage: The case vehicle's contact with the Chevrolet primarily involved the front with the damage distributed on approximately the left two-thirds (Figures 5 and 10 above). Direct damage began at the front left bumper corner and extended 150 centimeters (59.1 inches) across the entire width of the front bumper. Field L was measured as 122 centimeters (48.0 inches) and also extended the entire width of the front bumper. Residual maximum crush was measured as 30 centimeters (11.8 inches) and was located 9 centimeters (3.5 inches) to the left of C₅ (Figure 11). The table below shows the case vehicle's crush profile.

Figure 11: Overhead view of case vehicle's frontal damage with contour gauge set at bumper level (case photo #30)

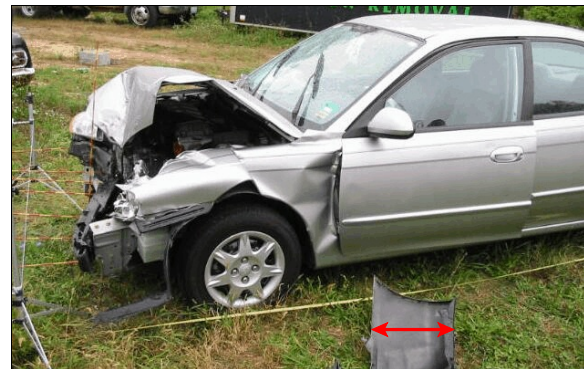
The case vehicle's wheelbase was essentially unaltered from the crash. The case vehicle's front bumper fascia, front bumper, grille, hood, radiator, left fender, and left headlight and turn signal assemblies were directly damaged and crushed rearward. The right headlight and turn signal assemblies sustained induced damage as well as the hood, both the right and left fenders, and the windshield's glazing. Remote buckling was also found on the left front door (Figure 12). No obvious induced damage or remote buckling was noted to the remainder of the case vehicle's exterior.

Figure 12: Case vehicle's frontal damage viewed from left front showing induced damage to hood, left fender, and driver's door; arrow indicates bumper's fascia (case photo #21)

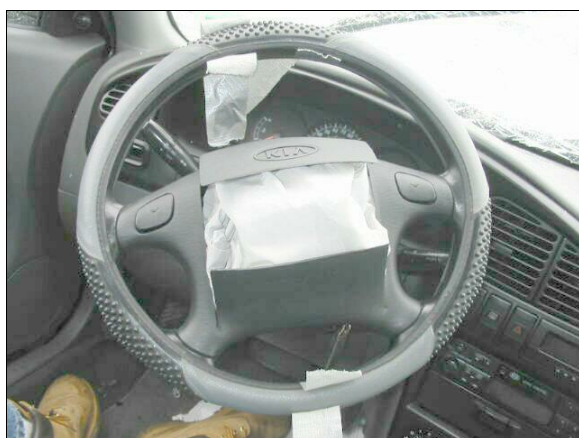
Figure 13: Elevated view of case vehicle’s steering wheel; Note: right side of steering wheel rotated forward toward left instrument panel and no obvious deformity of steering wheel’s rim and/or hub/spokes (case photo #34)

Interior Damage: Inspection of the case vehicle's interior revealed a significant lateral rightward movement to the steering column (**Figure 13** above) and steering wheel rim (**Figure 14** above), most likely from loading by the case vehicle's driver. The steering column moved 3 centimeters (1.2 inches) and the steering wheel rim moved 5 centimeters (2.0 inches). There was no other evidence of intrusion to the case vehicle's interior and no deformation to the steering wheel rim. Furthermore, the steering column compression could not be determined. Although there was no evidence of occupant contact to the left or center instrument panels (**Figures 15** and **16** above), the driver's knee bolster, the rearview mirror, or either sun visor, there was contact evidence on the windshield's glazing (**Figure 15** above and **Figure 17**). Based on the interview with the husband of the case vehicle's driver, the driver's left hand most likely came off of the steering wheel rim, striking and cracking the windshield's left glazing (**Figure 17**). In addition, the available evidence (discussed below) indicates that the driver most likely contacted the windshield's right glazing (**Figure 16** above).

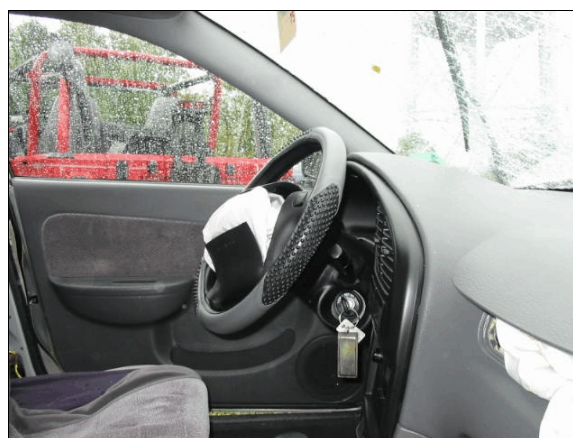
Figure 14: Case vehicle’s collapsed steering wheel viewed from right (case photo #34a)

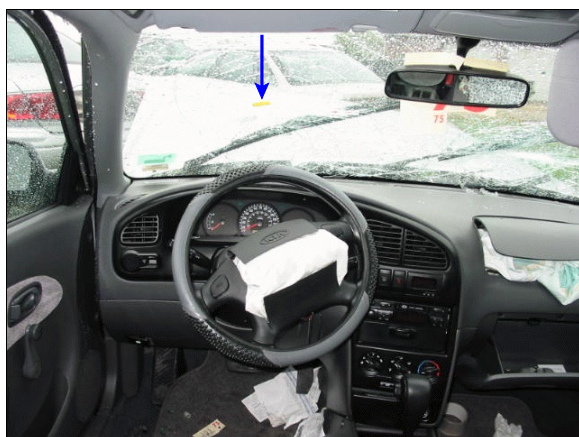
Figure 15: Case vehicle’s driver seating area showing deployed driver air bag, collapsed steering wheel, and contact (i.e., yellow tape–arrow) to left side of windshield’s glazing (case photo #35)

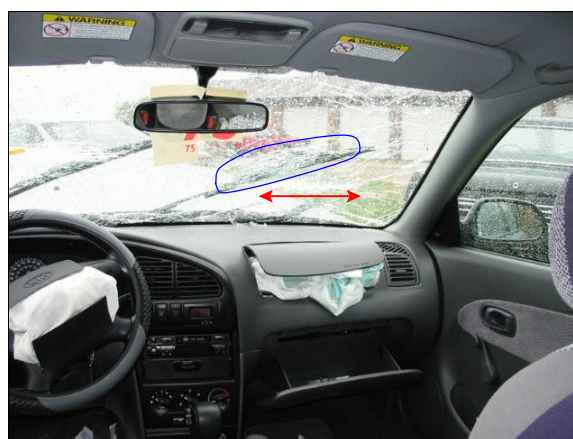
Figure 16: Case vehicle’s front right seating area showing deployed front right air bag and cracks to right side of windshield’s glazing; Note: lower crack (red arrows) is most likely from contact by front right air bag module’s cover flap while upper crack (blue line) most likely resulted from contact by driver (case photo #37)

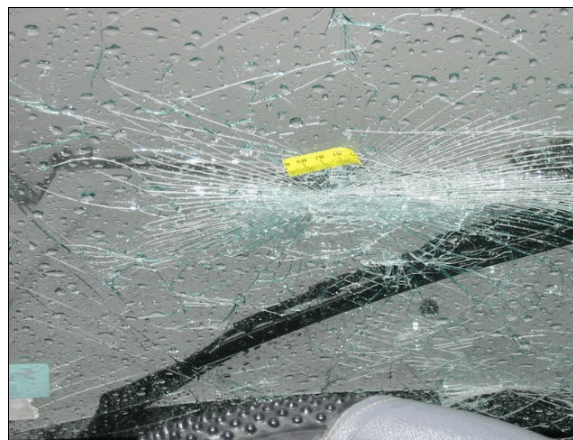
Figure 17: Close-up of left side of case vehicle's windshield glazing, directly in front of steering wheel rim, showing occupant contact evidence (case photo #53)

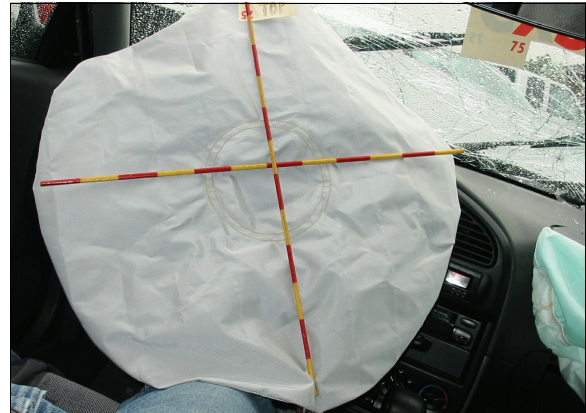
had two vent ports, approximately 4 centimeters (1.6 inches) in diameter, located towards the center at the 9:30 and 2:30 clock positions. The deployed driver's air bag was round with a diameter of 64 centimeters (25.2 inches). An inspection of the driver's air bag fabric revealed no contact evidence readily apparent on the air bag's fabric (**Figure 18**).

Figure 18: Case vehicle's deployed driver air bag showing no apparent occupant contact evidence on front surface of air bag's fabric (case photo #40)

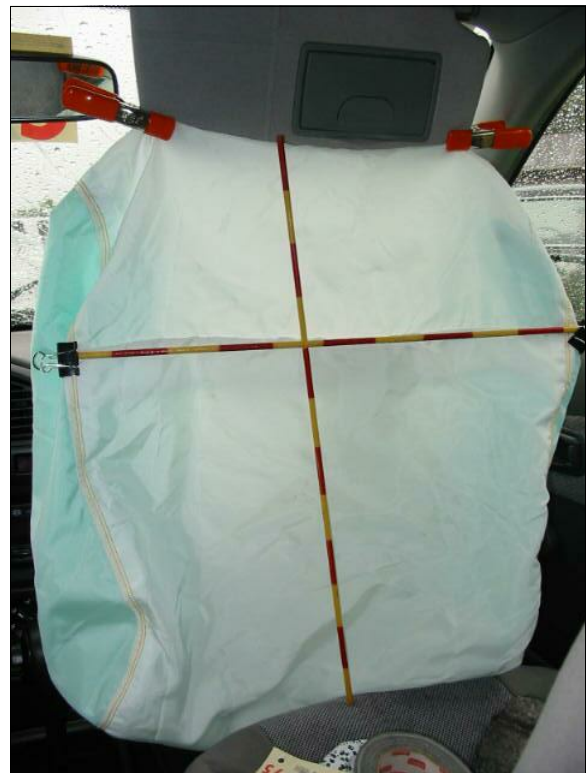
The front right passenger's air bag was located in the middle of the instrument panel. There was a single, essentially rectangular, modular cover flap. The cover flap was made of a medium weight stiff vinyl. The flap's dimensions were 33 centimeters (13.0 inches) at the lower horizontal seam and 20 centimeters (7.9 inches) along both vertical seams. The profile of the case vehicle's instrument panel resulted in a 1 centimeter (0.4 inch) setback of the leading edge of the cover flap relative to the protruding right instrument panel. The distance between the right "B"-pillar and the front surface of the air bag's fabric at full excursion was 28 centimeters (11.0 inches). An inspection of the front right air bag module's cover flaps and the air bag's fabric revealed that the cover flap opened at the designated tear points, and there was no evidence of damage during the deployment to the air bag or the cover flap. The front right passenger's air bag was designed with one tether, approximately 10 centimeters (3.9 inches) in width and located horizontally at the middle of the air bag. The front right air bag had no vent ports. The deployed front right air bag was rectangular with a height of approximately 68 centimeters (26.8 inches) and a width of approximately 51 centimeters (20 inches). An inspection of the front right passenger's air bag fabric revealed no contact evidence readily apparent on the front right air bag's fabric (**Figure 19**).

Figure 19: Case vehicle's deployed front right passenger air bag showing no apparent evidence of occupant contact on front surface (case photo #48)

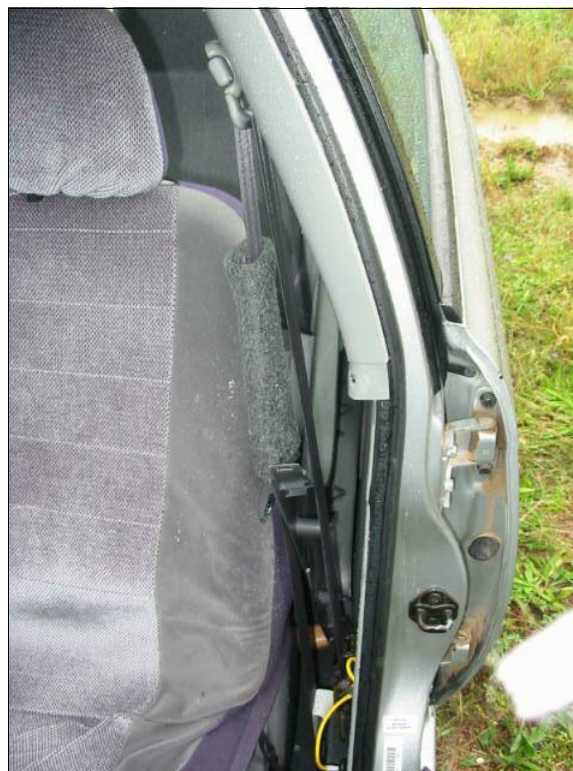
Figure 20: Rigid webbing along left "B"-pillar from case vehicle's driver safety belt indicating that pretensioner actuated while belt was not in use (case photo #54)

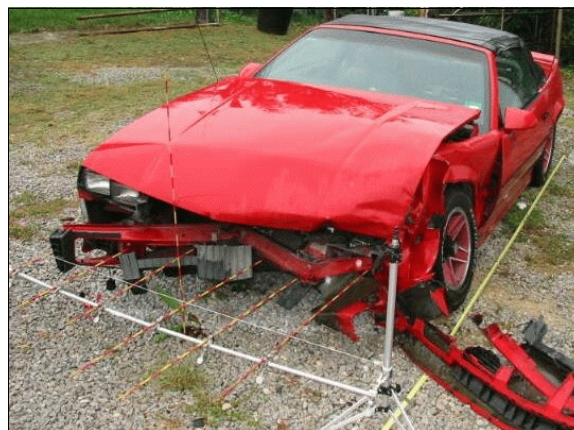
Exterior Damage: The Chevrolet's contact with the case vehicle involved the entire front with the damage distributed all the way across (**Figure 21** and **Figure 22** below). Direct damage began at

Figure 21: Elevated view of Chevrolet's frontal damage viewed from left of front with contour gauge present at bumper level; Note: bumper fascia in lower right of photo (case photo #61)

the left front bumper corner and extended, a measured distance of 89 centimeters (35.0 inches), inward along the steel front bumper. The Field L along the actual bumper was 121 centimeters (47.6 inches). An undeformed end width of 160 centimeters (63.0 inches) was used for reconstruction purposes. Direct damage offset was determined to be -30 centimeters (-11.8 inches). Residual maximum crush was measured as 54 centimeters (21.3 inches) at C₁. The table below shows the case vehicle's crush profile.

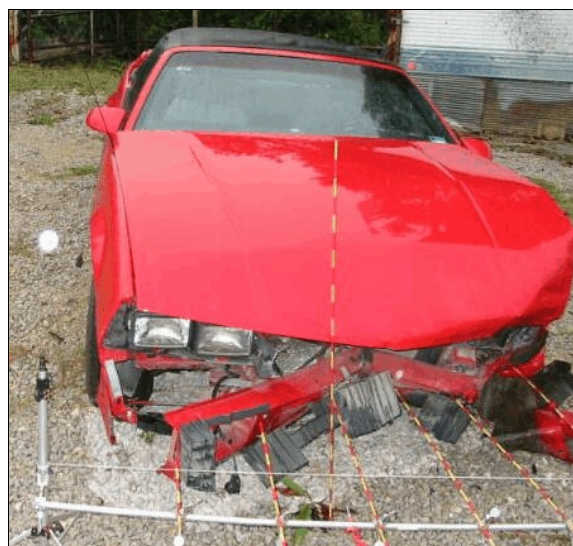
The wheelbase on the case vehicle's left side was shortened 22 centimeters (8.7 inches) while the right side was extended approximately 1 centimeter (0.4 inches). The Chevrolet's front bumper fascia, front bumper grille, hood, radiator, left fender, and left headlight and turn signal assemblies were directly damaged and crushed rearward. The right headlight and turn signal assemblies sustained induced damage as well as the hood and left fender.

Figure 22: Elevated view from front right of Chevrolet's frontal damage with contour gauge present at bumper level (case photo #71)

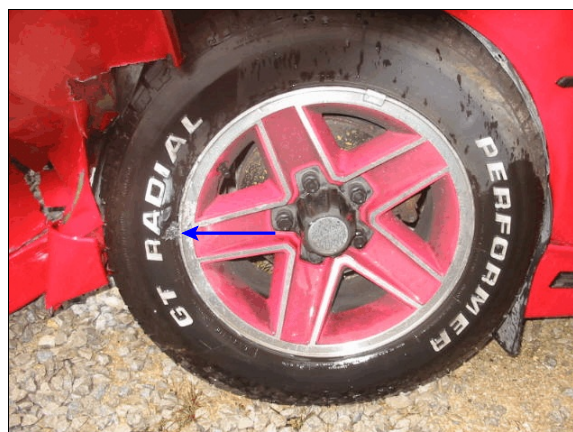
The case vehicle manufacturer's recommended tire size was: P215/65R15, but the Chevrolet was equipped with tire size: P265/65R15. The case vehicle's tire data are shown in the table below. In addition, the Chevrolet's left front tire was damaged and physically restricted from the crash (Figure 23 below).

Figure 23: Chevrolet's damaged (arrow) and restricted left front wheel (case photo #63a)
