**SCI 1 ON-SITE CERTIFIED ADVANCED 208-COMPLIANT  
VEHICLE CRASH INVESTIGATION**

**SCI 1 CASE NO. – CA03-042**

**SUBJECT VEHICLE – 2003 CHEVROLET AVALANCHE**

**CRASH DATE – JUNE 2003**

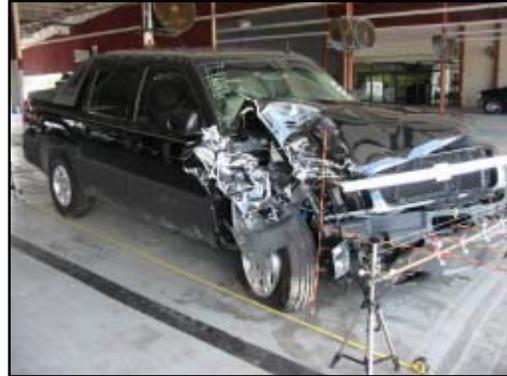
**Figure 1. Frontal damage to the 2003 Chevrolet Avalanche.**

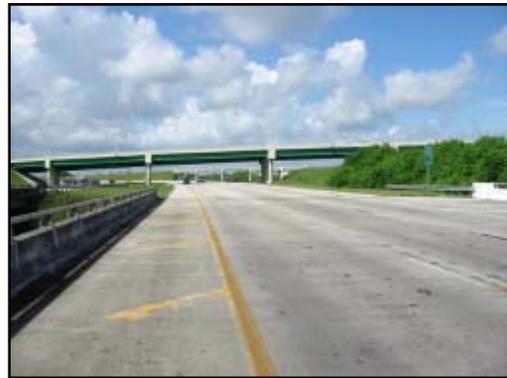
The 38-year-old restrained male driver of the Avalanche was operating the vehicle southbound in the left lane of the three-lane interstate (**Figure 2**). The driver stated to the SCI investigator that he attempted to avoid a non-contact vehicle that was traveling ahead of his position. The driver initiated a right steering input that redirected the Avalanche across the travel lanes and departed the right side of the road in a tracking mode. The Avalanche traveled onto the shoulder and traversed the grass embankment. The driver began to brake and steer left; however, he could not regain control of the vehicle. The police report stated that the driver experienced chest pains which resulted in the loss of control of the vehicle. The driver stated to the SCI investigator that he did not experience chest pain until after the crash. The EDR download data showed that the vehicle was traveling at 62.7 km/h (39.0 mph) five seconds prior to the crash and had slowed to 40.2 km/h (25.0 mph) one second prior to impact. The EDR data also indicated that the driver applied the brakes three seconds prior to the crash.

**Figure 2. Southbound approach to the crash site.**

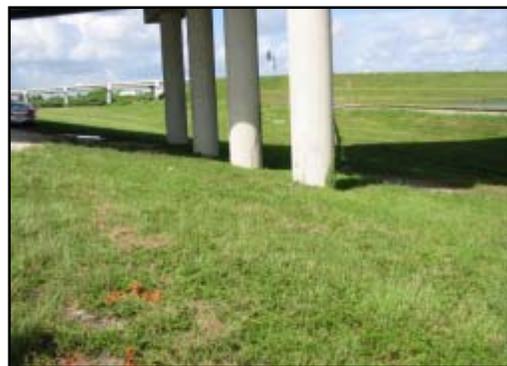
The front right area of the Avalanche impacted the concrete overpass support pillar (**Figure 3**) in a 12 o'clock impact configuration. The impact resulted in moderate damage to the front of the Avalanche. The damage algorithm of the WinSMASH program computed a total delta-V of 21.0 km/h (13.0 mph) for the Avalanche. The longitudinal and lateral components were -21.0 km/h (-13.0 mph) and 0.0, respectively. The EDR recorded a maximum velocity change of -27.9 km/h (-

**Figure 3. Impact to concrete overpass support.**

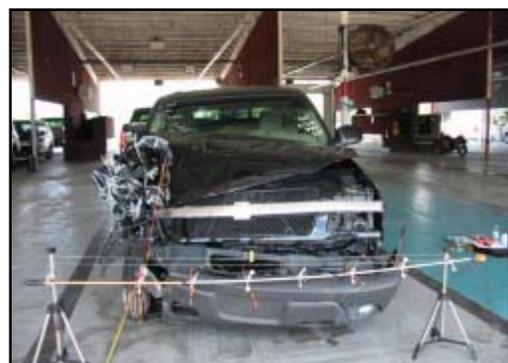
The 2003 Chevrolet Avalanche sustained moderate frontal damage as a result of the impact with the concrete overpass support pillar (Figure 4). The maximum crush was 62.0 cm (24.4”) and the direct contact damage began

**Figure 4. Front of Chevrolet Avalanche.**

47.0 cm (18.5”) right of the centerline and extended 42.0 cm (16.5”) to the front right bumper corner. The combined direct and induced damage was 153.0 cm (60.2”) that extended the full width of the bumper. The damaged components included the bumper cover, bumper beam and right support frame, hood, and right fender (**Figure 5**). The right front wheel and suspension components were fractured and the right wheelbase was reduced by 6.0 cm (2.4”). The right front tire was restricted against the rear of the right front fender (**Figure 6**). The base of the windshield at the right A-pillar was fractured from contact with the hood edge. The side and rear glazing were not damaged. The left front door exhibited a round dent approximately 30.5 cm (12.0”) in diameter from tow yard damage. Six crush measurements were documented at the bumper beam and are as follows: C1 = 0.0 cm, C2 = 1.0 cm (0.4”), C3 = 7.0 cm (2.8”), C4 = 12.0 cm (4.7”), C5 = 14.0 cm (5.5”), C6 = 62.0 cm (24.4”). The Collision Deformation Classification for the impact was 12-FREW-3.

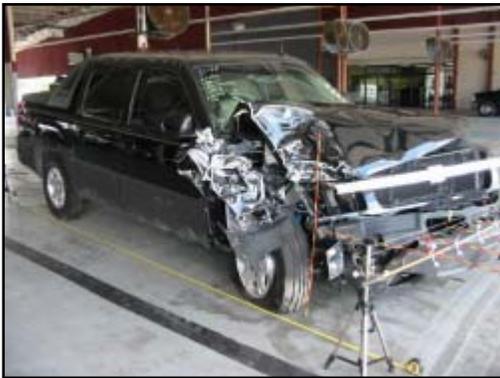
**Figure 5. Right view of the frontal damage.**

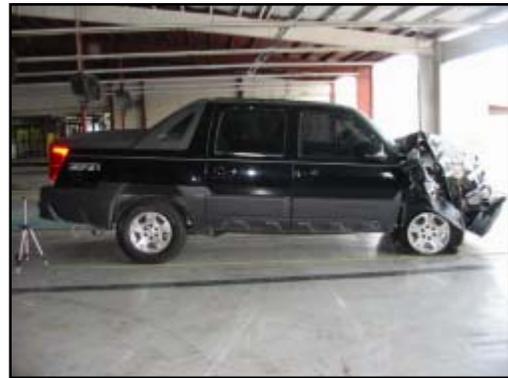
**Figure 6. Lateral view of the crush profile.**

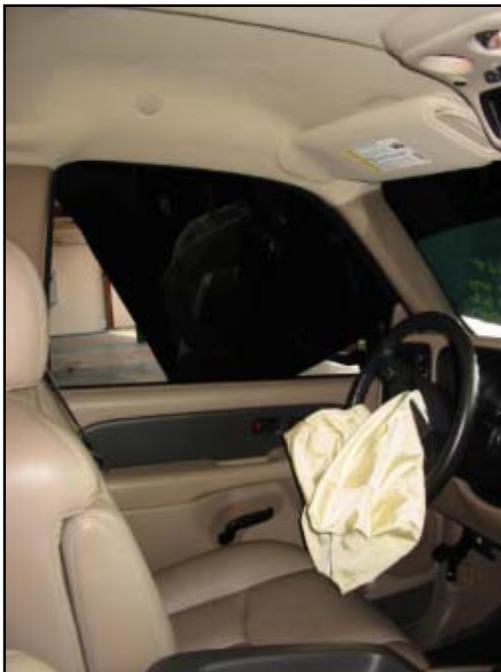
**Figure 7. Driver's area.**
