ON-SITE CERTIFIED ADVANCED 208- COMPLIANT VEHICLE INVESTIGATION

CASE NUMBER - IN-03-042
LOCATION - KENTUCKY
VEHICLE - 2003 CHEVROLET K1500 SILVERADO
CRASH DATE - August 2003

1. <i>Report No.</i> IN-03-042		2. <i>Government Accession No.</i>		3. <i>Recipient's Catalog No.</i>	
4. <i>Title and Subtitle</i> On-Site Certified Advanced 208-Compliant Vehicle Investigation Vehicle - 2003 Chevrolet K1500 Silverado Location - Kentucky			5. <i>Report Date:</i> September 7, 2007

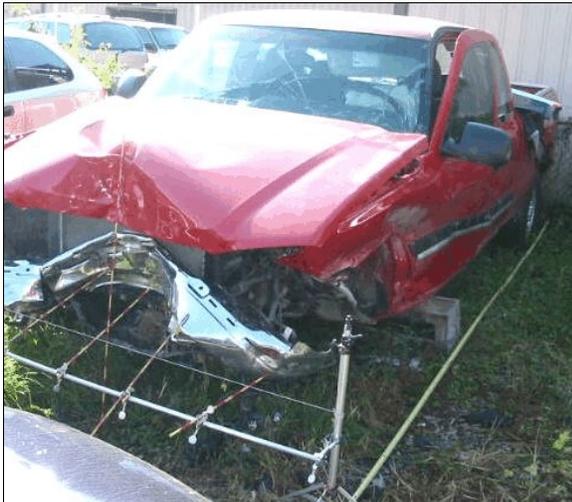
Figure 6: Case vehicle's left front and frontal damage viewed from left of front; left front damage from impact with Peterbilt's logging trailer, frontal damage from large tree (case photo #31)

The front left of the case vehicle (**Figures 6** and **7**), which was following the Ford, impacted the left rear portion of the Peterbilt's, rotating, semitrailer on the right (northern) shoulder—where the case vehicle's driver had taken evasive action.

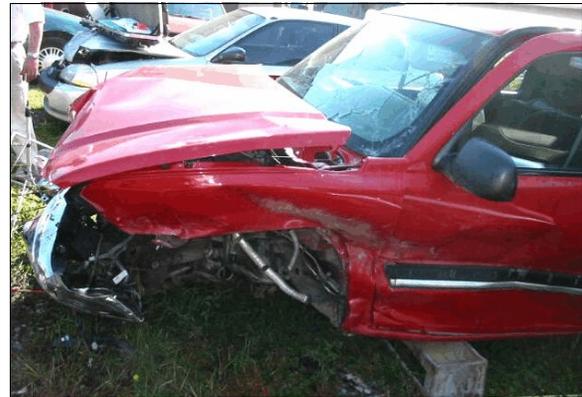
Figure 7: Case vehicle's left front damage from impact with Peterbilt's logging trailer; Note: left front wheel assembly sheared off by trailer (case photo #33)

Exterior Damage: The case vehicle's initial contact with the Peterbilt involved its front left corner (**Figures 6** and **7** above). It is not possible to determine exactly where direct damage began for

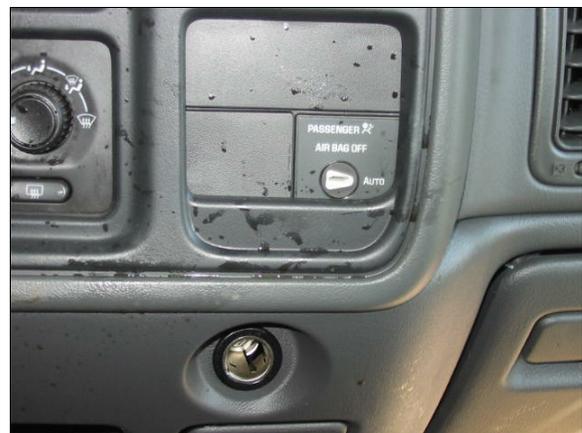
Figure 8: Case vehicle's front right passenger air bag cutoff switch set to "Auto" (case photo #48)

The case vehicle’s impact with the semitrailer caused the case vehicle's driver (only) supplemental restraint (air bag) to deploy. Based on the downloaded EDR data only one stage of the driver’s dual stage air bag was activated. The case vehicle was equipped with a switchable (i.e., a cutoff switch) front right passenger supplemental restraint (air bag) that was set to the “auto” position (**Figure 8** above). This air bag did not deploy during the crash sequence.

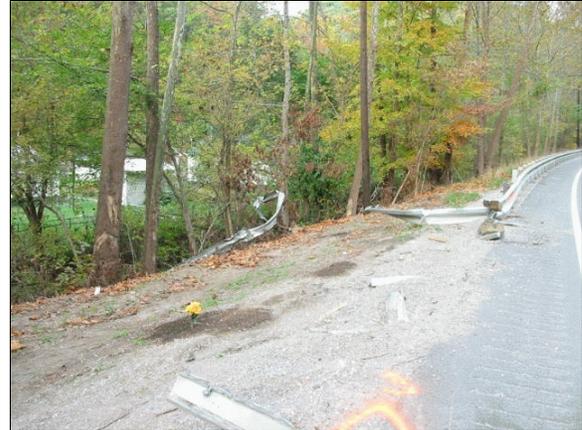
Figure 14: Damage to roadway's northern longitudinal barrier caused by overturned Peterbilt tractor-semitrailer; Note: contact damage to trees on northern roadside (case photo #06)

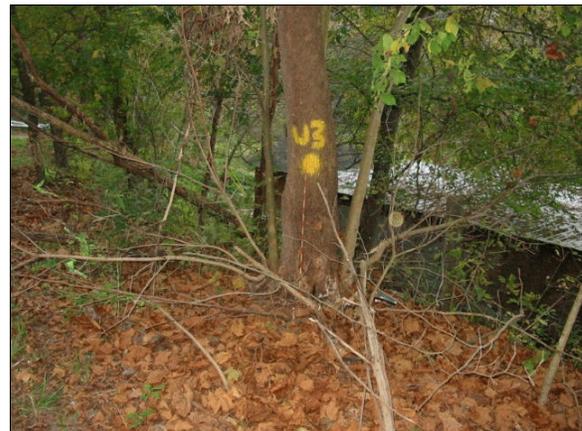
The collision with the semitrailer redirected the case vehicle further to the right (**Figure 16** below) where it impacted a couple of small trees and large tree with its front (**Figure 17** below). The case vehicle came to rest on the northern roadside, near the large tree, heading in a west-northwesterly direction.

Figure 17: Case vehicle's impact and approximate final rest position against large tree on roadway's northern roadside; Note: case vehicle struck and knocked over at least two small trees prior to large tree (case photo #17)

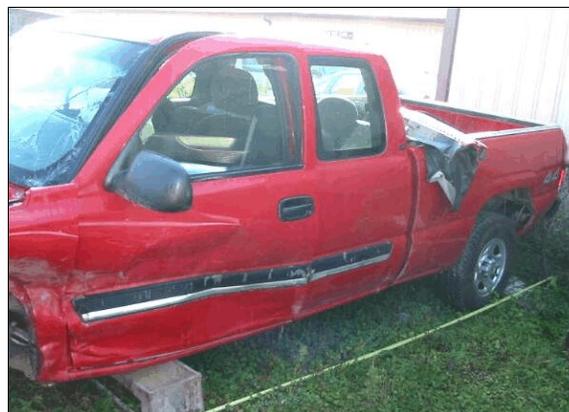
this impact, but it extended from the left front bumper corner back to the left front door (**Figure 18**). No crush measurements could be obtained. The case vehicle's contact with the trees involved the front central portion. Direct damage began 40 centimeters (15.7 inches) leftward from the front right bumper corner (**Figure 19**) and extended 63 centimeters (24.8 inches) inward along the front bumper. Residual maximum crush was measured as 40 centimeters (15.7 inches) near C₄ (**Figure 20**). The table below shows the case vehicle's composite crush profile for the three tree impacts.

Figure 18: Continuation of case vehicle's left front damage from impact with Peterbilt's logging trailer onto left front door (case photo #34)

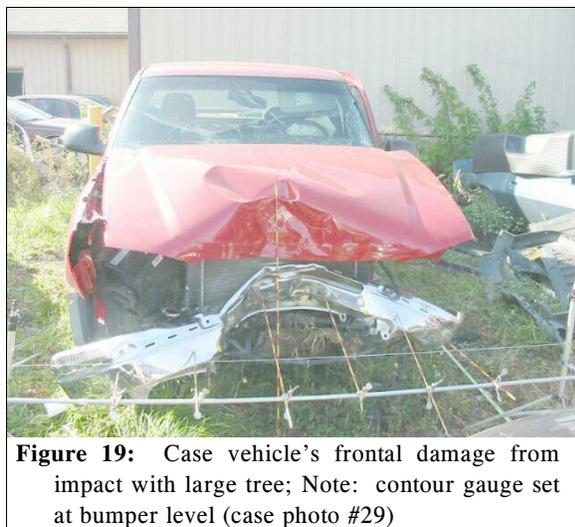
Figure 19: Case vehicle's frontal damage from impact with large tree; Note: contour gauge set at bumper level (case photo #29)

The wheelbase on the case vehicle's left side was shortened approximately 19 centimeters (7.5 inches) while the right side was extended at most 1 centimeter (0.4 inches). As a result of the initial impact, the case vehicle's front left bumper, left fender, and left headlight and turn signal assemblies were directly damaged and crushed rearward. The left front wheel assembly was sheared off, and the left front door was crushed inward. As a result of the tree impact, the case vehicle's front bumper, bumper fascia, grille, hood, and radiator were directly damaged and crushed rearward. The right, and possibly some portion of the left, headlight and turn signal assemblies were detached from the vehicle as a result of either direct or induced damage or physical removal by salvage personnel. There was induced damage to the hood, both the right and

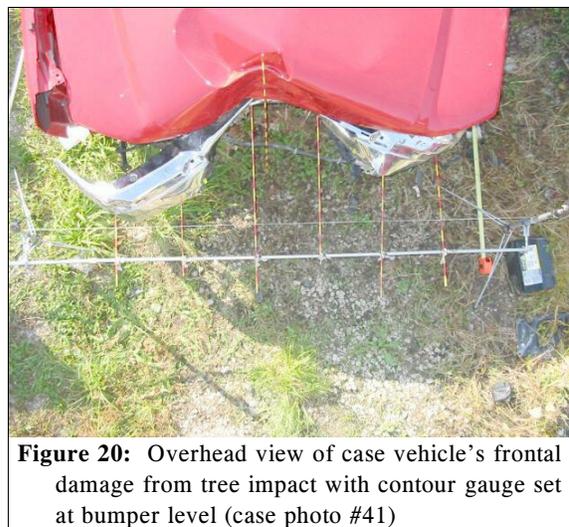
Figure 20: Overhead view of case vehicle's frontal damage from tree impact with contour gauge set at bumper level (case photo #41)

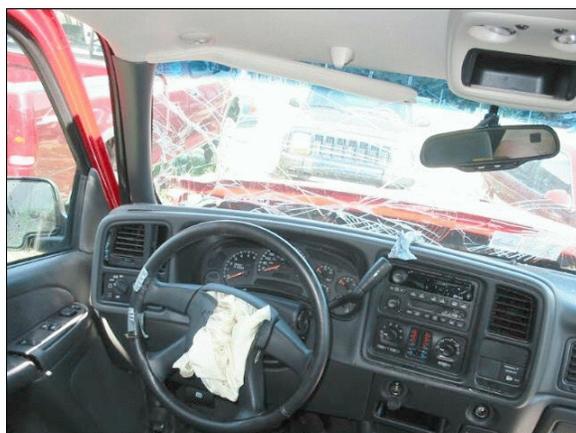
Figure 21: Case vehicle’s driver seating area showing deployed driver air bag, cracked windshield’s glazing, and no apparent contact evidence to steering wheel rim, center instrument panel, or greenhouse areas (case photo #46)

Interior Damage: Inspection of the case vehicle’s interior (**Figures 21** and **22**) revealed moderate scuffing on the driver’s knee bolster, left of the steering column (**Figure 23** below) and a possible contact to the right windshield’s glazing (**Figure 22**). The knee bolster contact most likely resulted from the driver’s left knee; although, no knee injury was reported. The contact to the right windshield’s glazing most likely resulted from contact by an interior loose object. There was longitudinal intrusion to the driver’s toe pan [19 centimeters (7.5 inches)] and the emergency parking brake pedal [18 centimeters (7.1 inches)]. In addition, there was lateral intrusion to the

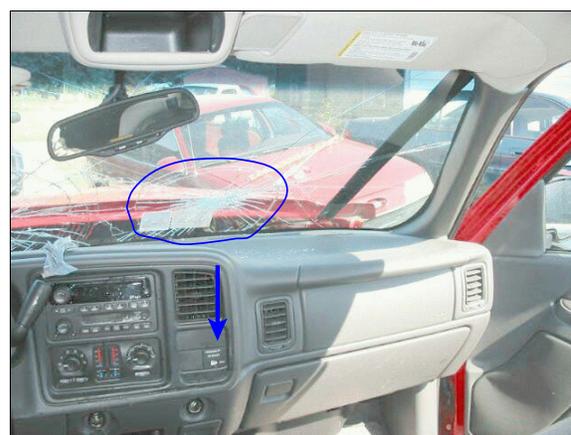
Figure 22: Case vehicle’s front right seating area showing non-deployed front right passenger air bag, air bag cutoff switch (arrow), cracks to windshield’s glazing—including a possible contact (circle) by an interior loose object, and no obvious contact evidence on center or right instrument panel or greenhouse areas (case photo #49)

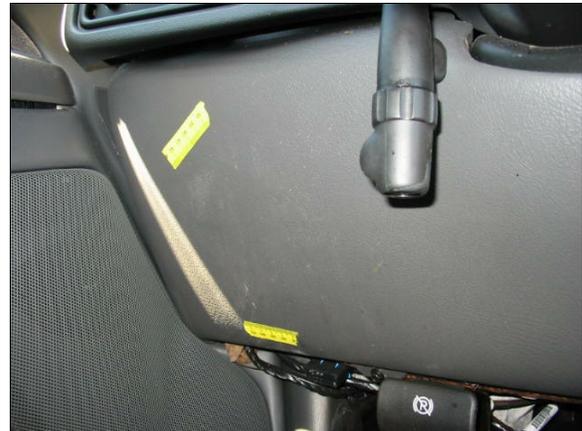
Figure 23: Contact evidence (i.e., scuff) on left portion of case vehicle's driver knee bolster (case photo #46a)

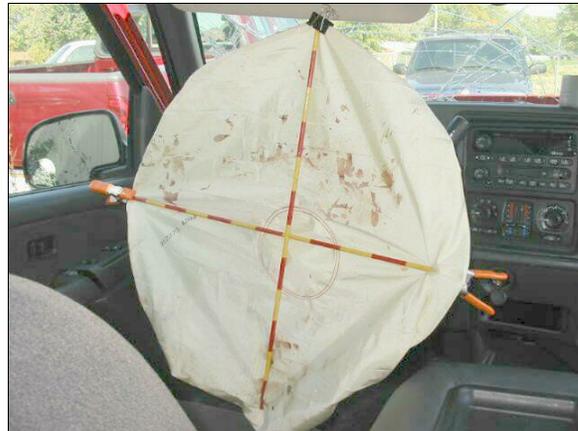
Figure 24: Case vehicle's deployed driver air bag showing copious blood evidence over three quadrants of the bag's front surface (case photo #50)

The driver was transported by ambulance to the hospital. He sustained minor injuries and was treated and released. The injuries sustained by the case vehicle's driver included: a minor, superficial laceration to his right eyelid, a contusion above his right eye, and an abrasion on his left wrist. The laceration and contusion were caused by his deploying air bag in conjunction with his eye glasses.

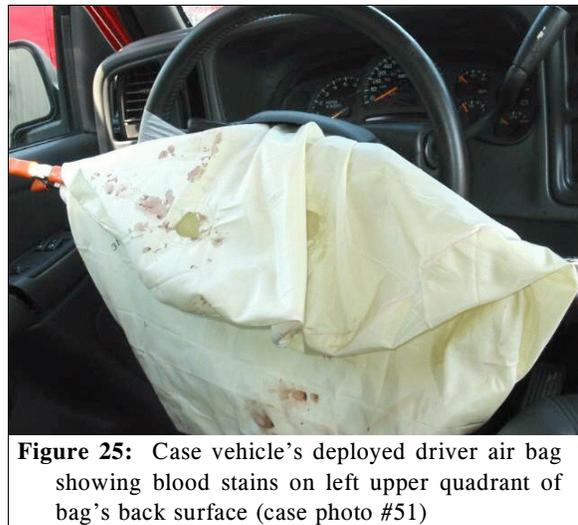
Figure 25: Case vehicle's deployed driver air bag showing blood stains on left upper quadrant of bag's back surface (case photo #51)

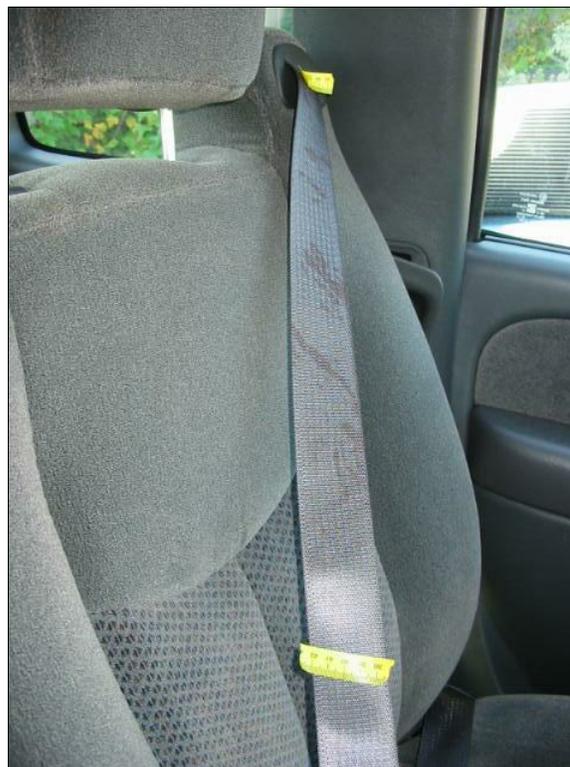
Based on this contractor's vehicle inspection and substantiated by the EDR data, the case vehicle's driver was restrained by his available, active, three-point, integral lap-and-shoulder, safety belt system; the belt system was not equipped with a pretensioner. There was no mention by the driver of belt pattern bruising and/or abrasions to the his body, but the inspection of the driver's seat belt webbing and latch plate showed there were blood stains on the outer portion of the belt webbing (**Figure 26**) and moderate scuffing and friction burns on the inside portion (**Figure 27**).

Figure 26: Blood stains on outward surface of shoulder portion of case vehicle's driver safety belt (case photo #55)

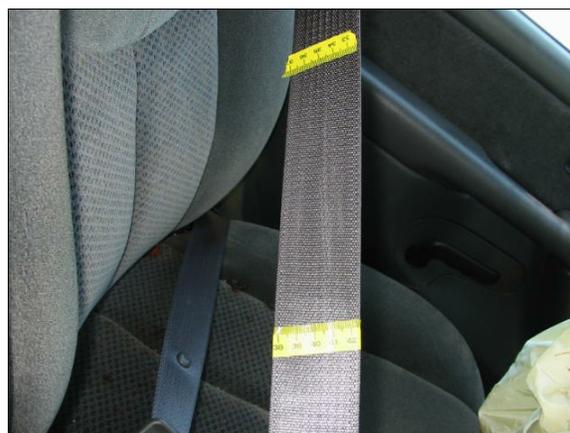
Figure 27: Scuffs/friction burns on inward surface (i.e., next to body) of shoulder portion of case vehicle's driver safety belt (case photo #56)

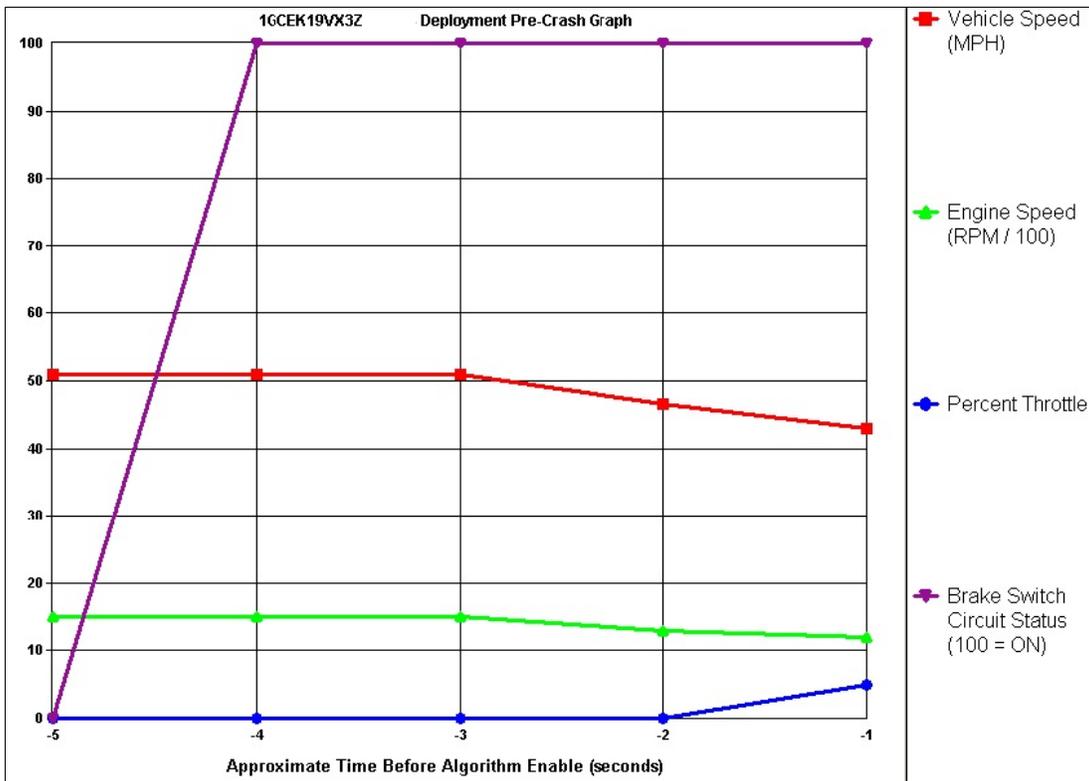
Figure 29: Case vehicle’s pre-crash speed and brake switch circuit status showing that the vehicle had been traveling at approximately 82 km.p.h. (51 m.p.h.) when the brake was activated approximately 5 seconds prior to algorithm enable.

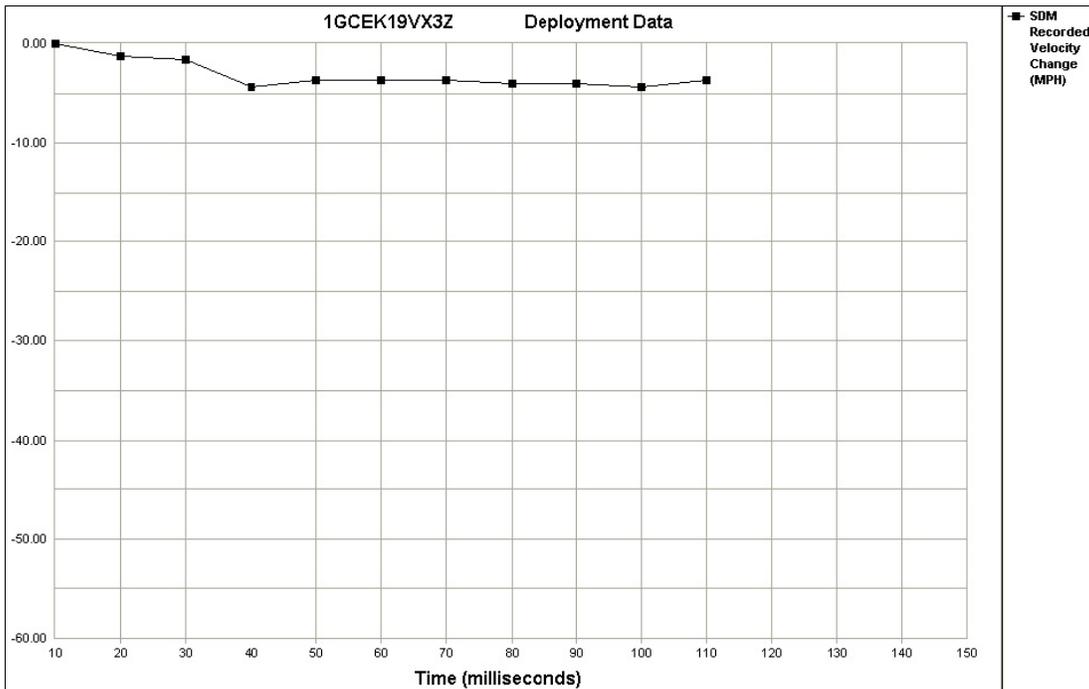
Figure 30: The case vehicle sustained a maximum velocity change of approximately 7.7 km.p.h. (4.8 m.p.h.) during the first 110 milliseconds after the crash was detected
