INDIANA UNIVERSITY

ON-SITE CERTIFIED ADVANCED 208- COMPLIANT VEHICLE INVESTIGATION

CASE NUMBER - IN-03-044
LOCATION - TEXAS
VEHICLE - 2004 LEXUS RX 330
CRASH DATE - October 2003

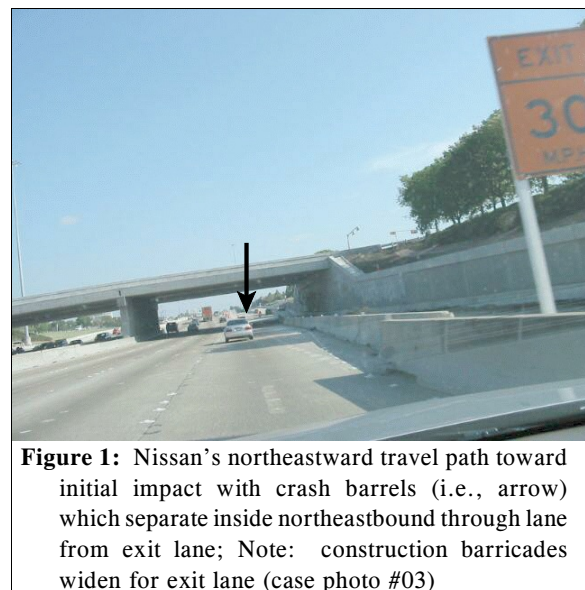
Figure 1: Nissan's northeastward travel path toward initial impact with crash barrels (i.e., arrow) which separate inside northeastbound through lane from exit lane; Note: construction barricades widen for exit lane (case photo #03)

Pre-Crash: The case vehicle had been traveling northeastward in the outside through lane of the northeast roadway (**Figure 1** above) and had moved onto the exit-ramp, intending to continue in its direction of travel on the ramp. The Nissan had been traveling northeast, ahead of the case vehicle, in the outside through lane of the same northeast roadway when suddenly the Nissan steered to the right in an attempt to exit the expressway onto the exit lane. The Nissan entered the gore that separated the exit ramp and the northeast roadway (**Figure 2**). It is unknown whether the Nissan's driver made any avoidance maneuvers just prior to the crash. The crash sequence was initiated within an interchange area, in the gore associated with the exit ramp.

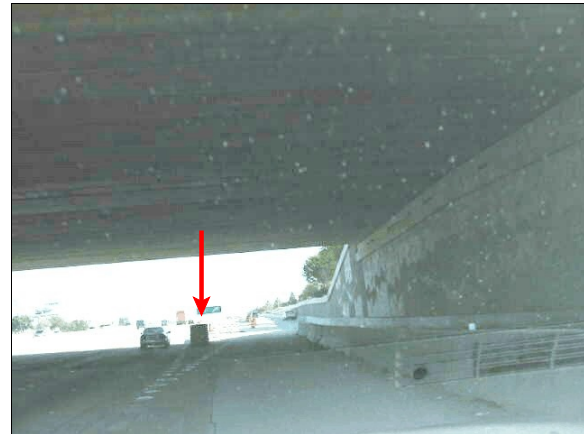
Figure 2: Construction barrels impacted by Nissan (i.e., arrow) and case vehicle's northeastward travel path to impact with redirected Nissan (case photo #05)

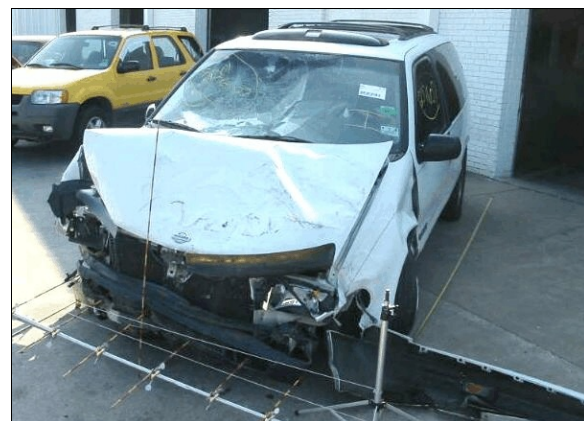
Crash: The front left (**Figure 3**) of the Nissan collided with a crash barrier (i.e., barrels) that protected the gore area between the right side of the northeast roadway and the exit ramp (**Figure 4** below). The Nissan entered the exit ramp while rotating approximately 160 degrees counter-clockwise after impacting the barrels, and it was most likely traveling backwards in a northeasterly

Figure 3: Elevated view of Nissan's overlapping frontal damage viewed from left of front; Note: front left half damage most likely from initial impact with barrels (case photo #54)

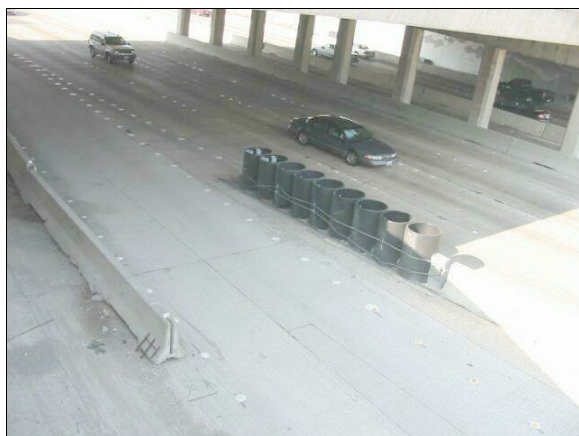
Figure 4: Impact area–Nissan hit barrels (1st event), case vehicle impacted Nissan (2nd event), and case vehicle’s left rear impacted barrels (3rd event); Note: barrel type and/or configuration likely different from date of crash (case photo #07)

along the exit ramp, and its left back corner (Figure 9) impacted the crash barrels (Figure 4 above) before coming to final rest between the crash barrels and the Nissan, heading in an east-southeasterly direction.

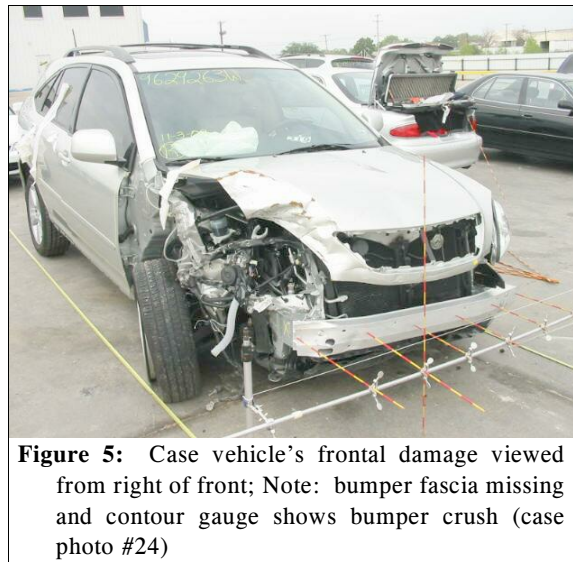
Figure 5: Case vehicle’s frontal damage viewed from right of front; Note: bumper fascia missing and contour gauge shows bumper crush (case photo #24)

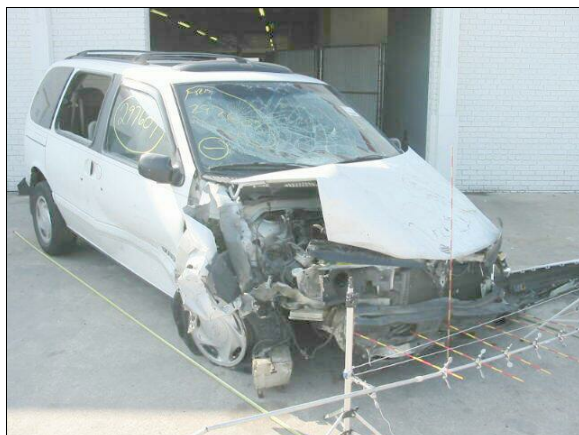
Figure 6: Overlapping frontal damage to Nissan viewed from right of front with contour gauge showing aggregate crush to bumper; Note: case vehicle impacted Nissan’s front right, with wrap-around damage extending to right front door (case photo #62)

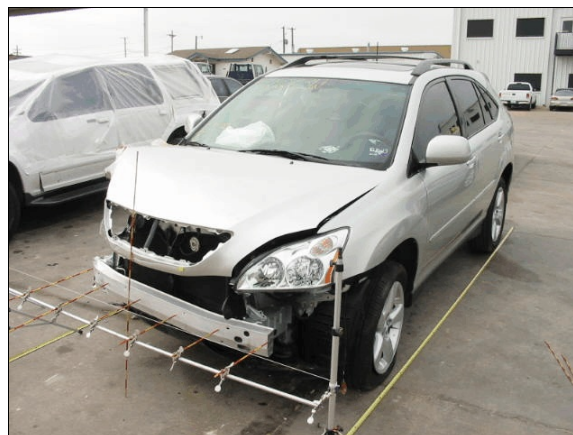
Figure 7: Case vehicle’s frontal damage from impact with Nissan viewed from left of front; Note: lesser damage to front left resulted from contact with Nissan’s right front door as case vehicle wrapped around Nissan’s right side (case photo #13)

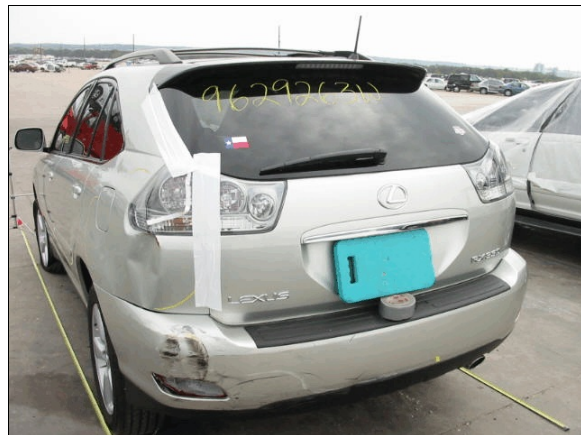
Figure 9: Damage to back portion of case vehicle's left rear quarter panel and bumper from impact with barrels during clockwise rotation to final rest (case photo #17)

Exterior Damage: The case vehicle’s contact with Nissan initially involved the front right. The case vehicle had sustained contact with the Nissan, eventually “wrapping around” the Nissan’s right side enabling the entire front of the case vehicle to sustain direct contact damage (**Figure 10**). The case vehicle’s front bumper fascia was torn off the bumper and, although it was present at the time of our inspection, the direct contact damage was best measured along the actual bumper and remaining structures, beginning at the front right corner and extending 81 centimeters (31.9 inches) leftward. Residual maximum crush was measured as 13 centimeters (5.1 inches) at C₆. The table below shows the case vehicle’s crush profile. Direct damage was also found on the case vehicle’s left rear corner, both at the bumper level and above (**Figure 9** above).

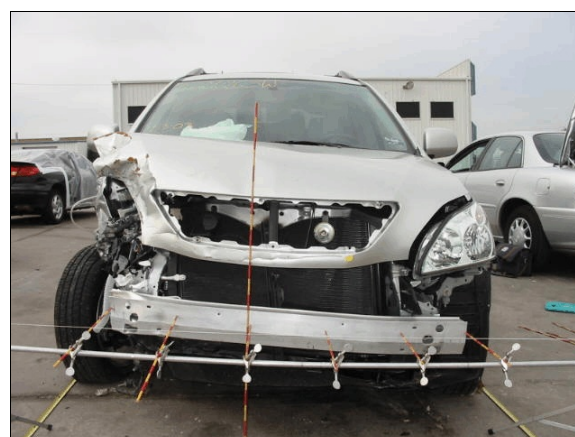
Figure 10: Case vehicle’s frontal damage from impact with Nissan; Note: contour gauge positioned along actual bumper (case photo #11)

The wheelbase on the case vehicle’s left side was shortened 2 centimeters (0.8 inches) while the right side was shortened 22 centimeters (8.7 inches). The case vehicle’s front bumper fascia,

bumper, grille, radiator, hood, right fender, and right headlight and turn signal assemblies were directly damaged and crushed rearward. The front bumper fascia was detached from the vehicle. The left headlight and turn signal assemblies sustained induced damage as well as the hood. No obvious induced damage or remote buckling was noted to the remainder of the case vehicle's exterior.

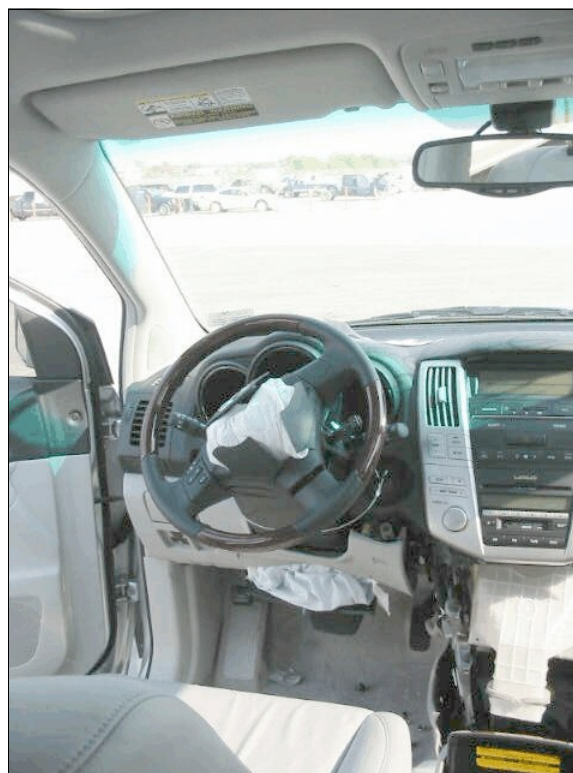
Vehicle Interior: Inspection of the case vehicle's interior revealed that there was no evidence of occupant contact on the interior surfaces of the case vehicle (**Figure 11** and **Figure 12** below). Finally, there was no evidence of intrusion to the case vehicle's interior, no evidence of compression to the energy absorbing shear capsules in the steering column, and no deformation to the steering wheel rim.

Figure 11: Vertical view of case vehicle's driver seating area showing no apparent evidence of occupant contact (case photo #26a)

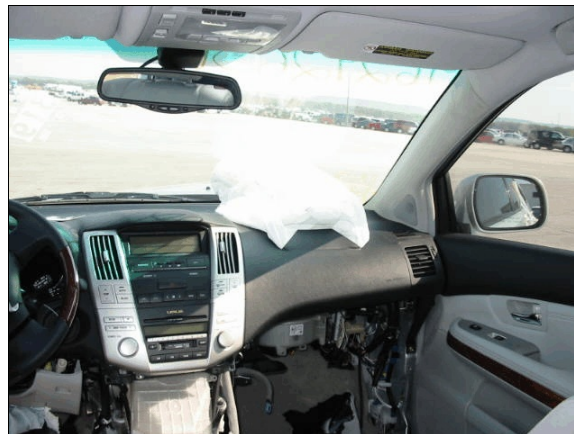
Figure 12: Case vehicle's front right passenger seating area showing no apparent occupant contact evidence (case photo #28)

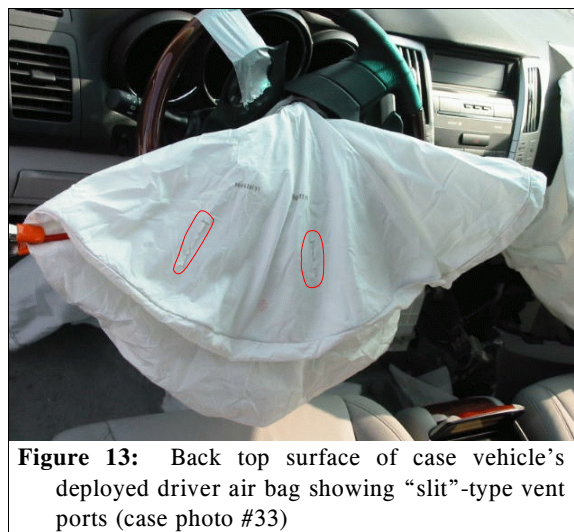
The case vehicle's driver air bag was located in the steering wheel hub. The module cover consisted of three cover flaps made of thick vinyl positioned within an overall hexagonal shape. The top flap was essentially a rectangle, except that its bottom was "S-curve"-shaped so as to accommodate the manufacturer's logo. The left and right bottom flaps were pentagonally-shaped and together formed a trapezoid. The width of the seam that separated the top flap from the bottom flaps was 13 centimeters (5.1 inches). The combined width of the lower seam for the two bottom flaps was 7.5 centimeters (3.0 inches), and the vertical height of the two outside seams was 11 centimeters (4.3 inches). An inspection of the air bag module's cover flaps and the air bag's fabric revealed that the cover flaps opened at the designated tear points, and there was no evidence of damage during the deployment to the air bag or the cover flaps. The driver's air bag was designed with two tethers, each approximately 10 centimeters (3.9 inches) in width, positioned at the 9 and 3 o'clock positions and sewn 23 centimeters apart (9.1 inches) at the center of the bag. The driver's air bag had two vent ports, which were essentially slits in the back of the air bag, each approximately 6 centimeters (2.4 inches) in length, located at the 11 and 1 o'clock positions (**Figure 13**). The deployed driver's air bag was

Figure 13: Back top surface of case vehicle's deployed driver air bag showing "slit"-type vent ports (case photo #33)

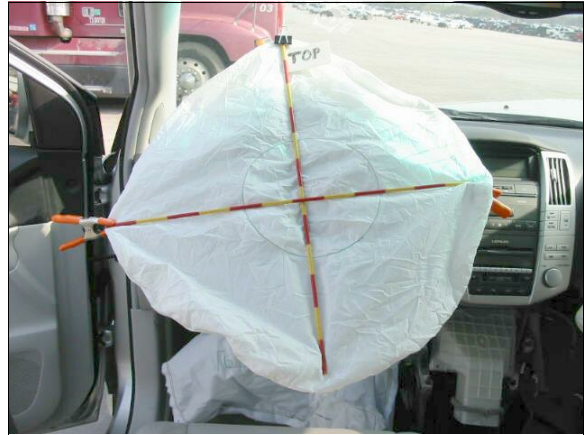
round with a diameter of 65 centimeters (25.6 inches). An inspection of the driver's air bag fabric revealed no contact evidence readily apparent on the air bag's fabric (**Figure 14**). The distance between the mid-center of the driver's seat back, as positioned at the time of the vehicle inspection, and the front surface of the air bag's fabric at full excursion was not determined.

Figure 14: Case vehicle's deployed driver air bag showing no obvious occupant contact evidence (case photo #32)

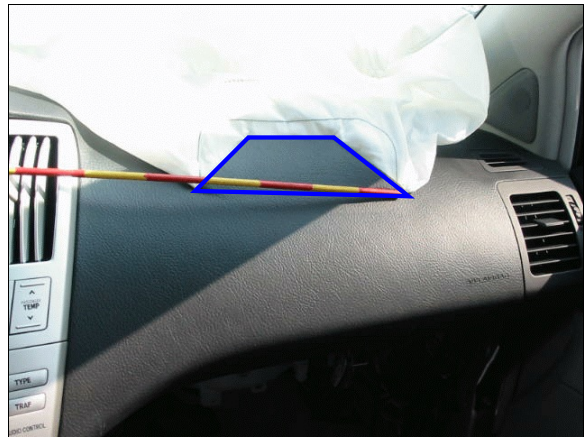
The front right passenger's air bag was located in the top of the instrument panel. There were two mirror-imaged, symmetrical, trapezoidal-configuration, cover flaps made of a thick vinyl that were an integral part of the front instrument panel and appeared seamless to the naked eye but were obviously pre-stressed for deployment purposes. The flaps had overall dimensions of 9 centimeters (3.5 inches) at the middle horizontal seam and 21 centimeters (8.3 inches) at the top and bottom horizontal seams. The vertical distance between the top and bottom horizontal seams was 12 centimeters (4.7 inches). An inspection of the front right air bag module's cover flaps and the air bag's fabric revealed no flaps, per se, but rather seams cut into the top of the dashboard, all of which opened at their designated tear points (**Figure 15**). Furthermore, there was no evidence of damage during the deployment to the air bag or evidence of "flap" damage. The front right passenger's air bag was designed without any tethers. The front right air bag had two vent ports, approximately 5 centimeters (2.0 inches) in diameter, located at the 2:30 and 9:30 clock positions. The deployed front right air bag was rectangular with a height of approximately 64 centimeters (25.2 inches) and a width of approximately 56 centimeters (22.0 inches). An inspection of the front right passenger's air bag fabric revealed no contact evidence readily apparent on the front right air bag's fabric (**Figure 16**). The distance between the mid-center of the front right seat back, as positioned at the time of the vehicle inspection, and the front surface of the air bag's fabric at full excursion was 37 centimeters (14.6 inches).

Figure 15: Case vehicle's deployed front right passenger air bag and air bag module's trapezoidal-shaped bottom cover flap (case photo #40)

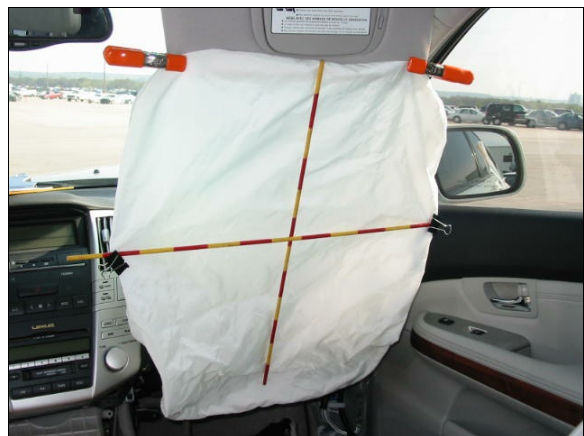
Figure 16: Case vehicle's deployed front right passenger air bag showing no apparent evidence of occupant contact (case photo #35)

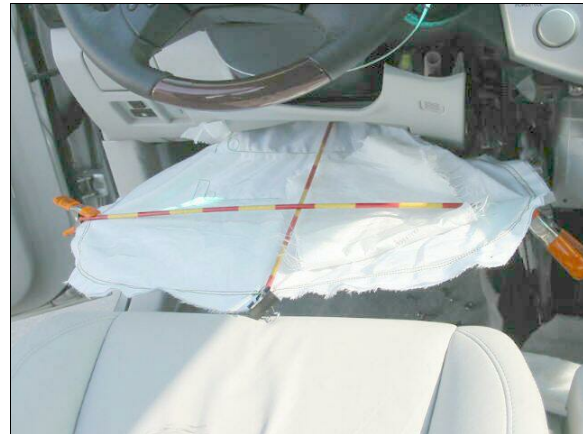
centimeters (9.8 inches) at the horizontal seam and 3 centimeters (1.2 inches) vertically for the upper flap and 4 centimeters (1.6 inches) vertically for the lower flap. An inspection of the air bag module's cover flaps and the air bag's fabric revealed that the cover flaps opened at the designated tear points, and there was no evidence of damage during the deployment to the air bag or the cover flaps. The knee bolster air bag was designed without any tethers or vent ports; however, there was stitching to the outside on both bottom and top surfaces. The driver's knee**r* air bag was rectangular with a height of 31 centimeters (12.2 inches) and a width of 58 centimeters (22.8 inches). An inspection of the driver's knee air bag fabric revealed no contact evidence readily apparent on the air bag's fabric (**Figure 17** above and **Figure 18**).

Figure 17: Elevated view of case vehicle's deployed, under column-mounted, knee bolster air bag showing no residual evidence of occupant contact (case photo #41)

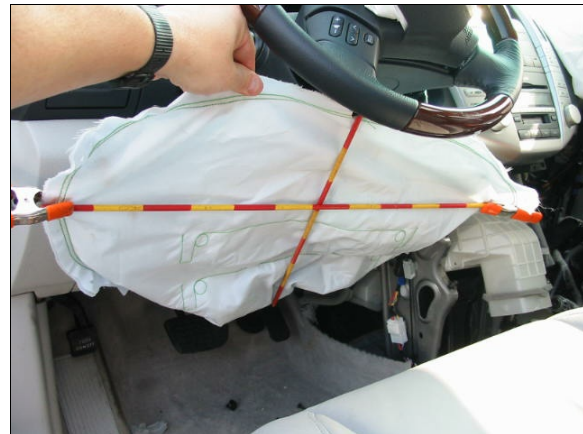
Figure 18: Seat level view of case vehicle's deployed, under column-mounted, knee bolster air bag showing no residual occupant contact evidence (case photo #42)

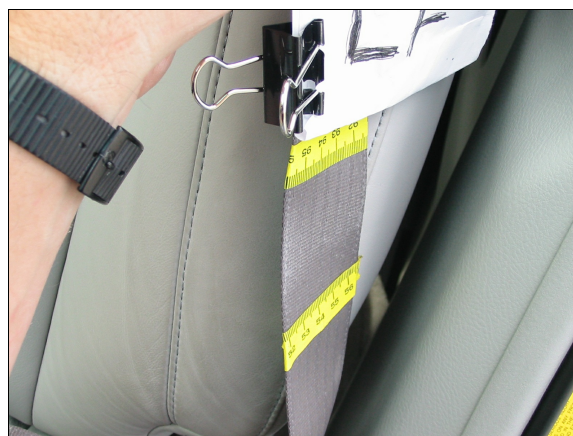
Based on this contractor's vehicle inspection, the case vehicle's driver was restrained by his available, active, three-point, lap-and-shoulder, safety belt system; the belt system was equipped with a retractor-mounted pretensioner with force load limiters, housed within the "B"-pillar. There was no mention by the driver of belt pattern bruising and/or abrasions to the driver's body, but the inspection of the driver's seat belt webbing, "D"-ring, and latch plate showed evidence of loading (**Figure 19**). Specifically there were friction burns on the torso portion of the webbing. In addition, it should be noted that the seat belt webbing for this seat position spooled and unspooled freely, indicating that the pretensioner may not have actuated.

Figure 19: Loading evidence (i.e., scuffs/friction burns) on webbing of torso portion case vehicle's driver safety belt (case photo #44)

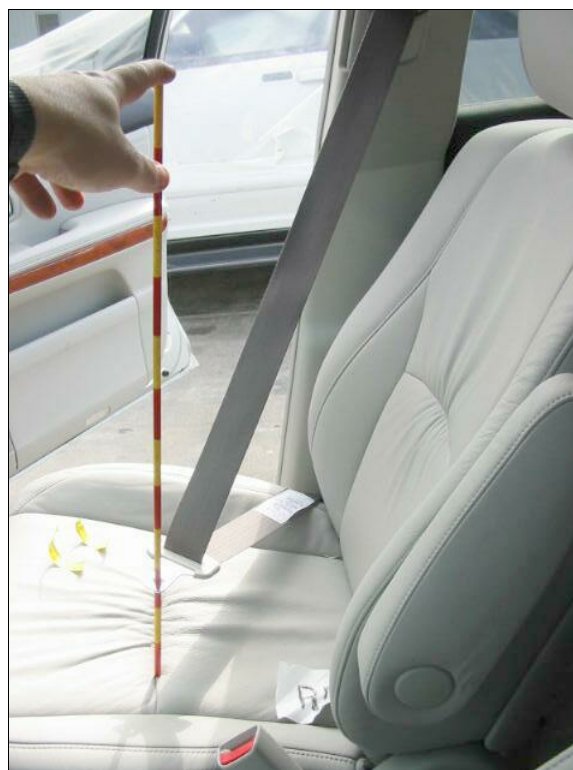
The case vehicle's front right passenger was restrained by her available, active, three-point, lap-and-shoulder, safety belt system; the belt system was equipped with a retractor-mounted pretensioner with force limiters, housed within the “B”-pillar. There was no mention by the driver of belt pattern bruising and/or abrasions to the front right passenger's body, but the inspection of the front right passenger's seat belt webbing, “D”-ring, and latch plate revealed that the pretensioner had actuated (**Figure 20**) and showed evidence of loading, specifically friction burns on the torso portion of the belt’s webbing (**Figure 21** below). This occupant’s seat belt webbing did not spool or unspool freely but rather, was frozen at the “D”-ring, indicating that the pretensioner had actuated.

Figure 20: Case vehicle’s front right passenger safety belt showing limit of belt’s post-crash extension (case photo #47)

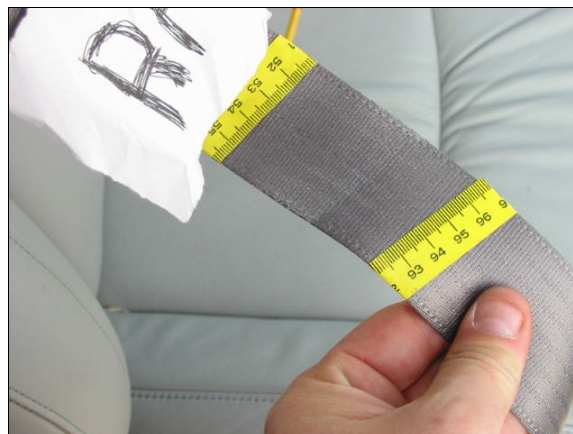
Figure 21: Loading evidence (i.e., scuff/friction burn) on webbing of case vehicle’s front right safety belt (case photo #48)

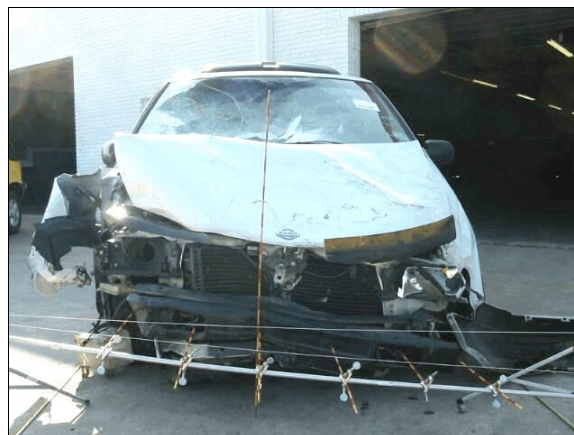
Exterior Damage: Although the front of the Nissan sustained overlapping damage, the initial contact with the crash barrels most likely involved the front left. After rotating approximately 160 degrees counterclockwise, the Nissan’s contact with the case vehicle initially involved its front right, but the contact was sustained, wrapping around the Nissan and involving its right fender and right front door. The combined direct damage involved the entire front bumper, from corner to corner, and extended a measured distance of 160 centimeters (63.0 inches) along the front bumper (**Figure 22**). The combined residual maximum crush was measured as 28 centimeters (11.0 inches) at C₆. The table below shows the case vehicle’s composite crush profile for the three tree impacts.

Figure 22: Overlapping damage to Nissan’s front from impact with barrels and case vehicle; Note: contour gauge positioned along actual bumper (case photo #52)

The wheelbase on the Nissan’s left side was shortened 17 centimeters (6.7 inches) while the right side was shortened 9 centimeters (3.5 inches). The Nissan’s front bumper, bumper fascia, grille, radiator, hood, right fender, and right and left headlight and turn signal assemblies were directly damaged and crushed rearward. Furthermore, the Nissan’s right fender and right front door were crushed inward during the wrap around portion of the crash sequence. There was
