**GENERAL DYNAMICS ON-SITE ADVANCED OCCUPANT PROTECTION SYSTEM
INVESTIGATION
SCI TECHNICAL SUMMARY REPORT**

CASE NO. CA03-044

VEHICLE – 2003 LEXUS SC 430

CRASH DATE – JULY 2003

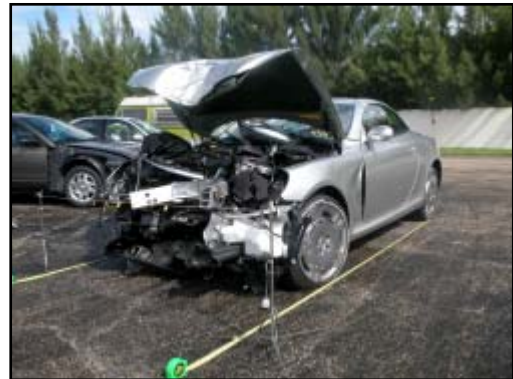
Figure 1. Damaged 2003 Lexus SC430

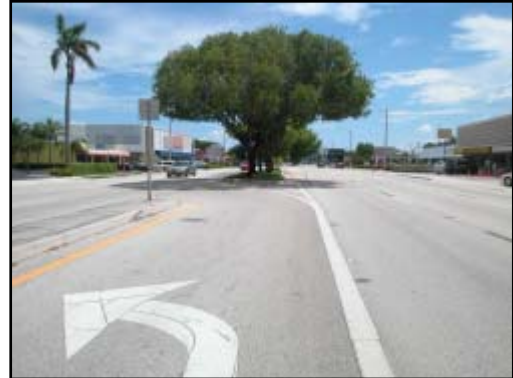
The 52-year-old male driver was operating the Lexus in the inboard southbound lane of the divided roadway. The police estimated pre-impact speed was 89 km/h (55 mph), and the driver exhibited signs of alcohol intoxication. The EDR-reported pre-crash speed was 57.9 km/h (36.0 mph) five seconds before impact and 56.0 km/h (34.8 mph) one second before impact. The driver stated to police that he looked away from the road in an attempt to locate a cellular telephone that was in the vehicle. He relinquished control of the Lexus and drifted into the left turn lane on approach to the left turn channel in the median (**Figure 2**). The driver did not attempt any avoidance maneuvers prior to the crash.

Figure 2. Southbound approach for the Lexus SC430

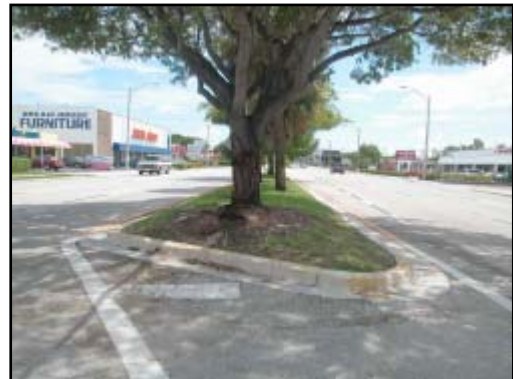
The vehicle traveled in a straight direction across the left turn channel (**Figure 3**) and struck the concrete curb face of the median on the south aspect of the channel. The bottom aspect of the bumper fascia struck the curb as the Lexus traveled onto the median. Due to the angle of the curb, the right front tire struck the curb and the Lexus rotated slightly clockwise (CW) and both wheels traveled over the curb as the Lexus continued onto the median. The front center aspect of the Lexus struck the tree that measured 45.7 cm (18.0”) in diameter located in the center of the median. The impact resulted in severe damage to the Lexus and was sufficient to deploy the driver’s frontal air bag and driver’s retractor-mounted safety belt pretensioner. The damage algorithm of the WinSMASH program computed a total delta-V of 43.0 km/h (26.7 mph) for the impact with the tree. The EDR reported a 0.5 km/h (0.3 mph) delta-V for the crash, which was not consistent with the reconstruction. The EDR output is summarized in the EDR section of this report. The Lexus rotated slightly in a CW direction around the tree and came to rest against the tree.

Figure 3. Close-up of concrete curb and struck tree

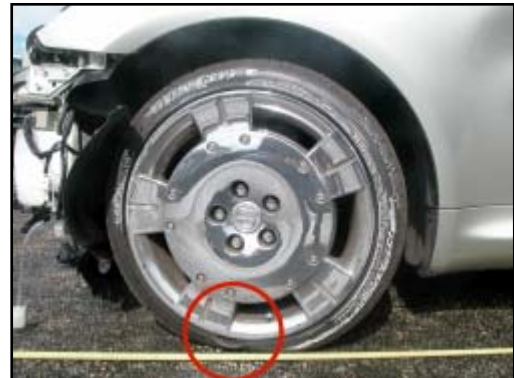
The 2003 Lexus SC430 sustained minor damage as a result of the curb impact. The bottom aspect of the bumper fascia sustained faint abrasions from contact with the concrete curb. The Collision Deformation Classification for the initial impact with the bottom of the bumper fascia was 12-FDLW-1. The damage to the front alloy wheels was minor, although the right front wheel sustained minor abrasions on the outer edge. Both front tires sustained minor sidewall damage as a result of the curb impact (**Figure 4**). The CDC's for the curb impact with the left and right front wheels were 12-FLWN-3 and 12-FRWN-3, respectively.

Figure 4. Left front wheel/tire showing minor sidewall damage

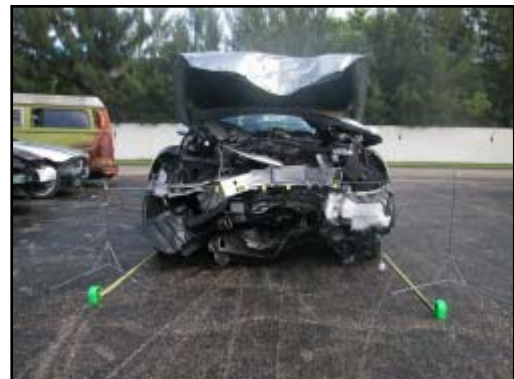
The Lexus sustained severe frontal damage as a result of the impact with the tree (**Figures 5 and 6**). The direct damage began 24.3 cm (13.5") right of the centerline and extended 77.5 cm (30.5") to the left along the bumper fascia and hood. Tree bark fragments and abrasions were present on the hood and front bumper fascia. The front bumper fascia was fractured and separated. The hood was crushed and buckled rearward and the bumper beam was displaced upward and crushed. The horizontal centerline of the front bumper beam was located 64.8 cm (25.5") above the ground at the vehicle centerline. The metal bumper beam exhibited an 8.9 cm (3.5") lateral tear on the face that was located 21.6 cm (8.5") inboard from the left corner of the beam. The maximum crush was located 9.5 cm (3.8") right of the centerline and measured 60.4 cm (23.8"). The combined direct and induced damage involved the entire frontal width of the Lexus and measured 67.3 cm (26.5") across the front bumper beam. The frontal damage displaced the left front wheel slightly rearward, which resulted in a 2.0 cm (0.8") reduction of the left wheelbase. Both front fenders were displaced rearward and buckled at the rear aspects as a result of interaction with the forward aspects of the side doors as they were opened. Additional induced buckling was present on the forward aspect of the left rear quarter panel. The windshield was fractured from impact forces and holed on the top left aspect. Six crush

Figure 5. Frontal view of damaged Lexus

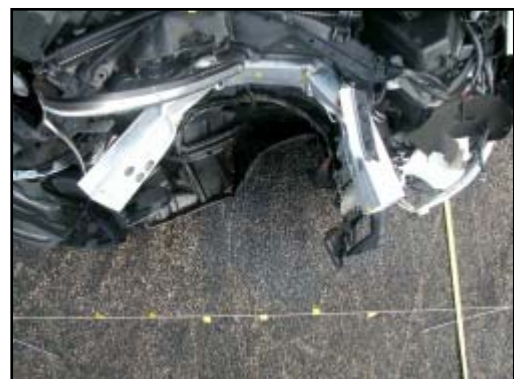
Figure 6. Overhead view of crushed bumper beam

measurements were documented along the front bumper beam and were as follows: C1 = 5.1 cm (2.0"), C2 = 57.2 cm (22.5"), C3 = 59.7 cm (23.5"), C4 = 57.5 cm (22.6"), C5 = 35.6 cm (14.0"), C6 = 9.5 cm (3.8"). The CDC for the frontal impact to the tree was: 12-FDEW-3.

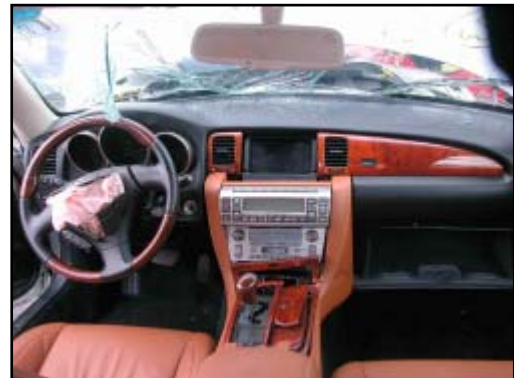
As shown by **Figure 7**, the instrumentation located in the center instrument panel was displaced from crash forces. The trim panels on the center console were displaced and fractured. The rear view mirror was separated and the glove box door opened during the crash and was jammed in the open position by interior deformation. A small scuff from probable left knee contact was located on the knee bolster 6.4 cm (2.5") left of the steering column centerline and 20.3 cm (8.0") below the top aspect of the bolster. The scuff measured 2.5 cm (1.0") in width and 5.1 cm (2.0") in length. Two faint linear scuffs were present on the headliner above the driver's seating position. Both scuffs measured 3.8 cm (1.5") in length.

Figure 7. View of damaged instrument panel area

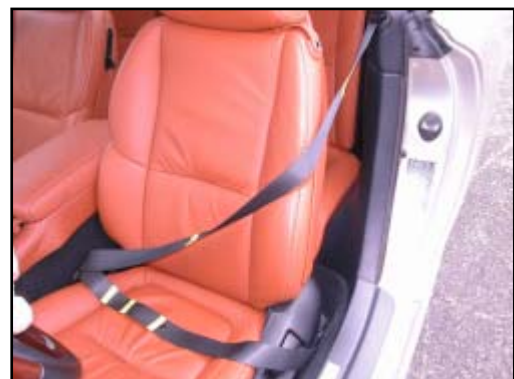
The Lexus SC430 was equipped with manual 3-point lap and shoulder belts for each seating position. The driver's safety belt was configured with a sliding latch plate and Emergency Locking Retractor (ELR). The driver's safety belt (**Figure 8**) was restricted in the used position at the time of the vehicle inspection. The plastic latch plate cover was abraded as a result of the driver loading against the safety belt webbing, and the driver's shoulder belt guide exhibited minor abrasions. Stretch marks in the driver's safety belt webbing began 61.0 cm (24.0") above the anchor and extended 53.3 cm (21.0") upward along the webbing. Two diagonal creases in the webbing were located 70.5 cm (27.8") and 73.0 cm (28.8") from the anchor from latch plate

Figure 8. View of restricted driver's safety belt

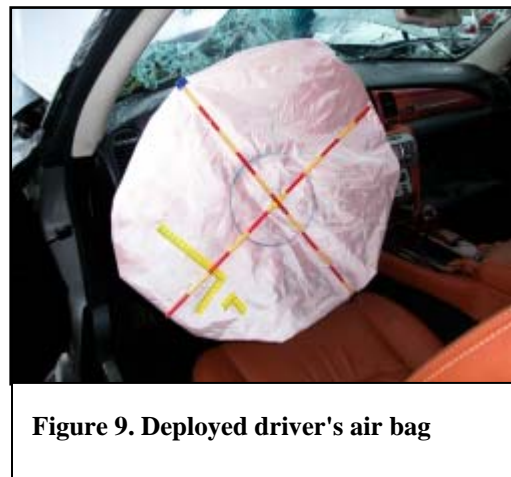
The driver's frontal air bag deployed as a result of the frontal impact with the tree. The air bag (**Figure 9**) deployed from the center of the steering wheel that was configured with a triangular cover flap configuration with a horizontal tear seam that measured 14.9 cm (5.9") in width. The top cover flap measured 7.6 cm (3.0") in height and the contoured symmetrical bottom flaps measured 5.1 cm (2.0") in height. The air bag measured 66.0 cm (26.0") in diameter. Faint vinyl linear transfers were present on the left aspect of the air bag face from the expansion of the air bag. The transfers began 17.8 cm (7.0") left of the vertical centerline and 1.9 cm (0.8") below the horizontal centerline and measured 3.8 cm (1.5") in width and 12.1 cm (4.8") in height. A 1.3 cm (0.5") diameter puncture was located on the lower left quadrant of the air bag. It was located 18.4 cm (7.3") left of the vertical centerline and 8.3 cm (3.3") below the horizontal centerline. Additional expansion-related linear transfers were present on the lower right quadrant of the rear panel of the air bag along the circumferential seam. The transfers measured 14.0 cm (5.5") in length and extended 1.9 cm (0.8") in depth from the seam.

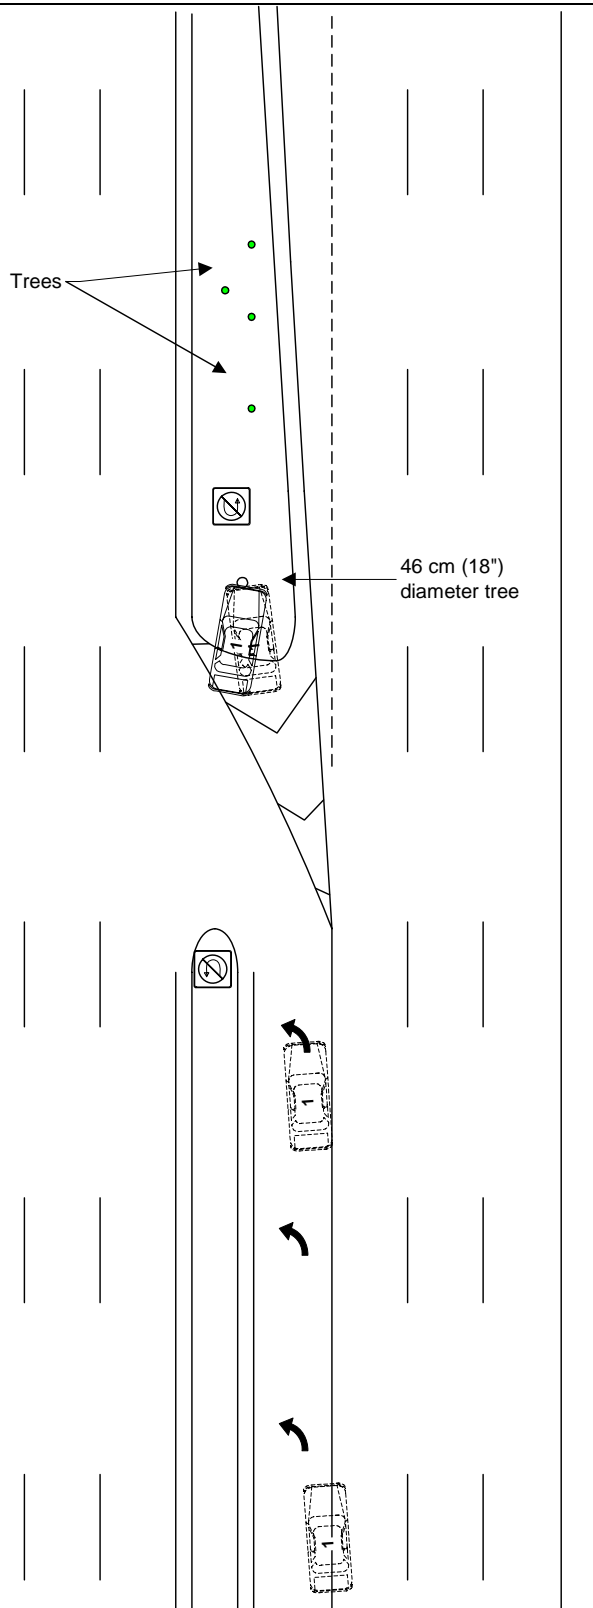
Figure 10. Scene schematic

This single vehicle crash occurred during the nighttime hours of July 2003 in the state of Florida. At the time of the crash, the weather was clear and the asphalt roadway surface was dry. The roadway was configured with three travel lanes in each direction that were separated by a curbed grassy median and bordered by 15 cm (6”) concrete curbs. Multiple trees were present on the median. The median narrowed north of the crash scene to accommodate a left turn lane adjacent to the inboard travel lane, which led to a left turn channel through the median. A tree that measured 45.7 cm (18.0”) in diameter was located in the center of the south median adjacent to the left turn channel. The roadside environment consisted of commercial businesses and the posted speed limit was 72 km/h (45 mph). The scene schematic is included as **Figure 10** of this report.
