# INDIANA UNIVERSITY

### ON-SITE SIDE IMPACT INFLATABLE OCCUPANT PROTECTION INVESTIGATION

CASE NUMBER - IN-03-046  
LOCATION - MINNESOTA  
VEHICLE - 1998 NISSAN MAXIMA SE  
CRASH DATE - October 2003

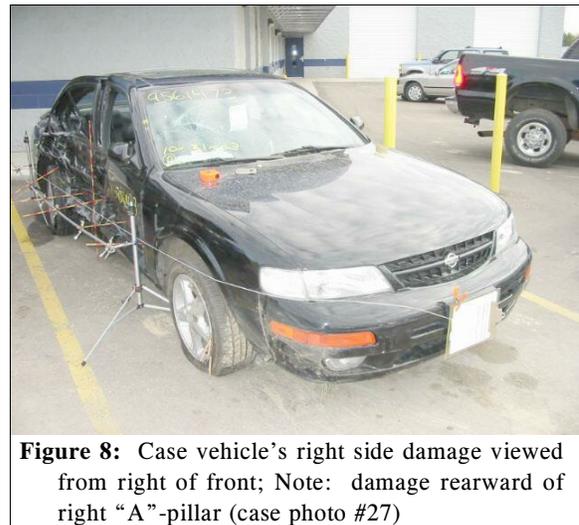
**Figure 8:** Case vehicle's right side damage viewed from right of front; Note: damage rearward of right "A"-pillar (case photo #27)

**Crash:** The right side (Figure 8) of the case vehicle was impacted by the front of the GMC, causing the case vehicle's driver and front right passenger supplemental restraints (air bags) to deploy. Furthermore, the right front, seat back-mounted side impact air bag also deployed.

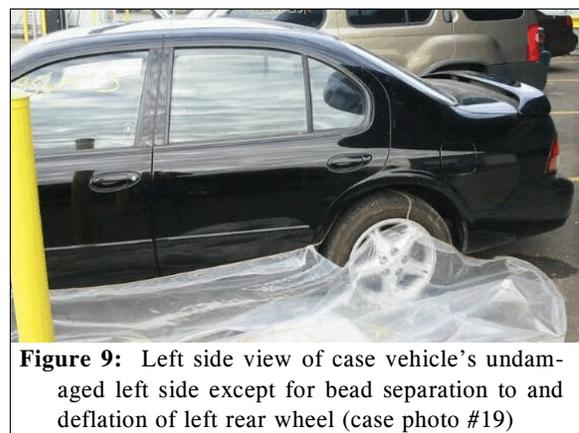
**Figure 9:** Left side view of case vehicle's undamaged left side except for bead separation to and deflation of left rear wheel (case photo #19)

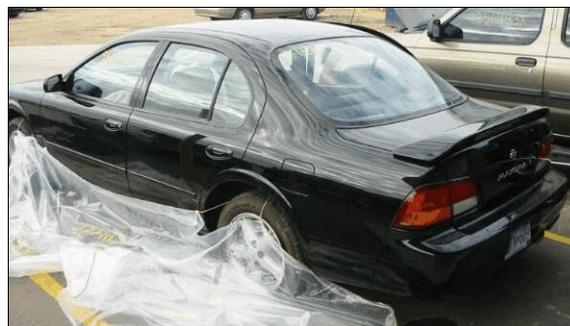
**Figure 10:** Left rear view of case vehicle's undamaged left side except for bead separation to and deflation of left rear wheel (case photo #20)

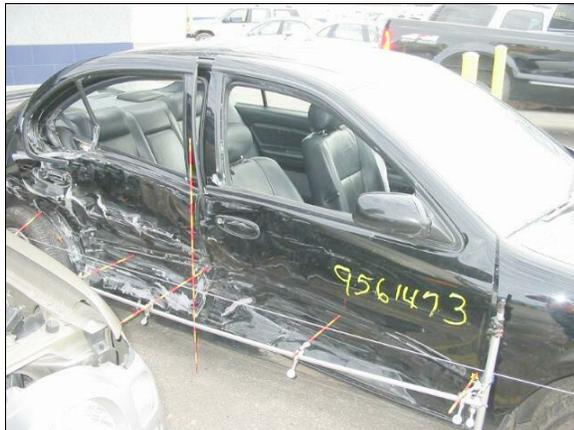
**Exterior Damage:** The case vehicle's contact with the GMC truck involved its right side, from the forward edge of the right front door rearward (**Figures 11** and **12** below). Direct damage began 50 centimeters (19.7 inches) rearward of the right front axle and extended 231 centimeters (90.9 inches) rearward, along the right side. The Field L was measured from the same starting point, but extended 265 centimeters (104.3 inches) rearward along the right side. Maximum crush

**Figure 11:** Case vehicle’s right side damage with contour gauge positioned above sill showing crush at 2<sup>nd</sup> through 6<sup>th</sup> positions (case photo #25)

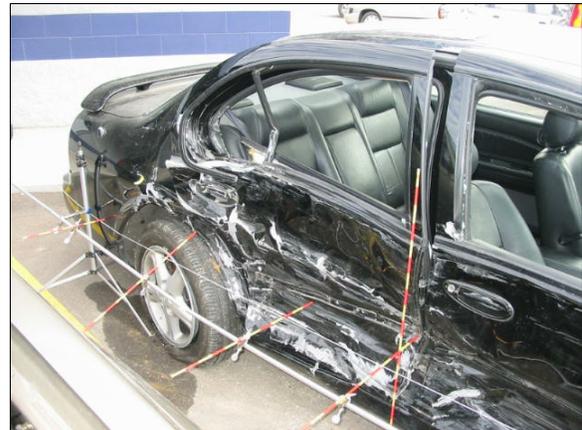
**Figure 12:** Case vehicle’s right side damage with contour gauge positioned above sill showing crush at 1<sup>st</sup> through 4<sup>th</sup> positions (case photo #24)

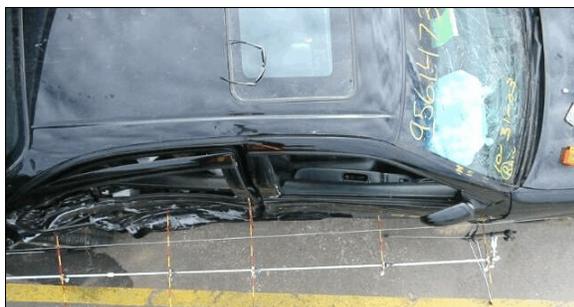
was measured as 21 centimeters (8.3 inches) at C<sub>4</sub> (Figure 13 and 14). The table below shows the case vehicle’s crush profile.

**Figure 13:** Overhead view of case vehicle’s right side damage showing crush positions 2 through 6 (case photo #29)

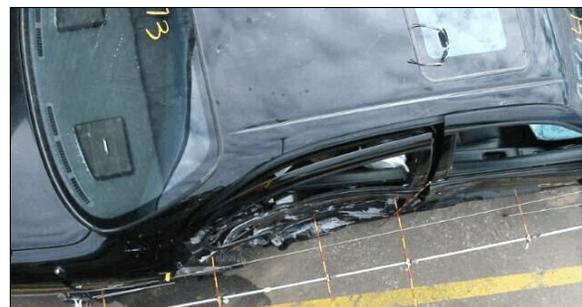
**Figure 14:** Overhead view of case vehicle’s right side damage showing crush positions 1 through 5 (case photo #30)

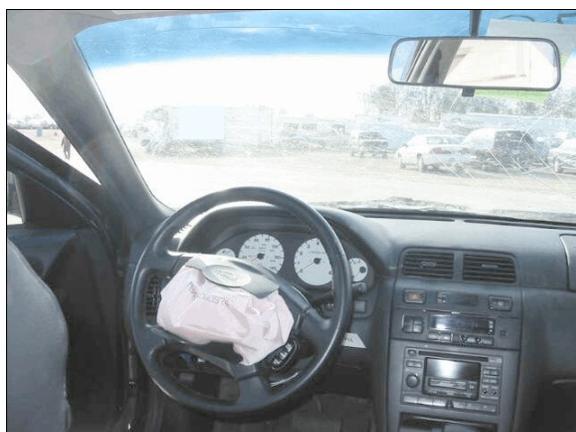
**Figure 15:** Case vehicle’s driver seating area showing deployed driver air bag, stress cracks to windshield’s glazing, and no obvious occupant contact evidence (case photo #34)

**Interior Damage:** Inspection of the case vehicle’s interior revealed no apparent evidence of occupant contact on either the front interior surfaces (**Figures 15 and 16**) or the right side interior surface of the case vehicle (**Figures 17 and 18** below). However, it is almost certain that, based on intrusions, the front right passenger was contacted by the inside of the right front door and arm rest, causing the interviewee-reported contusion to his right arm. Intrusions were noted to the interior surface of the right front door, the right “B” pillar, the right rear door, and the right rear sill area. The largest intrusion occurred to the right rear door’s surface [i.e., 16 centimeters (6.3 inches)]. Finally, there was no evidence of compression of the energy absorbing shear capsules in the base of the steering column and no deformation to the steering wheel rim.

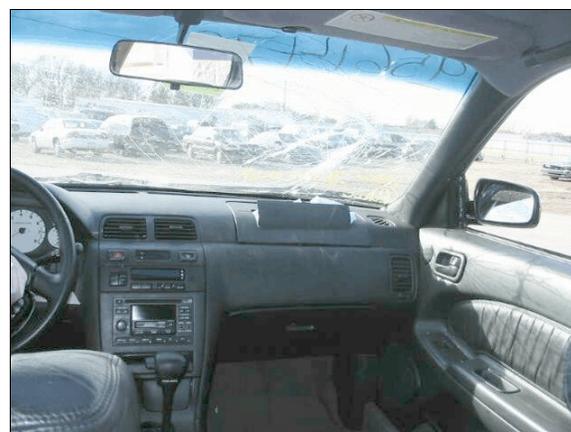
**Figure 16:** Case vehicle’s front right passenger seating area showing deployed front right passenger air bag, stress cracks to windshield’s glazing, and no apparent evidence of occupant contact to interior surface of right front door, right instrument panel, or greenhouse areas (case photo #36)

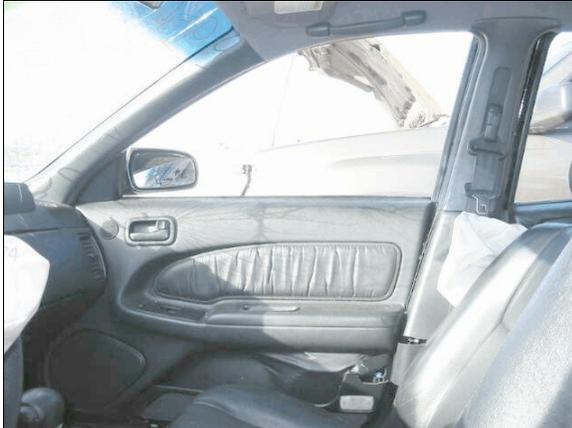
**Figure 17:** Interior surface of case vehicle's right front door showing no obvious occupant contact evidence on intruding surface (case photo #31)

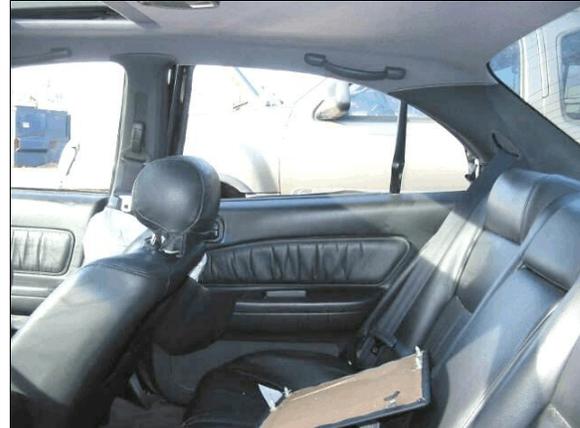
**Figure 18:** Interior surface of case vehicle's right rear door showing 16 cm (6.3 in) of intrusion to back right seating area (case photo #64)

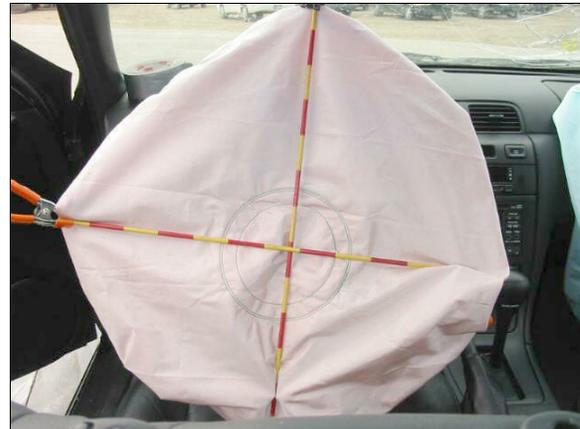
inches). An inspection of the driver's air bag fabric revealed no contact evidence readily apparent on the air bag's fabric other than routine deployment dirt/grease scuffs (**Figure 19**).

**Figure 19:** Case vehicle's deployed driver air bag showing no apparent evidence of occupant contact (case photo #40)

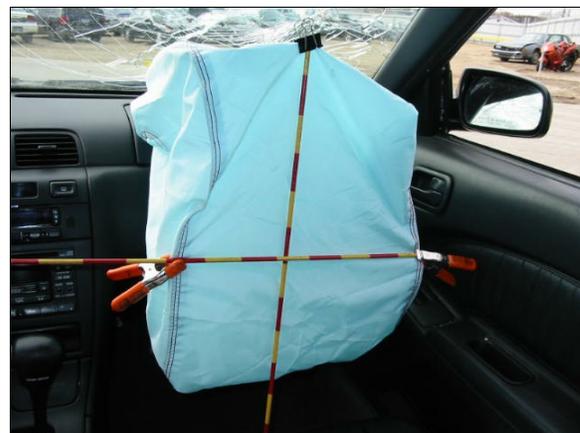
The front right passenger's air bag was located in the top of the instrument panel. There were two asymmetrical, "H"-configuration, modular cover flaps made of a thick semi-pliable vinyl. The top cover flap was shaped like a parallelogram and the bottom flap was trapezoidal. The top flap had an overall width 24.5 centimeters (9.6 inches) from side to side and was 3 centimeters (1.2 inches) along both vertical seams. The bottom cover flap measured 24.5 centimeters (9.6 inches) at the bottom horizontal seam, 7.5 centimeters (3.0 inches) vertically along its left side, and 6.5 centimeters (2.6 inches) vertically along its right side. The profile of the case vehicle's instrument panel resulted in a 11 centimeter (4.3 inch) setback of the leading edge of the cover flap relative to the protruding right instrument panel. An inspection of the front right air bag module's cover flaps and the air bag's fabric revealed that the cover flaps opened at the designated tear points, and there was no evidence of damage during the deployment to the air bag or the cover flaps. The front right passenger's air bag was designed without any tethers. The front right air bag had two vent ports, approximately 3 centimeters (1.2 inches) in diameter, located at the 2:30 and 9:30 clock positions. The deployed front right air bag was rectangular with a height of approximately 52 centimeters (20.5 inches) and a width of approximately 38 centimeters (15.0 inches). An inspection of the front right passenger's air bag fabric revealed an obvious contact on the front right air bag's fabric (i.e., a smudge/scuff) near the top center portion, most likely from contact by the front right passenger (**Figures 20 and 21**).

**Figure 20:** Front surface of case vehicle's deployed front right passenger air bag showing only a small area (i.e., scuff) of occupant contact near the 12 o'clock position (case photo #44)

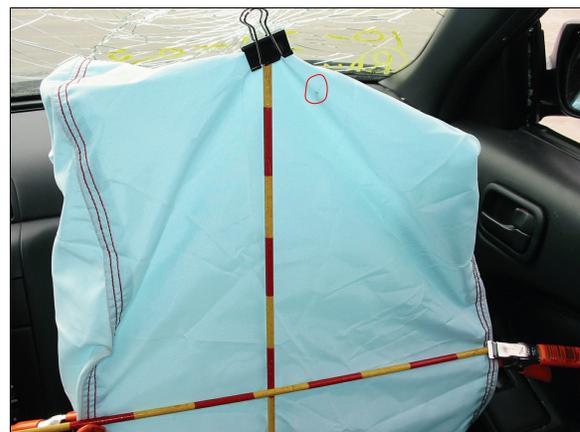
**Figure 21:** Close-up of scuff (highlighted) on case vehicle's deployed front right passenger air bag (case photo #45)

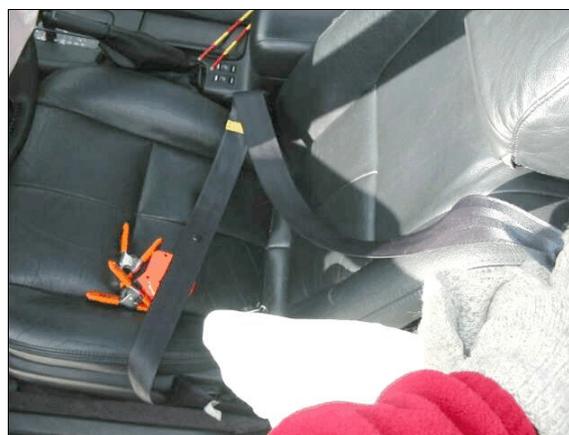
**Figure 28:** Loading evidence on lap portion of case vehicle's driver safety belt (case photo #59)

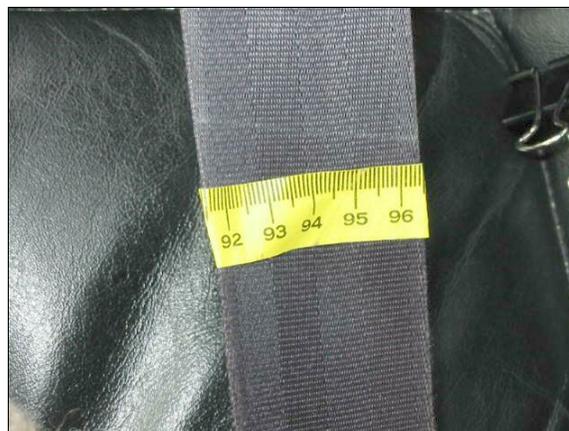
The case vehicle's driver was restrained by his available, active, three-point, lap-and-shoulder, safety belt system. There was no mention by the interviewee (i.e., driver's mother) of belt pattern bruising and/or abrasions to the driver's body, but the inspection of the driver's seat belt webbing, "D"-ring, and latch plate showed evidence of loading (i.e., stress mark from the driver's latch plate—**Figure 28** above and **Figure 29**).

**Figure 29:** Lap belt portion of case vehicle's driver safety belt showing loading mark from latch plate (case photo #60)
