**ON-SITE AIR BAG NON-DEPLOYMENT/
DRIVER FATALITY INVESTIGATION**

CASE NO: CA03-046

VEHICLE: 2001 HYUNDAI ELANTRA

CRASH DATE: AUGUST, 2003

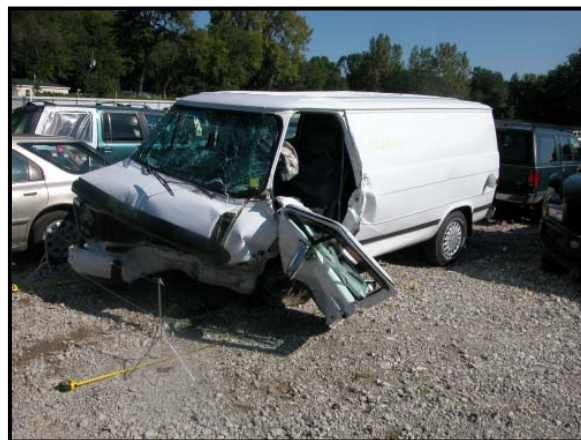
The front plane of the Chevrolet (**Figure 6**) sustained 162.6 cm (64.0 in) of combined direct and induced damage that extended across the vehicle's frontal end width. The direct damage measured 113.0 cm (44.5 in) and began 31.8 cm (12.5 in) left of center and extended to the left front corner. This frontal direct contact wrapped around the left front corner and extended 43.2 cm (17.0 in) onto the left side. The left front wheel assembly was displaced rearward into the aft aspect of the wheel opening. The left front tire deboned and was restricted. The left wheelbase was reduced 53.1 cm (20.9 in). The left front door was jammed shut by deformation and opened by extrication. The residual crush profile measured along the front bumper was as follows: C1 = 93 cm (36.6 in), C2 = 80.0 cm (31.5 in), C3 = 65.0 cm (25.6 in), C4 = 55.0 cm (21.7 in), C5 = 12.0 cm (4.7 in), C6 = 0. The maximum crush was located at the left front corner (C1). The Collision Deformation Classification (CDC) was 12-FYEW-6. The total delta V calculated by the damage algorithm of the WinSmash model was 45.5 km/h (28.3 mph). The longitudinal and lateral delta V components were -45.5 km/h (-28.3 mph) and 0, respectively.

Figure 6: Left front view of the Chevrolet.

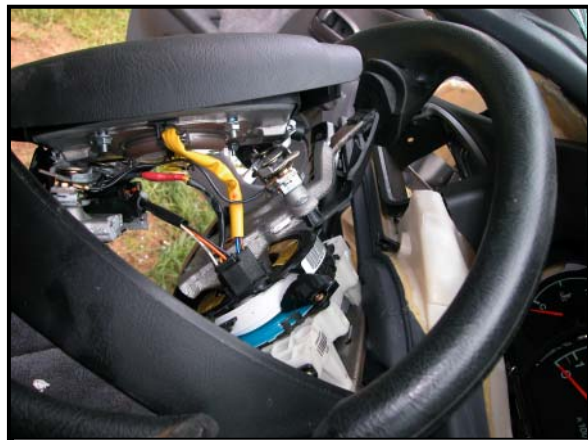
The 4-spoke steering wheel rim was rotated approximately 90 degrees clockwise at inspection. The steering column was completely separated from the shear capsules and the column had dropped. The left and right shear separation measured 5.1 cm (2.0 in) and 4.6 cm (1.8 in), respectively. The steering wheel rim support casting (fastened to the steering column end) was fractured by inertial loading from the occupant. The steering wheel rim was cut in 1 and 9 o'clock sectors during the extrication process for unknown reasons. **Figure 8** is a view of the deformed steering wheel rim. **Figure 9** is a lateral view across the steering wheel viewed from the 1 o'clock sector to the 8 o'clock sector of the fractured casting.

Figure 9: Lateral view across the plane of the steering wheel from 1 to 8 o'clock.

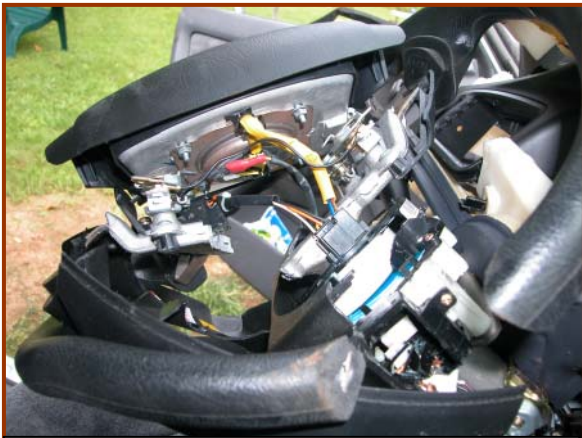
The driver bag was a located in the center hub of the steering wheel. It was not deployed. **Figure 13** is a lateral view of the driver air bag module attached to the fractured casting. **Figure 14** is a close-up view of the back side of the module and the inflator. The inflator was manufactured by Autoliv Inc. and was identified by the following: *MAF M27 1M AOH*. Inspection of the inflator determined the electrical connector was still attached to the inflator; however, the connector was crushed. The connector had impacted the casting, when the casting was fractured by driver loading. **Figure 15** is a close-up view of the casting. Yellow transfers from the connector's housing were identified on the casting indicative of the contact. It should be noted that this contact sequence occurred late in the overall crash sequence and would not have compromised the proper deployment of the driver air bag.

Figure 13: Left lateral view of the DAB.

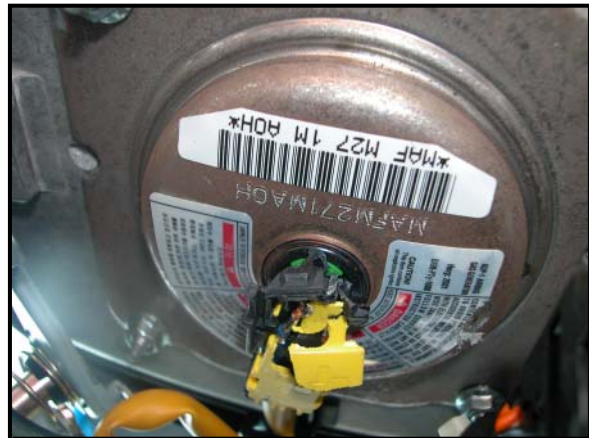
Figure 14: View of the DAB inflator.
