**GENERAL DYNAMICS ON-SITE ADULT AIR BAG RELATED FATALITY  
INVESTIGATION**

**GENERAL DYNAMICS CASE NO. – CA03-047**

**SUBJECT VEHICLE – 2000 CHEVROLET PRIZM**

**CRASH DATE – AUGUST 2003**

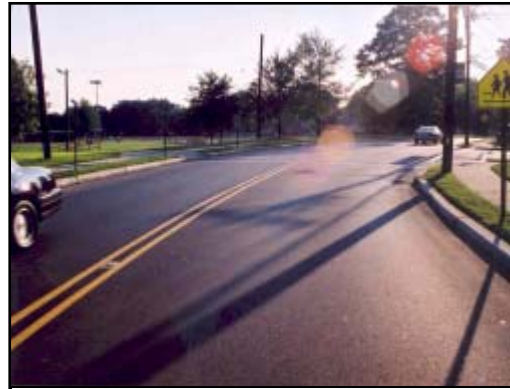
**Figure 2. Eastbound view of the intersection.**

This two-vehicle crash occurred during the evening hours of August 2003. At the time of the crash, the weather was clear with no adverse conditions. Although not intersection related, the crash occurred at a “T” intersection (**Figure 2**) of two local roadways. The east/west roadway consisted of an S-type curve and was configured with one travel lane in each direction, separated by a double-yellow centerline. The eastbound curve began as a right curve with a positive grade. The westbound curve began as a left curve with a negative grade. The north/south roadway was configured with one travel lane in each direction. Concrete curbs bordered the east/west roadway. East/west traffic flow through the intersection was not controlled. The posted speed limit for the east/west roadway was 40 km/h (25 mph). The scene schematic is included as (**Figure 10**) of this report.

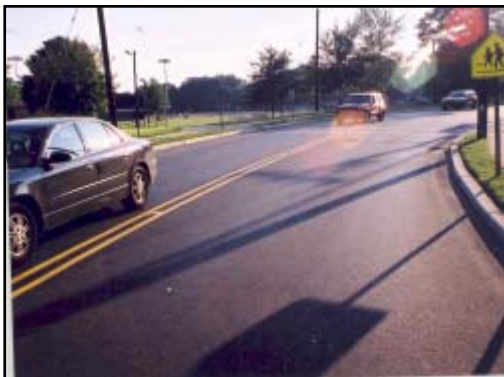
**Figure 3. Chevrolet's eastbound approach.**

The 79-year-old female driver of the Chevrolet was operating the vehicle eastbound on the two-lane roadway negotiating the "S" curve on approach to the "T" intersection (**Figure 3**). The 38-year-old male driver of the Audi was traveling westbound (**Figure 4**) approaching the "T" intersection entering the left curve. The police reported that the driver of the Chevrolet steered left to avoid a pedal cyclist that was traveling in the same direction, adjacent to the curb. The driver of the Prizm steered back to the right to maintain her lane position; however, she lost directional control of the vehicle.

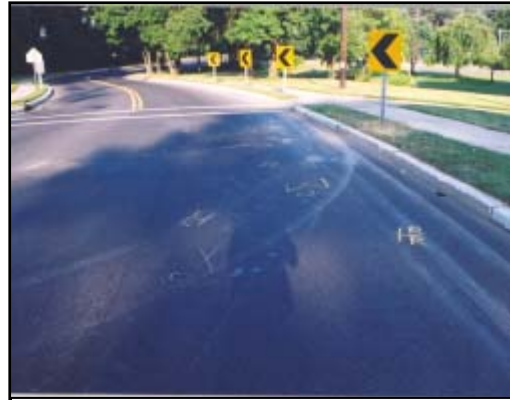
**Figure 5. Area of impact.**

As the driver of the Chevrolet steered right to re-enter the eastbound lane, she traveled beyond the lane and impacted the curb with the right front tire. The Chevrolet then rebounded off the curb and back onto the roadway. The driver of the Chevrolet steered right and impacted the curb with the right front and right rear tires. The sidewall of the right front tire was abraded circumferentially. A dent that was 0.6 cm (0.25”) in depth was present on the right front wheel rim at the bead. The sidewall and hubcap of the right rear tire were abraded from contact with the curb.

The Chevrolet then re-entered the road, crossed the centerline, and entered the intersection. The front of the Chevrolet impacted the front of the Audi in a head-on (12/11 o'clock) impact configuration (**Figure 5**). The impact resulted in severe damage to the front of the Chevrolet and moderate damage to the front of the Audi. The damage algorithm of the WinSMASH program computed a total delta-V of 38.0 km/h (23.6 mph) for the Prizm. The longitudinal and lateral components for the Prizm were -37.4 km/h (-23.3 mph) and -6.6 km/h (-4.1), respectively. The total delta-V for the Audi was 29.0 km/h (18.0 mph) and the longitudinal and lateral components for the Audi were -27.3 km/h (-16.9 mph) and 9.9 km/h (6.2 mph), respectively.

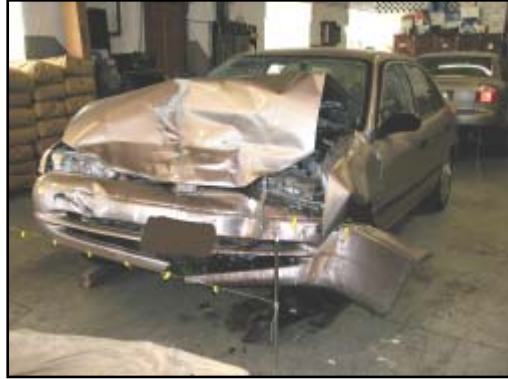
**Figure 6. Damaged Chevrolet Prizm.**

The 2000 Chevrolet Prizm sustained severe frontal damage (**Figure 6**) as a result of the impact with the Audi. The direct contact damage began at the left front bumper corner and extended 142.8 cm (56.25”) along the bumper fascia to the right front bumper corner. Maximum crush was located at the left front corner of the bumper beam and was 62.8 cm (24.75”). The left wheelbase was reduced 10.2 cm (4.0”) from the displaced left front axle.

The left front wheel was restricted against the rear of the left front fender. The frame rails were shifted slightly left and crushed rearward.

The left front fender and hood were also deformed. The base of the windshield was fractured with scattered stress fractures from contact with the hood edge and the deploying front right air bag. The side and rear glazing were not damaged. All four doors remained closed during the crash and were operational post-crash. The Collision Deformation Classification (CDC) for the impact with the Audi was 12-FDEW-3. Six crush measurements were documented at the bumper beam using a combined direct and induced damage width of 106.0 cm (41.75”) and were as follows: C1 = 62.8 cm (24.75”), C2 = 59.2 (23.3”), C3 = 44.5 cm (17.5”), C4 = 32.1 cm (12.65”), C5 = 21.8 cm (8.6”), C6 = 5.1 cm (2.0”).

The sidewall of the right front tire was abraded circumferentially. The right front hubcap was missing from the Prizm at the time of the crash, however it was not known if this was crash related. A dent that was 0.6 cm (0.25”) in depth was present on the right front wheel rim at the bead. The sidewall and hubcap of the right rear tire were abraded from contact with the curb. The CDC’s for the three curb impacts were as follows: 12-FRWN-3, 12-FRWN-3, and 12-FRWN-9.

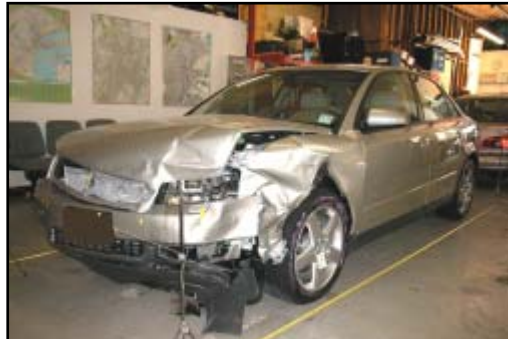
**Figure 7 - Damaged 2003 Audi.**

The 2003 Audi A4 sustained moderate frontal damage (**Figure 7**) as a result of the impact with the Chevrolet. The direct contact damage was 48.3 cm (19.0”) in length and began on the left front bumper corner and extended to 17.8 cm (7.0”) left of the centerline. The combined direct and induced damage was 116.0 cm (45.5”) along the front bumper fascia. The maximum crush was located at the left front bumper corner and was 34.3 cm (13.5”). The left front wheel was displaced rearward and was restricted against the left front fender. The left wheelbase was reduced 7.6 cm (3.0”).

The base of the windshield at the A-pillar was damaged from contact with the hood edge.

The side, rear and roof glazing were not damaged. All doors remained closed during the crash and were operational post-crash. Six crush measurements were documented along the front bumper and were as follows: C1 = 34.3 cm (13.5”), C2 = 22.1 cm (8.7”), C3 = 12.9 cm (5.1”), C4 = 2.1 cm (0.8”), C5 = 2.0 cm (0.8”), C6 = 0.0 cm (0.0”). The CDC for the frontal impact with the Chevrolet was 12-FYEW-2.

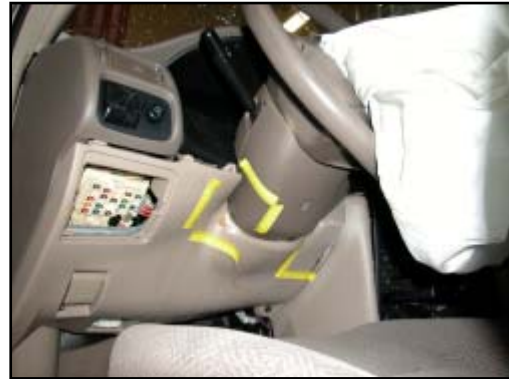
**Figure 8. Driver's knee bolster contacts.**

Interior damage to the 2000 Chevrolet Prizm was moderate and attributed to passenger compartment intrusion and occupant contact. The left toe pan was intruded approximately 13.0 cm (5.2”) from the engine compartment deformation. The left floor buckled upward 7.6 cm (3.0”) from the deforming toe pan. At impact, the driver initiated a forward trajectory into the path of the deploying air bag. The driver, while moving forward, began to submerge the knee bolster. The driver loaded the air bag and steering column. The driver’s loading bent the steering wheel rim forward 1.9 cm (0.75”) at the lower right quadrant and compressed the steering column. The steering column compression resulted in the displacement of the shear capsules. The left shear was displaced 3.2 cm (1.25”) and the right was displaced 2.5 cm (1.0”). The driver’s left knee contacted the left side of the knee bolster (**Figure 8**), deforming the knee bolster to a depth of 3.2 cm (1.75”). A bone fragment penetrated the left side of the knee bolster from the driver’s contact. The right side of the knee bolster was contacted by the driver’s right knee deforming it to a depth of 1.0 cm (0.375”).

As the driver continued her forward motion, her knees contacted and deformed the knee bolster resulting in the fracture and dislocation of the right knee joint, two vertically aligned lacerations of the left knee [2.5 cm and 1.3 cm (1.0" and 0.5")], and a proximal left tibia fracture. The driver also sustained symmetrical bilateral distal femur fractures that were a result of her knee's loading against knee bolster. A bone fragment that was embedded into the knee bolster evidenced the knee bolster contact area.

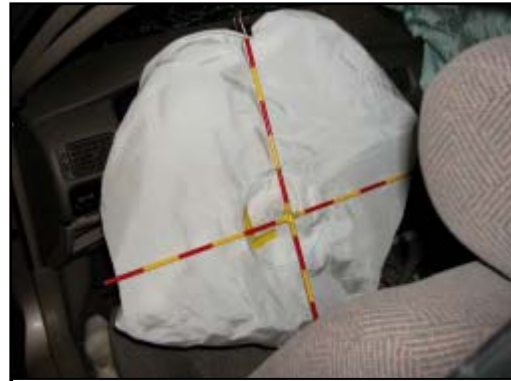
Figure 9. Driver's air bag.

The 2000 Chevrolet Prizm was equipped with a redesigned frontal air bag system that deployed as result of the crash with the Audi. The driver’s air bag was configured with asymmetrical H-configuration module cover flaps. The top flap measured 17.1 cm (6.75”) wide and 5.7 cm (2.25”) in height. The lower flap was 17.1 cm (6.75”) wide by

8.6 cm (3.375”) in height. The driver’s air bag (Figure 9) deployed from the center of the steering wheel hub and contained the following nomenclature on the rear aspect of the air bag at the 12 o’clock position: 062239. The center face of the bag was stamped with 23/S. The diameter of the air bag was 66.0 cm (26.0”) in it’s deflated state. Two symmetrical vent ports vented the air bag at the 11 and 1 o’clock positions on the backside of the air bag. Two tether straps at the 3 and 9 o’clock positions tethered the air bag internally. A subtle flesh tone transfer was documented near the left tether strap area of the air bag from possible contact with the driver’s face.

The 79-year-old female driver of the 2000 Chevrolet Prizm was seated in a presumed upright posture in a forward track position. This seat track position placed her in close proximity to the steering assembly and the driver air bag module. The driver was not restrained by the manual 3-point lap and shoulder belt. At impact, the frontal air bag deployed and expanded against the driver’s chest, which resulted in a 0.6 cm (0.25”) contusion of the left chest adjacent to the sternal border, and a 2.5 cm (1.0”) contusion of the chest wall along the right costal margin, symmetrical bilateral rib fractures 1-9 with flail chest and 1000cc of blood in the right chest, a tear of the left atrium on the interatrial septum, a 1.3 cm (0.5”) laceration of the descending aorta with near transection [attached by 1.3 cm (0.5”) thread], patchy contusions and hemorrhages of all lobes of the lungs, superficial stretch tears of the atria endocardium, and an oblique fracture of the mid body of the sternum. The continued bag expansion abraded and contused the bridge of her nose.
