# INDIANA UNIVERSITY

### ON-SITE CERTIFIED ADVANCED 208- COMPLIANT VEHICLE INVESTIGATION

CASE NUMBER - IN-03-048  
LOCATION - TEXAS  
VEHICLE - 2003 CHEVROLET K1500 SUBURBAN Z71  
CRASH DATE - October 2003

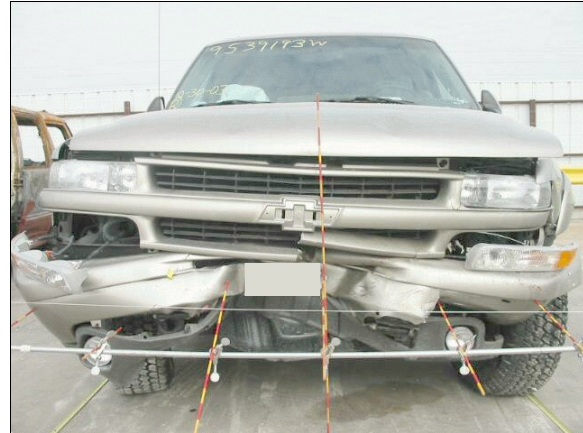
**Crash:** The front (**Figure 4** and **Figure 5**) of the case vehicle impacted the right front of the Ford, causing the case vehicle's driver and front right passenger supplemental restraints (air bags) to deploy. Based on the downloaded **EDR** data only one stage of the multi-stage air bags was activated.

**Figure 4:** Case vehicle's frontal damage from impact with Ford; Note: contour gauge positioned at bumper level (case photo #11)

**Exterior Damage:** The case vehicle’s initial contact with Ford involved its front (Figures 4 and 5 above). Direct damage began at the front left bumper corner and extended inward 116 centimeters (45.7 inches), along the front bumper. Residual maximum crush was measured as 31 centimeters (12.2 inches) at C<sub>3</sub> (Figure 9). The table below shows the case vehicle’s crush profile.

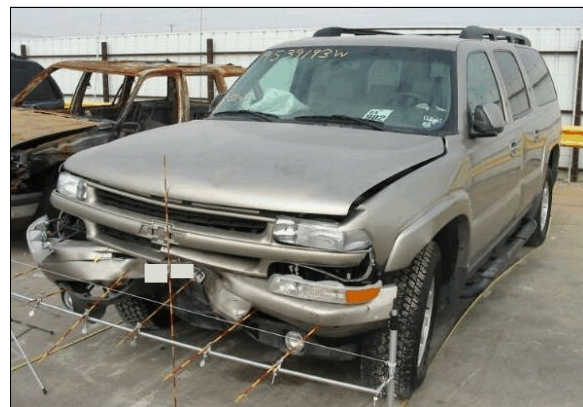
**Figure 5:** Case vehicle's frontal damage from impact with Ford viewed from left of front with contour gauge set at bumper level (case photo #13)

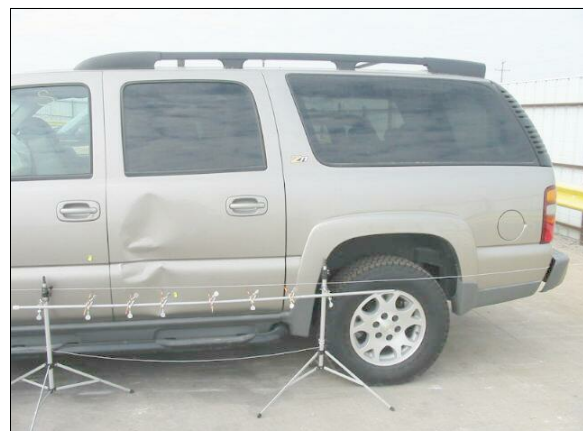
**Figure 6:** Case vehicle's side slap damage, primarily to left rear door (case photo #16)

From the frontal impact, the case vehicle’s front bumper, bumper fascia, grille, hood, and right headlight and turn signal assemblies were directly damaged and crushed rearward. For the side impact, the left rear door was directly damaged and crushed inward. In addition, for the frontal impact, there was induced damage to the left headlight and turn signal assemblies as well as the hood, and both the right and left fenders. For the side slap impact, there was induced damage to the left front and left rear doors. No obvious induced damage or remote buckling was noted to the remainder of the case vehicle’s exterior.

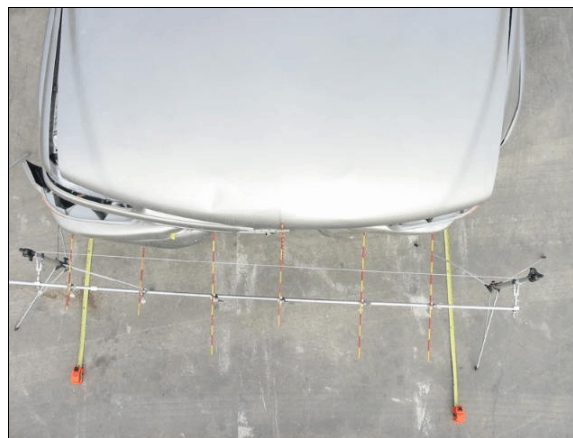
Figure 9: Overhead view of frontal damage to case vehicle from impact with Ford (case photo #23)

**Damage Classification:** Based on the vehicle inspection, the CDCs for the case vehicle were determined to be: **11-FDEW-2 (340 degrees)** for its initial impact with the Ford and **09-LPEW-1 (270 degrees)** for the side slap impact. The WinSMASH reconstruction program, missing vehicle algorithm, was used on both of the case vehicle's impacts. For the highest severity impact to the case vehicle, the Total, Longitudinal, and Lateral Delta Vs are, respectively: 20.0 km.p.h. (12.4 m.p.h.), -18.8 km.p.h. (-11.7 m.p.h.), and +6.8 km.p.h. (+4.2 m.p.h.). For the second highest severity (i.e., side slap) impact to the case vehicle, the Total, Longitudinal, and Lateral Delta Vs are, respectively: 3.0 km.p.h. (1.9 m.p.h.), 0.0 km.p.h. (0.0 m.p.h.), and +3.0 km.p.h. (+1.9 m.p.h.). Based on the vehicle inspection and the data from the **EDR**, this collision fits the reconstruction model, but the results appear to be high. The case vehicle was towed due to damage.

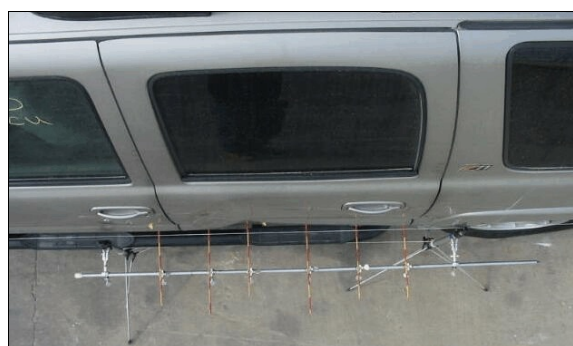
The wheelbase on the case vehicle’s left side was shortened by approximately 1 centimeter (0.4 inches) while the right side was extended approximately 2 centimeters (0.8 centimeters). The case vehicle’s side slap contact with the Ford involved its left side (Figure 6 above). Direct damage began 125 centimeters (49.2 inches) forward from the left rear axle and extended 42 centimeters (16.5 inches) forward along the left side. The Field L began 64 centimeters (25.2 inches) forward from the left rear axle and extended 103 centimeters (40.6 inches) forward along the left side. Residual maximum crush was measured as 5 centimeters (2.0 inches) at C<sub>4</sub> (Figure 10). The table above shows the case vehicle’s crush profile.

Figure 10: Overhead view of side slap damage, primarily to case vehicle’s left rear door (case photo #15a)

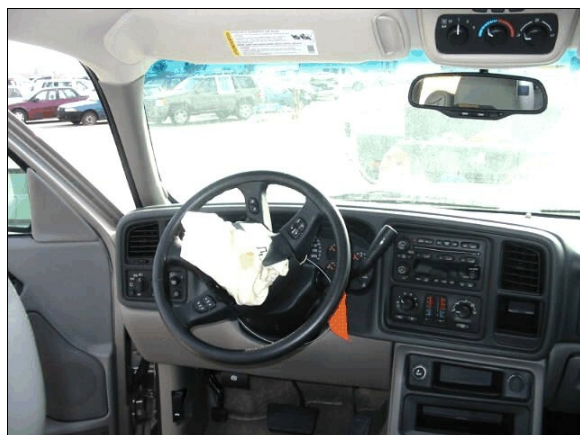
**Figure 11:** Case vehicle’s driver seating area showing deployed driver air bag and no apparent evidence of occupant contact (case photo #27)

**Interior Damage:** Inspection of the case vehicle’s interior revealed that there was no evidence of occupant contact on the interior surfaces of the case vehicle (**Figures 11 and 12 and Figure 13** below). Finally, there was no evidence of intrusion to the case vehicle’s interior, no evidence of compression to the energy absorbing shear capsules in the steering column, and no deformation to the steering wheel rim.

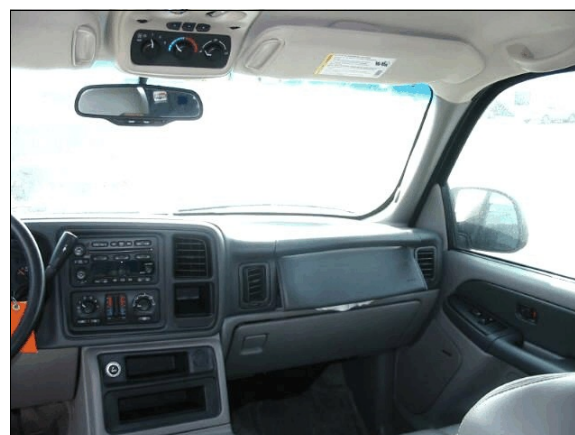
**Figure 12:** Case vehicle’s front right seating area showing deployed front right passenger air bag and no apparent occupant contact evidence (case photo #29)

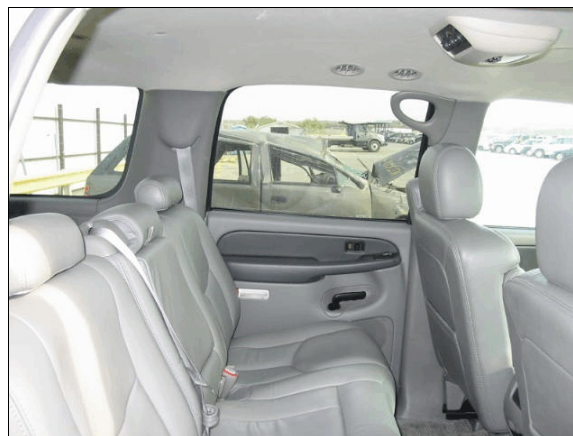
**Figure 13:** Case vehicle's second seating area viewed from right showing no apparent evidence of occupant contact and second seat center's integrated three-point lap and shoulder safety belt system (case photo #51)

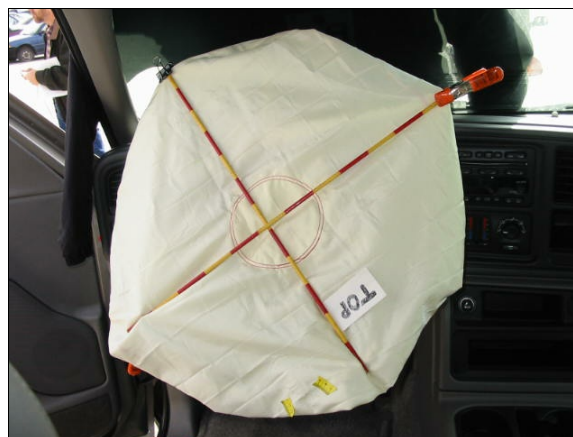
**Figure 14:** Case vehicle's deployed driver air bag showing only slight scuff near 1 o'clock position; Note: air bag rotated approximately 140 degrees clockwise (case photo #33)

positioned at the time of the vehicle inspection, and the front surface of the air bag's fabric at full excursion was 43 centimeters (16.9 inches). An inspection of the driver's air bag fabric revealed a slight transfer on the upper right portion of the air bag's fabric, near the 1 o'clock position (**Figure 14** above and **Figure 15**).

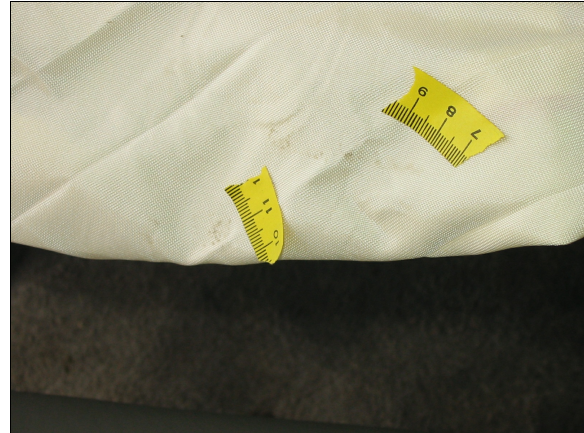
**Figure 15:** Close-up of scuff on case vehicle's deployed driver air bag near 1 o'clock position (case photo #34)

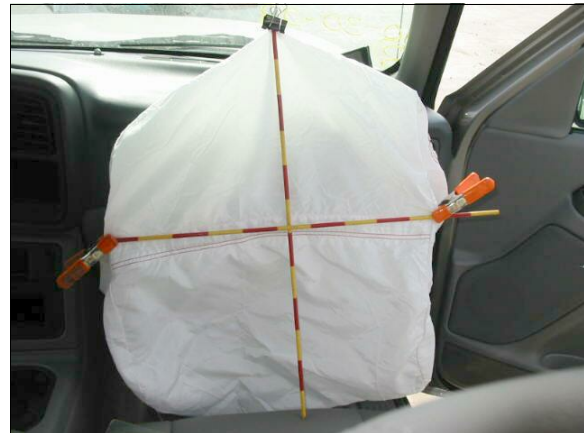
The front right passenger's air bag was located in the middle of the instrument panel. There was a single, essentially rectangular, modular cover flap. The cover flap was made of a thick vinyl over a thick cardboard type frame. The flap's dimensions were 38.5 centimeters (15.2 inches) at the lower horizontal seam and 14.5 centimeters (5.7 inches) along both vertical seams. The profile of the case vehicle's instrument panel was flush with the leading edge of the cover flap. An inspection of the front right air bag module's cover flap and the air bag's fabric revealed that the cover flap opened at the designated tear points, and there was no evidence of damage during the deployment to the air bag or the cover flap. The front right passenger's air bag was designed with one wide tether, approximately 47 centimeters (18.5 inches) in width. The front right air bag had two vent ports, approximately 3 centimeters (1.2 inches) in diameter, located at the 10 and 2 o'clock positions. The deployed front right air bag was rectangular with a height of approximately 68 centimeters (26.8 inches) and a width of approximately 49 centimeters (19.3 inches). The distance between the mid-center of the front right seat back, as positioned at the time of the vehicle inspection, and the front surface of the air bag's fabric at full excursion was 40 centimeters (15.7 inches). An inspection of the front right passenger's air bag fabric revealed no contact evidence readily apparent on the front right air bag's fabric (**Figure 16**).

**Figure 16:** Case vehicle's deployed front right passenger air bag showing no apparent evidence of occupant contact on front surface (case photo #38)

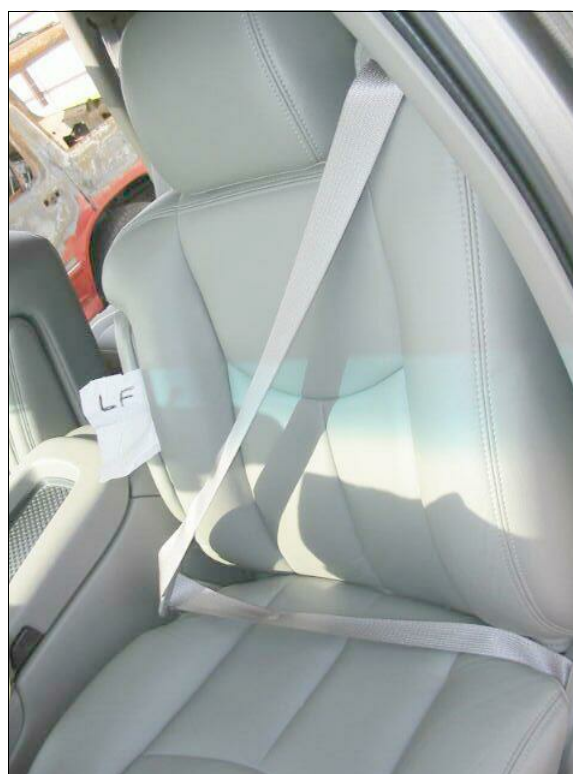
**Figure 17** Case vehicle's driver seat and integrated safety belts showing no apparent loading evidence on webbing (case photo #42)

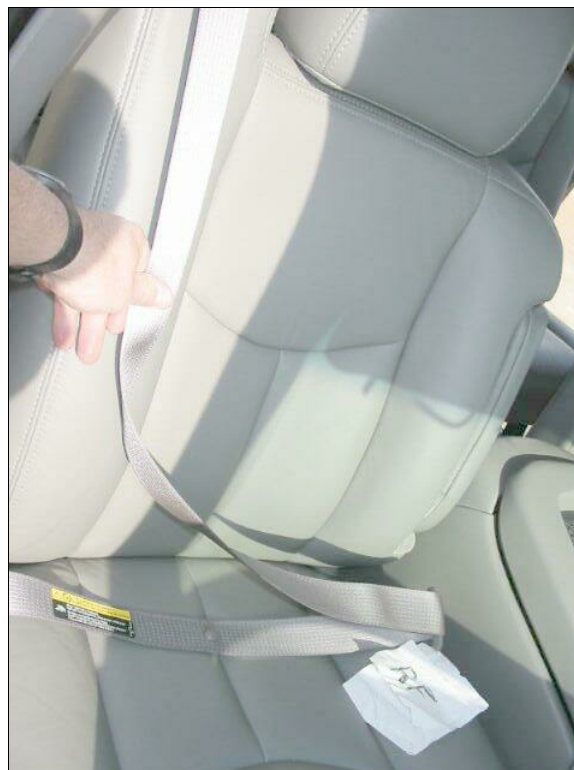
Figure 18: Case vehicle's front right seat and integrated safety belts showing no apparent loading evidence on webbing (case photo #47)

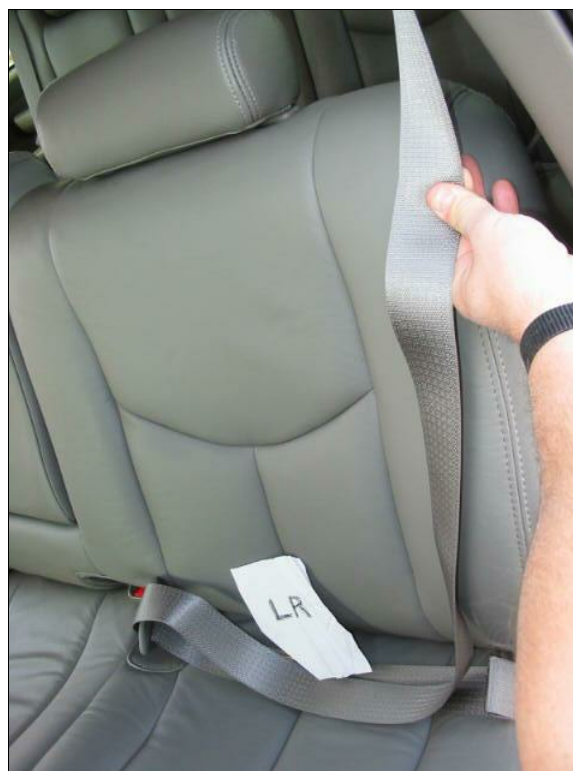
**Figure 19:** Case vehicle's second left seat cushion, adjustable head restraint, and safety belts; Note: no apparent loading evidence on webbing (case photo #52)

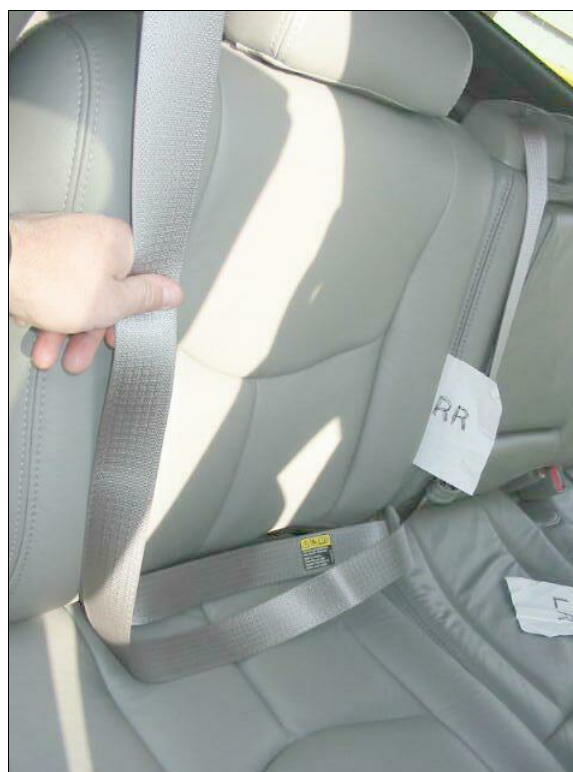
**Figure 20:** Case vehicle's second right seat cushion, adjustable head restraint, and safety belts showing no apparent loading evidence on webbing (case photo #55)

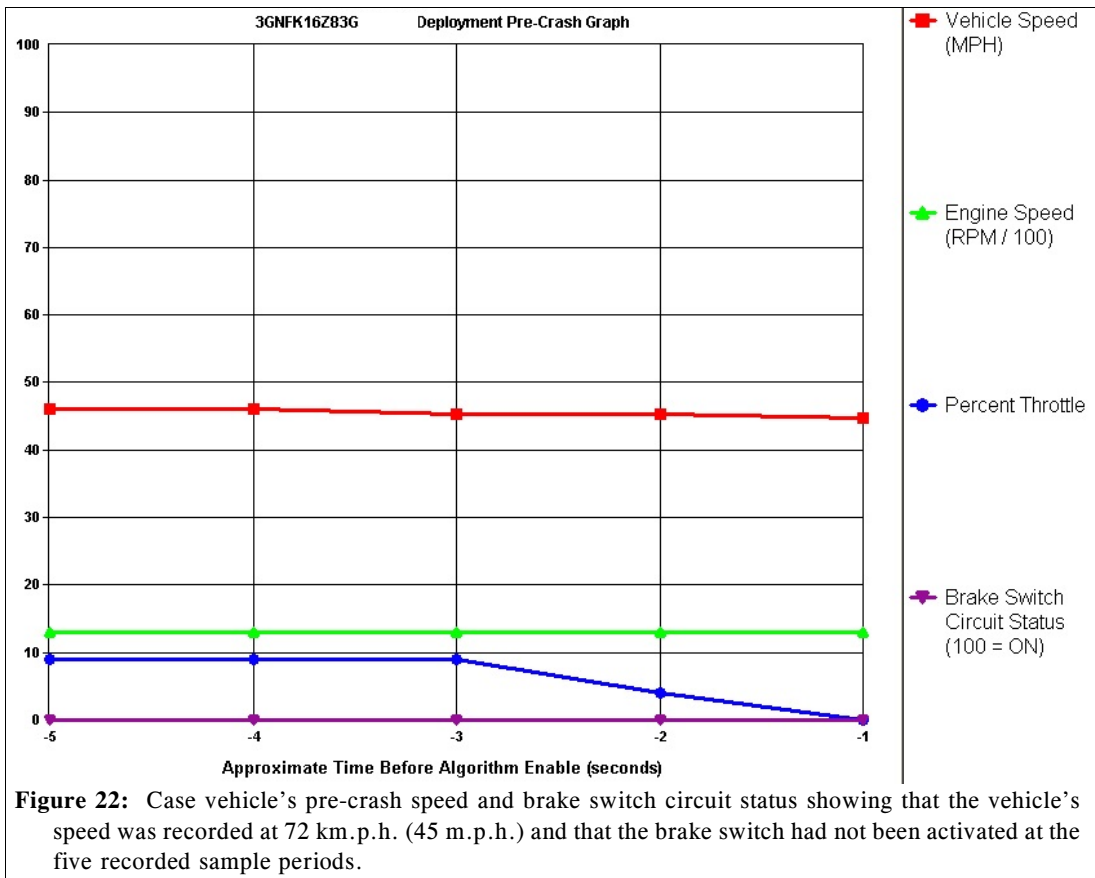
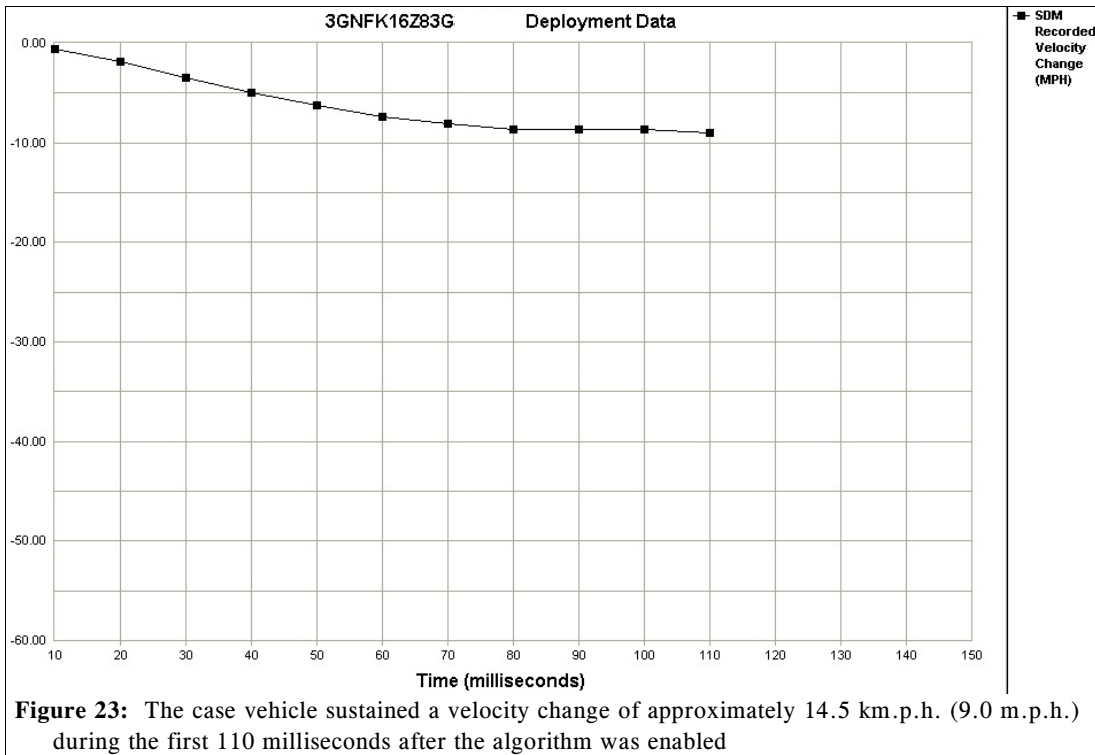
of the multi-stage air bags was not activated, and the Delta V reached a value of 14.47 km.p.h. (8.99 m.p.h.) at the 110 millisecond mark of recorded data; see **EVENT DATA RECORDER DATA (Figures 21 through 23)** below. This contractor believes that the recorded Delta V seems reasonable considering the collision dynamics and amount of deformation to the case vehicle's front.

**Figure 21:** Case vehicle's at deployment data including: pre-crash speed, brake switch status, restraint system status, and activation data for vehicle's dual inflation air bags, and the case vehicle's change in velocity (Delta V) over the first 110 milliseconds post deployment
