**TRANSPORTATION SCIENCES
CRASH DATA RESEARCH CENTER**

ON-SITE REAR IMPACT CRASH AND FIRE INVESTIGATION

VEHICLE: 1998 LINCOLN TOWN CAR LIMOUSINE

CASE NO: CA03-053

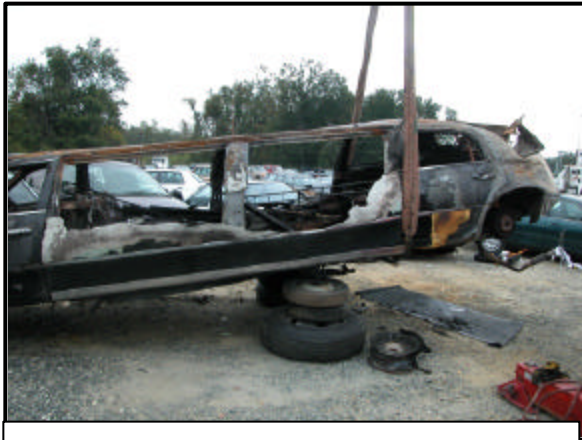
cm x 0.31 cm (45.4 in x 121.3 in x 1/8th in) steel panel. There was no (mechanical) impact damage to the limousine forward of the E-pillars/rear doors. There was no separation of any welds in the modification. The exterior body panel of the limousine was a 305 cm (120 in) continuous aluminum panel that was formed to the original contour of the vehicle. The right side panel was consumed in the fire and the left side panel was partially melted.

All the side window glazings had disintegrated, presumably due to the heat of the fire. The side windows measured 138.4 cm x 43.2 cm (54.5 in x 17.0 in). An 86 cm x 43 cm (34 in x 17 in) sunroof was located immediately forward of the D-pillar. Its glazing had disintegrated. The sunroof appeared to be fixed; there was no identified mechanism that would have allowed this roof window to open.

Figure 5: Left side view of the limousine.

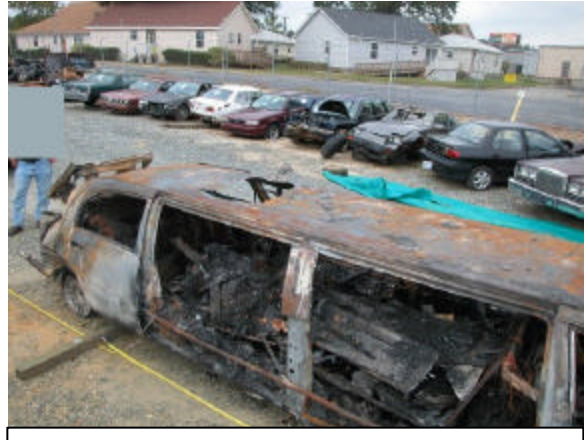
Figure 6: Right side view.

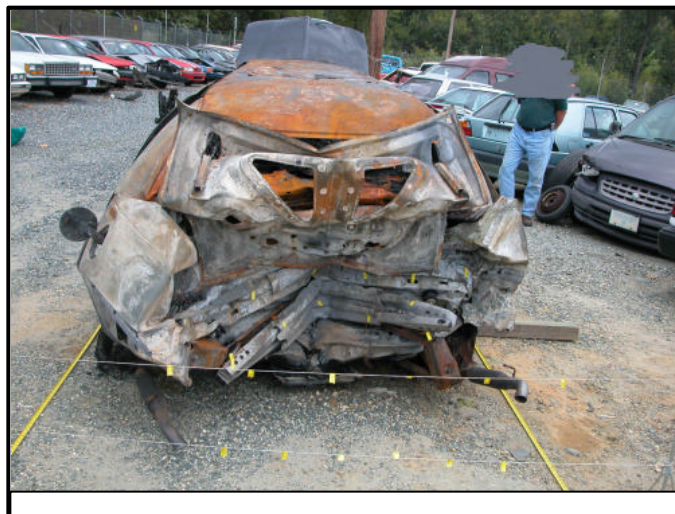
Figures 7 through 9 are the rear, left lateral and right lateral views of the Lincoln. The vehicle sustained severe fire damage from the back plane forward to the A-pillars. The back plane of the vehicle sustained 157 cm (62 in) of direct and induced damage that extended across the vehicle's end width. The width of the direct damage measured 107 cm (42 in) and it began 28 cm (11 in) left of center extending to the right rear corner. The direct contact damage was biased to the right indicative of the offset impact configuration. The Ford's front bumper impacted the Lincoln's rear bumper causing longitudinal deformation of the Lincoln's bumper structure, rear frame members, rear quarterpanels and a complete collapse of the trunk. During the impact sequence the Ford F150's bumper overrode the Lincoln's rear bumper resulting in the deepest penetration at the elevation of the rear trunk body line. The rear deformation jammed both doors shut.

The rear crush profile was documented along the rear bumper reinforcement and rear trunk body line. The crush profile measured along the bumper reinforcement was as follows: C1 = 77.0 cm (30.3 in), C2 = 105.0 cm (41.3 in), C3 = 131.0 cm (51.6 in), C4 = 116.0 cm (45.7 in), C5 = 108.0 cm (42.5 in), C6 = 92.0 cm (36.2 in). The longitudinal displacement (crush) of the left and right EAD's of the rear bumper measured 76.4 cm (30.1 in) and 91.1 cm (35.9 in), respectively. The right EAD compressed its entire 3.48 cm (1.38 in) stroke and was jammed. The left EAD stroke

measured 2.0 cm (0.8 in). The crush profile documented along the rear trunk edge was as follows: C1 = 58.0 cm (22.8 in), C2 = 87.0 cm (34.3 in), C3 = 102.0 cm (40.2 in), C4 = 107.0 cm (42.1 in), C5 = 107.0 cm (42.1 in), C6 = 112.0 cm (44.1 in). An impression of the left front frame rail end of the Ford F150 was identified on the approximate centerline of the Lincoln at the elevation of the crush profile. The trunk lid buckled and was displaced forward through the backlight. The reduction of the left and right wheelbase measurements were 3.8 cm (1.5 in) and 17.3 cm (6.8 in), respectively. The rear doors were jammed shut. The right rear door panel overlapped the right rear quarterpanel sheet metal 5 cm (2 in) due to the rear deformation. An average of the aforementioned crush profiles was used to quantify the crash severity using the Damage Algorithm of the WINSMASH model. The calculated delta V calculated was 38.2 km/h (23.7 mph). The longitudinal and lateral components were +38.2 km/h (+23.7 mph) and 0, respectively. The Collision Deformation Classification (CDC) was 06-BZEW-6.

Figure 7: Rear view of the Lincoln.

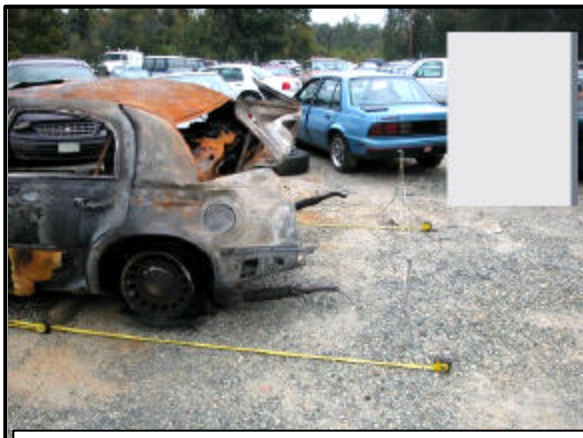
Figure 8: Left lateral view

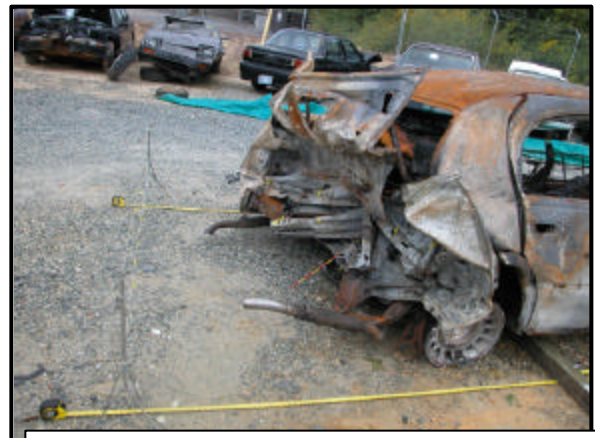
Figure 9: Right lateral view across the back plane.

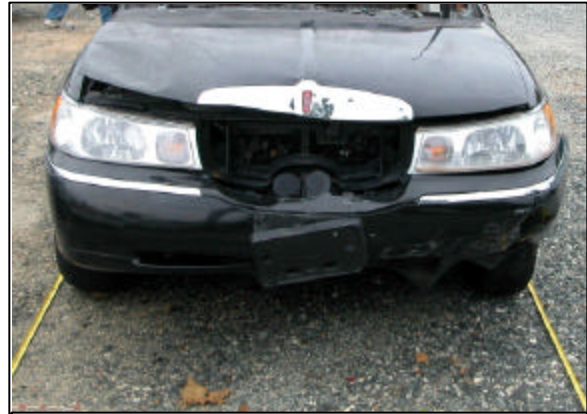
The front bumper of the Lincoln, **Figure 10**, sustained 84.6 cm (33.3 in) of direct contact damage during its secondary collision with the rear of the Ford Escort. The direct contact began 8.9 cm (3.5 in) right of center and extended to the left corner. The damage consisted of abrasions to the bumper fascia and displacement of the fascia wrap-around at the left corner. There was no residual crush of the front bumper reinforcement. There was no damage to the headlamp assemblies, hood or upper radiator support. The center grille had separated in the impact. The CDC of this minor impact was 12-FYLW-1. The calculated longitudinal delta V was -9.8 km/h (-6.1 mph). This minor front crash was below the threshold to warrant deployment of the Lincoln's frontal air bag system. Inspection of the front interior revealed the front right passenger air bag was still packed within the module and melted due to the fire. The steering wheel and driver air bag module were consumed by the fire.

Figure 10: Front view of the Lincoln.

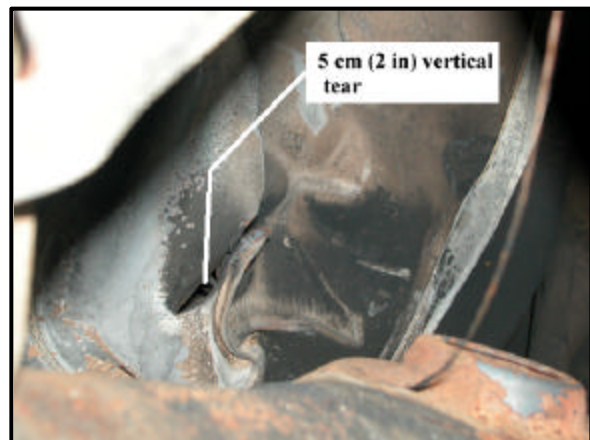
The fuel tank was severely crushed from the left attachment strap to its right end. The width of this region measured 89 cm (35 in). The extent of the crush was approximately the full thickness of the tank. The fuel tank was punctured on the bottom right forward corner from contact with the right rear suspension and drive axle. The puncture was a vertical slit that measured 50mm x 6 mm (2 in x 0.25 in), **Figure 16**. Above and outboard of the slit, was a second puncture that measured 6 mm x 3 mm (0.25 in x 0.12 in). The right lower aspect of the tank was creased both horizontally and vertically over an 8.9 cm x 5.1 cm (3.5 in x 2.0 in) area. Located 15 cm (6 in) above the bottom edge of the tank was a 15 cm x 5 cm (6 in x 2 in) concave section from contact with the right exhaust. The center section of the tank was crushed to its full thickness, aft of the differential. The forward wall of the tank exhibited four indentations from the bolt heads of the differential cover. The indentations ranged from 6 mm to 13 mm (0.25 in to 0.5 in) in depth. A small hole, approximately 3 mm (0.12 in) in diameter, was located in an indentation 8.9 cm (3.5 in) above the tank's bottom edge. The residual dimension between the differential cover and deformed tank measured 4.6 cm (1.8 in). The forward left aspect of the tank was scuffed and dented over a broad area from contact with the left rear shock bracket, spring base and sway bar bracket. There were no perforations of the tank's left side. The retrofitted fuel lines, fuel filter, and sending unit were intact. There was no separation of the fuel filler neck from the tank.

Figure 16: Tear and deformation of the lower right aspect of the tank.

The burn pattern observed on the vehicle indicated that the fire originated and was fueled from the right side of the fuel tank. The right side undercarriage components appeared scorched and heat stressed. These components were relatively free of soot and smoke as compared to the left. The center and left aspects of the fuel tank and undercarriage were coated with soot.

The procedure to grind the tabs on the sway bar bracket referenced in the Technical Safety Bulletin (TSB) issued by Ford on October 21, 2001 was not completed on this vehicle. However, it did not appear the sway bar brackets played a role in the tank failure. The shield kit developed by Ford Motor Company, in response to the Police Interceptor tank failures, was not installed on the vehicle.

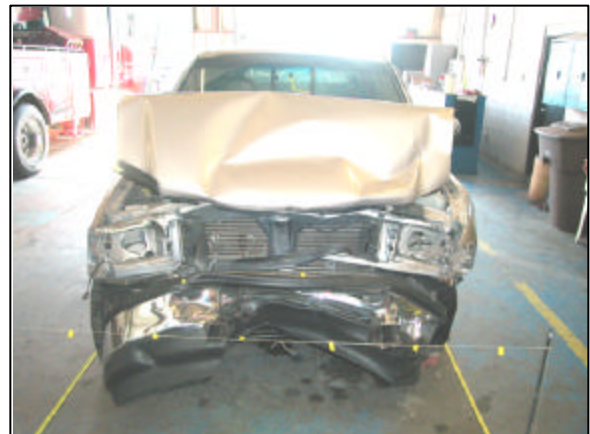
The frontal plane of the Ford sustained 157.5 cm (62.0 in) of direct and induced damage as a result of the crash, **Figure 18**. The direct damage measured 128.0 cm (50.4) and began 51.0 cm (20.1 in) right of center extending to the left front corner. The crush profile measured along the front bumper was as follows: C1 = 57.0 cm (22.4 in), C2 = 35 cm (13.8 in), C3 = 46.0 cm (18.1 in), C4 = 47 cm (18.5 in), C5 = 20.0 cm (7.9 in), C6 = 11.0 cm (4.3 in). The maximum crush was located at C4. The frame rails had penetrated the front bumper during its deformation. The direct contact extended vertically across the center grille and radiator to the leading edge of the hood. Both front fenders shifted rearward and were overlapped by the front doors. The hood buckled and folded at the designated fold points. The left wheelbase was reduced 20.3 cm (8.0 in). The right wheelbase was unchanged. There was evidence of cab-to-bed contact on the left side and the bed cap was shifted rearward. The windshield was fractured directly forward of the driver's position from head contact. The Collision Deformation Classification (CDC) was 12-FDEW-3. The Delta V calculated by the Damage Algorithm of the WINSMASH model was 57.5 km/h (35.7 mph). The longitudinal and lateral components were -57.5 km/h (-35.7 mph) and 0, respectively.

Figure 18: Front view of the F150.

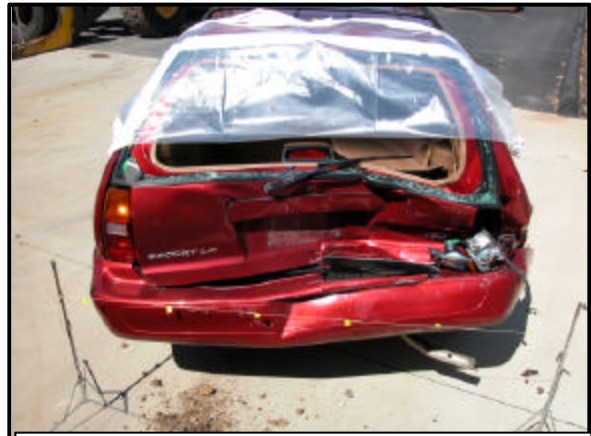
Figure 19 is the rear view of the damaged Escort. The vehicle sustained 149.4 cm (58.8 in) of induced and direct damage that extended across the end width of the rear plane as a result of the secondary collision with the Lincoln. The direct damage measured 112.8 cm (44.4 in) and began 37.6 cm (14.8 in) left of center extending to the right rear corner. The front bumper of the Lincoln engaged and deformed the rear bumper of the Escort and then partially overrode it, impacting the rear tailgate. The vehicle's crush profile was documented along the bumper reinforcement and along the rear edge of the tailgate. The averaged measured crush profile was as follows: C1 = 0, C2 = 2.0 cm (0.8 in), C3 = 6 cm (2.4 in), C4 = 21.0 cm (8.3 in), C5 = 14.0 cm (5.5 in), C6 = 19.0 cm (7.5 in).

Figure 19: Rear view of the Escort.

The tail gate latch released during the impact. The rear window glazing had disintegrated. All the doors were operational and the side window glazings were intact. There was no measurable change in wheelbase dimensions. The Collision Deformation Classification (CDC) was 06-BDEW-2. The Delta V calculated by the Damage Algorithm of the WINSMASH model was 22.0 km/h (13.6 mph).
