**GENERAL DYNAMICS ON-SITE AIR BAG NON-DEPLOYMENT
INVESTIGATION**

GENERAL DYNAMICS CASE NO. – CA03-057

SUBJECT VEHICLE – 1995 PONTIAC GRAND PRIX

CRASH DATE – OCTOBER 2003

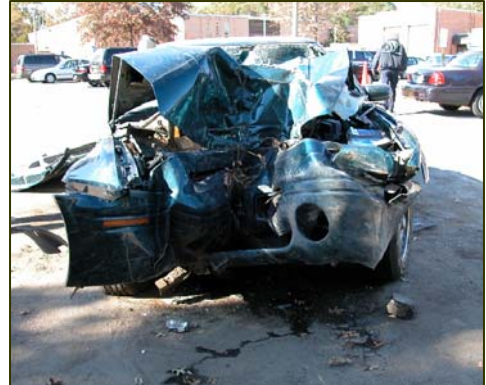
Figure 1. Frontal damage to the 1995 Pontiac Grand Prix.

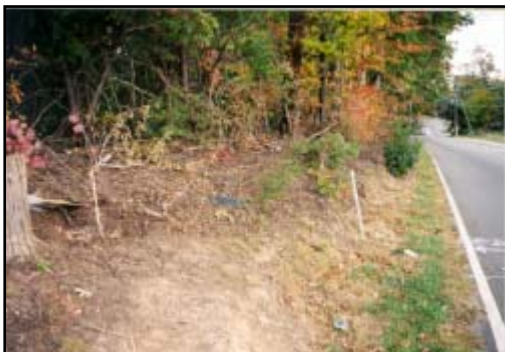
Figure 4. Impacts with the embankment and numerous small diameter trees.

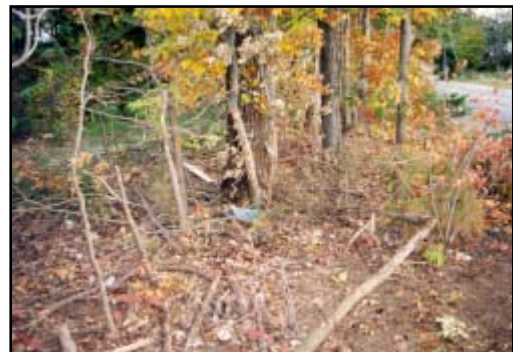
Figure 5. Struck 48.3 cm (19.0”) diameter tree.

The center front area of the Pontiac impacted a 48.3 cm (19.0”) diameter tree (**Figure 5**) that was located 4.3 m (14.0’) outboard of the east road edge. A 7.6 cm (3.0”) diameter tree was growing

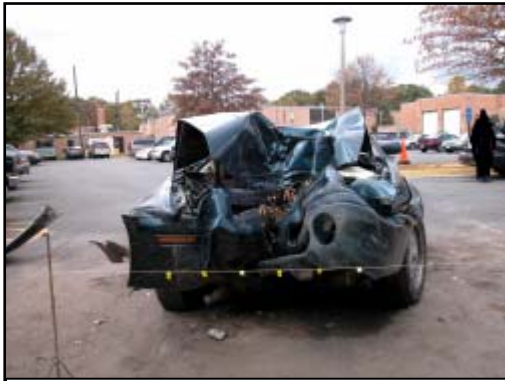
The 1995 Pontiac Grand Prix sustained severe frontal damage (**Figure 6**) as a result of the primary impact with the 48.3 cm (19.0") diameter tree. Maximum crush was 99.0 cm (38.9") and was located on the bumper beam at the location of C3. The direct contact damage was 43.2 cm (17.0") in width and began 11.4 cm (4.5") inboard of the right hood crease and extended left. The impact deformed the entire frontal width of the Grand Prix, bending the bumper beam to a U-configuration. The combined direct and induced damage width was 74.9 cm (29.5") and extended from corner-to-corner on the bumper beam. The left wheelbase was reduced in length by 7.1 cm (2.8") and the right wheelbase was reduced by 9.4 cm (3.7"). A crush profile (**Figure 7**) was documented at the level of the bumper beam and was as follows: C1 = 31.0 cm (12.2"), C2 = 86.0 cm (33.8"), C3 = 99.0 cm (38.9"), C4 = 84.0 cm (33.1"), C5 = 59.0 cm (23.2"), C6 = 43.0 cm (16.9"). The Collision Deformation Classification (CDC) for this primary impact was 12-FCEW-4.

Figure 6. Frontal damage from the large diameter tree.

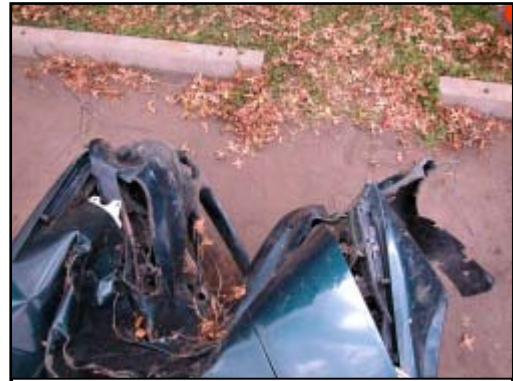
Figure 7. Overhead view of the crush profile.

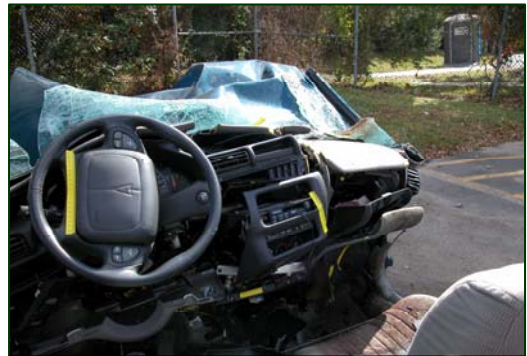
The 1995 Pontiac Grand Prix sustained severe interior damage as result of intrusion and occupant contacts. The driver loaded the steering assembly, which compressed the energy absorbing steering column. The left shear bracket was displaced 1.9 cm (0.75") and the right shear bracket was displaced 4.0 cm (1.6"). There was no deformation of the steering wheel rim or spokes. The driver's right knee impacted and deformed the lower center instrument panel and subpanel. The contact produced a 6.4 cm (2.5") deep area of deformation that was centered 50.1 cm (20.0") below the top of the instrument panel. The right knee engaged the wiring harness that was contained within the lower center instrument panel. There was no contact evidence to the knee bolster.

Figure 8. Driver's trajectory and contact points.

The driver contacted the center mounted radio trim panel. The panel was fractured and displaced forward from contact with his right torso. The top aspect of the right center instrument panel was fractured and displaced forward from probable contact with the driver's chin or right arm. The area of contact was located 15.2-27.9 cm (6.0-11.0") right of center. His head continued forward and impacted the windshield right of the vehicle's centerline. Hair was embedded into the cracked windshield glazing 30.5 cm (12.0") above the top instrument panel. The investigating police officer stated that the driver was found in the vehicle with his head penetrated through the windshield. **Figure 8** is a view of the driver's trajectory and contact points.

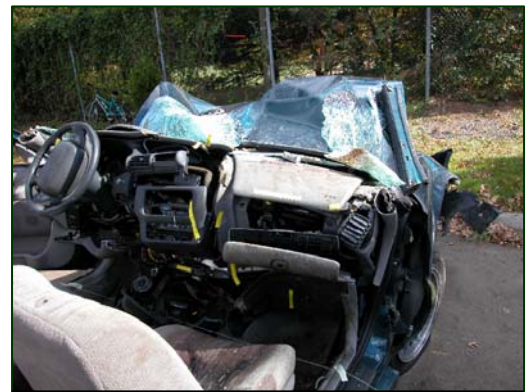
The front right passenger's knees contacted the glove box door. His left knee scuffed and fractured the door 7.6-12.7 cm (3.0-5.0") right of the left edge of the door and 20.3-30.5 cm (8.0-12.0") below the top of the door. The front right passenger was presumably slumped pre-crash, which allowed his head to contact the leading edge of the front right passenger air bag module cover. Hair was embedded in the leading edge and the cover flap was rotated forward, similar to a deployed flap position. Blood was also noted on the non-deployed front right air bag membrane. The front right passenger subsequently impacted the windshield with his head 22.9 cm (9.0") inboard of the right A-pillar and 12.7-33.0 cm (5.0-13.0") above the bottom edge of the glazing. Hair and blood deposits were noted in this area of contact. The front right

Figure 9. Overall view of front right area and the passenger's contact points.

passenger's head contacted the deformed hood as he penetrated the windshield a dent was located 23.4-30.0 cm (8.8-11.8") inboard of the right hood edge and 3.8-15.2 cm (1.5-6.0") forward of the rear hood edge and measured approximately 1.3 cm (0.5") in depth. **Figure 9** is an overall view of the front right area and the passenger's contact points.

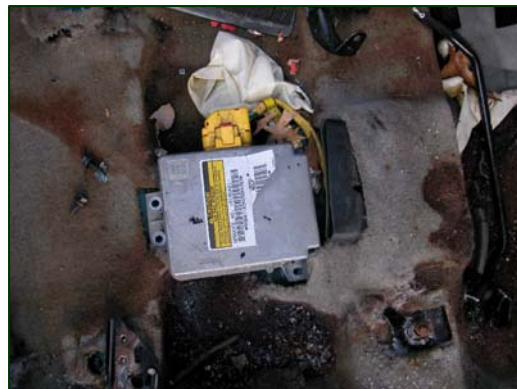
The 1995 Pontiac Grand Prix was equipped with a Sensing and Diagnostic Module (SDM) that had EDR capabilities. The EDR was mounted to the floor of the vehicle, under the front right seat (**Figure 10**). Although the 12-volt battery power was retained following the crash, the EDR could not be downloaded through the diagnostic port. This connector could not be located within the passenger compartment of the vehicle. Due to a potential biohazard of pooled blood on the floor of the vehicle, the police reconstructionist requested the services of the local fire department to remove the front right seat to allow for full, unimpeded access to the EDR. The fire fighters used hydraulic equipment to remove the seat. Although the fire fighters removed the roof and right front door post-crash, they failed to disconnect the battery or cut the cables prior to initiating their extrication activities.

Figure 10. Mounted position of the EDR prior to removal from vehicle.

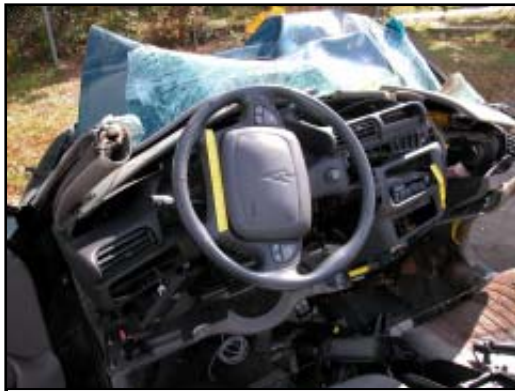
The 1995 Pontiac Grand Prix was equipped with frontal air bags for the driver and front right passenger positions. The driver's air bag was located within the steering wheel hub and was concealed by I-configuration module cover flaps. The front right air bag was located on the top of the right instrument panel. A single forward hinged cover flap concealed the front right air bag. The air bag system did not deploy in this crash (**Figures 11 and 12**).

Figure 11. Non-deployed driver's frontal air bag.

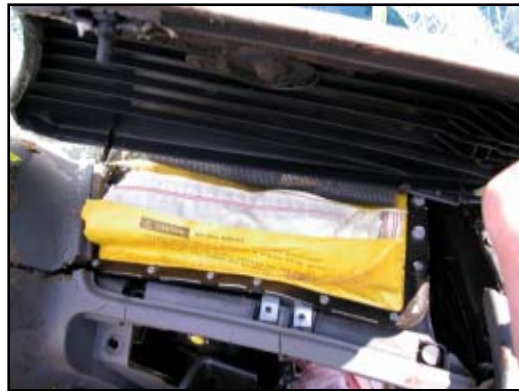
Figure 12. Non-deployed front right frontal air bag.

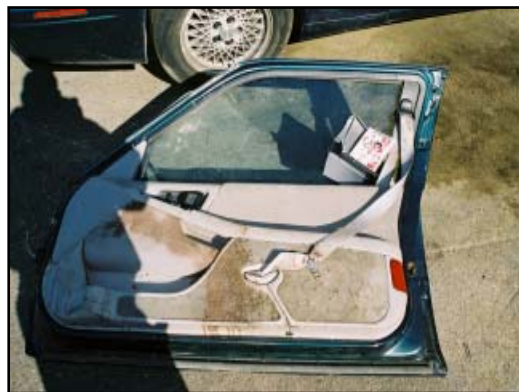
The 1995 Pontiac Grand Prix was equipped with automatic door mounted 3-point lap and shoulder safety belts for the front outboard seating positions (**Figure 13**). The front safety belts were configured with sewn-on latch plates and Emergency Locking Retractors (ELR's). No crash related evidence such as stretching, transfers etc., were noted to the safety belts which was indicative of the driver and front right passenger not utilizing the safety belts in this crash. The rear seat was equipped with manual 3-point lap and shoulder belts and a 2-point lap belt for the center rear position. The rear outboard safety belts were configured with sliding latch plates and switchable ELR/Automatic Locking Retractor's (ALR's). The rear center safety belt was configured with a locking latch plate and no retractor.

Figure 13. Front right 3-point automatic safety belt system.
