**GENERAL DYNAMICS ON-SITE CERTIFIED ADVANCED-208 COMPLIANT  
VEHICLE CRASH INVESTIGATION**

**SCI TECHNICAL SUMMARY REPORT**

**GENERAL DYNAMICS CASE NO. – CA03-055**

**SUBJECT VEHICLE – 2003 CHEVROLET SILVERADO**

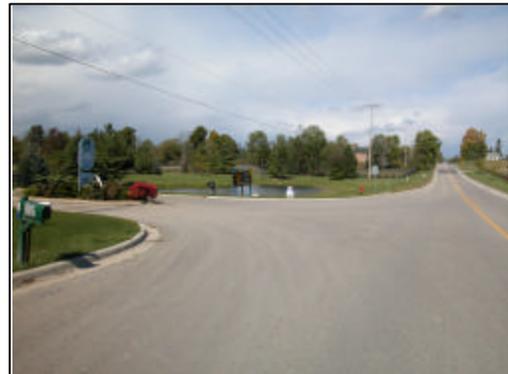
**Figure 2. Northwest view of crash site.**

The 45-year-old male driver of the Chevrolet was operating the vehicle northbound on the two-lane, two-way roadway approaching the “T” intersection. The driver stated to the SCI investigator that he fell asleep as he was driving. The Chevrolet drifted into the southbound lane as it approached the intersection (**Figure 2**). The lack of pre-impact evidence indicated that no avoidance maneuvers were attempted by the driver. It should be noted that, the EDR recorded an “On” status for the vehicle’s brake switch for a four-second period prior to the Non-Deployment event. It was assumed that the driver’s foot was resting on the brake pedal as he fell asleep; therefore he was not intending an avoidance maneuver.

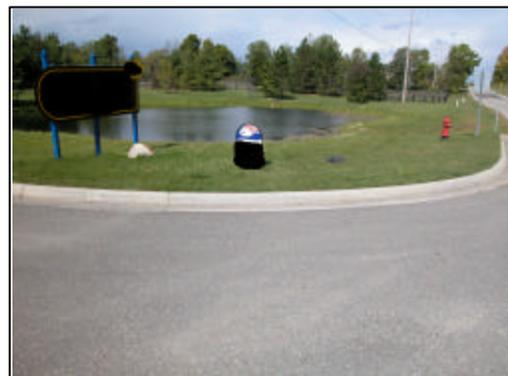
**Figure 3. Impact to small sign and pond.**

The Chevrolet overrode the northwest mountable curb and impacted a real estate sign with the right aspect of the front plane. The sign was located 4.9 meters (16.1’) north of the curb (**Figure 3**). The Chevrolet continued in a northwest direction an additional 3.6 meters (11.8’) off-road and impacted a fresh water pond with its frontal undercarriage. The driver stated to the SCI investigator that vehicle traveled approximately 6-15 meters (20-50’) into the pond before the vehicle stopped and began to sink. At rest, the vehicle was totally submerged in the pond. The frontal CAC system did not deploy in this crash. The impact with the pond produced a Non-Deployment event that was recorded by the EDR. The maximum-recorded delta-V was -9.0 km/h (-5.6 mph) at 227.5 milliseconds after algorithm wake-up.

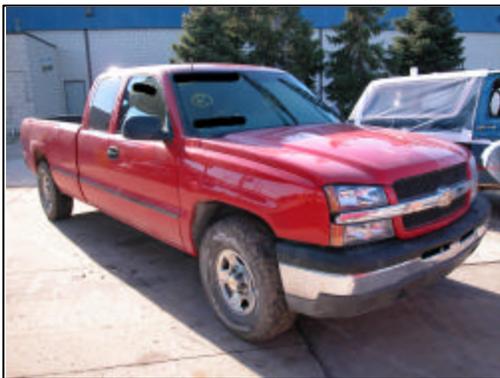
The 2003 Chevrolet Silverado sustained minor cosmetic damage as a result of the impact with the real estate sign. The direct contact damage from the impact with the sign consisted of a fractured trim panel at the front right headlight assembly (**Figure 4**). No residual crush was

present to the bumper of the Chevrolet; therefore a crush profile was documented. The Collision Deformation Classification (CDC) for this impact was 12-FREE-1.

**Figure 4. Fractured trim panel near front right headlight assembly.**

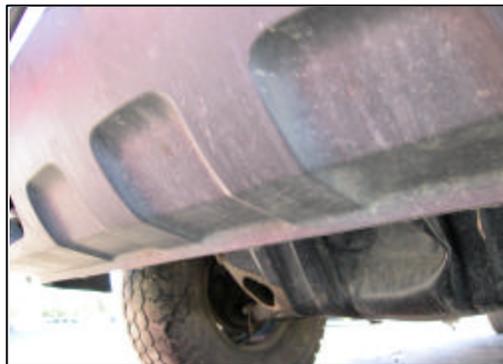
The second event consisted of the undercarriage plastic stone guard impacting the water as the Chevrolet entered the pond. The damage consisted of a dent to the undercarriage plastic stone guard that shielded the front of the engine. The dent was 22.0 cm (8.7”) in width and 20.0 cm (7.9”) in height and approximately 2.5 cm (1.0”) in depth (**Figure 5**). The location of the damage was above the level of the curb; therefore it was presumed to be associated with the vehicle striking the water as it entered the pond. This impact was also consistent with the recorded Non-Deployment event for both the magnitude and the duration of the impact. The CDC for this event was 12-UFCN-1.

**Figure 5. Damage to stone guard from pond.**

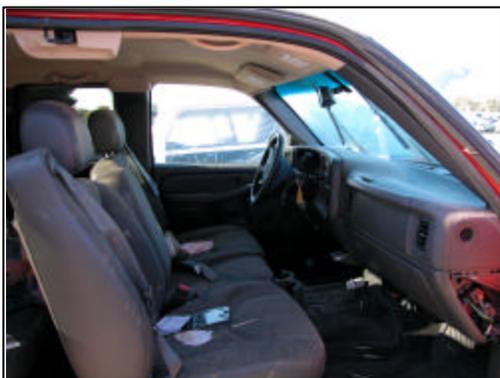
**Figure 6. Interior from right to left.**

The 2003 Chevrolet Silverado sustained moderate interior damage that was attributed to the passenger compartment being submerged underwater (**Figure 6**). The water shorted the electronic components in the instrument cluster and corroded the vehicle’s fuse panels (**Figure 7**). No intrusions or occupant contact points were noted to the interior of the vehicle.

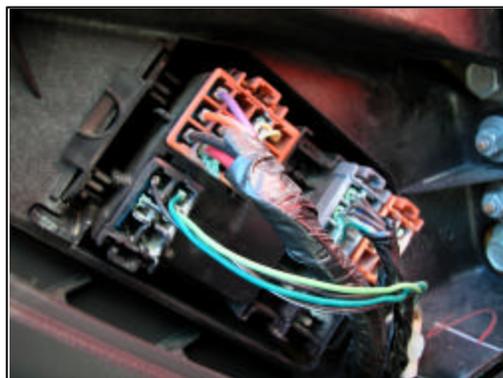
**Figure 7. Right side fuse panel. Note oxidation from water damage.**

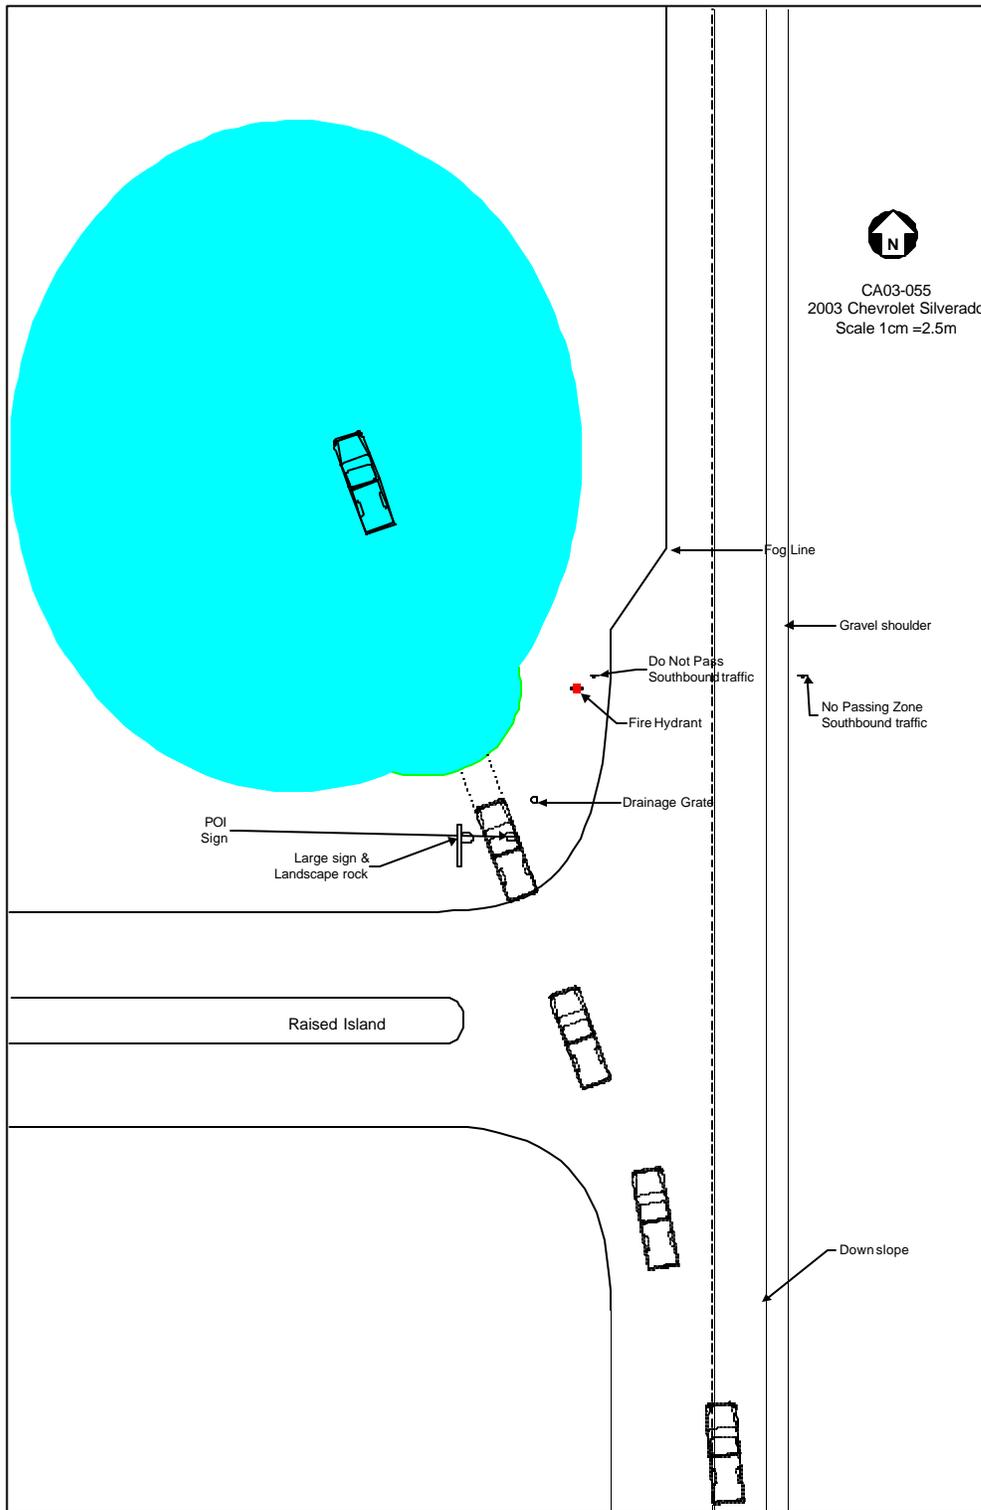
Figure 9. Scene schematic

respectively. The north/south roadway was configured with one travel lane in each direction and was separated by a double-yellow centerline and was bordered with gravel shoulders. The roadway was straight with a downhill grade for the northbound direction. The posted speed limit for northbound traffic was 89 km/h (55 mph). The scene schematic is included as **(Figure 9)** of this report.
