**CALSPAN ON-SITE CHILD SAFETY SEAT/SIDE IMPACT INFLATABLE CURTAIN  
DEPLOYMENT INVESTIGATION**

**CASE NO.: CA03-058**

**VEHICLE: 2003 SATURN L200**

**CRASH DATE: OCTOBER 2003**

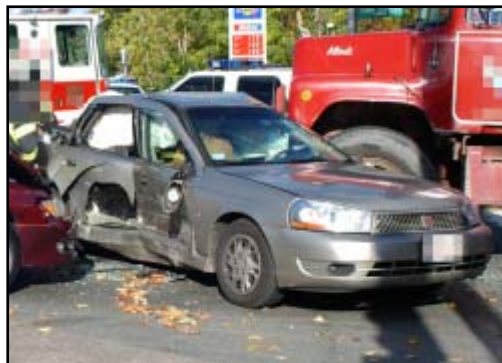
**Figure 1. On-scene photograph of the damaged Saturn L200**

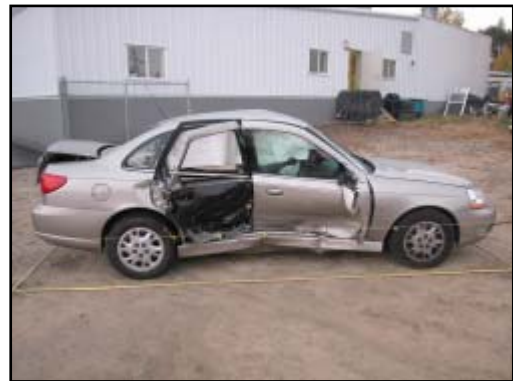
The 2003 Saturn sustained moderate left and right side damage as a result of the multiple impacts. As **Figure 6** illustrates, the direct contact damage on right side plane began 3.8 cm (1.5”) aft of the leading edge of the right front door and extended rearward 167.6 cm (66.0”). Paint transfers were present along the direct damage length and extended 47.0 cm (18.0”) vertically above the sill. The right front plastic door panel was fractured and the right rear door panel was completely separated. The sill also exhibited paint transfers and lateral crush. The combined direct and induced damage along the right side plane began 45.5 cm (17.9”) aft of the right front axle and extended 189.2 cm (74.5”) rearward. The maximum crush located at the center of the right front door and measured 34.0 cm (13.4). Deflection points were present forward of the right front door and aft of the right rear door and the right rear door glazing was disintegrated. The Collision Deformation Classification (CDC) for the initial right side impact with the Lexus ES300 was 02-RPEW-3. Six crush measurements were documented along the right side composite body panels, 10.2 cm (4.0”) above the sill, and were as follows: C1 = 0.0 cm, C2 = 21.0 cm (8.3”), C3 = 30.2 cm (11.9”), C4 = 31.8 cm (12.5”), C5 = 17.8 cm (7.0”), C6 = 5.1 cm (2.0”).

**Figure 6. Right side damage to the Saturn L200**

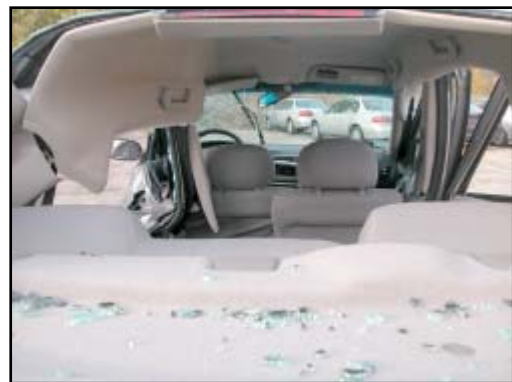
The 2003 Saturn L200 sustained moderate interior damage as a result of passenger compartment intrusion (**Figure 8**). The left front, left rear, and right front doors were jammed shut. The right rear door had been pried open by rescue personnel. A faint scuff mark was present on the left side of the center instrument panel from probable contact with the driver’s right knee. The rear view mirror was displaced CW. The right outboard aspect of the front right passenger’s seat back exhibited a scuff mark that measured 5.1 cm (2.0”) in width and 6.4 cm (2.5”) in height from contact with the intruded right B-pillar. The interior aspect of the right rear door was deformed as a result of intrusion, and two areas of scuff marks were present below the armrest from contact with the front right corner of the BPB.

**Figure 8. View through the backlight of the Saturn L200 showing lateral intrusions**

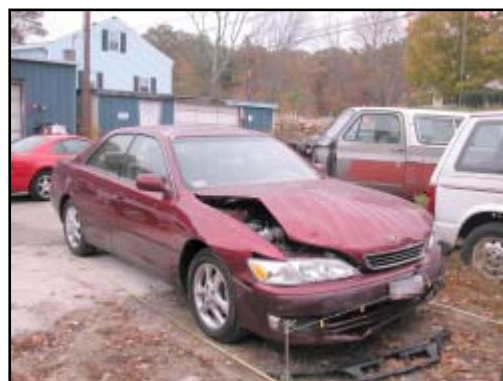
The 2000 Lexus ES300 sustained moderate frontal damage (**Figure 9**) as a result of the impact with the Saturn. The direct damage began at the front right bumper corner and extended laterally 161.3 cm (63.5") across the entire bumper. Lateral paint transfers and scuff marks were present along the entire width of the front bumper fascia. The entire bumper fascia was shifted 5.1 cm (2.0") to the right. The combined direct and induced damage involved the entire frontal width of the Lexus. The hood was buckled slightly rearward and the right front fender was bowed outward. The CDC for the frontal impact with the Saturn was 11-FDEW-1. Six crush measurements were documented along the front bumper and were as follows: C1 = 3.2 cm (1.2"), C2 = 2.5 cm (1.0"), C3 = 2.2 cm (0.9"), C4 = 2.5 cm (1.0"), C5 = 2.5 cm (1.0"), C6 = 5.1 cm (2.0").

**Figure 9. Damaged 2000 Lexus ES300**

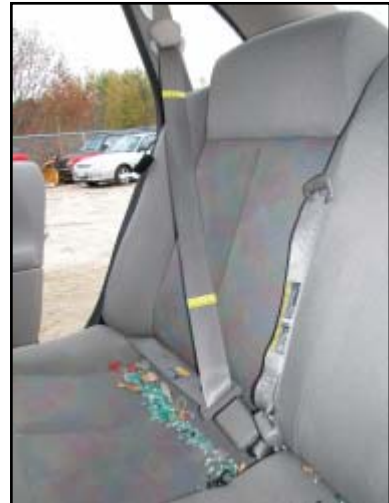
The rear right safety belt (**Figure 11**) was used to restrain the 4-year-old child in the BPB. Subtle corrugations were present in the safety belt webbing, possibly from prior use or minor occupant loading in this crash. The corrugations began 57.2 cm (22.5") above the lower anchor and extended 40.6 cm (16.0") up the webbing.

**Figure 11. View of rear right safety belt**

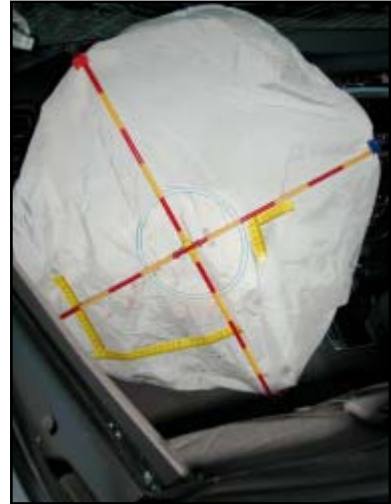
The 2003 Saturn L200 was equipped with redesigned frontal air bags for the driver and front right passenger positions. The frontal air bags deployed as a result of the longitudinal deceleration during the initial right side impact with the Lexus. The driver's air bag deployed from the steering wheel hub through symmetrical I-configuration module cover flaps. The cover flaps measured 8.3 cm (3.3") in height and 10.8 cm (4.3") in width. The driver's air bag (**Figure 13**) measured 61.0 cm (24.0") in diameter in its deflated state. An apparent lipstick transfer was present on the face of the air bag, 2.5 cm (1.0") to the right of the vertical centerline and 9.5 cm (3.8") above the horizontal centerline. A large area of makeup transfer was also present on the face of the air bag. The makeup transfer began 2.5 left of the vertical centerline and extended 16.5 cm (6.5") in width. It began at the horizontal centerline and extended 19.7 cm (7.8") downward. A faint body fluid (blood) transfer was present on the circumferential seam at the vertical centerline.

**Figure 13. Deployed driver's air bag (steering wheel rotated 60 degrees CW)**

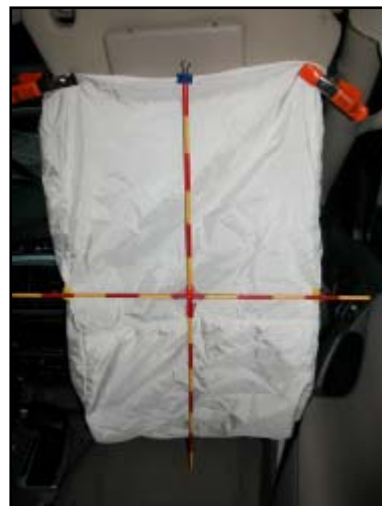
The front right passenger's air bag deployed from a mid-mount module configured with a rectangular cover flap hinged at the top aspect. The vinyl cover flap measured 30.5 cm (12.0") in width and 21.6 cm (8.5") in height. Due to the lateral intrusion at the right A-pillar, the vinyl cover of the instrument panel continued to tear beyond the outline of the cover flap, and the right corner of the instrument panel intruded under the open cover flap (**Figure 14**). An additional tear that measured 15.3 cm (6.0") in length radiated forward and to the left from the bottom left aspect of the cover flap. A 5.1 cm (2.0") tear radiated forward from the top right corner of the cover flap. The front right passenger's air bag (**Figure 15**) measured 40.6 cm (16.0") in width and 66.0 cm (26.0") in height in its deflated state.

**Figure 15. Deployed front right passenger's air bag**

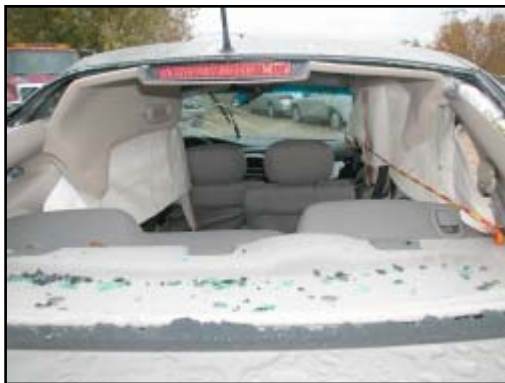
The 2003 Saturn L200 was also equipped with a side impact Inflatable Curtains (IC). The right and left side IC's deployed as a result of the right side impact with the Lexus and the left side impact with the concrete delivery truck, respectively. The IC's (**Figures 16 and 17**) deployed downward from the roof side rails through the separation of the outboard edges of the headliner between the A- and C-pillars. The headliner separation measured 127.0 cm (50.0") in length and 7.6 cm (3.0") laterally on each side. Both IC's measured 162.6 cm (64.0") in length and 40.6 cm (16.0") in height in their deflated state. The IC's were tethered on the front and rear outboard aspects. The front tether was triangular in shape and was attached via two stitch points on the outboard aspect of each IC. The tether was tapered at the forward aspect and was anchored to a square plastic tube that measured 1.3 cm (0.5") in width and extended 23.5 cm (9.3") rearward from each A-pillar. A 17.8 cm (7.0") long tether that measured 1.3 cm (0.5") in width was stitched to the rear outboard aspect of each IC and was anchored to the interior C-pillars.

**Figure 16. View from backlight showing left and right side IC's**

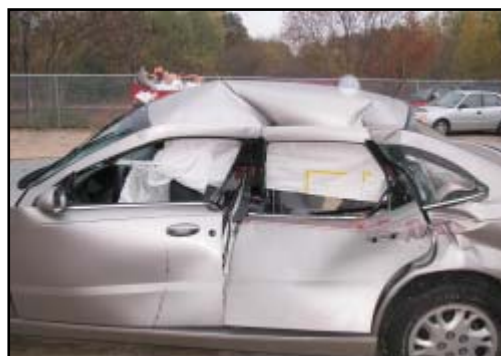
There was no occupant contact evidence on either inboard aspect of the IC's. The outboard aspect of the left IC exhibited scuff marks and a small paint transfer in the area of the left rear door window from direct contact with the concrete delivery truck's bumper (**Figure 18**).

**Figure 18. Outboard view of left IC showing areas of scuff marks**
