**ON-SITE DRIVER AIR BAG RELATED FATALITY INVESTIGATION**

**CASE NO: CA03-066**

**VEHICLE: 1996 FORD TAURUS**

**CRASH DATE: MARCH 2000**

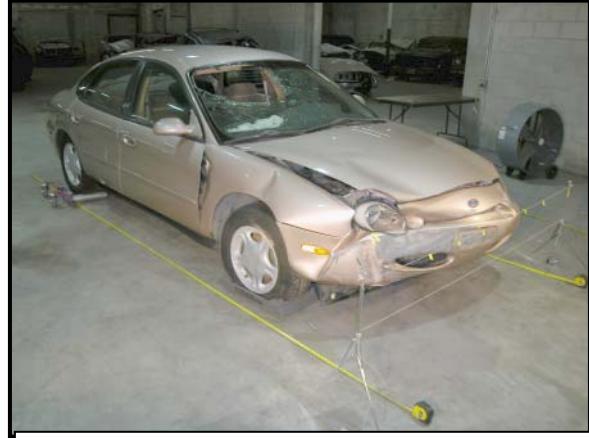
**Figure 1: Front right view of the Ford Taurus.**

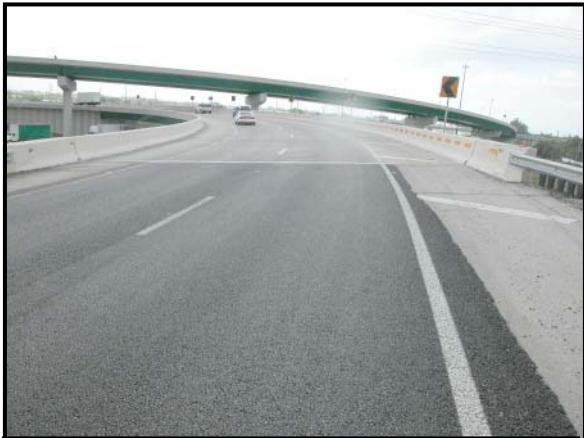
**Figure 3: Westerly approach view to the ramp.**

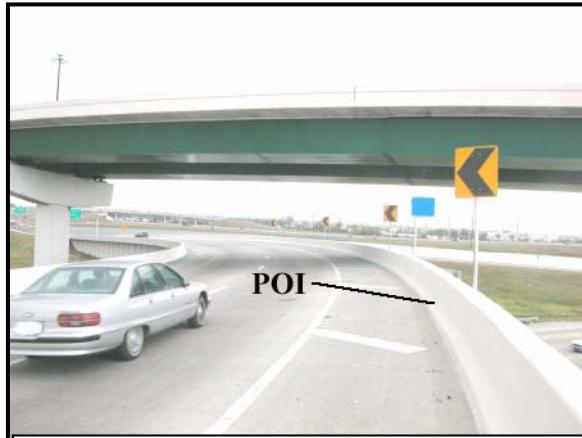
**Figure 2: Southwesterly view at the point of impact.**

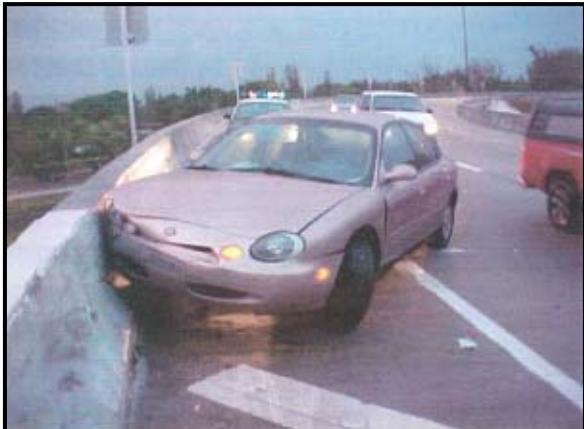
**Figure 5:** Look back view of the Taurus at final rest.

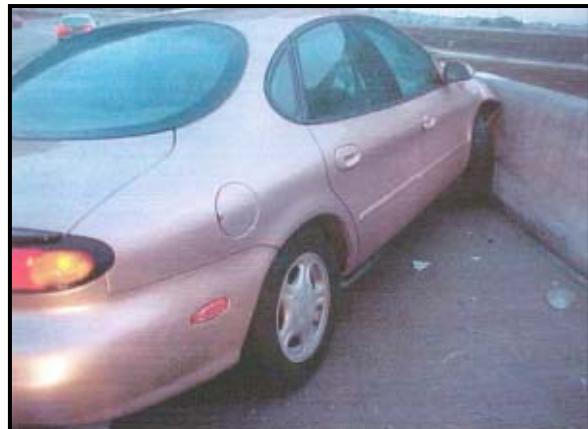
counterclockwise direction. The Taurus came to rest in contact with the wall at a relative heading angle of approximately 35 degrees. **Figures 4 through 6** are on-scene photographs taken during the police investigation of the final rest position of the vehicle and the right front tire scuff, respectively. A schematic of the crash is included at the end of this report, **Figure 11**. The force of the impact induced deceleration was sufficient to cause the deployment of the Ford's Supplemental Restraint System. The crash severity (total delta V) calculated by the Barrier Algorithm of the WINSMASH model was 13.3 km/h (8.3 mph).

**Figure 4:** Final rest of the Taurus against the retaining wall.

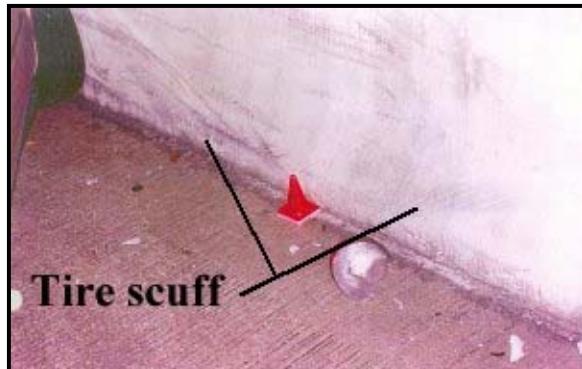
**Figure 6:** Right front tire scuff identified at the scene.

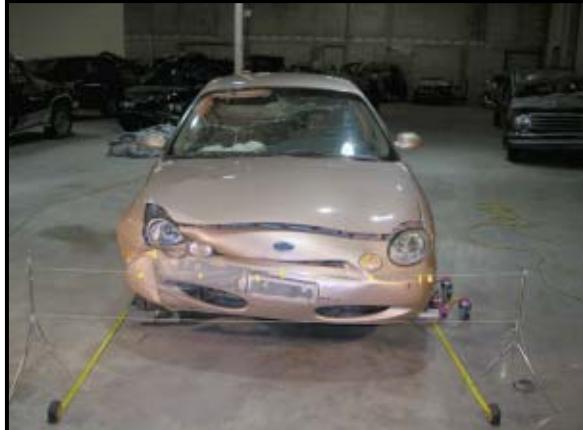
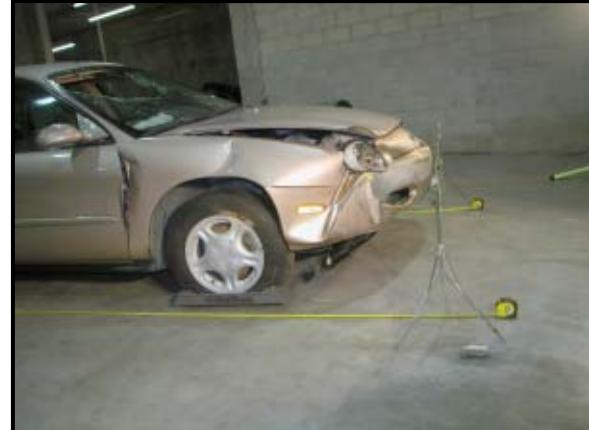
**Figures 7 and 8** are the front and right lateral views of the Ford. The front plane of the Ford sustained 132.0 cm (52.0 in) of direct and induced damage that extended across the vehicle's front end width. The direct damage measured 99.0 cm (39.0 in). The direct contact began 33.0 cm (13.0 in) left of center and extended to the right corner. The direct damage wrapped around the front right corner and extended 30.5 cm (12.0 in) onto the forward aspect of the right side. The damage profile was biased to the right indicative of an angular contact with the retaining wall. The abrasions on the bumper fascia were directed from the upper left to the lower right (with respect to the vehicle). The vehicle's residual crush measured along the front bumper was as follows: C1 = 0 cm (0 in), C2 = 0 cm (0 in), C3 = 6.0 cm (2.4 in), C4 = 11.0 cm (4.3 in), C5 = 17.0 cm (6.7 in), C6 = 16.0 cm (6.3 in). There was no measurable change in the wheelbase dimensions. The right front wheel rim was abraded due to contact with the retaining wall. Both front fenders shifted rearward and restricted the operation of the front doors. The right aspect of the windshield was fractured by the deploying front right passenger air bag cover flap.

The Collision Deformation Classification was 11-FZEW-1. The Barrier Algorithm of the WINSMASH model was used to assess the crash severity (delta V) based the above referenced

crush profile. The Ford's calculated total delta V was 13.3 km/h (8.3 mph). The longitudinal and lateral components were -10.2 km/h (-6.3 mph) and 8.5 km/h (5.3 mph), respectively.

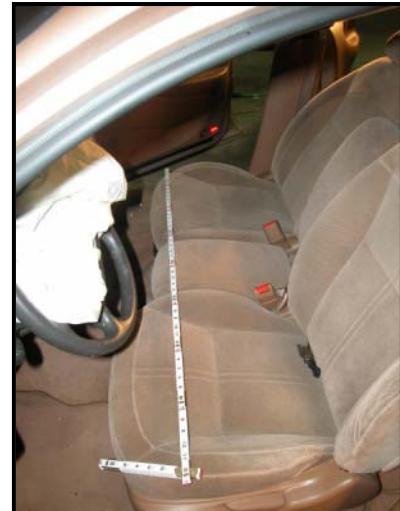
**Figure 9: Driver seat position.**

The lack of electrical power precluded moving the powered driver seat at the time of the inspection. Its position was measured with respect to the manual front right seat, **Figure 9**. The front right seat was adjusted to the full rear track position. The total seat track travel measured 22.4 cm (8.8 in). The driver seat was located in a mid-track position and measured 10 cm (4 in) forward of full rear. The seat back angle measured 12 degrees aft of vertical. The horizontal distance from the center of the air bag module to the seat back measured 62.2 cm (24.5 in).

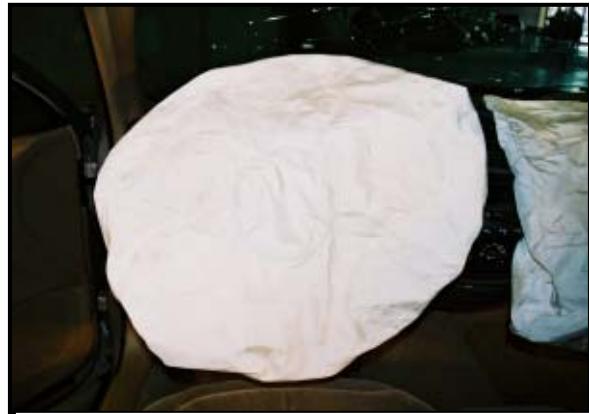
**Figure 10: Driver air bag.**

The driver air bag module was located in the center hub of the steering wheel. The air bag was housed in a module that had H-configuration cover flaps. The top flap measured 5.8 cm x 7.6 cm (5.8 in x 3.0 in), width by height. The lower flap measured 14.0 cm x 5.1 cm (5.5 in x 2.0 in). The deployed driver air bag, **Figure 10**, measured 61 cm (24 in) in diameter in its deflated state. It was tethered by two 8 cm (3 in) wide straps. It was not externally vented. The face of the air bag was soiled / smudged with dirt in its 3, 6 and 9 o'clock sectors from probable post-crash handling. There was an 8.9 cm (3.5 in) diagonal ink mark (pen) in the 5 to 6 o'clock sector.

Inspection of the remainder of the air bag was unremarkable. There was no direct evidence of driver contact to the air bag.

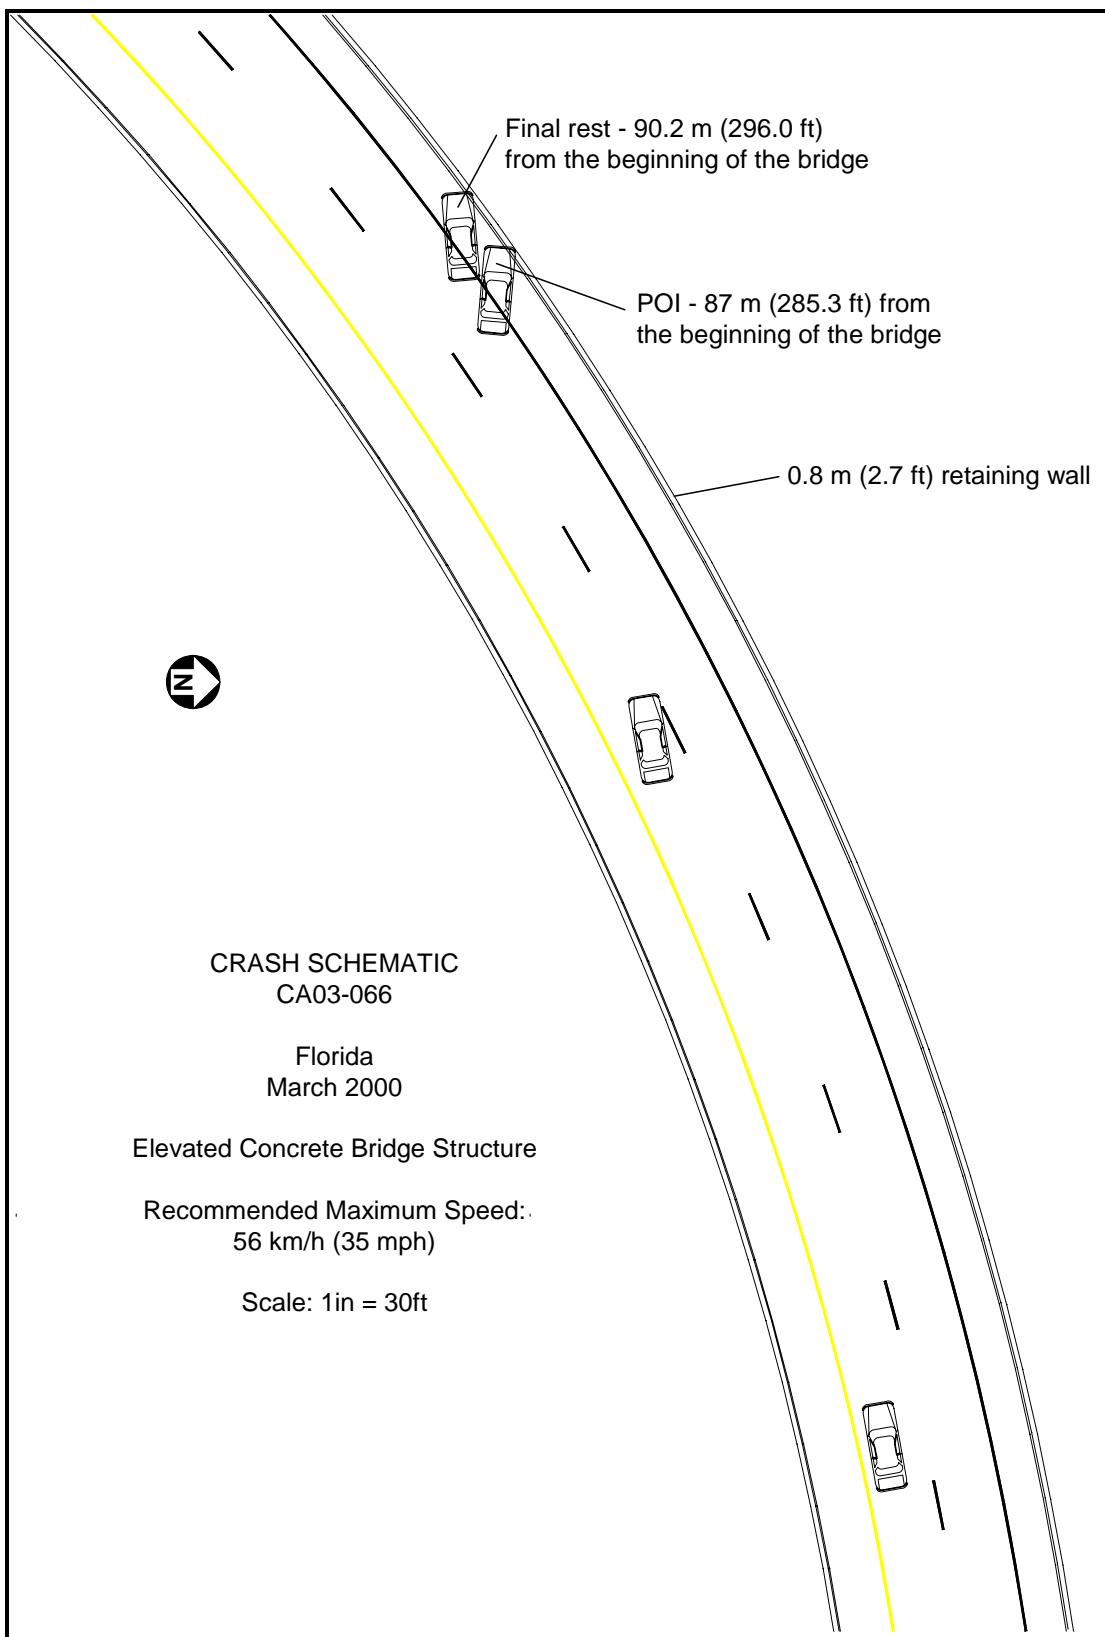
**Figure 11. Crash Schematic**

The crash occurred when the front right aspect of the Ford impacted the bridge retaining wall. The relative heading angle of the vehicle was an estimated 40 degrees to the right of the direction of the roadway at the point of impact. The principle direction of the impact force was in the 11 o'clock sector. A tire scuff on the retaining wall attributed to the right front tire of the Taurus identified the point of impact. This mark was identified during the on-scene investigation by the Florida Highway Patrol. The scuff was located 87.0 m (285.3 ft) from the beginning of the bridge. The Taurus slid along and remained in contact with the retaining wall for a distance of 3.3 m (10.7 ft). During its engagement with the wall the right front tire contacted and then disengaged from the wall. This dynamic was evidenced by the tire scuff documented during the police investigation. Due to its interaction with the wall, the Taurus was redirected in a
