**CALSPAN REMOTE ADULT AIR BAG RELATED SERIOUS
INJURY CRASH INVESTIGATION**

CASE NO: 2004-08-087J

VEHICLE: 2001 MITSUBISHI GALANT

CRASH DATE: MAY 2004

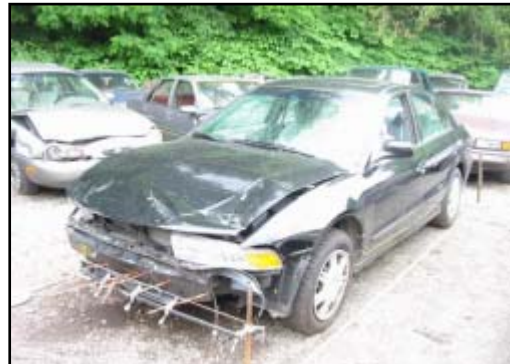
Figure 1. Subject 2001 Mitsubishi Galant.

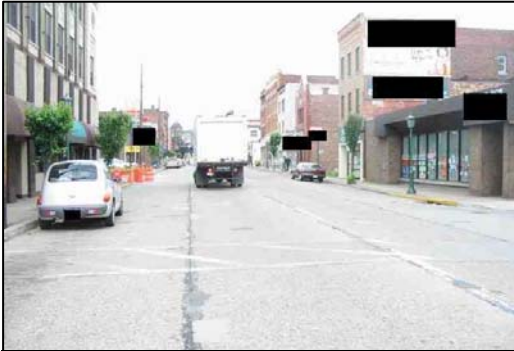
The 52-year old driver of the 2001 Mitsubishi Galant was traveling northbound on the left lane of two-lane, one-way roadway (**Figure 2**). The 53-year old male driver of the 2003 Dodge Dakota was on the west shoulder and was rolling forward while he anticipated a break in traffic to merge into the traffic lane (**Figure 3**). An onlooker, who was seated in her parked vehicle behind the Dodge, witnessed the events as they occurred. The driver of the Galant drifted to the left and partially off the left roadside. The driver of the Galant believed that she fell asleep prior to the road departure. The left side wheels mounted the curb, evidenced by tire marks on the curb.

Figure 2 - Northbound approach of Mitsubishi.

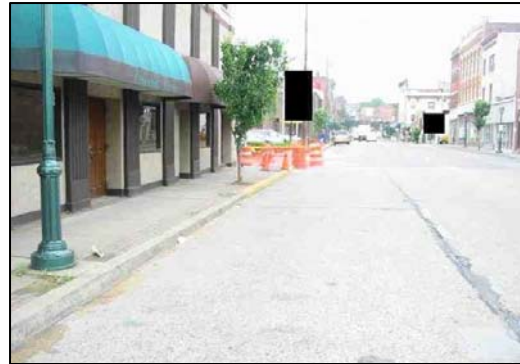
Figure 3 - Vicinity of Dodge Dakota as it rolled to merge.

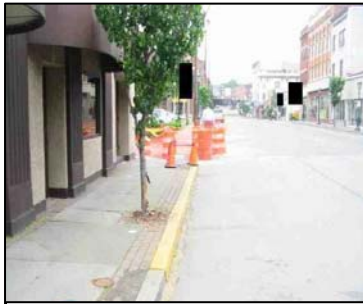
The Galant continued northbound with its left wheels on the curb and right wheels on the roadway and traveled approximately 6 meters (20') from the point of departure until the front left corner swiped a small diameter tree (**Figures 4 and 5**). The Galant continued forward another 12 meters (40') and struck a breakaway light standard with the left aspect of its frontal plane (**Figure 6**). This impact separated the post of the light standard from its base causing the post to fall to the ground. As the lamp was descending, it impacted the hood, the right side of the windshield and possibly the roof of the Galant before resting on the roadway. The Galant continued its forward trajectory until its frontal plane contacted the back plane of the Dodge as the Dodge was attempting to merge into northbound traffic. Based on the damage to the pickup's back bumper, it was probably angled approximately 20 degrees to the northeast. The NASS Researcher completed a missing vehicle algorithm with the WinSMASH program using the damage profile of the Dodge. Based on the minimal resultant damage from the first two events, the SCI review was able to separate the impacts and thereby utilize both crush profiles to complete a damage algorithm of the WinSMASH program. The subsequent results from

Figure 4 - Departure area of Mitsubishi traveling to first event.

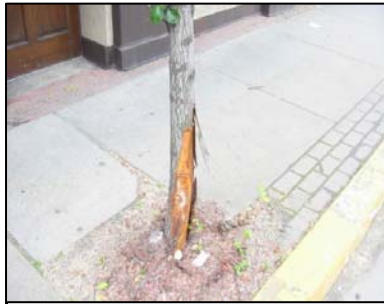
Figure 5 - Impacted small diameter tree.

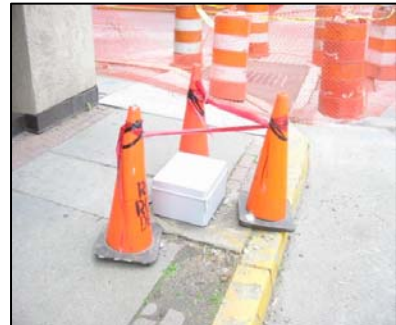
Figure 6 - Base of light standard.

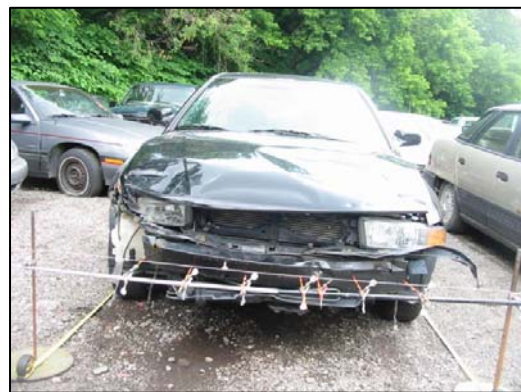
Figure 7 - Damaged 2001 Mitsubishi Galant.

The Galant (**Figure 7**) sustained moderate severity frontal damage as a result of the impact with the 2003 Dodge Dakota pickup. Both the direct contact damage and the combined direct and induced damage encompassed the entire front end and measured 111 cm (43.7") in width. The maximum crush was located at the front right bumper corner and was 9 cm (3.5") in depth. Six

equidistant crush measurements were taken to the vehicle's bumper beam and were as follows: C1 = 6 cm (2.4"), C2 = 7 cm (2.8"), C3 = 7 cm (2.8"), C4 = 6 cm (2.4"), C5 = 5 cm (2") and C6 = 9 cm (3.5"). The SCI revised CDC for this impact was 12-FDEW-1.

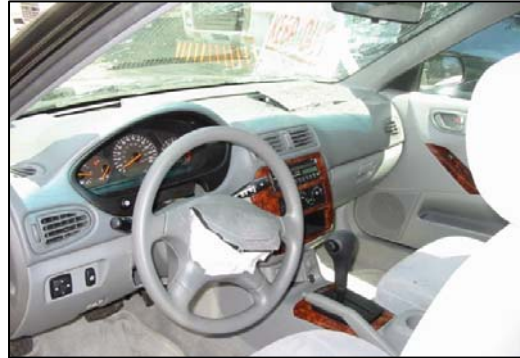
The interior of the 2001 Mitsubishi Galant sustained minor damage as a result of the impact with the 2003 Dodge Dakota (Figure 8). The only discernable contact evidence identified during the NASS inspection was a red fabric transfer to the driver's single air bag cover flap (Figure 13). The steering wheel rim contained no contact evidence and the column shows no sign of compression. There were no passenger compartment intrusions or component damage inside the Galant.

Figure 8 - Overall view of driver's area.

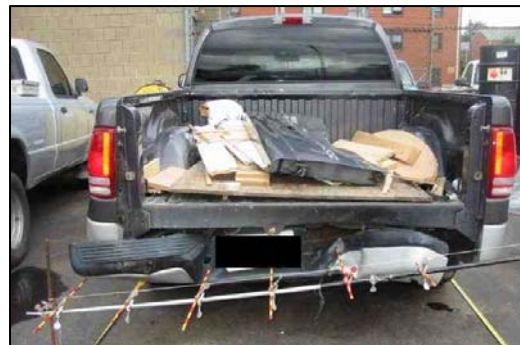
The 2003 Dodge Dakota Pickup truck (Figure 9) sustained moderate severity back plane damage as a result of the impact with the 2001 Mitsubishi Galant. The SCI revised direct contact damage began at the left back bumper corner and extended 117 cm (46") to the right. The combined direct and induced damage encompassed the entire back bumper and measured 137 cm (54") in width. The maximum crush was located 41 cm right the vehicle's centerline on the back bumper and measured 24 cm (9.4") in depth. Six equidistant measurements were taken to the vehicle's back bumper and were as follows: C1 = 7 cm (2.8"), C2 = 11 cm (4.3"), C3 = 17 cm (6.7"), C4 = 18 cm (7.1"), C5 = 24 cm (9.4") and C6 = 0 cm. Due to the angle of this vehicle at impact, the Principal Direction of Force (PDOF) to the vehicle was 160 degrees, and the back bumper was shifted to the left. The SCI revised CDC for this impact was 05-BDEW-1.

Figure 9 - Damaged 2003 Dodge Dakota.

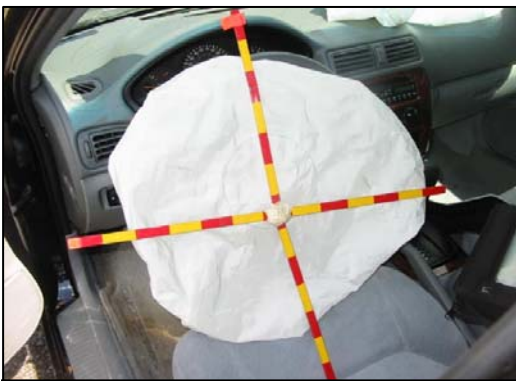
The 2001 Mitsubishi Galant was equipped with redesigned frontal air bags for the driver and front right seating position. The frontal air bags deployed as a result of the impact with the 2003 Dodge Dakota. The driver's air bag (**Figure 10**) deployed through a single top-mounted trapezoidal air bag cover flap. The cover flap measured 17 cm (6.7") horizontally along its upper edge and 8 cm (3.1") in length horizontally along its lower edge. The cover flap was 12 cm (4.7") in height. The deployed driver's air bag measured 60 cm (23.6) in diameter in its deflated state. The NASS coding reported that the driver's air bag was not tethered; however, circular stitching is present indicative of an internal tether. The NASS coding reported that the air bag contained no vent ports. No occupant loading evidence on the air bag membrane was identified during the NASS inspection.

Figure 10 - Deployed driver's air bag.

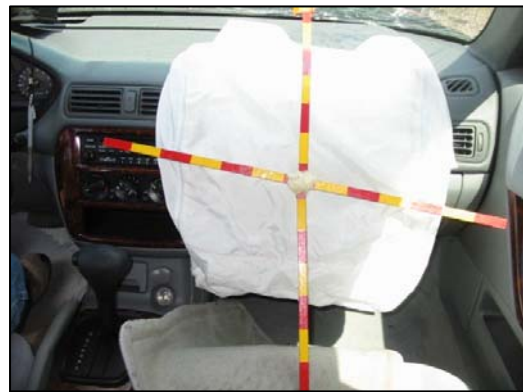
The front right passenger's air bag (**Figure 11**) deployed from a top-mount module configured with a single rectangular cover flap hinged at the top aspect. The cover flap measured 32 cm (12.6") horizontally and 17 cm (6.7") vertically. The deployed front right passenger's air bag measured 40 cm (16") horizontally and 50 cm (20") vertically in its deflated state. The air bag was tethered by a full-width tether strap at the horizontal centerline. It was vented by two circular ports located at the 4 and 8 o'clock aspects on the back of the air bag. There was no contact evidence on the front right passenger's air bag.

Figure 11 - Deployed front right air bag.

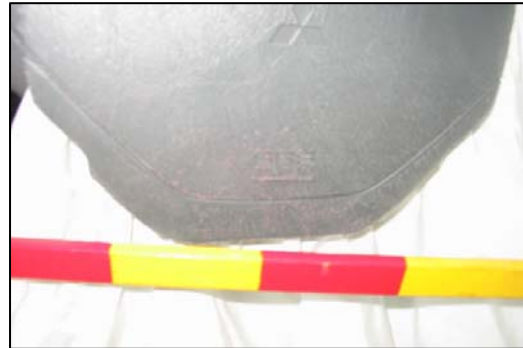
Injury	Injury Severity (AIS 90/Update 98)	Injury Source
Lacerated aorta (major)	Critical (420210.5,4)	Driver's air bag cover flap
Fractured right ulna (comminuted)	Serious (753204.3,1)	Center instrument panel
Closed head injury (LOC)	Minor (160499.1,0)	Expanding driver's air bag
Chest contusion	Minor (490402.1,4)	Driver's air bag cover flap

Figure 12 - Driver's cover flap.

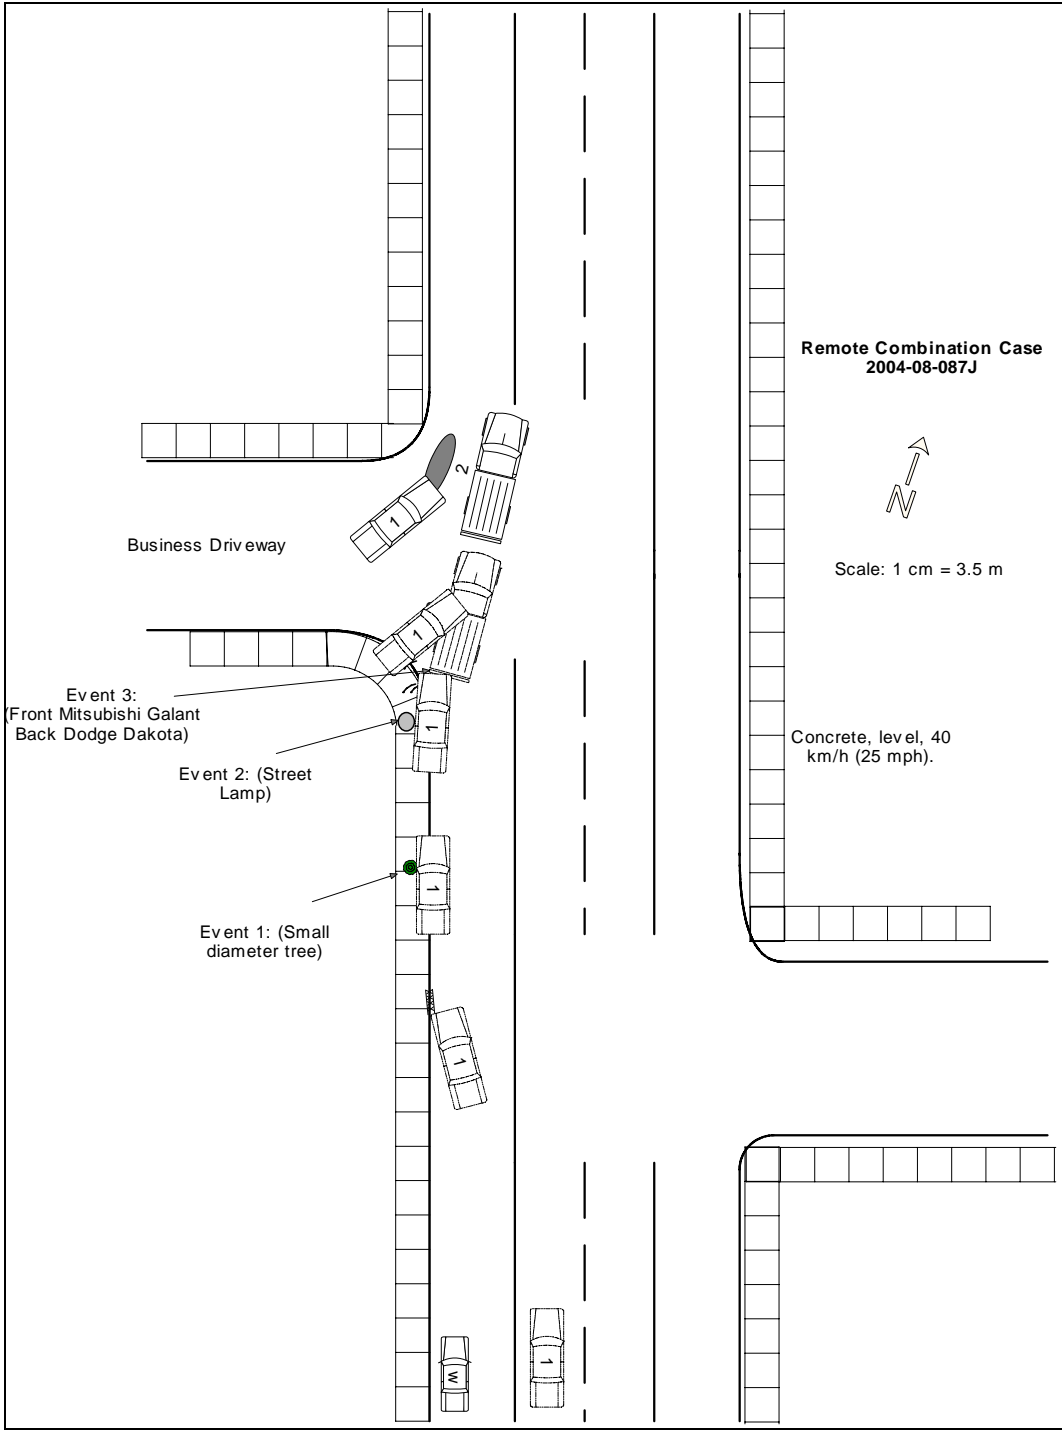
Figure 13 – SCI Revised Scene Schematic

The crash occurred on a two-lane, one-way roadway in an urban setting during daylight hours. The roadway was configured with two northbound through lanes with two outboard parking lanes. The roadway was surfaced with worn asphalt and there were no adverse weather conditions at the time of the crash. The through lanes were 3 meters (10') in width and were delineated by broken painted white lines. The roadway was bordered by asphalt shoulders and white fog lines and accommodated short-term business parking. The roadside environment consisted of multiple business dwellings, concrete sidewalks, driveways, and alleyways. The posted speed limit was 64 km/h (40 mph). An SCI revised scene schematic is included as **Figure 13** at the end of this narrative report.
