**CALSPAN REMOTE ALTERNATIVE FUEL VEHICLE CRASH
INVESTIGATION**

CASE NO: 2004-11-080F

VEHICLE: 2004 TOYOTA PRIUS

CRASH DATE: APRIL 2004

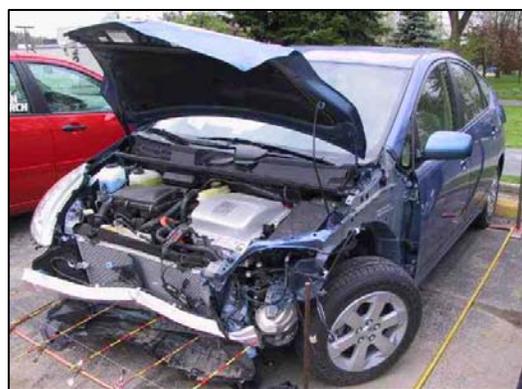
The 2004 Toyota Prius (**Figure 4**) sustained moderate damage as a result of the impact with the 2000 Dodge Intrepid. The crush data was over representative; therefore, the NASS vehicle inspection measurements were revised in the SCI remote investigation. The SCI investigation revealed that the maximum crush was located 32 cm (12.6") left of the vehicle's centerline and measured 29 cm (11.4") in depth. The direct contact began at left front reinforcement bar corner and extended 100 cm (39.4") to the right. The Field L measurement began at the front left reinforcement bar corner and extended across the entire front end and measured 108 cm (42.5"). The crush profile measured to the reinforcement bar and adjusted for missing components was as follows: C1 = 28 cm (11.0"), C2 = 29 cm (11.4"), C3 = 27 cm (10.6"), C4 = 20 cm (7.9"), C5 = 9 cm (3.5") and C6 = 0 cm. The Collision Deformation Classification (CDC) was 12-FYEW-2.

Figure 4 - Damaged 2004 Toyota Prius.

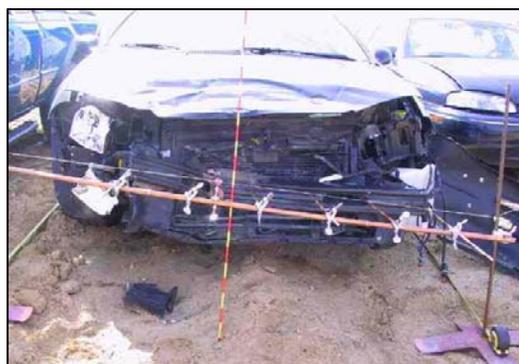
The 2000 Dodge Intrepid (**Figure 5**) sustained moderate damage as a result of the impact with the 2004 Toyota Prius. The NASS vehicle inspection measurements were revised in the SCI remote investigation, due to the over estimation of the crush. The SCI investigation revealed that the maximum crush was located 24 cm (9.4") right of the vehicle's

Figure 5 - Damaged 2000 Dodge Intrepid.

centerline and measured 25 cm (9.8”) in depth. The direct contact damage began at the right front bumper corner and extended 80 cm (31.5”) to the left across the front plane. The Field L measurement began at the right front corner and extended across the entire front measuring 108 cm (42.5”). The crush profile measured to the reinforcement bar and adjusted for missing components was as follows: C1 = 0 cm, C2 = 12 cm (4.7”), C3 = 14 cm (5.5”), C4 = 23 cm (9.1”), C5 = 15 cm (5.9”) and C6 = 0 cm. The SCI revised CDC is 01-FZEW- 1.

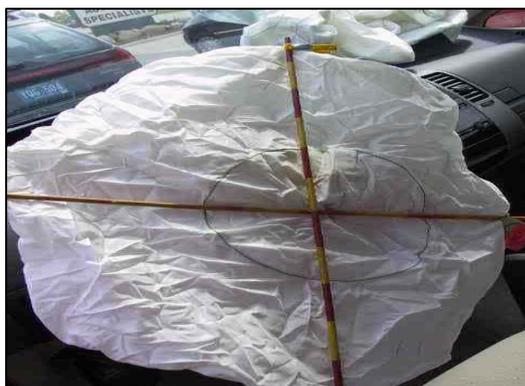
The 2004 Toyota Prius was equipped with redesigned frontal air bags for the driver and front right seating positions. The frontal air bags deployed as a result of the impact with the 2000 Dodge Intrepid. Both frontal air bags (**Figure 6 and 7**) deployed through H-configuration module cover flaps with the one-piece upper and lower flaps separated by a center vertical seam. No air bag dimensions were recorded during the NASS vehicle inspection.

Figure 6 - Driver's air bag.

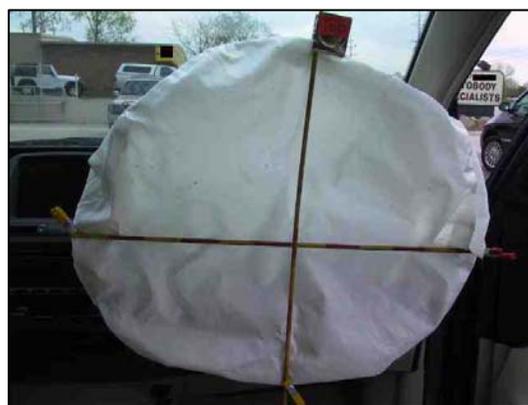
Figure 7 - Right front passenger air bag.

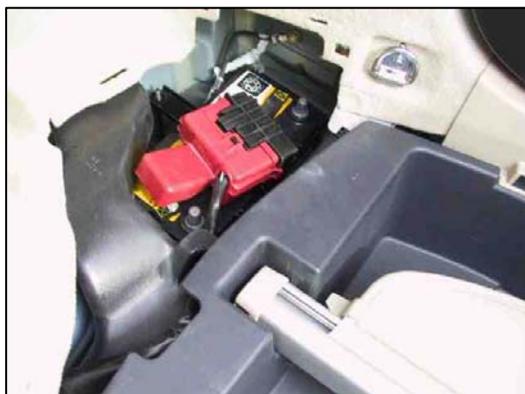
Figure 8 - Onboard battery system.

There was no intrusion of the battery pack area or damage to the area of the left side harness. The engine compartment was only minimally damaged missing the hybrid components completely. This crash did not expose a risk to the driver.

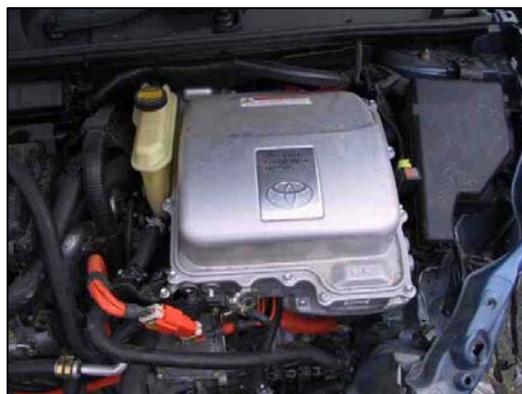
Figure 9 - Engine Components.
