**CALSPAN REMOTE AIR BAG RELATED SERIOUS INJURY
CRASH INVESTIGATION**

CASE NO: 2004-11-200K

VEHICLE: 1996 OLDSMOBILE NINETY-EIGHT

CRASH DATE: SEPTEMBER 2004

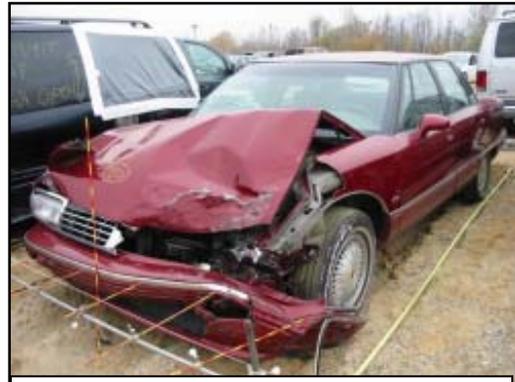
Figure 1. Subject 1996 Oldsmobile Ninety-Eight.

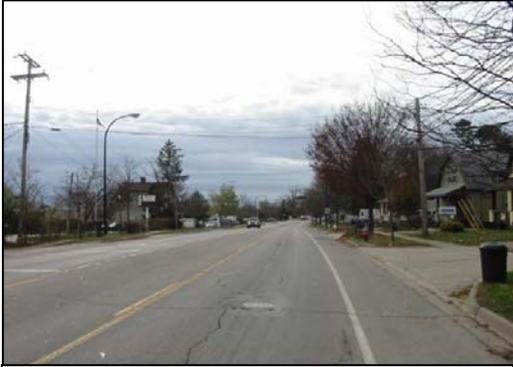
The 80-year old driver of the Oldsmobile was operating the vehicle southbound on the three-lane roadway and was intending to continue straight (**Figure 2**). The 56-year old male driver of the Jeep Cherokee was exiting a private driveway from the west side of the roadway and was intending to turn left to travel northbound (**Figure 3**). The driver of the Oldsmobile claimed that he saw the Cherokee pull out from the driveway and had no time to initiate any avoidance measures. He denied any avoidance measures; however,

Figure 2 - Southbound approach of 1996 Oldsmobile Ninety-Eight.

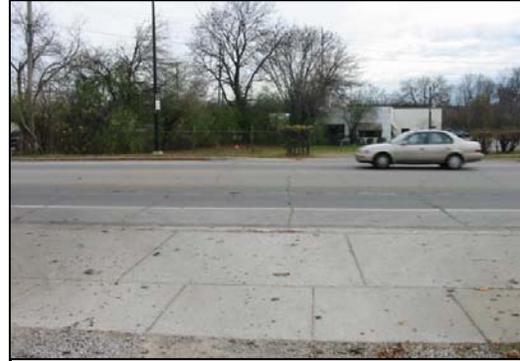
Figure 3 - Westbound approach of 1993 Jeep Cherokee.

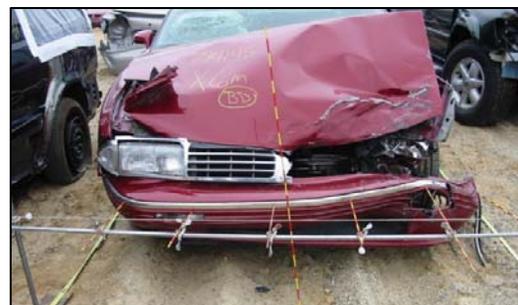
The 1996 Oldsmobile Ninety-Eight (**Figure 4**) sustained moderate frontal damage as a result of the impact with the 1993 Jeep Cherokee. The SCI revised direct contact damage began at the left front corner and measured 78 cm (30") in

Figure 2 - Damaged 1996 Oldsmobile Ninety-Eight.

length. The combined direct and induced damage encompassed the entire front end and measured 156 cm (61.4”). The maximum crush was located at the front left bumper corner and measured 41 cm (16.1”) in depth. Six equidistant crush measurements were documented across the full width of the bumper and were as follows: C1 = 41 cm (16.1”), C2 = 26 cm (10.2”), C3 = 19 cm (7.5”), C4 = 12 cm (4.7”), C5 = 7 cm (2.8”), C6 = 1 cm (0.4”). The Collision Deformation Classification (CDC) was 01-FYEW-2.

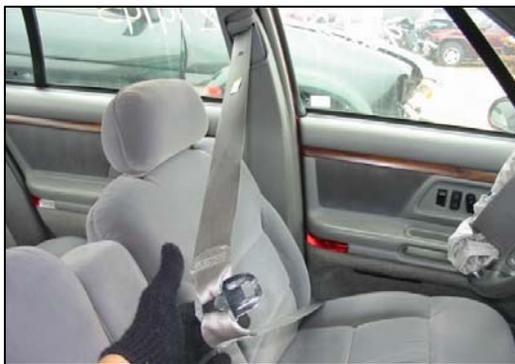
Figure 5 - Driver 3-point lap and shoulder restraint.

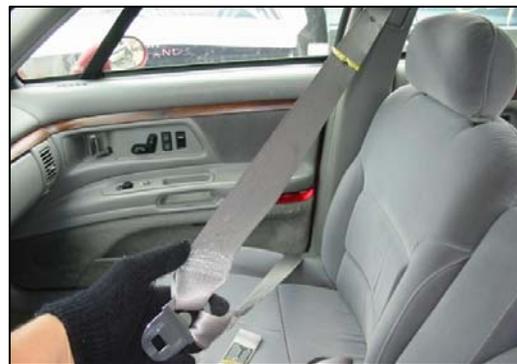
Figure 6 - Front right passenger's 3-point lap and shoulder restraint.

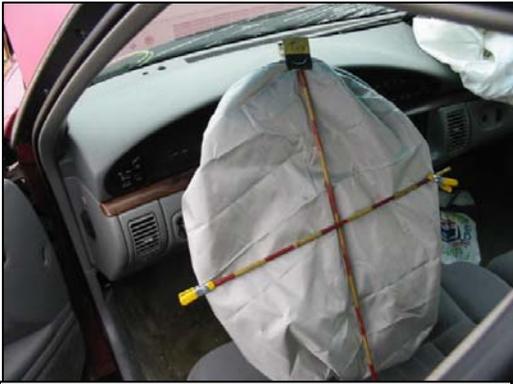
The 1996 Oldsmobile Ninety-Eight was equipped with frontal air bags for the driver’s and front right passenger’s seating positions. The driver’s air bag (**Figure 7**) deployed from the steering wheel hub through symmetrical I-configuration module cover flaps. Each cover flap measured 8 cm (3.2”) in width and 12 cm (4.7”) in height. The deployed driver’s air bag measured 56 cm (22”) in diameter in its deflated state. The air bag was vented by two ports located near the membrane’s centerline in the 3 and 9 o’clock

positions on the back of the bag. The air bag was not tethered and exhibited no discernable contact evidence.

Figure 7 - Deployed driver's air bag.

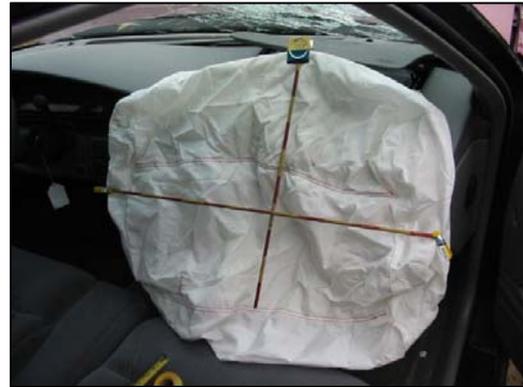
The front right air bag deployed through a top-hinged single cover flap that was 39 cm (15.4”) in width and 20 cm (7.9”) in height. The deployed front right air bag (**Figure 8**) was 61 cm (24”) in width and 48 cm (18.9”) in height in its deflated state. The air bag was vented by two ports located at the 10 and 2 o’clock positions on the rear of the bag and was tethered by two straps in unknown locations. Vinyl striations were present on the upper aspect of air bag; however, no discernable occupant loading evidence was present.

Figure 8 - Deployed front right air bag.

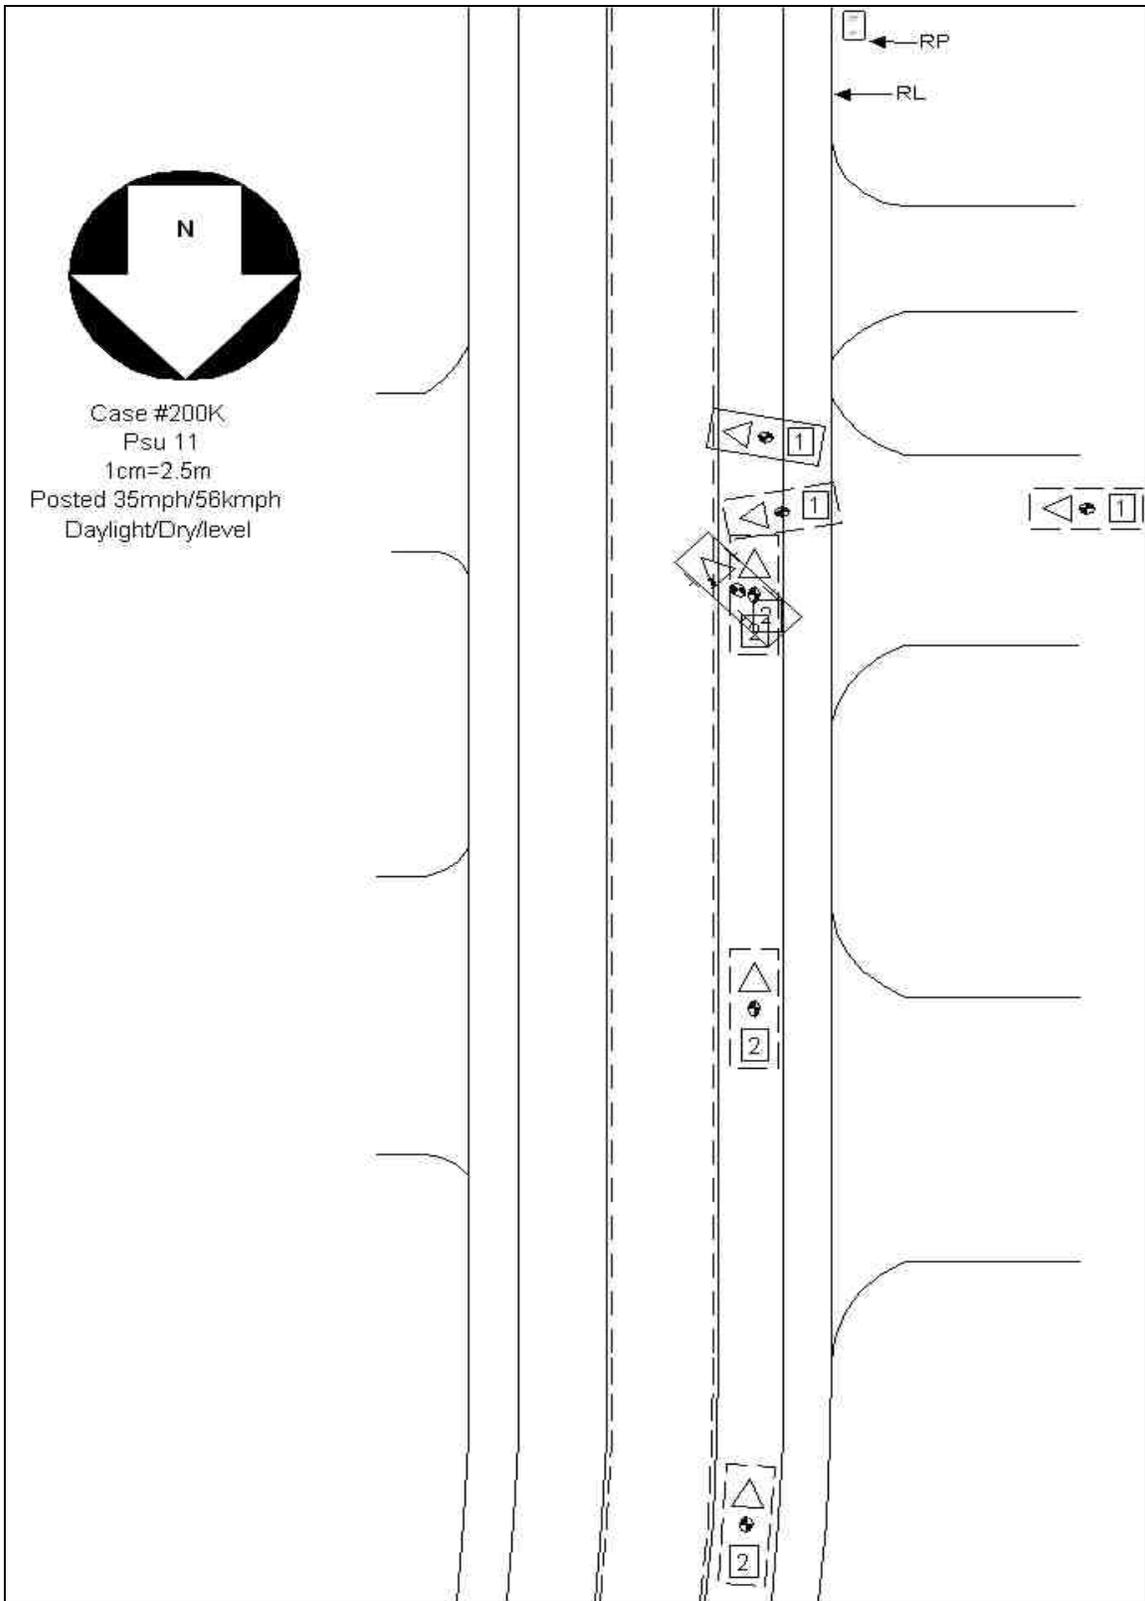
Figure 9 – NASS Scene Schematic

asphalt roadway was dry. The north/south roadway consisted of one lane in each direction separated by a center turn lane. The lanes were delineated by solid and broken yellow lane markings separating the center turn lane from the travel lanes. Asphalt shoulders with white fog lines bordered the roadway on both sides. The roadside environment consisted of natural growth and multiple private residences and driveways in a suburban setting. The roadway was straight and level and the posted speed limit was 56 km/h (35 mph). The NASS scene schematic is included as **Figure 9** at the end of this narrative report.
