**CALSPAN REMOTE CERTIFIED ADVANCED 208-COMPLIANT CRASH  
INVESTIGATION**

**NASS/SCI COMBO CASE NO.: 04-12-083J**

**SUBJECT VEHICLE: 2003 GMC SIERRA PICKUP TRUCK**

**CRASH DATE: MAY 2004**

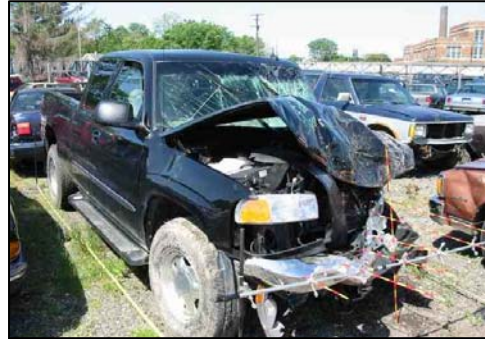
The 2003 GMC Sierra sustained severe damage as a result of the impact with the 1987 GMC P4500 step van (**Figure 4**). The NASS investigation revealed that the maximum crush was located 73 cm (28.7”) left of the vehicle’s centerline at the front left bumper corner and measured 80 cm (31.5”). The direct contact damage began 73 cm (28.7”) left of the vehicle’s centerline and extended 115 cm (45.3”) along the

**Figure 4 – Frontal damage to 2003 GMC Sierra.**

bumper to the right. The Field L measurement began at the left front bumper corner and extended across the entire front-end 145 cm (57.1”) to the right front bumper corner. The crush profile measured to the bumper level was as follows: C1 = 80 cm (31.5”), C2 = 70 cm (27.6”), C3 = 48 cm (18.9”), C4 = 21 cm (8.3”), C5 = 0 cm, and C6 = 0 cm. The NASS reported Collision Deformation Classification (CDC) was 12-FDEW-3. The Principal Direction of Force (PDOF) was 350 degrees.

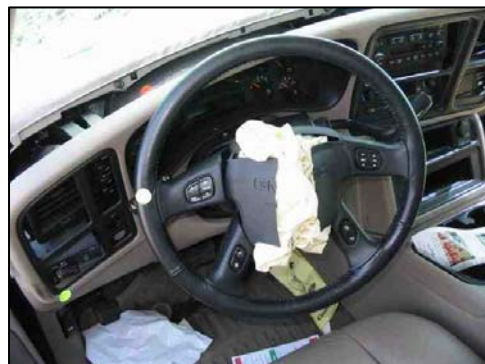
The driver loaded the steering assembly through the deployed air bag during the impact (**Figure 5**). A small blood transfer located 5 cm (2”) left of center on the horizontal centerline was present on the driver’s air bag. As the driver loaded through the air bag, the steering column compressed an undetermined amount and the hub and spoke pivoted to the right approximately 20 degrees (**Figure 6**). The left half aspect of the wheel rim was deformed approximately 3 cm (1.2”) (**Figure 7**). There were two distinct scuffmarks on the rigid plastic faced knee bolster, usually indicative of knee contact. The NASS

**Figure 5 – Steering assembly and instrument panel of the 2003 GMC Sierra.**

team also reported a “starburst” crack on the windshield and surmised that the driver’s left hand may have struck the component.

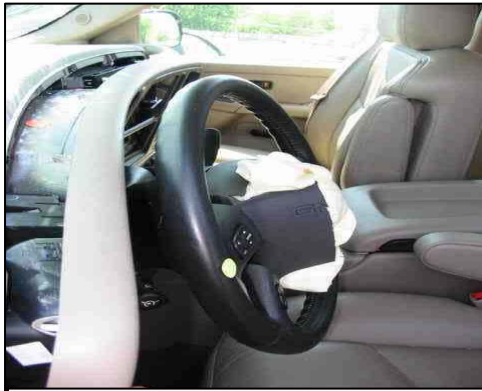
**Figure 6 – Lateral view of steering wheel/column compression.**

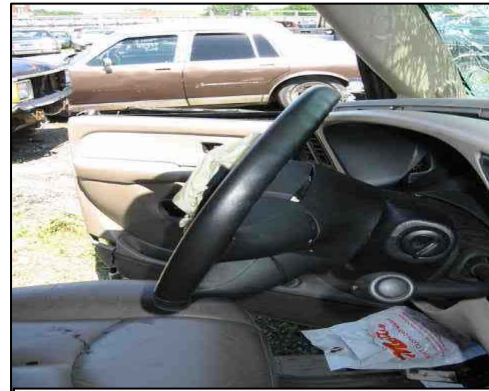
**Figure 7 – Lateral view of steering wheel rim deformation.**

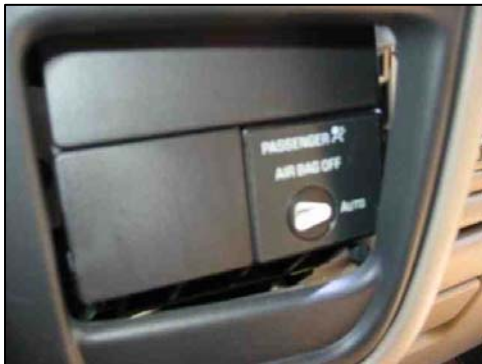
Automatic position. In the Off position the mid-mounted passenger air bag is suppressed and will not deploy. In the Automatic position, the SDM determines whether to deploy the air bag and will suppress it if the seat is unoccupied, if a child is seated in the front right position, or if the impact does not warrant supplemental restraint deployment. The setting at the time of the NASS inspection was in the Automatic position (**Figure 8**); therefore, given that the seat was unoccupied, the front right system was suppressed during this crash.

**Figure 8 – Passenger's air bag switch in automatic mode.**

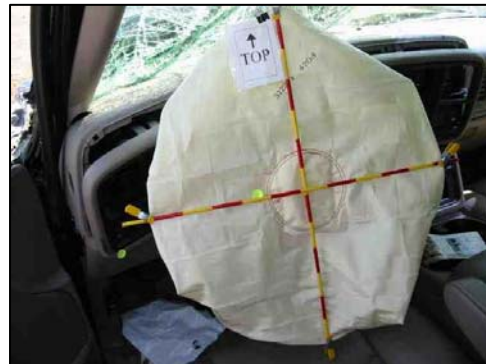
**Figure 9 – Driver's air bag.**

The driver's frontal bag deployed at impact with the P4500 step van. The air bag was housed in the center of the steering wheel hub and deployed through two I –configuration cover flaps (**Figure 9**). According to the NASS investigation, the cover flaps were symmetrical and measured 8 cm (3.1") in width and 12 cm (4.7") in height. The air bag membrane measured 70 cm (27.6) in diameter in its deflated state. The air bag contained two vent ports that were located in the 10 and 2 o'clock positions. Two internal straps, the locations of which were not reported, tethered the air bag. A small blood transfer located 5 cm (2") left of center on the horizontal centerline was present on the driver's air bag.
