**CALSPAN ON-SITE NASS/SCI COMBO ADAPTIVE CONTROL
VEHICLE CRASH INVESTIGATION**

CASE NO: 2004-13-108D

VEHICLE: 1998 FORD E-150 VAN

CRASH DATE: APRIL 2004

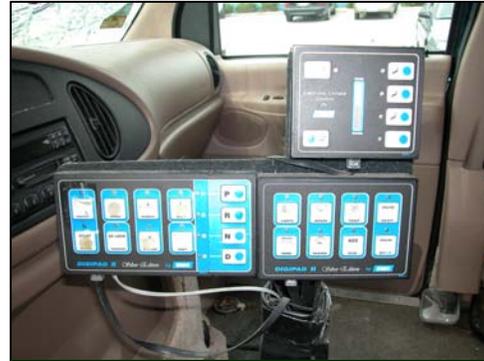
A touch pad control panel was mounted on a stalk at the center area of the frontal passenger compartment. This unit provided the driver with touch pad functions for vehicle ignition, wiper, horn, power windows, power door locks, HVAC, and transmission selection functions (**Figure 4**). These units were not damaged in the crash.

Figure 4. Vehicle function touch pads.

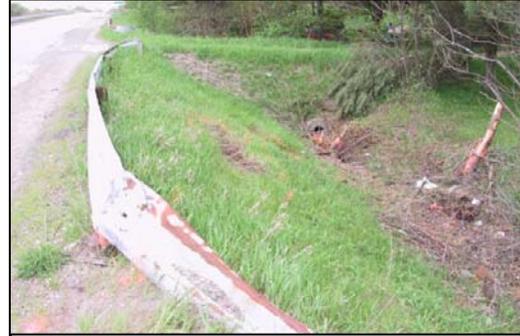
Figure 9 - Area of impact and subsequent rollover.

As the vehicle departed the roadway, the front right bumper corner impacted the guardrail. The impact resulted in minor damage to the right corner of the bumper. Following the initial impact, the vehicle sideswiped the guardrail resulting in minor contact damage abrasions to the right front fender. The vehicle then mounted the guardrail, and while still engaged with the guardrail, began to overturn right-side leading. The vehicle descended down the ditch slope and overturned six-quarter turns (**Figure 9**). As the vehicle was rolling into the ditch, the left front fender and left roof side rail areas impacted small diameter trees resulting in minor damage. Due to the non-horizontal aspect of these impacts, delta-Vs were not computed. The vehicle came to final rest on its roof facing westbound.

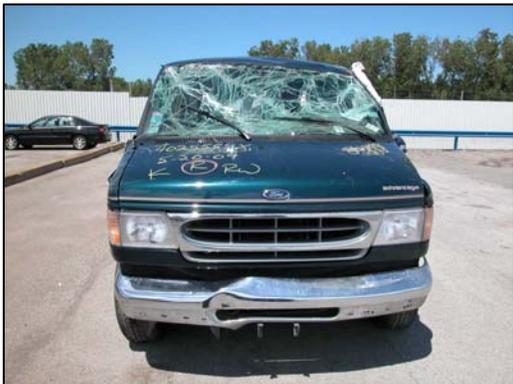
The SCI investigation determined that the direct contact frontal damage began at the front right bumper corner and extended 9 cm (3.5") to the left (**Figure 10**). The damage was limited to the bumper with white paint transfers from the guardrail present. The maximum crush was located at the front right bumper corner and was 3 cm (1") in depth. The combined direct and induced damage encompassed the entire front end measuring 175 cm (69") in width. The SCI revised Collision Deformation Classification (CDC) for this frontal impact was 01-FRLS-1. Six equidistant crush measurements were documented across the full width of the chrome bumper and were as follows: C1 = 0 cm, C2 = 0 cm, C3 = 0 cm, C4 = 1 cm (0.4"), C5 = 1 cm (0.5"), C6 = 3 cm (1").

Figure 10 – Frontal damage to the 1998 Ford E-150

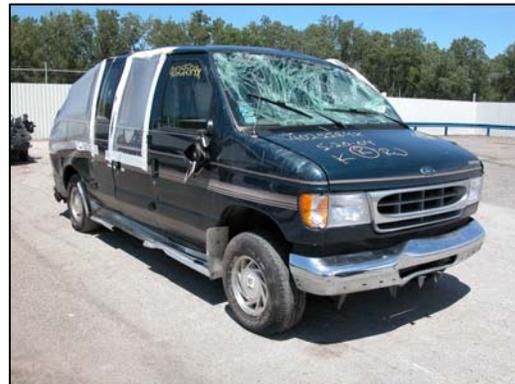
Figure 11 - Right side damage.

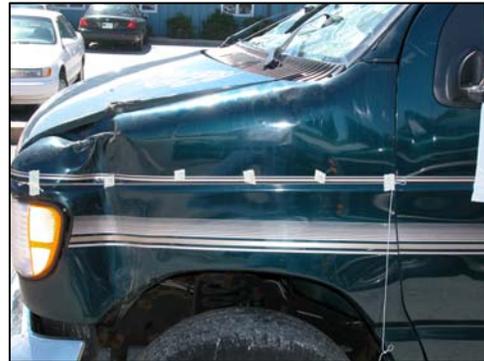
As the vehicle was on its roof in the second quarter turn of this six-quarter turn rollover event, the left front fender contacted a small diameter tree located off the roadside (**Figure 12**). The direct contact damage for this impact began 28 cm (11") forward of the front left axle and extended forward 10 cm (4"). The combined direct and induced damage began 37 aft the front left axle and extended forward 88 cm (35"). The maximum crush was located 32 cm forward of the front left axle and measured 5 cm (2") in depth. The crush measurements for this impact were as follows: C1 = 0 cm, C2 = 1 cm (0.25"), C3 = 2 cm (0.6"), C4 = 2 cm (0.8"), C5 = 5 cm (2"), C6 = 0 cm. The vehicle was on its roof during this event and therefore the CDC was 00-LFEN-2.

Figure 12 –Tree impact damage to the left front fender.

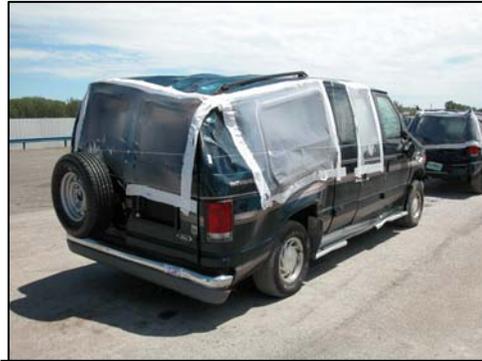
Figure 14 - Right side and roof damage.

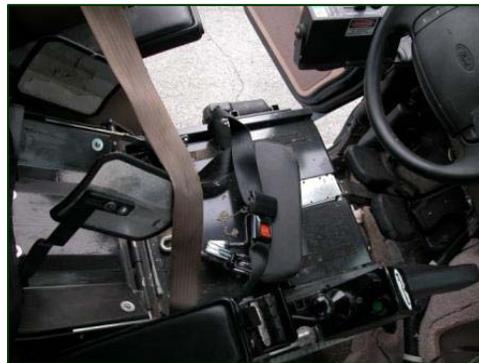
The shoulder belt webbing was worn and cupped in the vicinity of the rigid lateral chest stabilizer that was mounted to the wheelchair. A black vinyl abrasion from frequent use was located immediately below the wear point on the webbing (**Figure 16**).

Figure 16. Wear mark of the shoulder belt webbing from chest stabilizer.

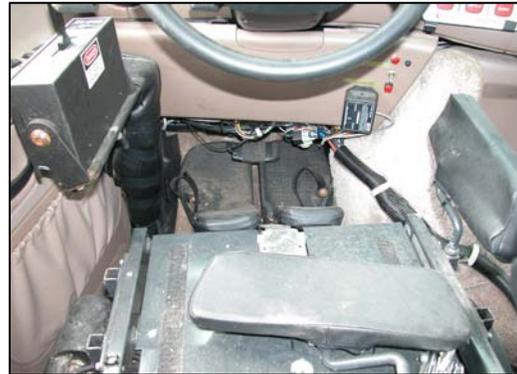
The 72-year old male driver of the 1998 Ford E-150 van was traveling north on an exit-ramp from an interstate and was approaching a "T" intersection. The driver stated that he attempted to brake by pulling back on the hand-activated throttle/brake controller as he was approaching the intersection and the braking system failed to engage. The SCI vehicle inspection revealed that the power-adjustable wheelchair foot rests were inadvertently positioned under and behind the OEM brake pedal (**Figure 17**). The

wheelchair foot rests interfered with the brake pedal travel, thus limiting the braking function of the vehicle. In response to the absence of braking, the driver steered sharply left at the intersection at a driver-estimated speed of 56 km/h (35 mph) and departed the right side of the intersecting roadway (**Figure 8**).

Figure 17. Wheelchair footrests inadvertently positioned behind and under the brake pedal.

The driver stated that as he attempted to apply the brakes with his left hand, the brakes failed to slow the vehicle. The power-adjustable foot-rests of the wheelchair were inadvertently adjusted by the driver during his trip which positioned the leading edge of the foot rests under and forward of the brake pedal (**Figure 17**).
