CALSPAN ON-SITE CHILD SAFETY SEAT CRASH INVESTIGATION

NASS/SCI COMBO CASE NO: 2004-45-131K

VEHICLE: 1989 FORD AEROSTAR

CRASH DATE: JULY 2004

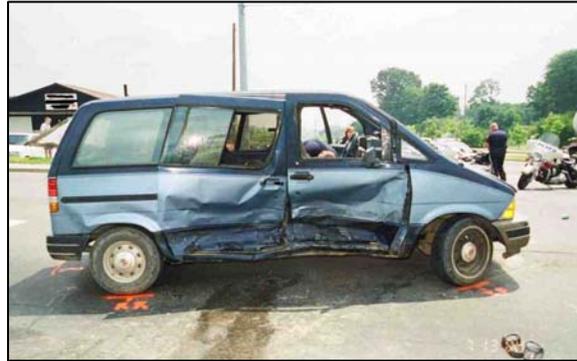
Figure 1 - Damaged 1989 Ford Aerostar.

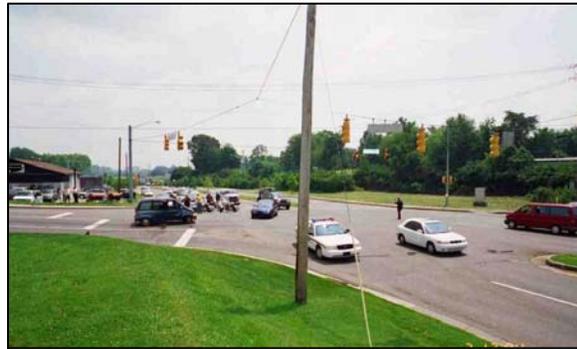
intersection. The 20-month-old male passenger seated in a CSS in the second row center position was fully ejected from the vehicle through the open second row right window. The Taurus rotated approximately 10 degrees in a clockwise direction and came to rest near the point of impact facing northwest. **Figure 4** illustrates the vehicles at final rest.

Figure 4 - Overall view of post-crash scene.

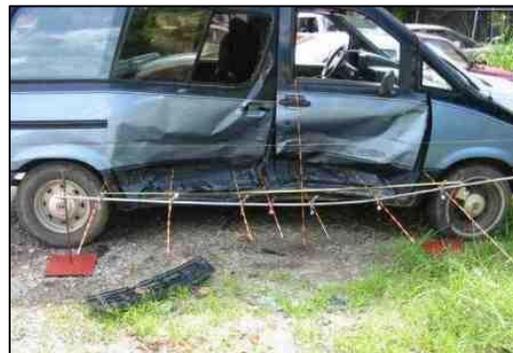
The 1989 Ford Aerostar (**Figure 5**) sustained moderate right side damage as a result of the impact with the 1996 Ford Taurus. The NASS vehicle inspection revealed that the direct contact damage began 30 cm (11.8") forward of the right rear axle and measured 230 cm (90.1") in length. The maximum crush was reportedly 145 cm (57.1") forward of the right rear axle and measured 43 cm (16.9") in depth. The NASS investigation revealed that the combined direct and induced damage was the same as the direct contact damage 230 cm (90.1"). It appears that the induced damage has been slightly understated as there is sheet metal buckling along the rear right quarter panel; although, this discrepancy is not sufficient enough to alter the delta-V. Previous damage was present along the rear bumper unassociated with these crash events. The SCI revised Collision Deformation Classification (CDC) for the impact with the Taurus was 02-RPEW-3.* Six equidistant crush measurements were documented at the mid-door level and were as follows: C1 = 3 (1.2"), C2 = 26 cm (10.2"), C3 = 40 cm (15.7"), C4 = 40 cm (15.7"), C5 = 30 cm (11.8"), C6 = 1 cm (2.5").

Figure 5 - 1989 Ford Aerostar crush profile.

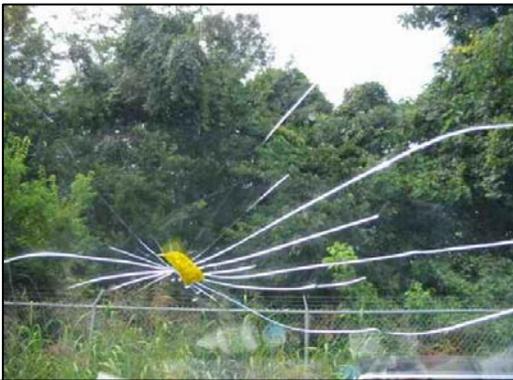
The left and center instrument panel revealed faint scuffmarks attributable to knee contacts from the unbelted driver, and the center console transmission shifter was deformed from the loading by the driver's right upper leg and hip as she traveled laterally responding to the 2 o'clock direction of force. The driver's left wrist contacted and fractured the windshield near the center point of the vehicle before the driver's kinematical movement subsided (**Figure 6**). The upper right instrument panel above the glove compartment exhibited heavy compression marks attributable to the loading of the unbelted front right passenger's knees (**Figure 7**). The right side interior door surface was fractured on the forward aspect at the beltline from interaction with the front right passenger's shoulder.

Figure 6 - Crack on windshield from driver's wrist.

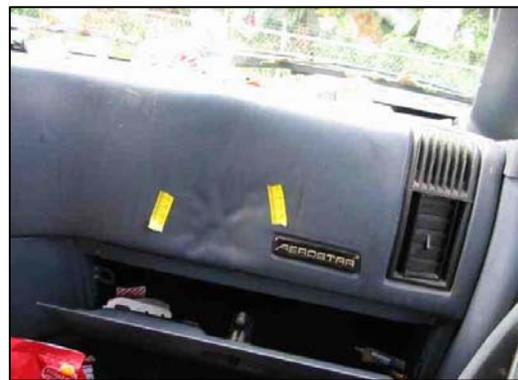
Figure 7 - Damage right instrument panel from right front passenger.

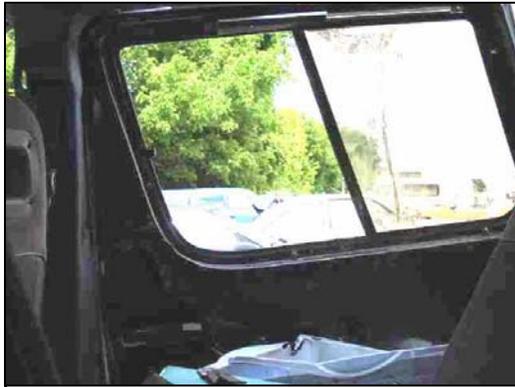
The right rear and backlight glazing were removed from the vehicle prior to the impact with the 1996 Ford Taurus. The unbelted 20-month-old male passenger, who was not restrained in the center position of the second row short-bench seat, was fully ejected through the right side window opening (**Figure 8**). As this occupant exited the vehicle, it was possible that he contacted the window frame (**Figure 9**). Evidence in the form of deformed sheet metal on the lower left aspect of the frame is present, but this correlation could not be confirmed from the NASS case.

Figure 8 - Ejection point of right center passenger.

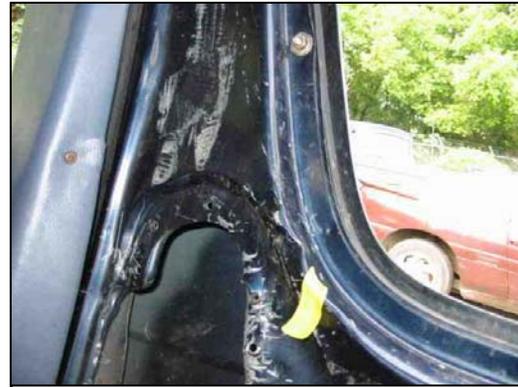
Figure 9 - Possible contact point from ejected passenger.

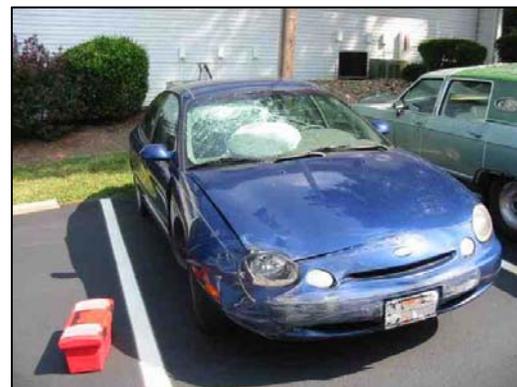
The 1996 Ford Taurus (**Figure 10**) sustained moderate frontal damage as a result of the impact with the 1989 Ford Aerostar. The NASS vehicle inspection revealed that the direct contact damage began 44 cm (17.3") left of the vehicle's centerline and extended 124 cm (48.8") across the front bumper to the right front corner. The maximum crush was recorded at the right front corner and measured 11 cm (4.3") in depth. The

Figure 10 - 1996 Ford Taurus damage profile.

combined direct and induced damage was reportedly across the entire frontal plane and measured 160 cm (63") in length. The CDC for the impact with the Aerostar was 11-FDEW-1. Six equidistant crush measurements were documented at the bumper level and were as follows: C1 = 0 cm, C2 = 0 cm, C3 = 0 cm, C4 = 2 cm (0.8"), C5 = 5 cm (2"), C6 = 11 cm (4.3").

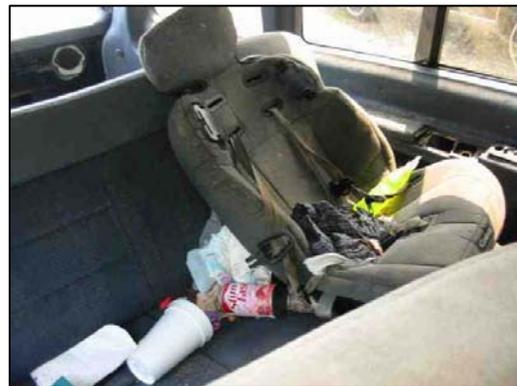
A Century Breverra Classic forward-facing CSS was installed in the rear left position of the Aerostar (**Figure 11**). The Model Number was 4865JTW01 and the Date of Manufacture was 12/11/2001. The CSS was intended for forward facing only, but could also be utilized as a high-back belt positioning booster seat. The CSS was configured with a 5-point integrated harness and a two-piece locking retainer clip. The CSS was designed for children weighing between 14 kg (30 lb) and 18 kg (40 lb). The 4-year-old female child was within the manufacturer's weight range for this CSS.

Figure 11 - CSS occupied by rear left passenger.

The owner was unsure whether the CSS had ever been in a crash prior to this, which is indicative of the CSS being obtained used. The CSS was secured in the vehicle with the 2-point lap belt, which was fastened through the belt path on the lower back aspect of the CSS. The 2-point belt held the CSS in place but was not tensioned to keep the CSS free of lateral movement. The integrated 5-point harness was routed through the bottom set of slots.

The 4-year-old child was placed in the CSS and the owner stated that the retainer clip was positioned between the child's armpits and belly button. The owner reported that the CSS was used daily and was originally installed by a friend. Following the crash the owner reported that the CSS was slightly tilted to the right. Based on the available information, the lap belt was not taut through the belt path.

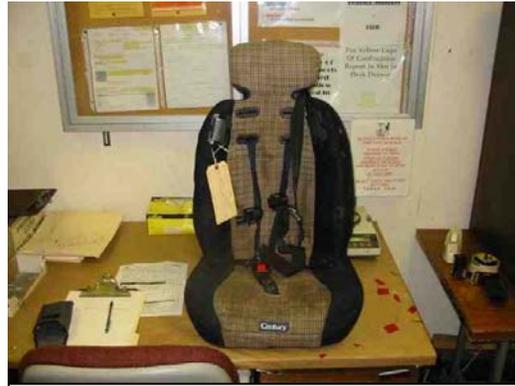
A Century Breverra Classic forward-facing CSS was installed in the rear center position of the Aerostar (**Figure 12**). The Model Number was 44865FRN and the Date of Manufacture was 07/15/2004. The CSS was intended for forward facing use only, but could also be used as a high-back booster seat. The CSS was configured with a 5-point integrated harness and a two-piece locking retainer clip. The CSS was designed for children weighing between 14 kg (30 lb) and 18 kg (40 lb). The 20-month-old male child was under the manufacturer's weight range for this CSS by 3 kg (7 lb).

Figure 12 - CSS for rear center passenger.

The 20-month-old child was placed in the CSS, but was not restrained by the integrated 5-point harness. The mother of the child claimed that the child might have undone the straps prior to the crash; however, this is unlikely due to the age of the child and worn condition of the CSS. The owner was unsure whether the CSS had ever been in a crash prior to this, which is indicative of the CSS being obtained used by the owner. The CSS was removed by police following the crash and was impounded.

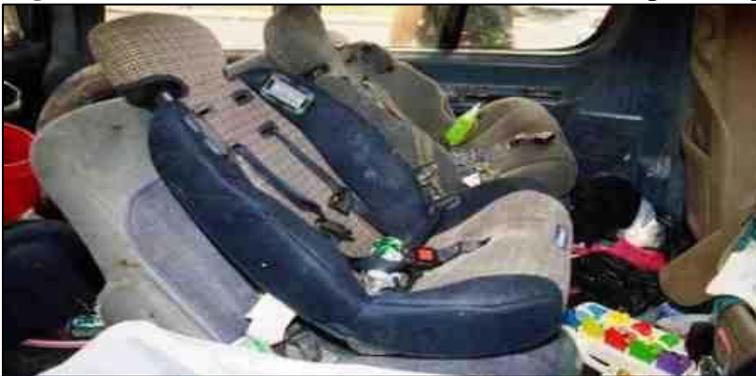
Figure 13 is an illustration of the CSS installation prior to police removal.

Figure 13 – CSS placement inside vehicle post crash.
