SCI/NASS COMBINATION FORD SAFETY CANOPY SPECIAL STUDY INVESTIGATION

CASE NUMBER - NASS-2004-49-034E

VEHICLE - 2003 FORD EXPEDITION

CRASH DATE - February 2004

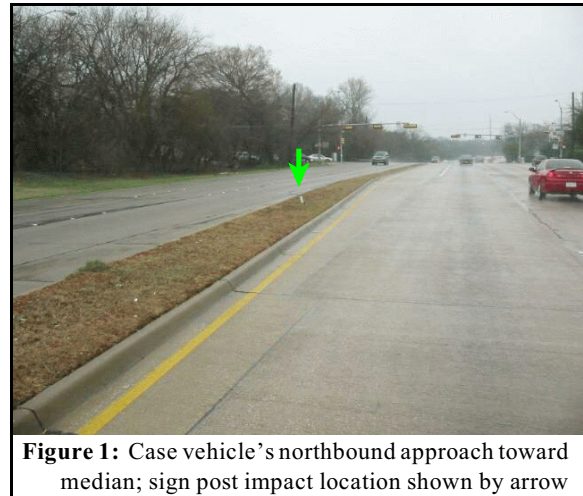
Figure 1: Case vehicle’s northbound approach 1

The sequence of crash events began when the case vehicle entered the median. The details of the case vehicle's interaction with the barrier curb and the grass/soil in the median are not fully understood and the NASS case indicates an undercarriage impact to the curb as the first harmful event (**Figure 1**). The case vehicle's approach toward the median curb was a shallow angle and each of the four wheels mounted the curb separately. The case vehicle continued along the median and the front of the case vehicle impacted a speed limit sign, shearing the sign post off from its foundation and bending the post (**Figure 2**). The case vehicle continued across the median and entered southbound lanes. The front of the case vehicle impacted the front of the other vehicle,

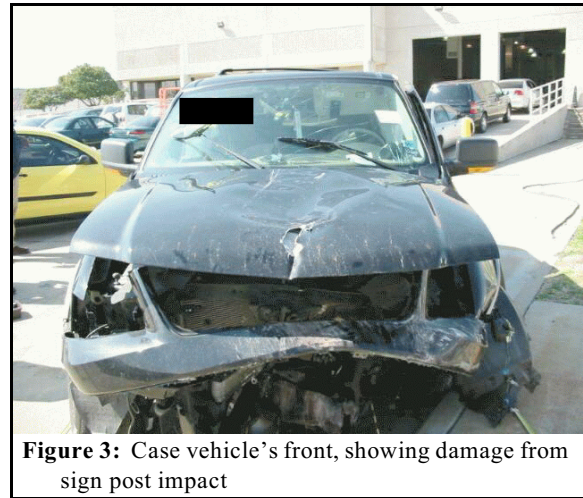
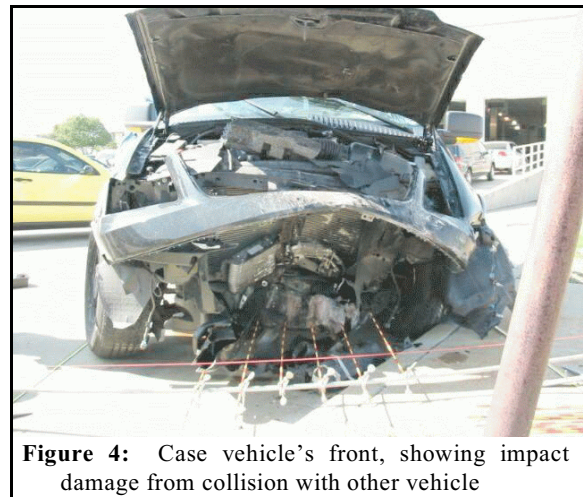
The case vehicle sustained heavy damage across the entire front (**Figures 3 and 4**) and the NASS case is coded to indicate front override for the impact involving the other vehicle (third event). The grille and both headlamp/turn signal assemblies were shattered and broken away. The plastic bumper cover was lifted upward and the steel bumper was sheared away from its mounting on the left and right frame rails and crushed

rearward. The lower portion of the radiator was crushed rearward against the engine block. The leading end of the left fender was crushed rearward and the top of the fender was folded downward. The left front wheel was pushed rearward against the left A-pillar, with the left wheelbase shortened by 45 centimeters [17.7 inches]. The A-pillar was displaced rearward and there was buckling of the roof above the driver's door (**Figure 5**). The NASS researcher measured 25 centimeters [9.8 inches] of rearward intrusion by the floor pan in the driver's footwell. The right fender sustained minor damage and the right front wheel moved forward slightly, extending the right wheelbase by 6 centimeters [2.4 inches]. Maximum crush was measured as 60 centimeters [23.6 inches], slightly inboard of the left frame rail. The case vehicle's impact with the speed limit sign resulted in a deep crease in the center of the leading edge of the hood. The speed limit sign post whipped down onto the hood, leaving dents and scraping back to the cowl, and the sign impacted the base of the windshield near the center, causing cracks to fan upward and outward through the center of the windshield (**Figure 3**). There was no other glazing damage. The left front tire was restricted but not deflated, the left rear tire was deflated but not otherwise damaged and both left wheels had areas of abrading on their outside edges but no significant damage. The right side wheels and tires did not sustain any visible damage.

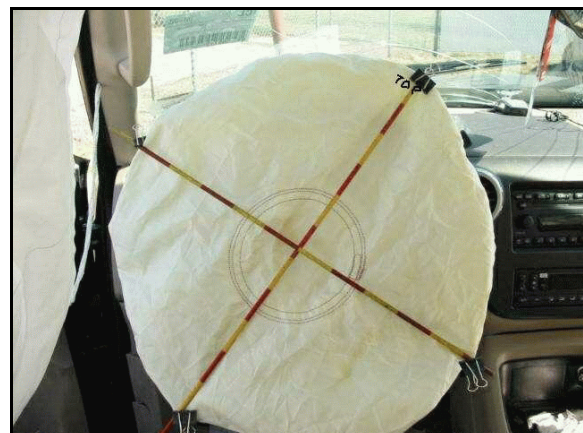
The driver's frontal air bag was installed in the steering wheel hub (**Figure 6**), with a single

Figure 6: Front of driver's air bag; left safety canopy is partially visible on the left in this photos

cover flap. The cover flap was irregular in shape measured as 25 centimeters [9.8 inches] horizontally along the top (hinge) edge, tapering to 16 centimeters [6.3 inches] horizontally along the bottom edge, and 13 centimeters [5.1 inches] vertically. The cover flap opened along the designated tear points and there is no evidence of damage to the cover flap. The deployed air bag was round with a diameter of 55 centimeters [21.7 inches]. There were two tether straps near the center. Two vent ports, of unknown diameter, were located at the ten and two o'clock positions on the back. There was a light scuff on the air bag fabric on the front near the center and no other evidence of occupant contact nor any damage on the driver's air bag.

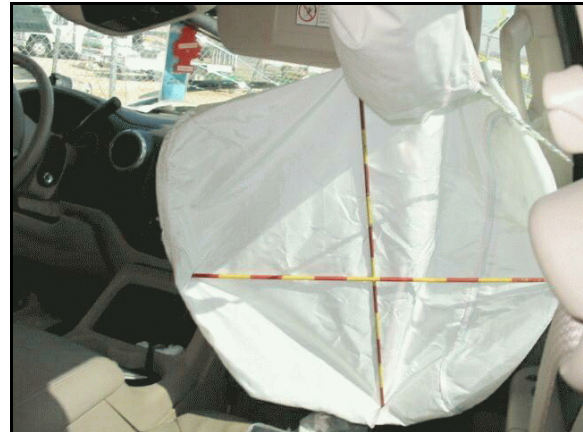
The front right passenger's frontal air bag was installed in the middle position on the right side of the instrument panel (**Figure 7**), with a single cover flap. The cover flap was rectangular, measuring 37 centimeters [14.6 inches] horizontally and 17 centimeters [6.7 inches] vertically. The cover flap opened at the designated tear points and there was no evidence of damage to the cover flap. The deployed air bag was rectangular, measuring 55 centimeters [21.7 inches] horizontally and 60 centimeters [23.6 inches] vertically. There was no tether strap. Two vent ports, of unknown diameter, were located in the center of the left and right fabric side panels. There was no evidence of occupant contact nor any damage on the front right passenger's air bag.

Figure 7: Front of front right passenger's air bag; right side canopy is hanging from above in this view

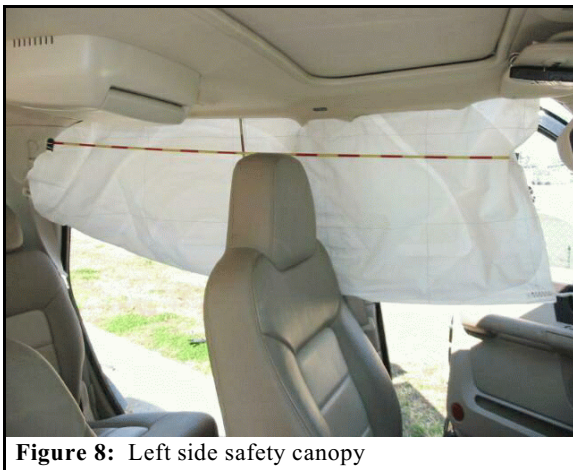
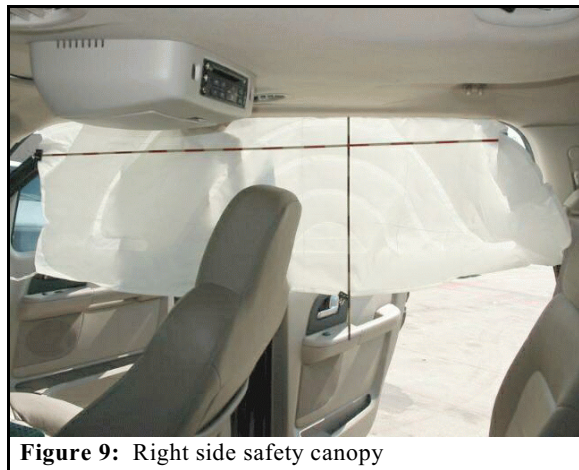
The two safety canopy air bags were installed in the left and right roof rails, extending from the top of the A-pillar to the top of the C-pillar (**Figures 8 and 9**). There was no cover flap as such. Rather, the expanding canopy bag causes the headliner to separate from the side panel and the canopy bag emerges through this opening. There was no evidence of damage to the headliner on either side. In addition to being attached along the length of the roof rail, each canopy had short

exterior fabric straps at the front and back lower corners of the canopy, tethered to the A- and C-pillars, respectively. The deployed canopy air bags were rectangular, measuring 136 centimeters [53.5 inches] horizontally and 46 centimeters [18.1 inches] vertically. There were no interior tether straps and no vent ports. Both air bags were manufactured with a series of interior baffles arranged in concentric half-circles. There was no evidence of occupant contact nor any damage to either of the safety canopies. The left A-pillar was displaced rearward by the impact with the other vehicle and this caused the roof to buckle above the driver's door. There is no evidence that the deformation of the left roof rail compromised the deployment of the left safety canopy.

The Ford safety canopy system is designed to deploy when the vehicle sustains a rollover or a side impact, neither of which happened in this crash. With the case vehicle's EDR not available, the circumstances that caused the safety canopy to deploy are not known.

The NASS case is coded to indicate that the safety canopy deployment was associated with the undercarriage impact (first harmful event). It is thought that the case vehicle's chassis may have been flexed or torqued as the vehicle bounced, one wheel at a time, over the near curb, into the median and then bounced down the far curb and back onto the road surface. This flexing stress to the chassis/frame may have caused the Restraints Control Module (RCM) to "wake up" and deploy the safety canopy system without any rollover or side impact.

Another scenario that may have caused the safety canopy to deploy is derived from the fact that, immediately following the case vehicle's impact with the other vehicle (event #3 in the NASS case), the case vehicle rotated approximately 90 degrees counterclockwise. This rapid spinning (i.e., counterclockwise rotation about the vertical axis) probably resulted in lateral loading of the tires on the right side and the case vehicle probably tipped to the right (i.e., brief clockwise rotation about the longitudinal axis) as it spun out and came to rest. This roll-type motion may have caused the RCM to "wake up" and anticipate a rollover, causing the safety canopy system to deploy.

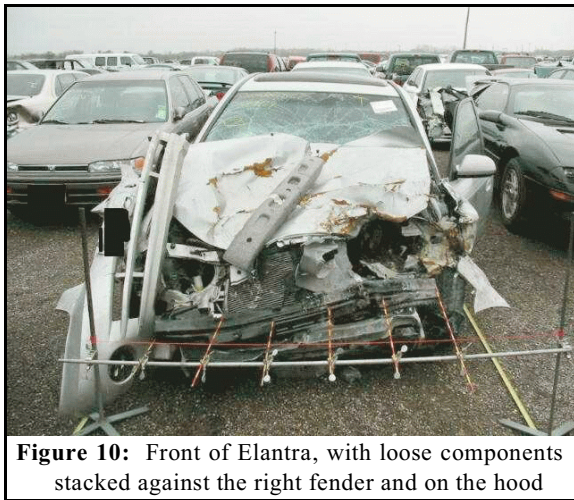
Figure 10: Front of Elantra, with loose components stacked against the right fender and on the hood

The Elantra sustained direct contact damage across the entire front, heavier on the left, and the NASS case is coded to indicate front underide (**Figures 10 and 11**). The grille and both turn signal/headlamp assemblies were shattered and broken away. The bumper cover and the energy absorbing foam bumper were torn off, with the steel bumper and radiator crushed rearward and with damage extending into the engine compartment. The hood was deformed and displaced rearward, such that it impacted and caused extensive fracture of the windshield. Maximum crush was measured as 39 centimeters [15.4 inches] at the front left bumper corner. The left fender was heavily deformed and crushed rearward. The wheelbase on the left side was shortened by 11 centimeters [4.3 inches], with the left front wheel displaced rearward against the left A-pillar and its rotation restricted. The right fender showed minor induced damage and the right front wheel moved forward, extending the wheelbase on the right by 2 centimeters [0.8 inches]. Other than the fractured windshield, there was no glazing damage. None of the tires were deflated.

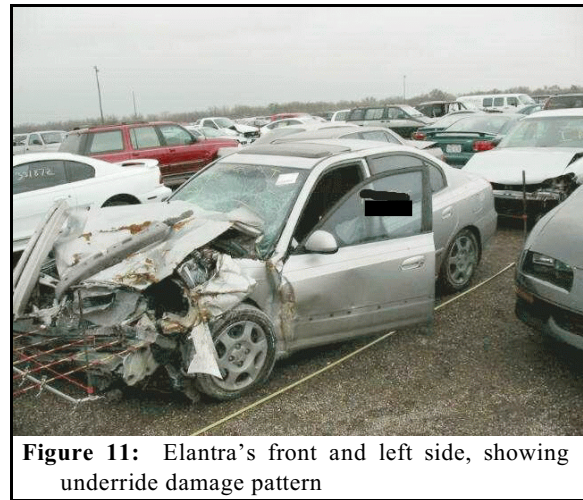
Figure 11: Elantra's front and left side, showing underide damage pattern
