SCI/NASS COMBINATION 208-COMPLIANT INVESTIGATION

CASE NUMBER - NASS-2004-49-132G

VEHICLE - 2004 LEXUS RX330

CRASH DATE - April 2004

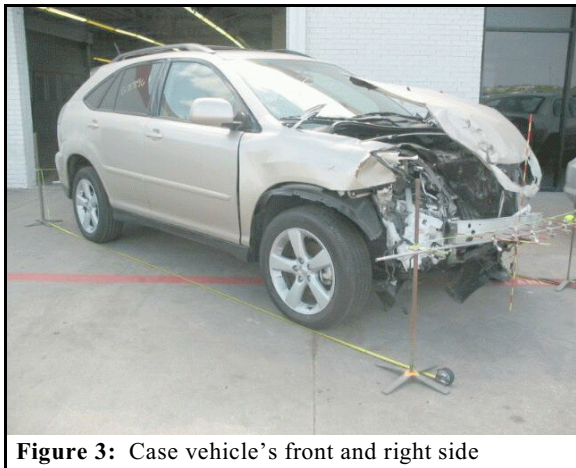
Figure 3: Case vehicle's front and right side

The case vehicle sustained direct contact across the entire front, with its front right corner area snagging against the other vehicle's left rear area such that there was substantial right-to-left lateral movement of the case vehicle's front end components. The front bumper cover was torn off and not available for inspection. The grille was shattered and broken away and the front of the engine hood was crushed rearward and distorted, with the hood's right hinge broken and the hood displaced upward and leftward. Both headlamp/turn signal assemblies were shattered and broken away and the leading edges of both fenders were crushed rearward. Maximum crush was recorded as 9 centimeters [2.4 inches] near the center of the front bumper. The case vehicle's front right corner area snagged against the other vehicle and all of the components in the case vehicle's front overhang were displaced to the left. The right fender was crushed inward from the snagging as well as

rearward from the initial engagement (**Figure 3**). The left fender sustained induced damage and was displaced outward well as being crushed rearward from the initial engagement (**Figure 4**). The wheelbase was lengthened 13 centimeters [5.1 inches] on the right and 6 centimeters [2.4 inches] on the left. None of the tires were deflated or restricted. There was a crack in the windshield on the right side and no other glazing damage. Inspection of the case vehicle's interior revealed that the left side of the instrument panel intruded slightly, measured as 3 centimeters [1.2 inches]. The steering wheel was not deformed. There were no other intrusions and there was no evidence of occupant contact on any of the interior components.

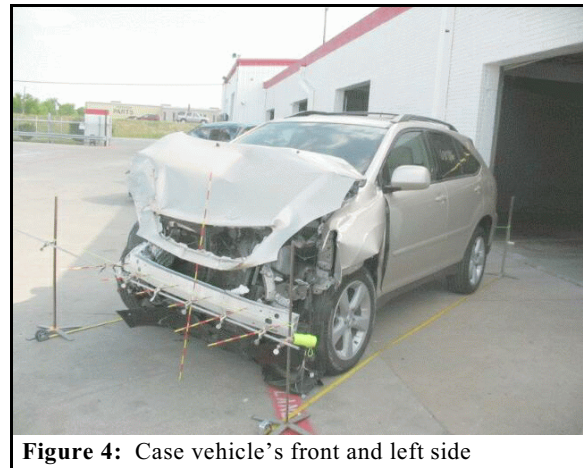
Figure 4: Case vehicle's front and left side

The CDC for the case vehicle's single impact was determined to be **02-FDEW-1 (50)**. The other vehicle was equipped with aftermarket running boards and much of the direct damage on the Toyota was to this add-on component, which renders this impact out of scope for the WinSMASH reconstruction program. (This is discussed further under **OTHER VEHICLE**, following the discussion of the case vehicle and its occupant.) The NASS investigator estimated that the single impact was of moderate severity (24-40 km.p.h. [15-25 m.p.h.]) for the case vehicle.

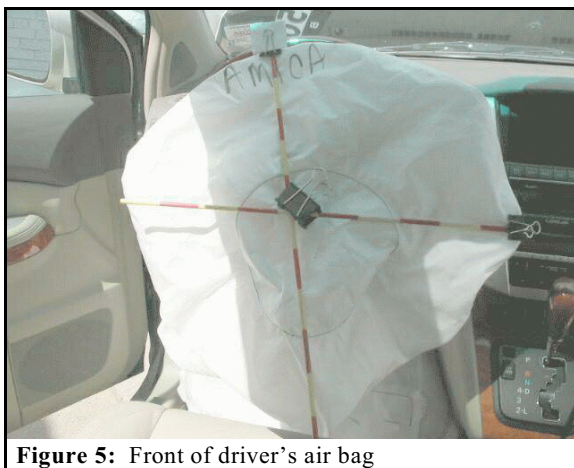
Figure 5: Front of driver's air bag

The driver's frontal air bag was located in the steering wheel hub. The module cover flaps were arranged in a "Y" configuration, aligned with the steering wheel spokes (see **Figure 7**). The flaps opened at the designated tear points and there was no evidence of damage to the cover flap or the adjacent structures. The driver's air bag was round with a diameter of 55 centimeters [21.7 inches] (**Figure 5**). There was no evidence of contact on the air bag fabric. The driver's air bag had two vent ports configured as slits on the back of the air bag at the 10:00 and 2:00 o'clock positions. Each slit was approximately 5 centimeters [2.0 inches] long (**Figure 6**).

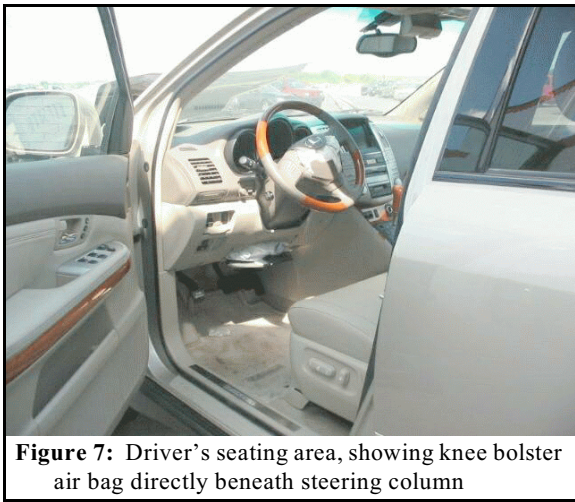
The driver's knee bolster air bag was mounted in the lower edge of the instrument panel, directly beneath the steering column (**Figure 7**). The module had two rectangular cover flaps, each measuring 25 centimeters [9.8 inches] horizontally. The forward flap measured 5 centimeters [2 inches] vertically and the rearward flap (i.e., closest to the driver) measured 4 centimeters [1.6 inches] vertically (**Figure 8**). The flaps opened at the tear points, with no evidence of damage to the flaps or the adjacent structures. The deployment caused the knee bolster panel to become slightly displaced on the right side of the steering column, near the center console (**Figure 9**). The deployed air bag was approximately rectangular, measuring 60 centimeters [23.6 inches] horizontally and 30 centimeters [11.8 inches] vertically (**Figure 10**). There was no evidence of damage or contact on the air bag fabric.

Figure 7: Driver's seating area, showing knee bolster air bag directly beneath steering column

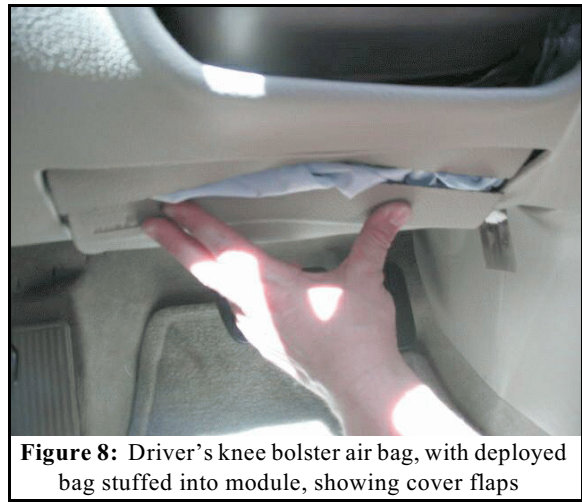
Figure 8: Driver's knee bolster air bag, with deployed bag stuffed into module, showing cover flaps

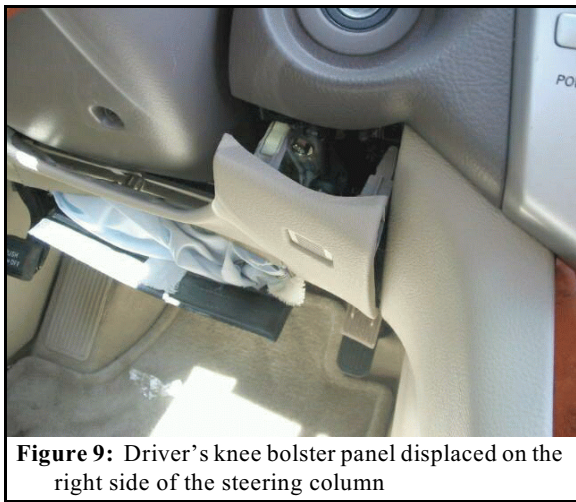
Figure 9: Driver's knee bolster panel displaced on the right side of the steering column

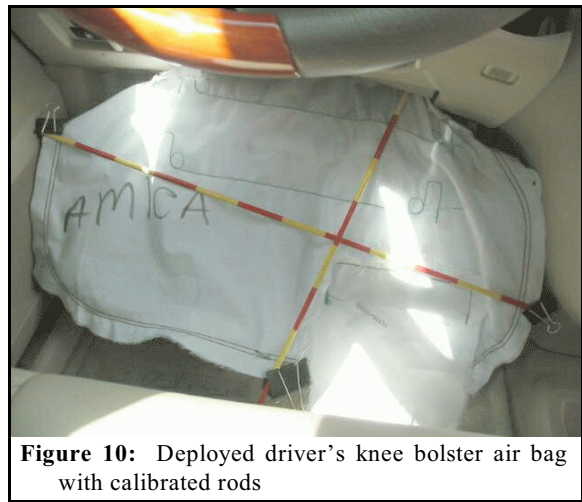
Figure 10: Deployed driver's knee bolster air bag with calibrated rods

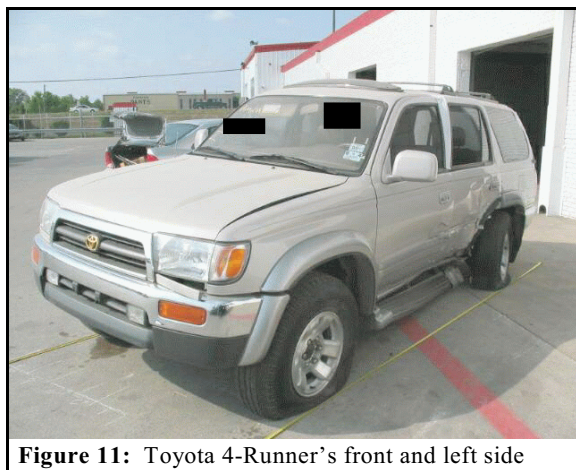
Figure 11: Toyota 4-Runner's front and left side

The 4-Runner sustained direct contact damage on its left side, from slightly forward of the B-pillar on the front door extending rearward to the left rear wheel well and wheel/tire assembly. The 4-Runner was fitted with after market running boards along the door sills and much of the visible damage consisted of crushing and bending of the left running board. There are no measurement protocols for such after market components and the NASS researcher did not attempt to obtain a crush profile. The left rear wheel was visibly displaced rearward with the leading edge bent outward and the left rear tire was deflated. The displacement/bending of the wheel and axle was the most severe damage on the 4-Runner. The 4-Runner's left rear wheel well and wheel/tire damage reflects the snagging of the case vehicle's front right corner structures.

The CDC for the 4-Runner was determined to be **11-LZEW-3 (320)**. This impact is out of scope for the WinSMASH reconstruction program because the damage included the after market running board and because the case vehicle's right front corner snagged against the 4-Runner's left rear wheel and wheel well area. The NASS investigator estimated that this was a crash of moderate severity (24-40 km.p.h. [15-25 m.p.h.]) for the 4-Runner.
