Certified Advanced 208-Compliant Vehicle Investigation / Vehicle to Object
Dynamic Science, Inc. / Case Number: 2004-78-124C
2004 Cadillac Escalade
Arizona
August, 2004

# Dynamic Science, Inc. Accident Investigation Case Number: 2004-78-124C

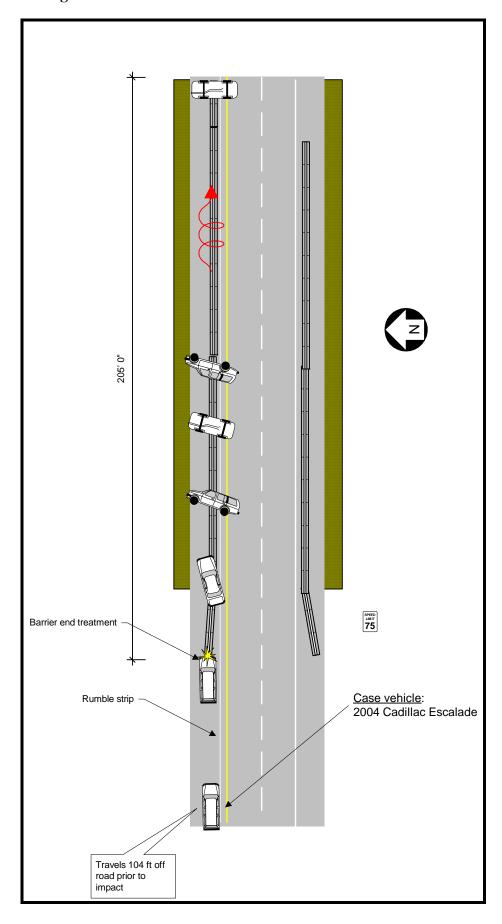
# Attachment 1. Scene Diagram

The Cadillac traveled for 32 m (104 ft) on the dirt median before striking the end treatment of the median guardrail with its front end (CDC=12FCEW2). At impact with the guardrail, the driver's air bag deployed. This was a second stage deployment. The EDR generated a deployment event. The Cadillac vaulted into the air and rolled on top of the guardrail for 62 m (205 ft). The investigator indicated that the vehicle had rolled 10 quarter turns, but this could not be verified. The Cadillac came to rest upside down straddling the guardrail and facing south

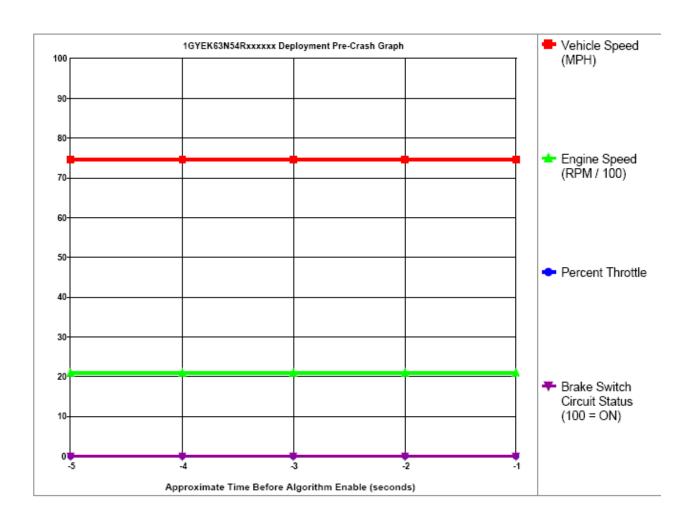
System Status At Deployment

- 5. Maximum SDM recorded velocity change was -15.57 km/h (-9.68 mph).
- 6. The time from algorithm enable (AE) to maximum recorded velocity change was 192.5 milliseconds

- 7. Driver first stage time algorithm enabled to deployment command criteria met was 5 milliseconds.
- 8. Driver's second stage time algorithm enable to deployment command criteria met was 7.5 milliseconds.

OFF
BUCKLED
177
180
-9.68
192.5
5
7.5
Suppressed
Suppressed
N/A
1
Yes
No
No

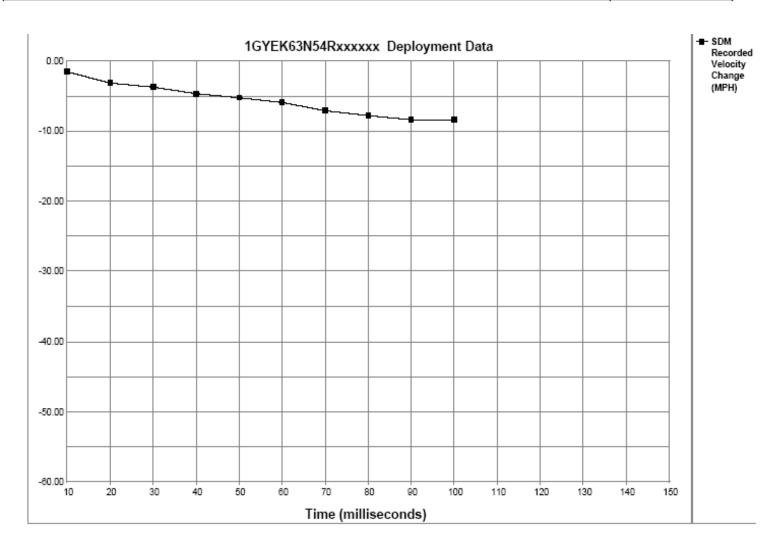
System Status At Non-Deployment

SIR Warning Lamp Status	OFF
Driver's Belt Switch Circuit Status	BUCKLED
Ignition Cycles At Non-Deployment	177
Ignition Cycles At Investigation	180
Maximum SDM Recorded Velocity Change (MPH)	-7.29
Algorithm Enable to Maximum SDM Recorded Velocity Change (msec)	162.5
Event Recording Complete	Yes
Multiple Events Associated With This Record	Yes
One Or More Associated Events Not Recorded	Yes
