Certified Advanced 208 Compliant Investigation / Vehicle to Vehicle
Dynamic Science, Inc. / Case Number: 2004-82-082B
2004 Acura MDX
Washington
July, 2004

1. Report No. 2004-82-082B	2. Government Accession No.		3. Recipient Catalog No.	
4. Title and Subtitle Remote Certified Advanced 208 Compliant Investigation			5. Report Date March 20, 2005

This remote investigation focused on the performance of the Certified Advanced 208-Compliant (CAC) supplemental restraint system in a 2004 Acura MDX. The multi-stage air bags were certified by the manufacturer to meet the advanced air bag requirement of Federal Motor Vehicle Safety Standard (FMVSS) No. 208. The vehicle was being driven by a 49-year-old female. The front right seat was occupied by a 49-year-old female. The Acura MDX was struck in the right side by a 1990 Honda Civic as the Acura was making a left turn. The driver of the Acura sustained a minor abrasion; the front right occupant sustained a sore right arm and leg.

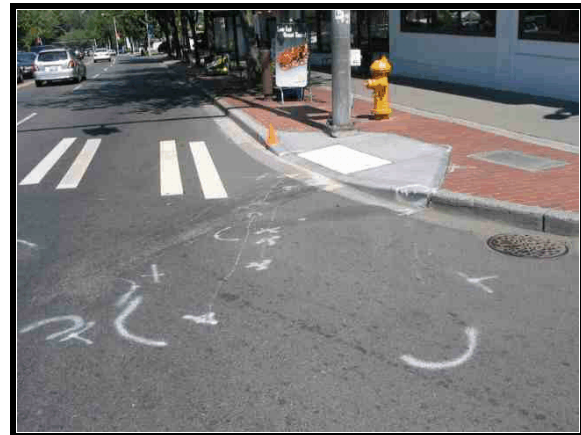
Figure 2. Acura MDX impact to the curb

The initial impact caused the Acura to rotate clockwise and it struck the northeast curb with the left rear wheel (09LBWN2). It appears likely that the left curtain and the seat back mounted front left side air bag both deployed at this time.

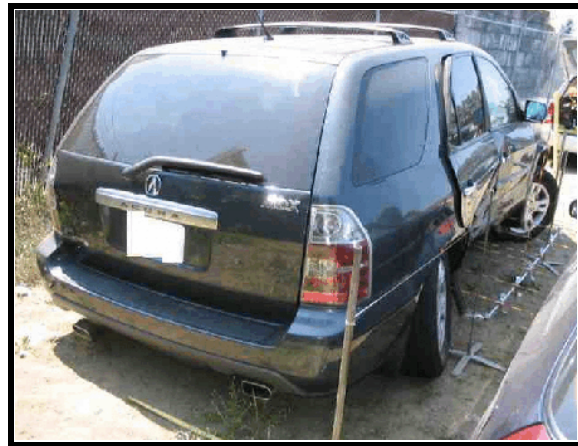
Figure 3. Rear right, Acura MDX

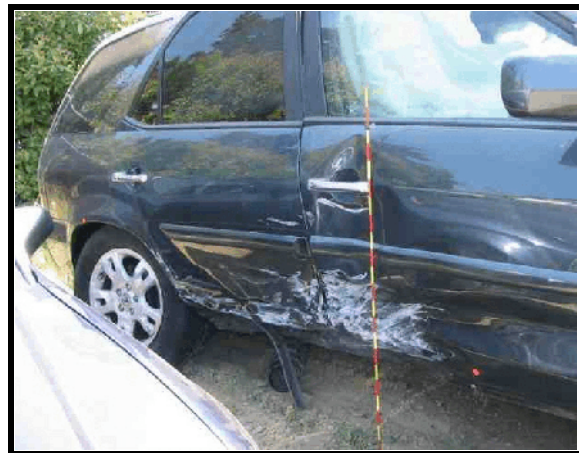
The front of the Honda Civic (12FDEW2) struck the right side of the Acura MDX (02RZEW2). There was 225.0 cm (88.6 in) of direct contact that began 97.0 cm (38.2 in) aft of the front axle and extended rearward. The maximum crush was located 16.0 cm (6.3 in) forward of C3 and measured 20.0 cm (7.9 in). The total velocity change as calculated by the damage only algorithm of the WinSmash collision model was 17.0 km/h (10.6 mph). The longitudinal and lateral velocity changes were -11.0 km/h (-6.8 mph) and -13.0 km/h (-8.1 mph), respectively. The right curtain and the seat back mounted front right side air bag both deployed at this time.

Figure 4. Right side, Acura MDX

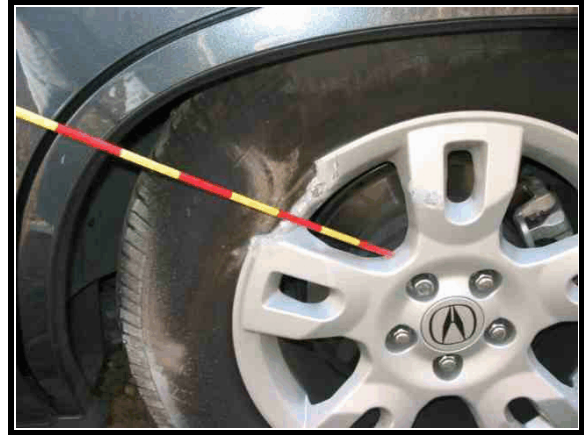
Figure 5. Curb impact to Acura MDX

Damage Description:	There was moderate crush damage to the right sill from the initial vehicle to vehicle impact. There right rear tire was restricted. There was minor damage to the left rear tire/rim from the impact with the curb. The vehicle was towed due to axle damage.	
CDC:	Impact 1: 02RZEW2 Impact 2: 09LBWN2	
Delta V (Impact 1):	Total	17.0 km/h (10.6 mph)
	Longitudinal	-11.0 km/h (6.8 mph)
	Lateral	-13.0 km/h (8.1 mph)
	Energy	31,151 joules (22,975 ft-lbs)

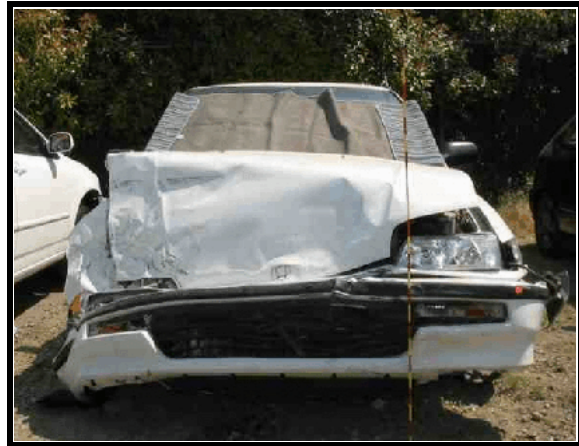
Figure 6. Front, 1990 Honda Civic

Description:	1990 Honda Civic four-door sedan	
VIN:	1HGED3559LAxxxxxx	
Odometer:	241,400 km (149,999 miles)	
Engine:	4 cylinder, 1.5 L	
Reported Defects:	None	
Cargo:	None, per vehicle inspection	
Damage Description:	Moderate front end damage. The front right tire was restricted. The vehicle was towed from the scene due to damage.	
CDC:	12FDEW2	
Delta V:	Total	32.0 km/h (19.9 mph)
	Longitudinal	-32.0 km/h (19.9 mph)
	Lateral	6.0 km/h (3.7 mph)
	Energy	55,400 joules (40,860 ft-lbs)

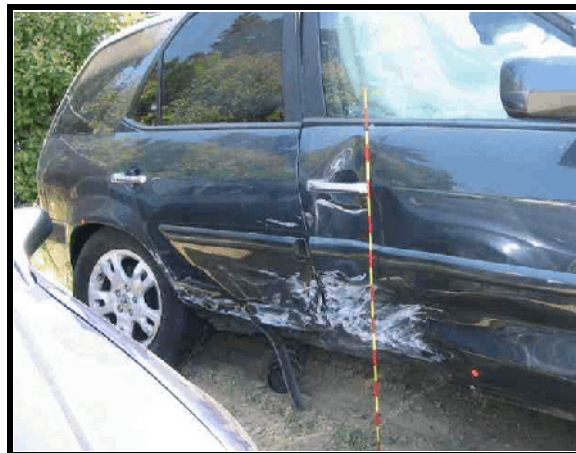
There was 225.0 cm (88.6 in) of direct contact that began 97.0 cm (38.2 in) aft of the front axle and extended rearward. A crush profile was taken along the sill and measured: C1=9.0 cm (3.5 in), C2=17.0 cm (6.7 in), C3=18.0 cm (7.1 in), C4=14.0 cm (5.5 in), C5=10.0 cm (3.9 in), C6=8.0 cm (3.1 in). The maximum crush was located 16.0 cm (6.3 in) forward of C3 and measured 20.0 cm (7.9 in).

Figure 7. Right side, Acura MDX

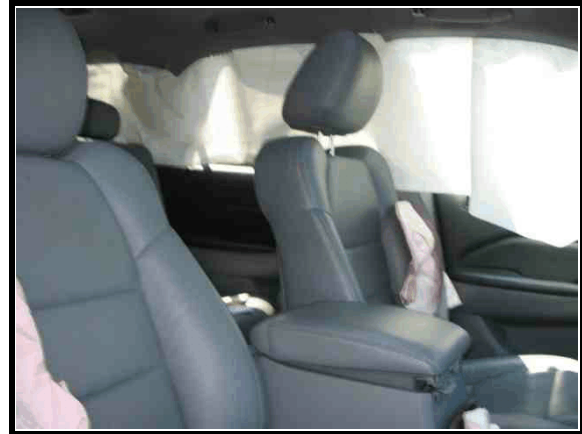
Figure 8. Left side air curtain

The side air curtains were mounted in the roof rail. The curtain is roughly rectangular in shape and covered all three rows of seats (running from A pillar to the D pillar). It is approximately 42.0 cm (16.5 in) high and 245.0 cm (96.5 in) long. There were no indications of any contact or damage to either side air curtain.

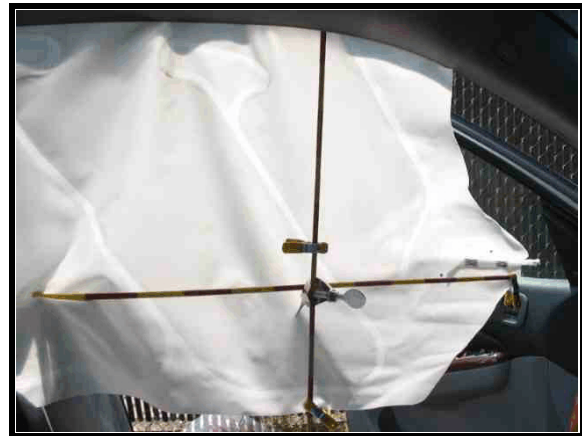
Figure 9. Left side air curtain, driver's position

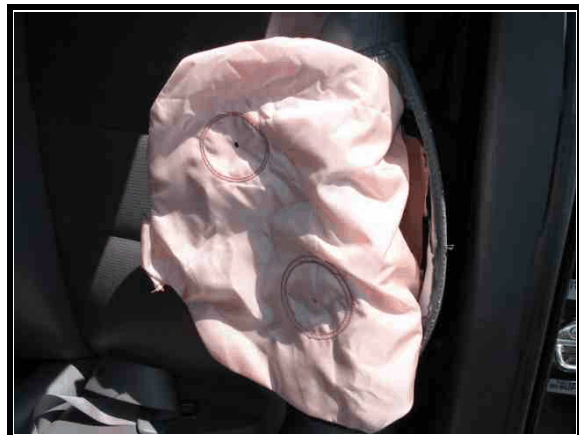
Figure 10. Driver's seat back mounted side air bag

The side air bags were mounted in the left and right respective seat backs. The seat back mounted air bags are essentially six-sided polygons that deploy forward from the seat back. There are two circular tethers at the 10 and 4 o'clock positions. There are also two vent ports found at the base of the air bag. There were no indications of any contact or damage to either side air bag.

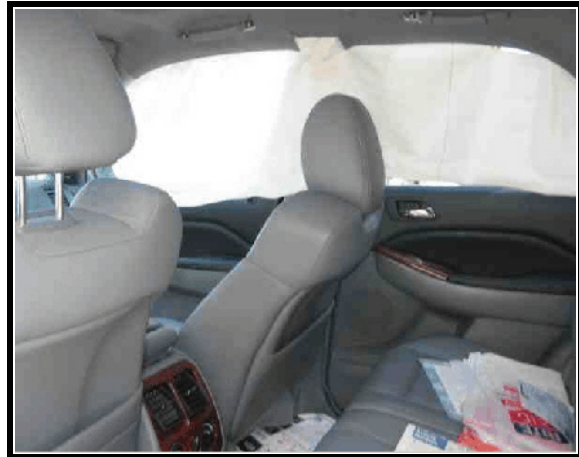
Figure 11. Right side air curtain

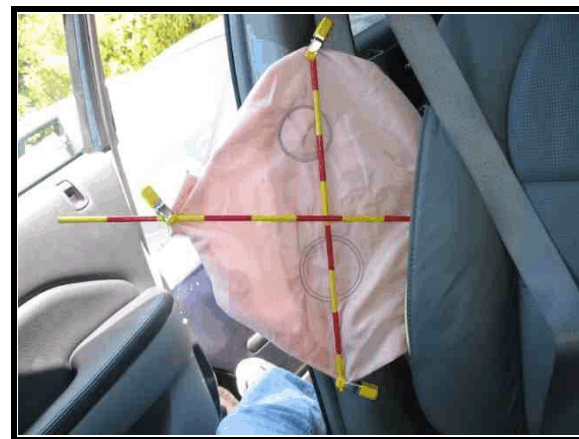
Figure 12. Front right seat back mounted side air bag

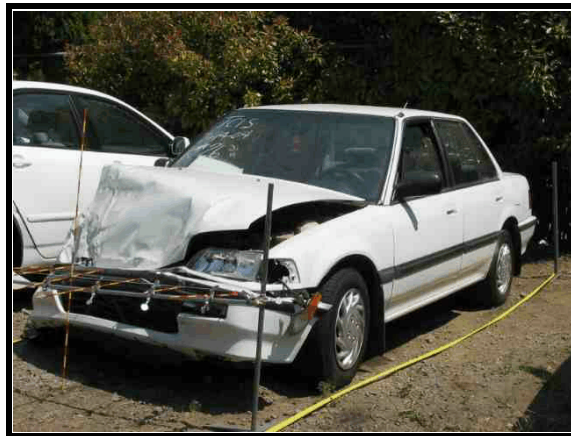
Figure 13. Front left, Honda Civic
