**ON-SITE CERTIFIED ADVANCED 208-COMPLIANT VEHICLE CRASH
INVESTIGATION
CALSPAN CASE NO: CA04-001**

VEHICLE: 2003 CHEVROLET C1500 SILVERADO PICK-UP TRUCK

**LOCATION: MARYLAND
CRASH DATE: DECEMBER, 2003**

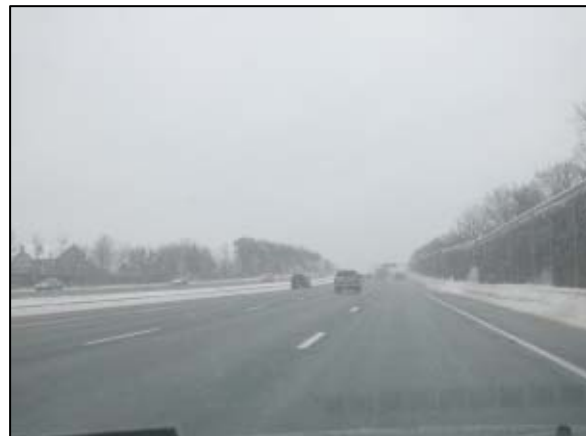
This two-vehicle crash occurred during the night time hours in December, 2003. At the time of the crash, it was dark without artificial lighting and there were no adverse weather conditions. The road surface was dry. The crash occurred on the southbound lanes of a four-lane limited access interstate highway. At the crash site, the southbound roadway was configured with four lanes. The police report indicated the crash occurred during a lane change from the outboard lane to the right center lane by the Chevrolet. The speed limit in the area of the crash was 89 km/h (55 mph). **Figure 2** is a southbound view of the roadway.

Figure 2: Southbound view at the crash site.

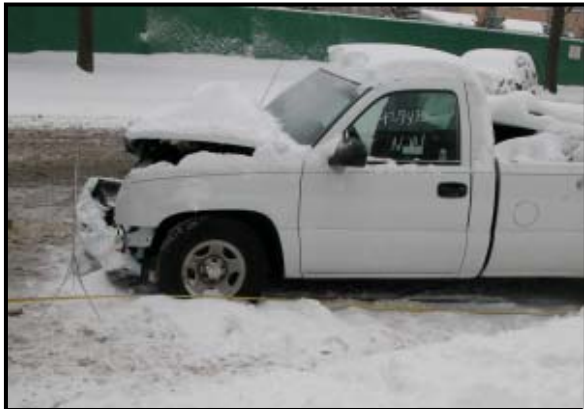
Figures 3 through 5 are the left lateral, right lateral and frontal views of the Chevrolet. The direct damage measured 140 cm (55.1 in). This direct damage extended from the left bumper corner to the right bumper corner. The damage pattern was indicative of an under-ride impact into the back plane of the semi-trailer with the maximum deformation occurring at the elevation of the upper radiator support. The damaged components included the front bumper, center grille, headlamp assemblies, hood and right front fender. The front bumper was deflected downward with the maximum deformation located at its left corner. The left end of the bumper deflected

inboard and rearward puncturing the left front tire. The residual crush measured along the front bumper was as follows: C1 = 13 cm (5.1 in), C2 = 1 cm (0.4 in), C3 = 0, C4 = 0, C5 = 0, C6 = 0.

The residual above-bumper crush from contact with the back plane of the trailer began at an elevation 51 cm (20 in) above the ground and extended vertically to 109 cm (43 in) above the ground reference. The maximum crush at this location measured 26 cm (10.2 in). The residual profile along the upper radiator support was as follows: C1 = 0, C2 = 5 cm (2.0 in), C3 = 12 cm (4.7 in), C4 = 14 cm (5.5 in), C5 = 26 cm (10.2 in), C6 = 24 cm (9.4 in). The hood buckled and folded in a V-shape pattern. The longitudinal contact length to the surface of the deformed hood measured 28 cm (11.0 in) at its right aspect. The length of the deformed right fender measured 79 cm (31 in). For reference, the length of the un-deformed left fender measured 119 cm (47 in). The right wheelbase was reduced 10 cm (4.0 in) and the right front tire was debanded. The left wheelbase measurement was unchanged. The principle direction of the impact force was in the 11 o'clock sector (an estimated 340 degrees). There was no evidence of cab-to-bed contact. The windshield was not damaged and there was no damage to the side glazings. The left door remained closed during the impact and was operational post-crash. The right door was removed post-crash and was located in the pick-up bed; it was not damaged.

Figure 3: Left lateral view of the Chevrolet.

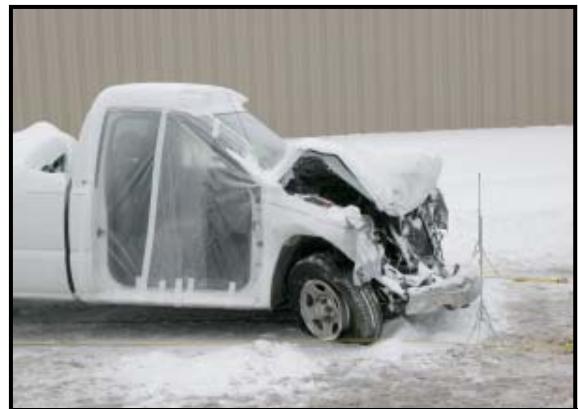
Figure 4: Right lateral view.

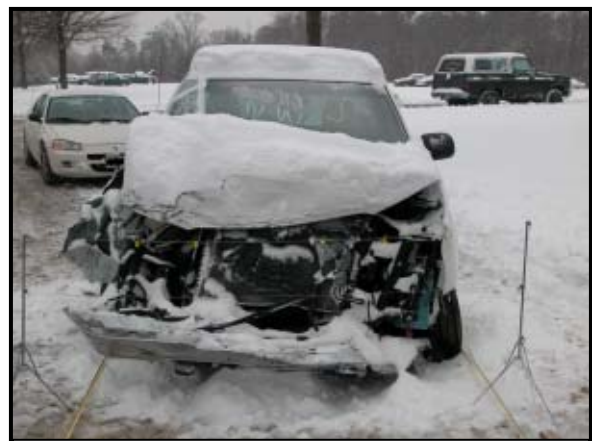
The Collision Deformation Classification was 11-FDEW-1. The Barrier Algorithm of the WINSMASH model was used to assess the crash severity (delta V) based on an average of the above referenced profiles. The crush profile used in that analysis was: C1 = 13 cm (5.1 in), C2 = 1 cm (0.4 in), C3 = 0, C4 = 7 cm (2.8 in), C5 = 13 cm (5.1 in), C6 = 12 cm (4.7 in). The calculated BES for the Chevrolet was 14 km/h (8.9 mph). The computed BES was in general agreement with the delta V recorded by the Event Data Recorder. The maximum recorded delta V was -

Figure 5: Front view.

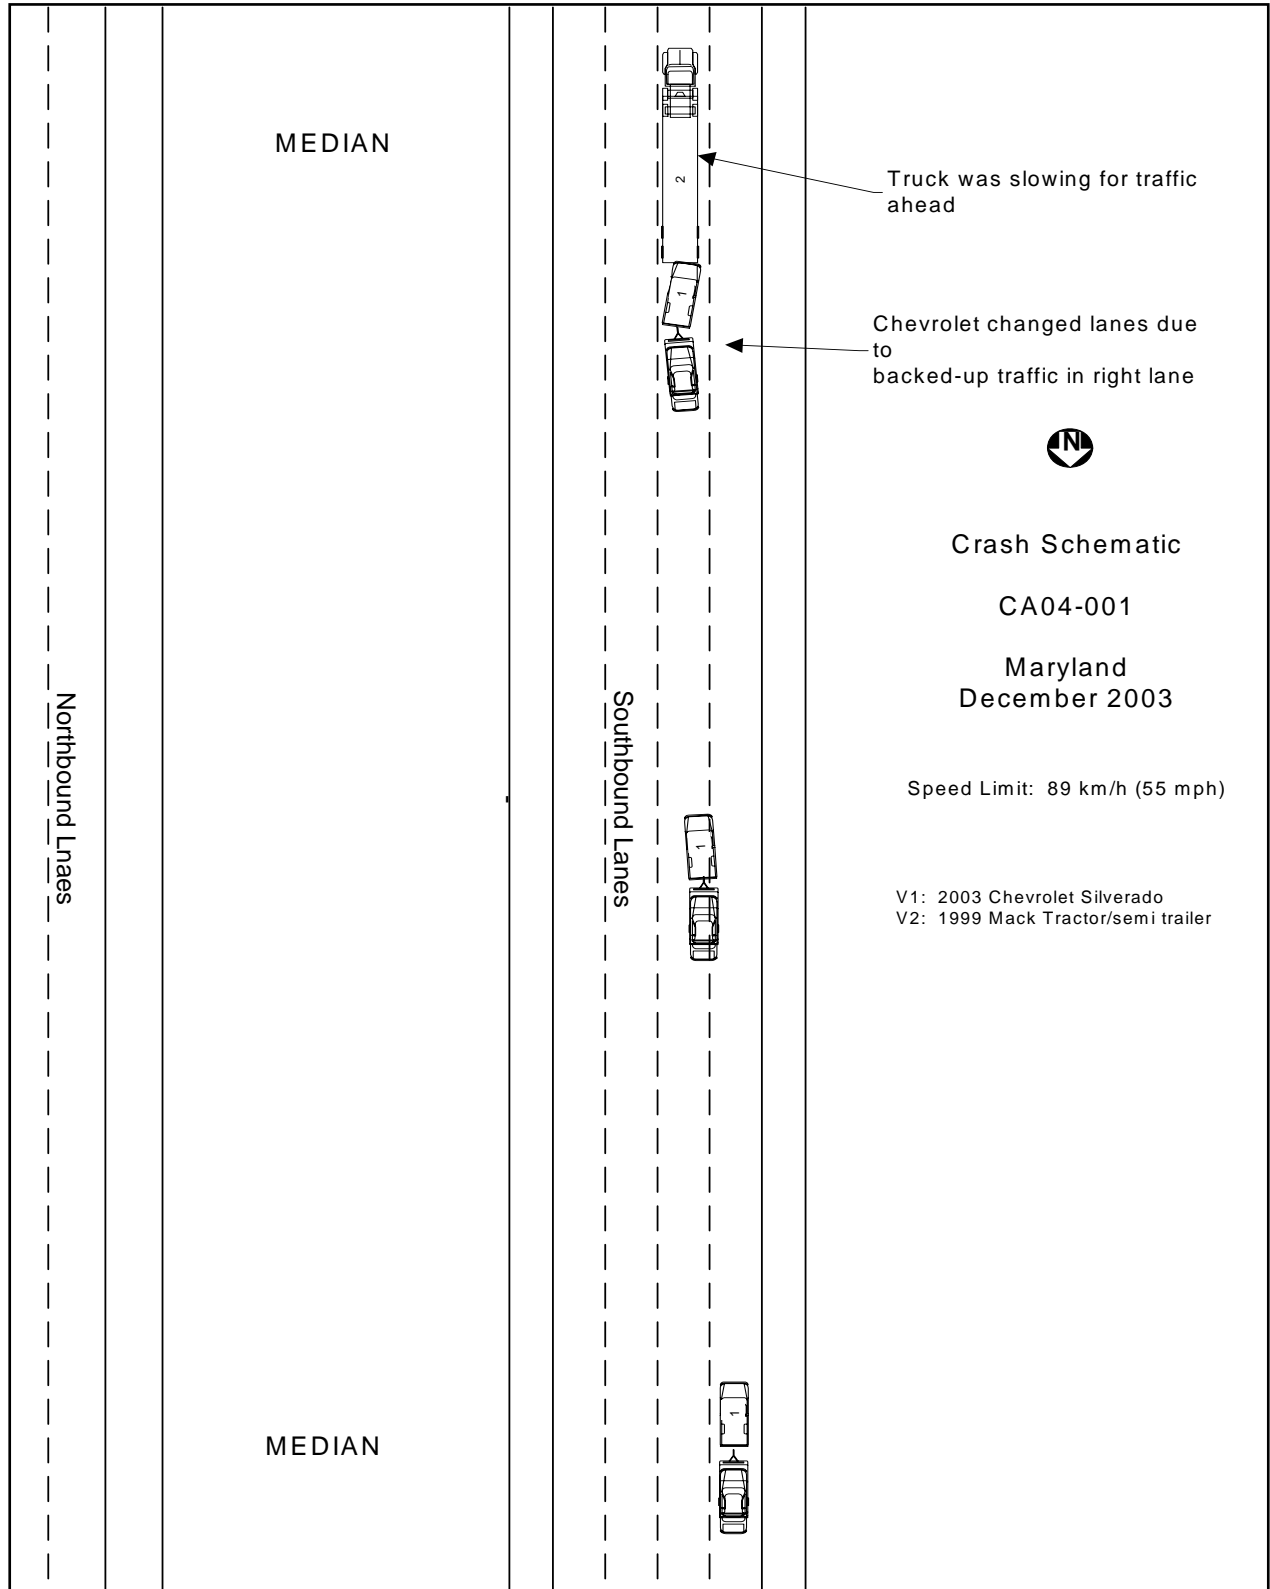
Figure 7: Crash Schematic.

The front plane of the Chevrolet impacted the back plane of the semi-trailer in a front-to-rear configuration. The nature of the damage suggested the Chevrolet was rotated slightly clockwise at impact. This orientation may have resulted from a loss of control of the towed vehicle. The Chevrolet underrode the back of the trailer due to the mismatch of the profiles of the respective vehicle. As a result of the under-ride, the primary damage sustained by the Chevrolet was above the elevation of the front bumper. The force of the impact was not sufficient to warrant the deployment of the Chevrolet's advanced frontal air bags. The WINSMASH program's barrier equivalent algorithm was used to calculate a Barrier Equivalent Speed (BES) for the Chevrolet. The calculated BES for the Chevrolet was 14 km/h (8.9 mph). The maximum longitudinal delta V recorded by the Chevrolet's EDR was 13 km/h (8.01 mph). **Figure 7**, at the end of this narrative report, is a schematic of the crash.

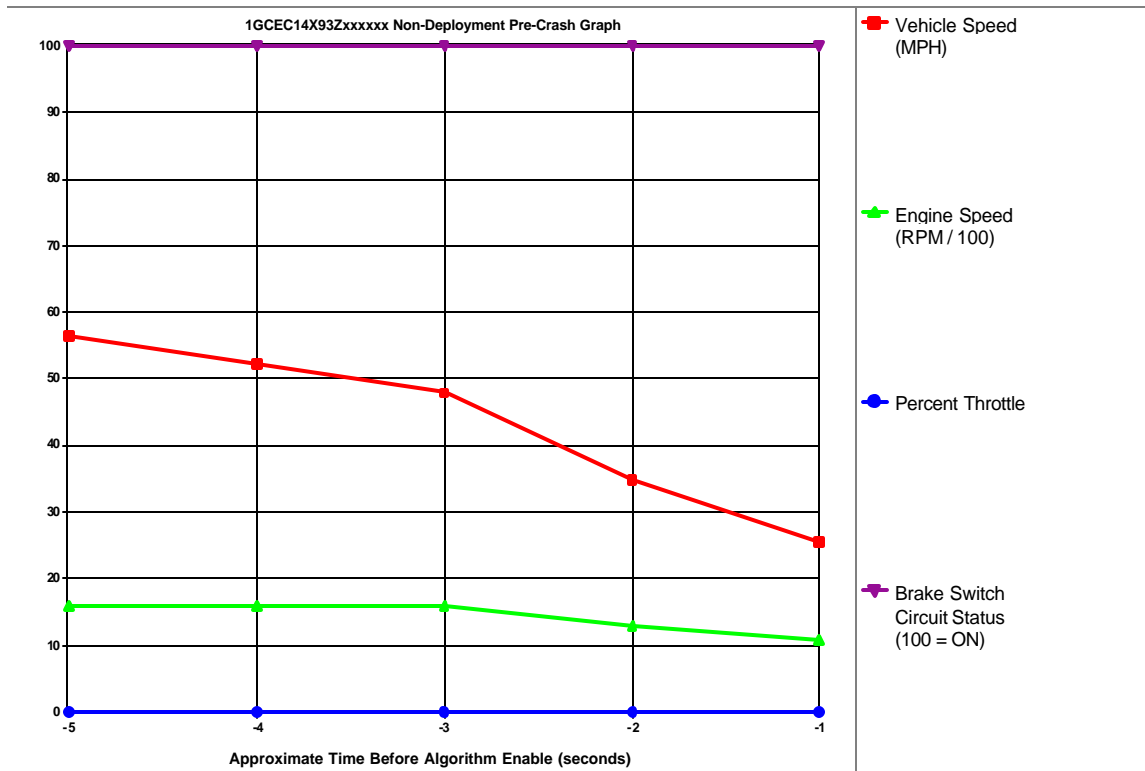
Seconds Before AE	Vehicle Speed (MPH)	Engine Speed (RPM)	Percent Throttle	Brake Switch Circuit Status
-5	57	1600	0	ON
-4	52	1600	0	ON
-3	48	1600	0	ON
-2	35	1344	0	ON
-1	25	1088	0	ON

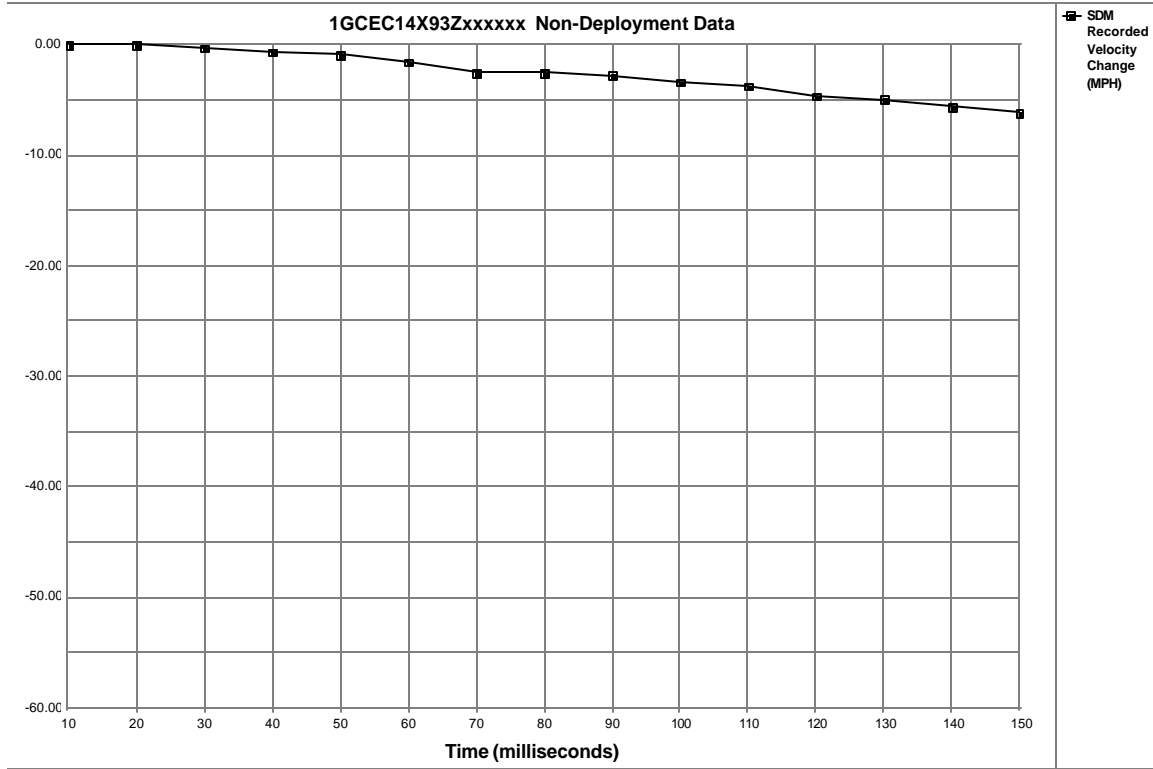
Time (milliseconds)	10	20	30	40	50	60	70	80	90	100	110	120	130	140	150
Recorded Velocity Change (MPH)	0.00	0.00	-0.31	-0.62	-0.93	-1.55	-2.48	-2.48	-2.79	-3.41	-3.72	-4.65	-4.96	-5.58	-6.20
