Child Safety Seat / Single Vehicle Rollover
Dynamic Science, Inc. / Case Number: DS04002
1991 Mercury Topaz
Arizona
January, 2004

1. Report No. DS04002	2. Government Accession No.		3. Recipient Catalog No.	
4. Title and Subtitle Child Safety Seat Investigation		5. Report Date August 18, 2004

Dynamic Science, Inc.
Crash Investigation
Case Number: DS04002

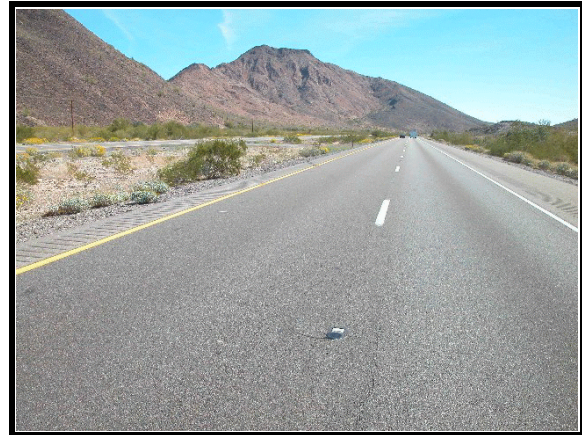
Figure 1. Approach to left hand road departure

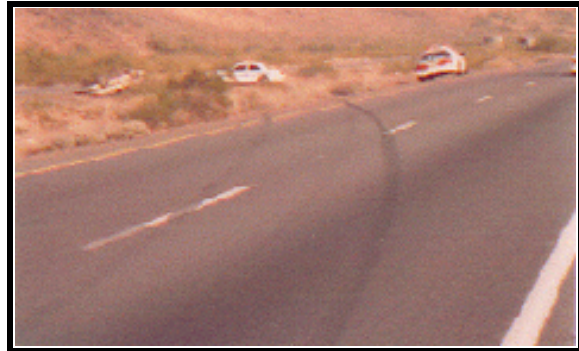
Figure 2. Vehicle in counterclockwise yaw traveling east toward road departure (police photo)

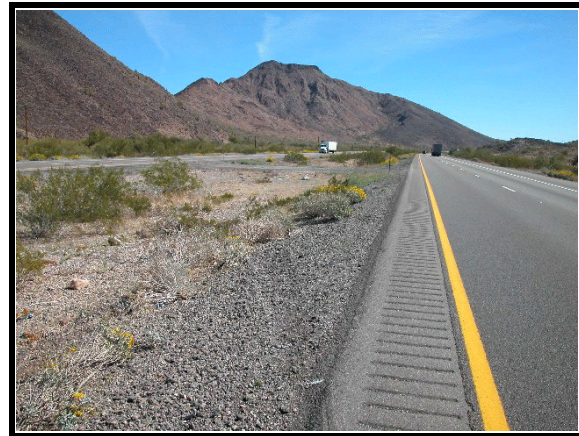
Figure 3. Area of road departure

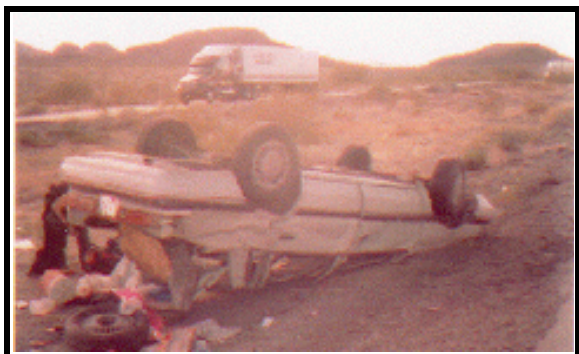
Figure 4. Final rest, facing west (police photo)

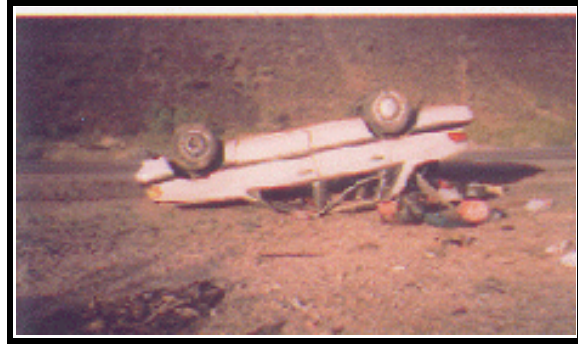
Figure 5. Final rest, looking north (police photo)

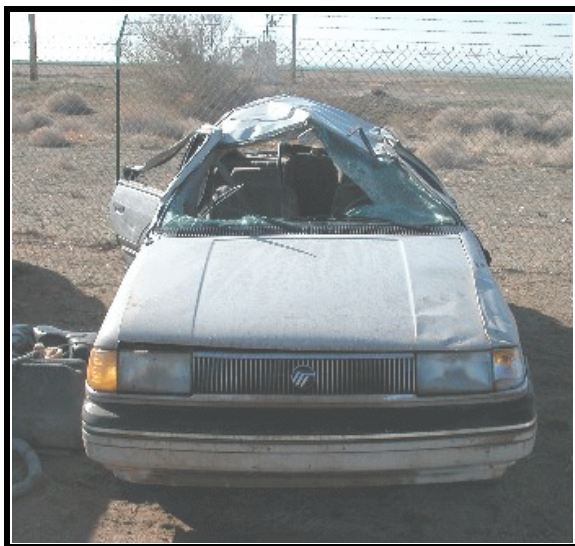
Damage Description: The driver, rear left, and front right doors were jammed shut. The glazing at all locations was either disintegrated or holed. There was intrusion to the left roof, left roof rails, and A/B/C pillars. The front right tire was flattened during the rollover.

Pillar	Left	Right
A	13.0 cm (5.1 in)	7.1 cm (2.8 in)
B	10.0 cm (3.9 in)	0 cm (0 in)
C	6.0 cm (2.4 in)	2.0 cm (0.8 in)

Figure 6. Case vehicle, front

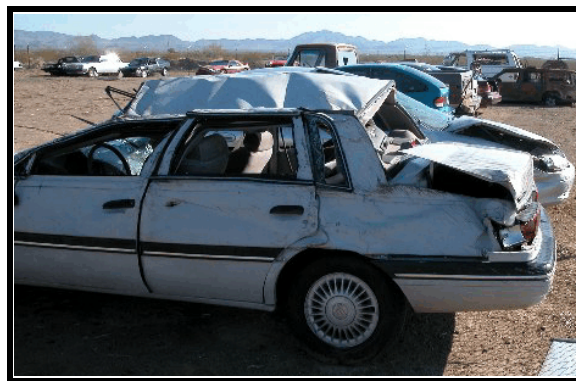
Figure 7. Case vehicle, left side

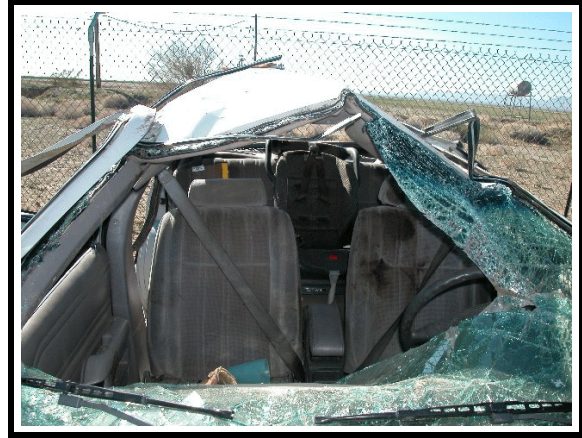
Interior damage to the Mercury Topaz was major and attributed to occupant contacts and passenger compartment intrusion. The windshield was fractured and holed from the rollover. All the right side windows were disintegrated from impact forces. All the side glass was disintegrated, as was the backlight. There was roof intrusion, as well as intrusion at each of the pillar positions. The most substantial intrusion was through the roof and extended longitudinally over the left front and left rear seating positions. The left front, left rear, and right front doors were jammed shut. There was pooled vehicle fluids and several blood patterns on the interior roof above the front two seat positions. There was dirt, stains, and roadside debris over the entire interior roof.

Figure 8. Overview of vehicle interior (front)

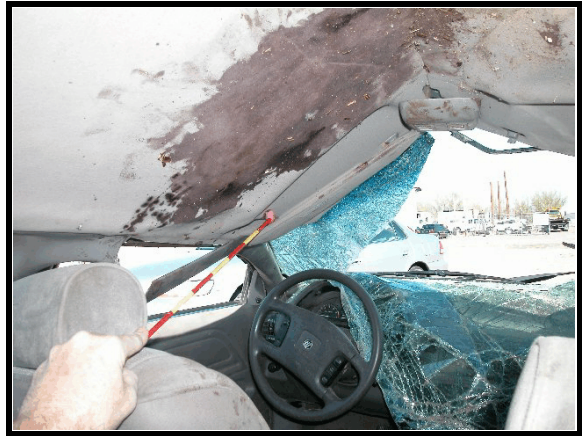
Figure 9. Spills and blood stains (darker patches are vehicle fluids)

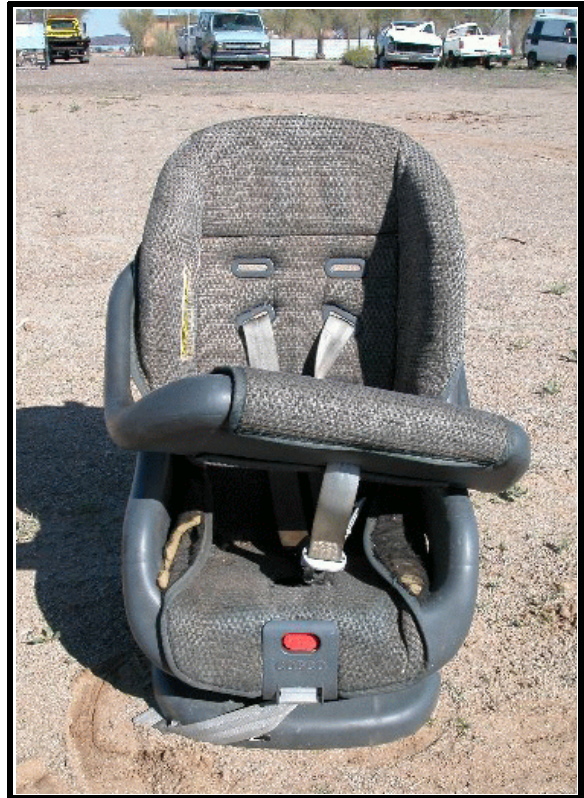
The rear middle seat of the 1991 Mercury Topaz was occupied by a 3-year-old male in a Cosco Regal Ride convertible child safety seat (model number 4359-4123, manufacture date unknown) with an overhead shield. The manufacturer recommends this seat be used in the forward facing mode for children weighing between 10-18 kg (22-40 lbs). It is not known if the child in this crash met these guidelines. According to the National Center for Health Statistics², the weight of a 3-year-old male in the 50th percentile would be 14 kg (31 lbs). The seat was being used in the forward facing mode and was anchored to the fabric covered bench seat using the available vehicle lap belt. The lap belt was equipped with a locking latch plate. The vehicle seat back angle was 69.4 degrees; the seat bottom angle was 4.4 degrees. The child seat was not tightly anchored to the vehicle seat. The child seat could be moved forward a minimum of 7.1 cm (2.8 in) at the top and 10.0 cm (3.9 in) at the bottom. The child was secured to the child seat using the available tray shield harness system. The harness was threaded through the middle of the three harness height adjustment slots. A harness clip was available but it is not known if it was used properly. The seat was configured with a recessed buckle. The left arm of the shield was broken away from the seat back during the crash.

Figure 10. Cosco Regal Ride convertible child seat

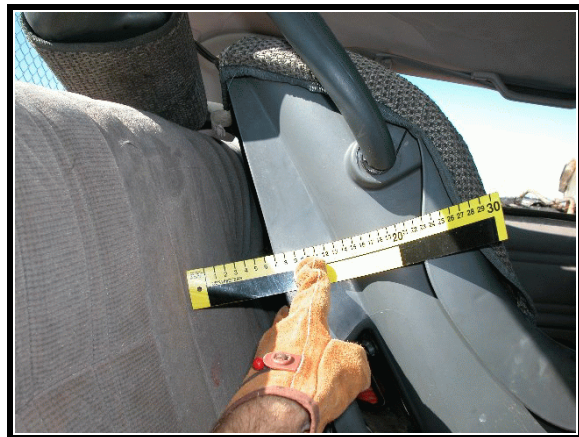
Figure 11. Available child seat movement (top)

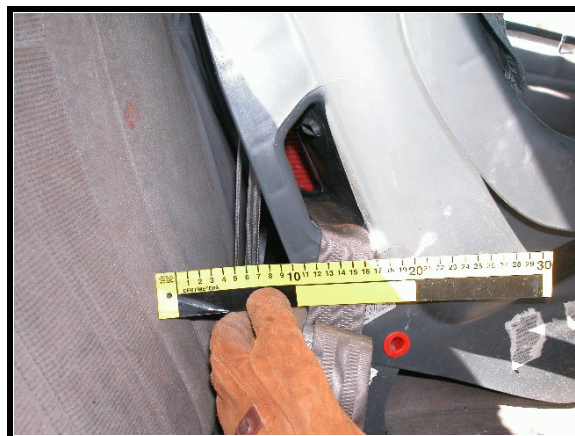
Figure 12. Available child seat movement (bottom)

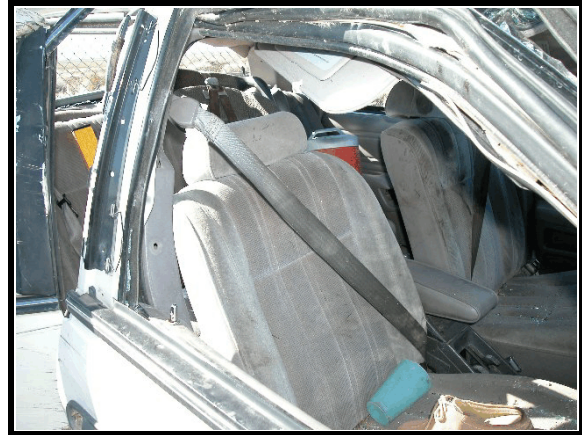
Figure 13. Overview of front seating positions

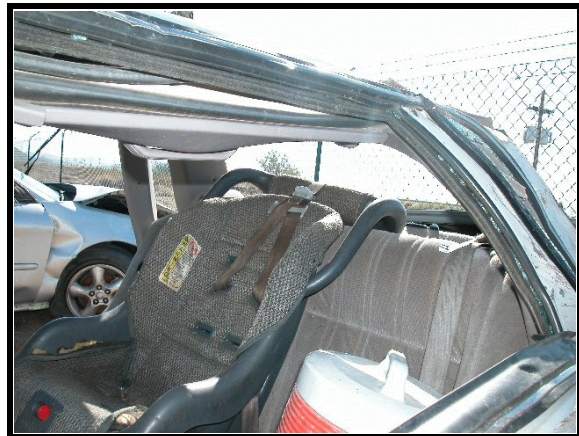
Figure 14. Cosco child seat in place in vehicle

The 3-year-old rear middle occupant was seated in a Cosco Regal Ride convertible child safety seat with an overhead shield. The seat was being used in the forward facing mode and was anchored to the fabric covered bench seat using the available vehicle lap belt. The lap belt was equipped with a locking latch plate. The vehicle seat back angle was 69.4 degrees; the seat bottom angle was 4.4 degrees. Upon inspection, the child seat was not tightly anchored to the vehicle seat. The child seat could be moved forward a minimum of 7.0 cm (2.8 in) at the top and 10.0 cm (3.9 in) at the bottom. The child was secured to the child seat using the available tray shield. The harness was threaded through the middle of the three harness height adjustment slots. A harness clip was available but it is not known if it was used properly. The shield was down and locked. As the vehicle rolled, the child remained in the child seat and the seat remained attached to the vehicle—though likely loose. The child rode down the rollover and there were no reported injuries. The left arm of the shield was broken away from the seat back during the crash. This may have been caused by the left rear occupant.

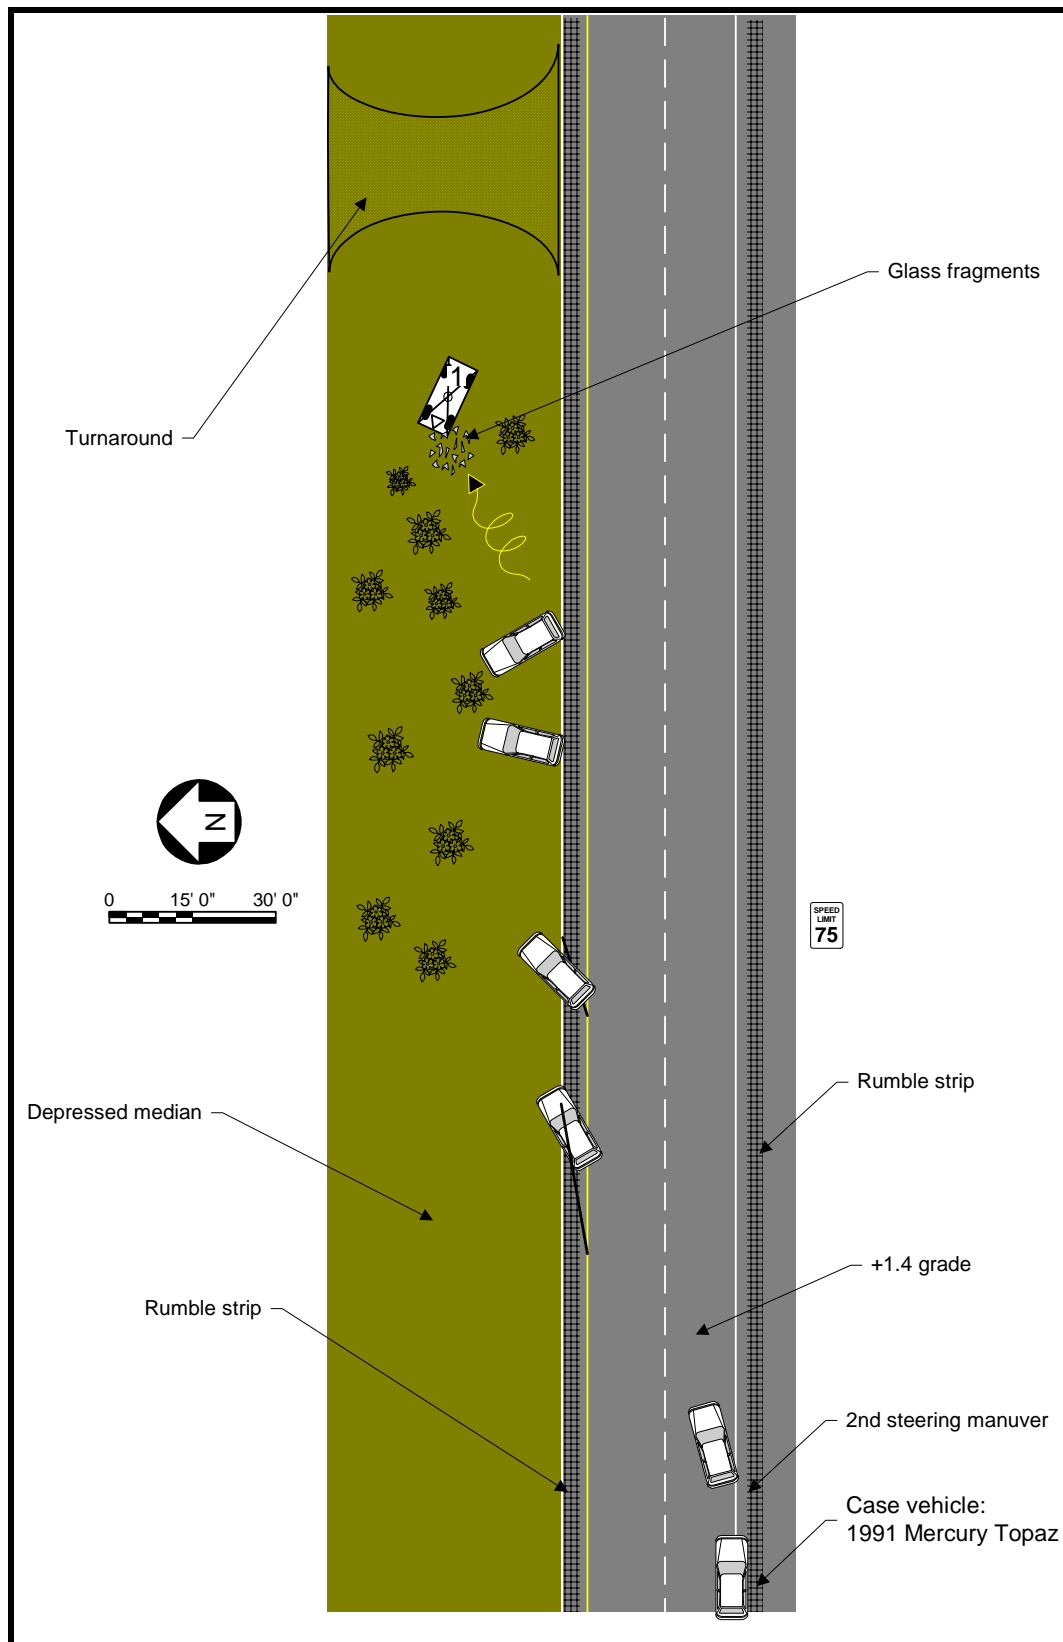
Attachment 1. Scene Diagram

The case vehicle was traveling eastbound in the far left lane. The rear right occupant gave directions to the driver of the vehicle. The driver appears not to have understood the directions and looked back to the rear right occupant. The case vehicle then veered to the left with the left side tires going off the roadway on the north edge. The driver likely steered to the right and the vehicle re-entered the roadway and crossed into the far right eastbound lane. The driver likely steered to the left losing control of the vehicle. The vehicle went into a counterclockwise skid and crossed the far left eastbound lane. The vehicle then went off the north roadway edge and entered the depressed dirt median and rolled over at least six quarter turns (00TDDO3). The vehicle came to final rest on its top facing west in the depressed dirt median.
