**CALSPAN REMOTE SIDE IMPACT INFLATABLE OCCUPANT PROTECTION  
SYSTEM CRASH INVESTIGATION**

**CASE NO: CA04-004**

**VEHICLE: 2000 MAZDA MPV**

**CRASH DATE: OCTOBER 2003**

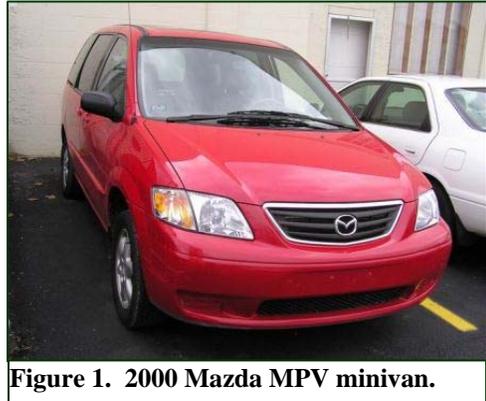
**Figure 1. 2000 Mazda MPV minivan.**

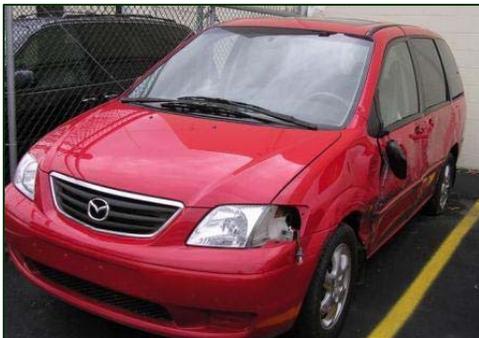
The exterior of the Mazda MPV sustained moderate severity sideswipe damage that was distributed along the full length of the vehicle (**Figure 2**). The damage began on the side surface of the front bumper fascia and continued rearward, involving the left front wheel, front fender, left front door, left outside rear view mirror, the left sliding door, left quarter panel, the left rear alloy wheel and tire, and the side surface of the rear bumper fascia (**Figure 3**). The direct contact damage involved black rubber transfers, abrasions, dents, and a cut of the left rear tire sidewall. The damage extended vertically from the above the sill level to the beltline. Maximum crush was 3-5 cm (1-2”) located at various points along the side surface. The Collision Deformation Classification (CDC) was 12-LDAS-2. The side view mirror of the Ford Ranger contacted the upper left A-pillar of the Mazda. The sideswipe impact snagged the leading edges of the left side doors, the dog-leg of the lower C-pillar, and the left rear alloy wheel.

**Figure 2. Left sideswipe damage to the Mazda MPV.**

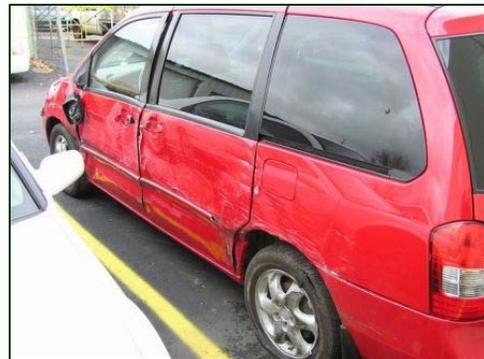
**Figure 3. Continuation of the sideswipe damage to the Mazda.**

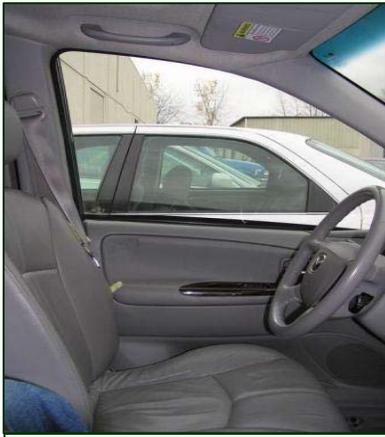
The interior of the Mazda MPV minivan sustained minor severity damage as a result of side impact air bag deployment and driver contact. There was no intrusion of the passenger compartment. The left seat back mounted side impact air bag deployed from the outboard aspect of the seat back. A localized contact point was noted to the upper rear aspect of the driver’s door panel. The padded panel was compressed with a black scuff surrounding the contact (**Figures 4 and 5**). This possibly resulted from the side impact air bag expanding between the driver’s left arm and her torso, displacing her left elbow laterally into the door panel. The driver loaded the manual safety belt system

**Figure 4. Left door panel driver contact point.**

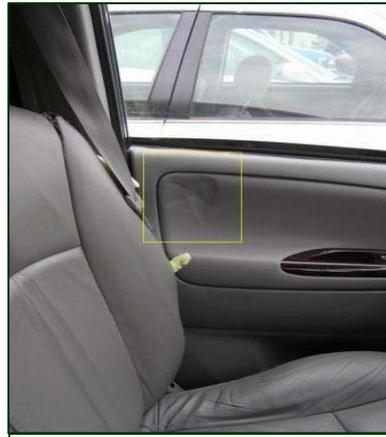
**Figure 5. Close-up view of the contact point.**

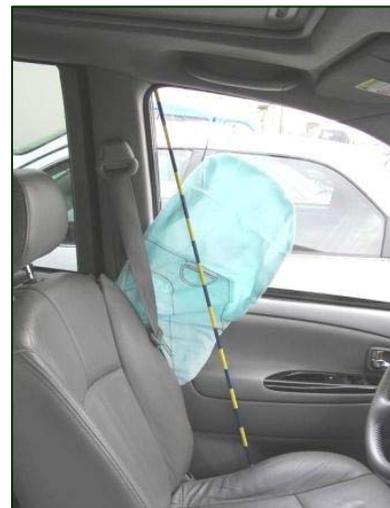
The left side impact air bag was concealed within the leather fabric of the seat back. As the air bag deployed, it tore the seam stitching of the seat back and deployed in a forward and upward direction. The air bag was tethered by a D-shaped stitch pattern in the center of the bag. In

**Figure 6. Deployed side impact air bag.**

its extended, but deflated stated, the side impact air bag measured 30 cm (12”) wide and approximately 51 cm (20”) in height. There was no damage or contact evidence on the air bag.

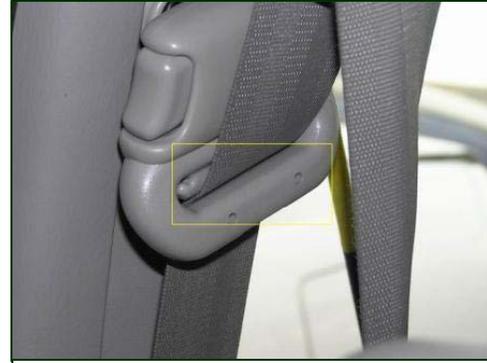
**Figure 7. D-ring frictional transfer.**

The driver was the sole occupant of the Mazda at the time of the crash. She was restrained by the belt system, evidenced by subtle frictional transfers to the D-ring (**Figure 7**) and latch plate. There was no damage or loading evidence to the belt webbing.

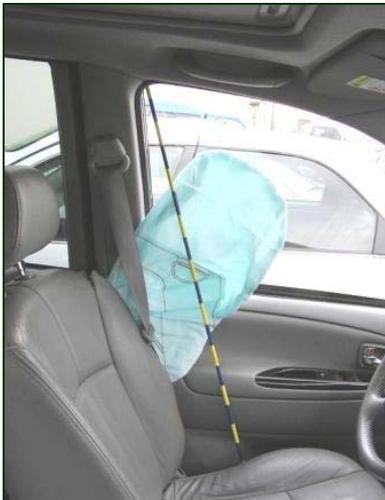
At impact, the left seat back mounted head and thorax side impact air bag deployed (**Figure 8**). The air bag expanded against the left posterior chest of the driver resulting in the left lower chest wall contusion, left rib fractures 9 and 11, a left lower lobe pulmonary contusion, and a the grade IV spleen laceration. There was no contact evidence to the deployed air bag.

**Figure 8. Deployed side impact air bag.**

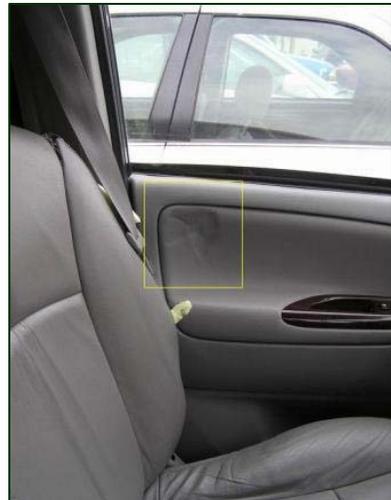
The air bag may have deployed between the driver’s left arm and her torso, displacing the arm laterally left. A circular area of compression occurred to the upper rear aspect of the left front door panel (**Figure 9**). This contact area was concealed by the deployed side impact air bag. The driver did not sustain injury from this suspected contact.

**Figure 9. Driver contact to the left door panel.**

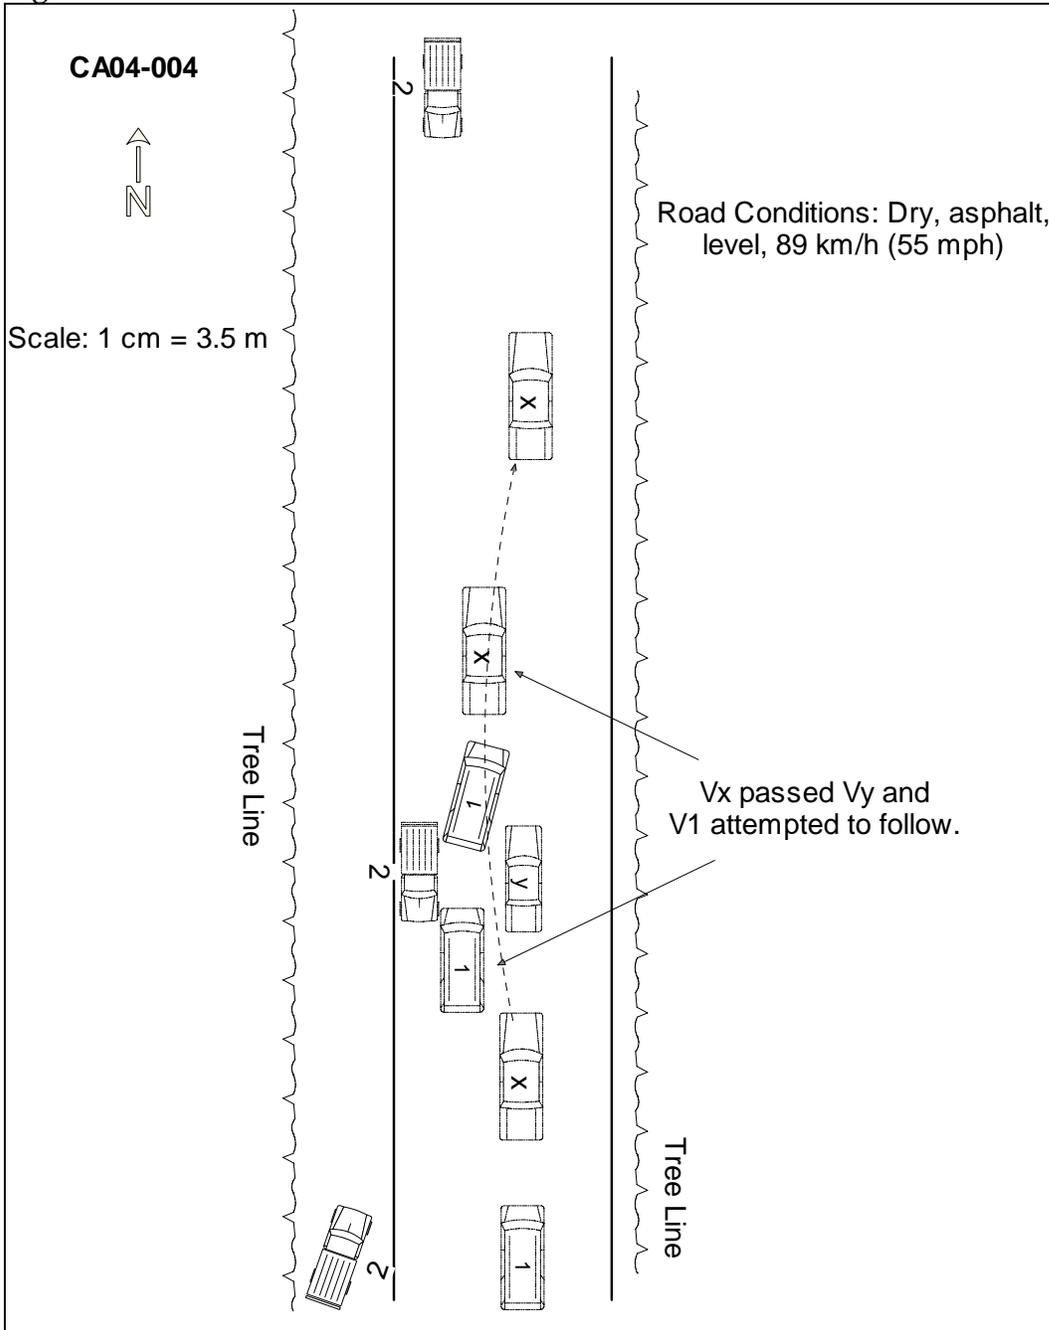
Figure 9 – Scene Schematic

The driver of the 2000 Mazda MPV minivan was traveling in a northbound direction on the two-lane roadway, following a non-contact vehicle. The driver of the non-contact vehicle encountered a slower moving northbound vehicle and initiated a passing maneuver by entering the southbound lane. Following the successful passing maneuver, this driver re-entered the northbound lane. The driver of the Mazda followed the non-contact vehicle and entered the southbound lane in an attempt to pass the slower moving vehicle. The Ford Ranger was traveling in a northbound direction and noted the Mazda enter his lane of travel. He attempted to steer right in an attempt to avoid the Mazda; however, the narrow road did not have adequate width to accommodate three vehicles. It was unknown if the driver of the Mazda attempted to avoid the crash. The Crash Schematic is included as **Figure 10** of this report.
