Side Air Bag Investigation/ Vehicle to Vehicle
Dynamic Science, Inc. / Case Number: DS04008
2004 Lexus RX330
California
April, 2004

1. Report No. DS04008		2. Government Accession No.		3. Recipient Catalog No.	
4. Title and Subtitle Side Air Bag Investigation				5. Report Date October 21, 2005

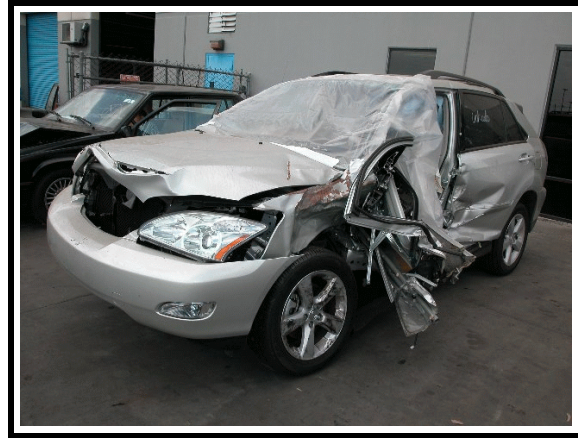
Figure 1. Front, left three-quarter view 2004 Lexus

The case vehicle sustained significant deformation to its left side plane with direct contact initiating 123.0 cm (48.4 in) forward of the left rear axle and extending 162.0 cm (63.8 in) forward. The combined direct and induced damage was 273.0 cm (107.5 in) in length. The left side doors were jammed shut. A hydraulic power spreader/wedgie tool was used to open the left front door at the B-pillar post. The left rear door was also opened as a result of the rescue efforts. After the door was opened, it was forcibly moved forward and the deployed left side air bag curtain was cut away for easier access to the injured driver. Damaged components included the left fender, left front, side door glazing, left side doors, left sill, hood, grille and front windshield glazing. Six equidistant crush measurements were documented along the left lower sill region and the residual measured crush profile is as follows: $C_1 = 0$ cm, $C_2 = 9.0$ cm (3.5 in), $C_3 = 11.0$ cm (4.3 in), $C_4 = 14.0$ cm (5.5 in), $C_5 = 28.0$ cm (11.0 in), $C_6 = 10.0$ cm (3.9 in). The maximum crush depth was 40.0 cm (15.7 in.) and was located at the lower left A-pillar.

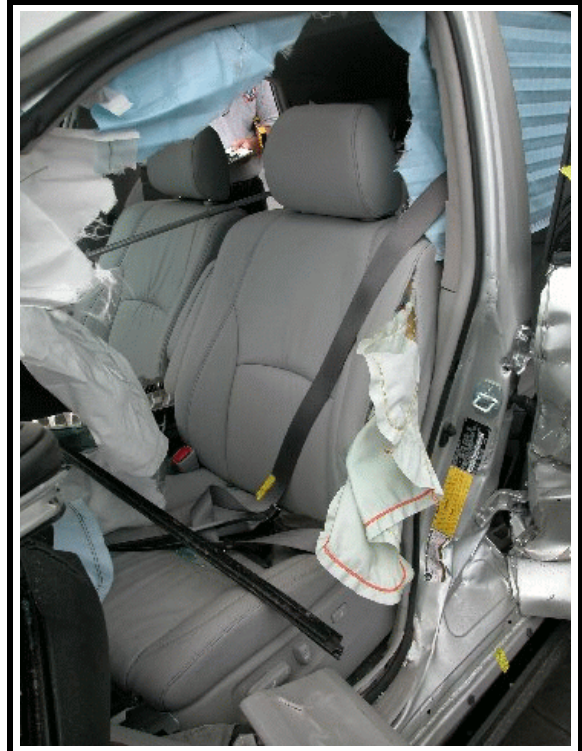
The driver's manual restraint system consisted of a continuous loop three-point lap and shoulder belt with a free sliding latch plate and an Emergency Locking Retractor (ELR). The shoulder belt adjuster was in the fully down position. The driver's lap and shoulder belt exhibited evidence of occupant loading. The plastic material of the free sliding latch plate loop showed a belt webbing load pattern with abraded plastic. There was a documented scuff/ retractor load mark noted to the drivers shoulder belt webbing. In addition, the pretensioner activated and locked the excess webbing in a spooled out position upon vehicle inspection.

Figure 4. View showing spooled out webbing

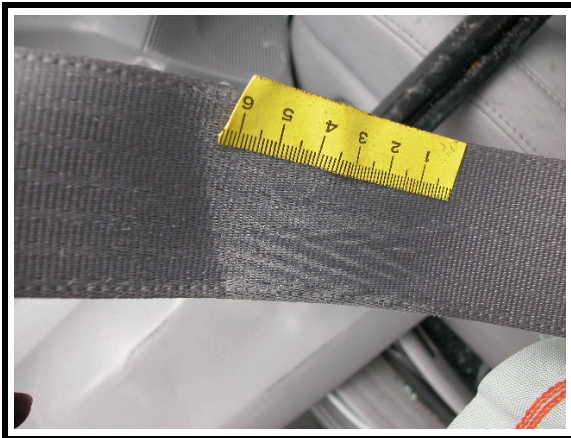
Figure 5. Scuff and retractor marks to drivers belt webbing

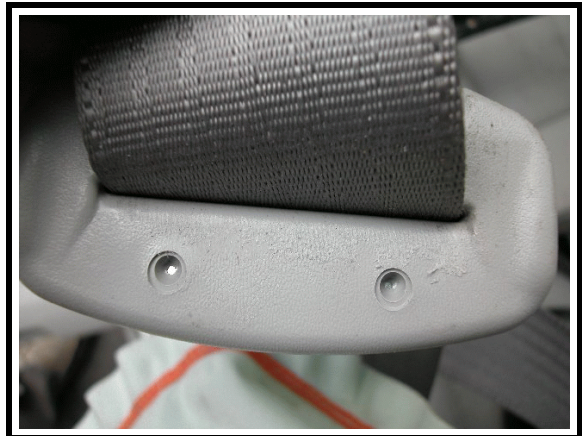
Figure 6. View showing belt load pattern to plastic free sliding latch plate loop

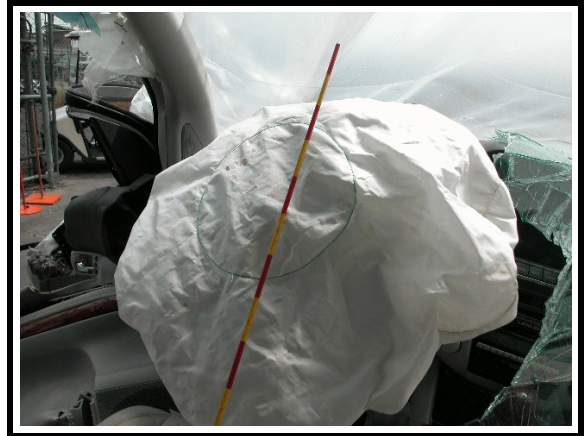
The driver's frontal air bag deployed during the crash. The driver air bag module was located in the center steering wheel hub with asymmetric horizontal flaps with side vertically oriented flap tear seams. The diameter of the deflated circular air bag was 54.0 cm (21.3 in.). It was equipped with two internal tether straps and had two exhaust vent port holes at the 11 and 01 o'clock positions. The maximum deflated air bag excursion was measured at 33.0 cm (12.9 in.). There were two 5.0 cm (2 in.) vertical tears located on the back of the air bag that were 17 cm (6.7 in.) apart. In addition, the back side of the air bag exhibited numerous small cuts or abrasions due to flying glass fragments. There were documented blood spatters and deposits noted at the front, center of the drivers air bag and residual lip stick cosmetic transfers were noted along the bottom seam.

Figure 7. View showing deployed drivers air bag

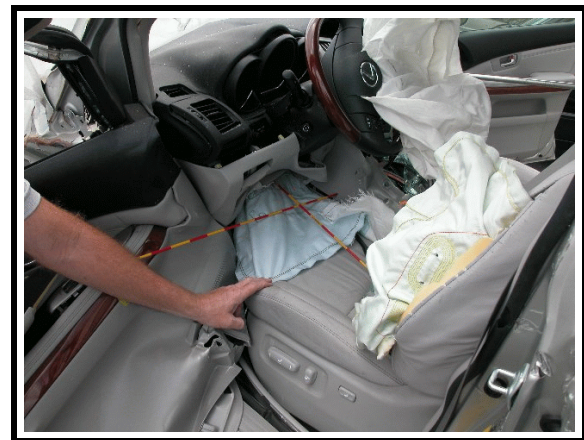
Figure 8. View showing deployed knee air bag

The front, left lower instrument panel mounted knee air bag deployed as a result of the left side impact. The module flaps consists of an asymmetric horizontal tear seam cover that opened at the designated areas. The deflated knee air bag measured 24.0 cm (9.4 in.) at the base and 55.0 cm (21.7 in.) at the leading edge. There was no damage or evident areas of occupant contact noted to the driver's knee air bag.

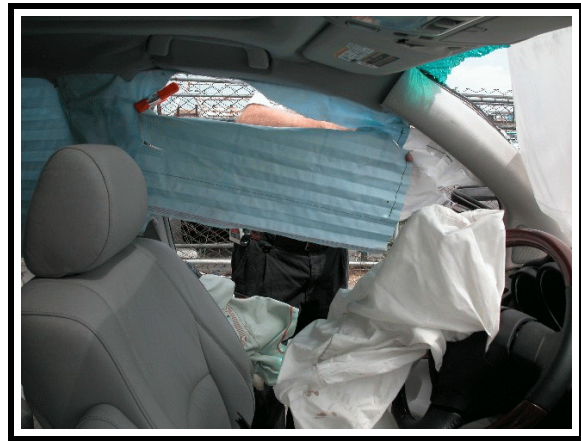
The left side roof side rail mounted curtain shield air bag deployed resultant to the left side impact forces. The entire curtain shield measured 167.0 cm (65.7 in.) in length and 39.0 cm (15.3 in.) in width. The forward section that extended from the left side B-pillar to the left A-pillar was cut out by rescue personnel during the extrication process. There were no indications of apparent occupant contacts noted to the side shield curtain.

Figure 9. View showing deployed left side curtain shield air bag

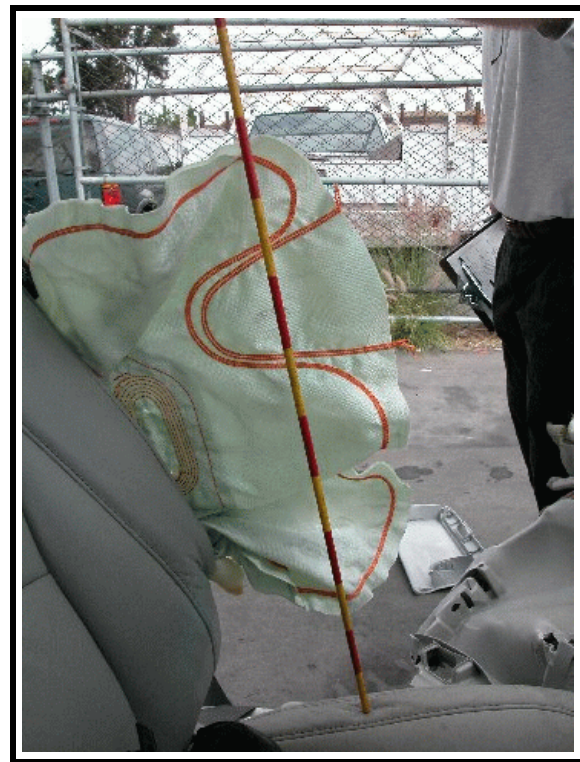
The front, left lateral seat back mounted side thoracic air bag deployed as a result of the left side impact. The deflated air bag unit measured 54.0 cm (21.3 in.) vertically and 25.0 cm (9.8 in.) wide. There were a total of 8 (4 on each side of air bag) vertically situated exhaust vent port holes that measured 0.5 cm (0.2 in) in diameter. The left, outboard surface of the thoracic air bag exhibited scuff marks that were attributed to contact with the intruding front, right door panel/armrest.

Figure 10. View showing deployed left side thoracic air bag
