## TRANSPORTATION RESEARCH CENTER

## ON-SITE CERTIFIED ADVANCED 208- COMPLIANT VEHICLE INVESTIGATION

CASE NUMBER - IN-04-008  
LOCATION - Texas  
VEHICLE - 2004 NISSAN QUEST  
CRASH DATE - March 2004

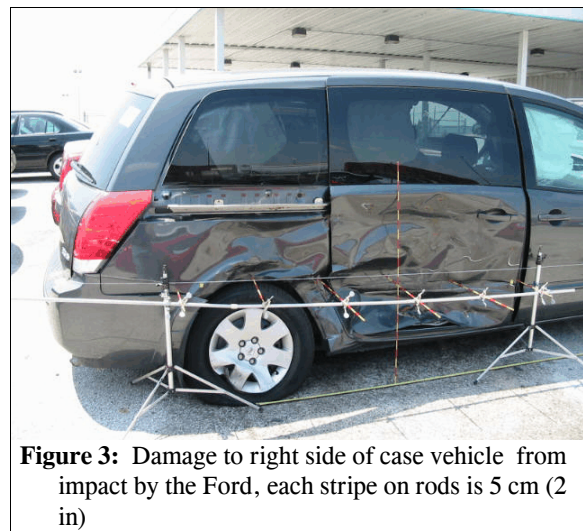
**Figure 3:** Damage to right side of case vehicle from impact by the Ford, each stripe on rods is 5 cm (2 in)

**Exterior Damage:** The case vehicle’s initial contact with the Ford involved the right rear sliding door, the right quarter panel, and the right rear wheel. Direct damage began 164 centimeters (64.6inches) rearward of the right front axle and extended 178 centimeters (70.1 inches) along the right side of the van. Residual maximum crush was measured as 19 centimeters (7.5 inches) occurring at C<sub>3</sub>. The case vehicle’s crush profile is shown in the table below.

The wheelbase on the case vehicle’s left side was extended 5 centimeters (2.0 inches) while the right side wheelbase was unaltered from the crash. The case vehicle’s right rear sliding door, right quarter panel, and right rear wheel were directly damaged and crushed inward. In addition, there was induced damage to the right rear door slider track cover, and the right rear window was detached from it’s latch assembly. No obvious induced damage or remote buckling was noted to the remainder of the case vehicle’s exterior.

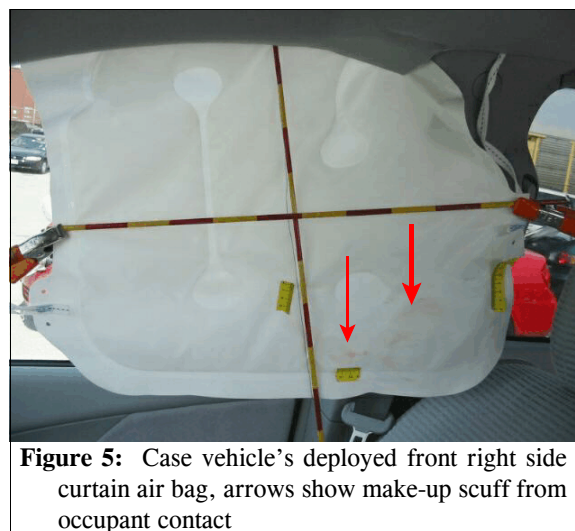
**Vehicle Interior:** Inspection of the case vehicle’s interior revealed occupant contact marks on the front right and back right side curtain air bags (**Figure 5** and **Figure 6** below). Occupant contact evidence was also found on the intruded, interior surface of the right rear sliding door at the belt line (**Figure 7** below), as well as the intruded right side panel and glazing adjacent to the back seat row (**Figures 6** and **8** below). Also, it was observed that the right rear window latch assembly was detached from it’s glue joint on the window glazing. The rear edge of the window could be manually pulled outward creating a potential ejection portal for the back right passenger. The case vehicle sustained two intrusions. The right side sliding door intruded laterally 14 centimeters (5.5 inches) into the second seat right passenger’s occupant space, and the right side panel intruded laterally 5 centimeters (2 inches) into the back seat right passenger’s occupant space. Lastly, there was no evidence of compression of the energy absorbing steering column or damage to the steering wheel.

**Figure 5:** Case vehicle’s deployed front right side curtain air bag, arrows show make-up scuff from occupant contact

The front right passenger's side curtain air bag (**Figure 11**) was located along the right roof side rail and extended from approximately mid-window to the middle of the right "B"-pillar. The air bag was approximately rectangular in shape and measured approximately 47 centimeters (18.5 inches) in width and approximately 38 centimeters (15 inches) in height. The air bag consisted of three irregularly shaped inflatable chambers. A 47 centimeter (18.5 inches) anchor cord extended from the front edge of the air bag to the "A"-pillar. This anchor cord attached to the right "A"-pillar approximately 22 centimeters (8.6 inches) above the belt line, and attached to the front edge of the air bag approximately 32 centimeters (12.5 inches) below the right roof side rail. A second anchor cord extended from the back edge of the air bag and to the top of the right "B"-pillar. It was 23 centimeters in length, and its attachment point on the back edge of the air bag was 20 centimeters (8 inches) below the roof side rail. The air bag was constructed without tethers, and there were no visible vent ports. There was no damage to the air bag due to the deployment or occupant contact. A make-up scuff from the front right passenger's face was observed on the lower right portion of this air bag (**Figure 5** above).

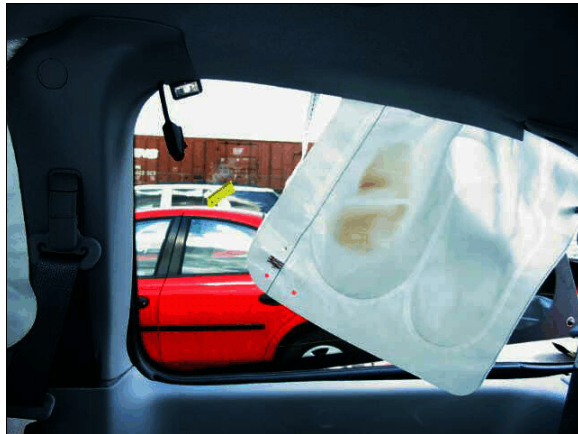
**Figure 6:** Yellow tape shows occupant contact mark on case vehicle's back right window, note make-up transfer on side curtain air bag

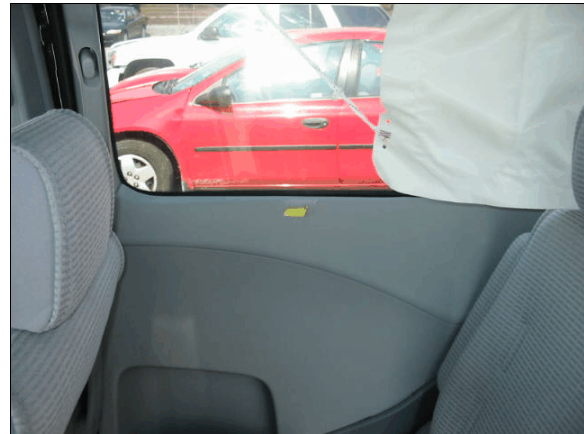
**Figure 7:** Intrusion and contact mark (yellow tape) on interior surface of right rear sliding door adjacent to second seating row.

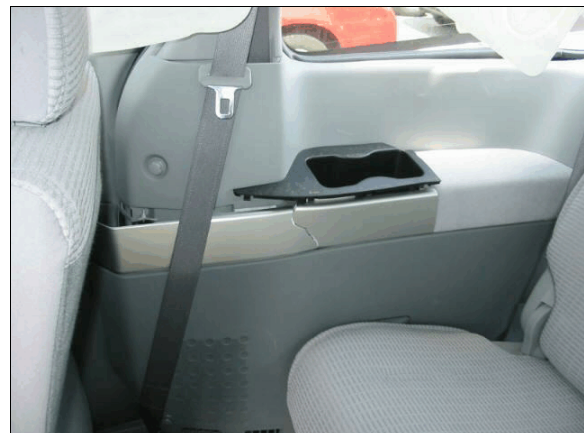
**Figure 8:** Damage and intrusion of case vehicle's side-panel into back right seat area.

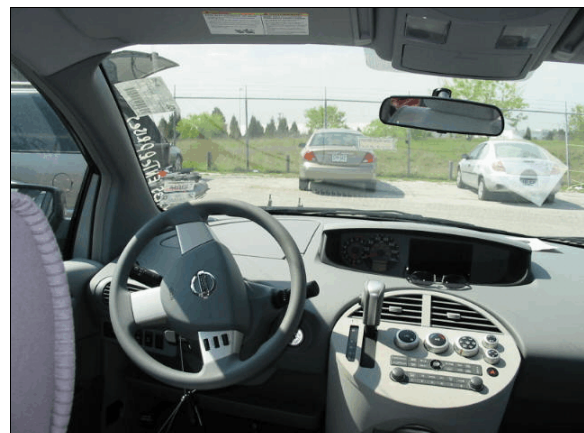
The driver's air bag was located in the steering wheel hub (**Figure 9**) and the front right passenger's air bag was located in the top of the instrument panel (**Figure 10** below). Neither of these air bags deployed in this crash because the case vehicle's crash sensing algorithm most likely determined that the longitudinal crash pulse would not be severe enough to require their deployment. This observation is supported by the results of the WinSMASH reconstruction that is presented above.

**Figure 9:** Case vehicle's driver seating area showing non-deployed driver air bag and no occupant contact evidence to interior surfaces

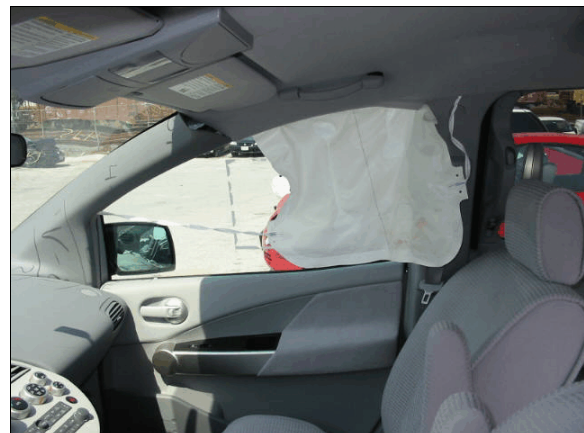
**Figure 11:** Overview of case vehicle's front right side curtain air bag

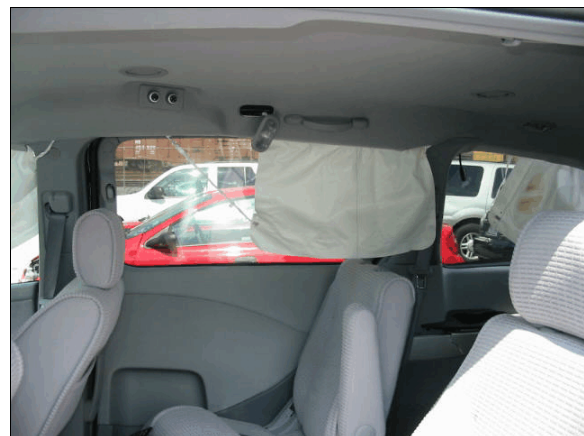
The second seat right side curtain air bag (**Figure 12**) was located along the right roof side rail, and extended from approximately the middle of the sliding door window to the approximate middle of the right "C"-pillar. This air bag was approximately rectangular in shape and measured approximately 47 centimeters (18.5 inches) in width and approximately 30 centimeters (11.8 inches) in height. The air bag consisted of three vertical inflatable chambers running nearly the

**Figure 12:** Overview of second seat right side curtain air bag

vertical height of the air bag. Each inflatable chamber was approximately 15 centimeters (5.9 inches) in width and approximately 25 centimeters (9.8 inches) in height. An anchor cord, 36 centimeters (14.2) in length, extended from the front edge of the air bag to the roof rail. This anchor cord attached to the right roof side rail approximately 27 centimeters (10.6 inches) rear of the right “B”-pillar, and attached to the lower front edge of the air bag. No second anchor cord was attached to the back edge of the air bag. The air bag was designed without tethers, and there were no visible vent ports. No damage occurred to this air bag during deployment, and no evidence of occupant contact was observed on the air bag material.

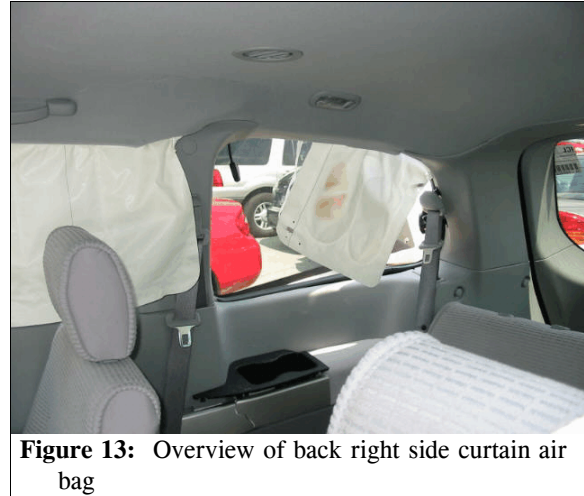
The back right side curtain air bag (**Figure 13**) was located near the back of the right rear window. It was square in shape and oriented at an angle (i.e., the forward bottom corner was higher above the belt line than the rear bottom corner). The air bag was approximately 31 centimeters (12.2 inches) in width and approximately 31 centimeters (12.2 inches) in height. The air bag consisted of two inflatable chambers, each 17 centimeters (6.7 inches) in width. A 24 centimeter (9.4 inches) anchor cord extended from the lower front edge of the air bag and attached to the right roof side rail approximately 22 centimeters (8.6 inches) rear of the right “B”-pillar. A second anchor cord, 4 centimeters (1.6 inches) in length, extended from the upper back corner of the air bag and attached to the upper corner of the right “D”-pillar. There was no evidence of damage to the air bag from the deployment. However, a large make-up scuff from the back right passenger’s face was observed on the forward inflatable chamber. This occupant contact mark measured 8 centimeters (3.1 inches) by 14 centimeters (5.5 inches). No other damage or occupant contact marks were observed on the air bag.

**Figure 13:** Overview of back right side curtain air bag
