**GENERAL DYNAMICS ON-SITE ADVANCED 208-COMPLIANT VEHICLE  
INVESTIGATION  
SCI TECHNICAL SUMMARY REPORT**

**CASE NO. CA04-009**

**VEHICLE – 2004 CADILLAC ESCALADE**

**CRASH DATE – JANUARY 2004**

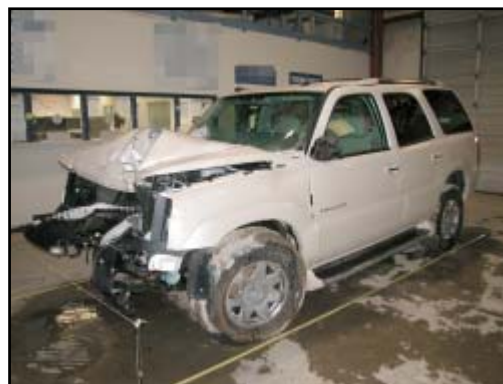
**Figure 1. Damaged 2004 Cadillac Escalade**

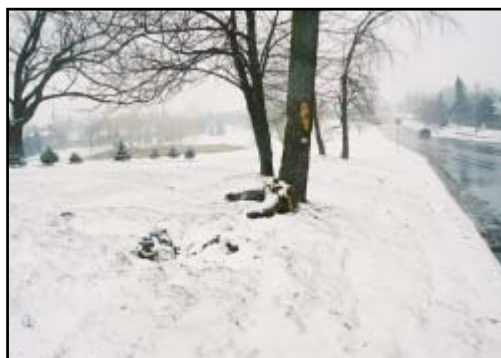
**Figure 3. Close-up of the struck trees**

secondary impact resulted in severe damage to the Escalade. The EDR recorded a Deployment Level event for the secondary impact, and the EDR-reported time between Deployment and Deployment Level events was 0.3 seconds. The Maximum SDM Recorded Velocity Change for the secondary impact was -53.5 km/h (-33.3 mph). The damage algorithm of the WinSMASH program calculated a total delta-V of 26.0 km/h (16.2 mph) based on the frontal crush profile. Based on the vehicle damage and EDR output, the WinSMASH-calculated delta-V appeared low. The Escalade rebounded slightly rearward and came to rest against the tree. **Figure 3** illustrates the proximity of the struck trees.

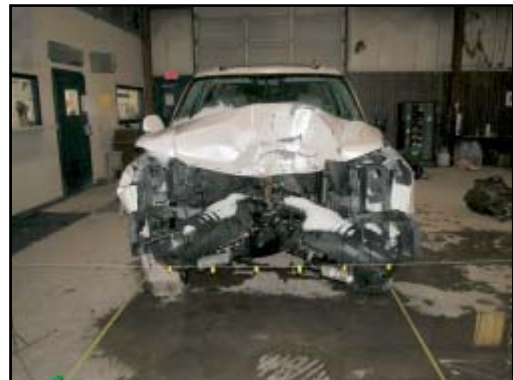
The 2004 Cadillac Escalade sustained severe frontal damage as a result of the two sequential tree impacts (**Figure 4**). Due to the masking nature of the damage, it was not possible to separate the two impacts. The direct contact damage began 35.6 cm (14.0") left of the centerline and extended 45.7 cm (18.0") to the right. Abrasions were present on the front aspect of the hood from direct contact with the trees. The maximum crush was located 17.8 cm (7.0") left of the centerline and measured 81.3 cm (32.0"). The tree impacts penetrated the bumper fascia, which separated from the vehicle, and crushed the bumper beam, and the upper and lower radiator supports. The steel bumper beam was completely fractured 83.8 cm (33.0") inboard from the front left corner and exhibited a 15.2 cm (6.0") lateral gap at the fracture site (**Figure 5**). The radiator core sustained direct contact scratches from the tree and fragments of tree bark were present on the entire vertical height of the direct damage area. The combined direct and induced damage measured 114.3 cm (45.0") in width between the damaged bumper corners. The severe crush pulled both corners of the beam inward and forward, and the center aspect was displaced slightly upward. The front aspects of the frame rails were displaced inward and the distance between the

**Figure 4. Frontal view of the damaged 2004 Cadillac Escalade**

frame rails measured 30.5 cm (12.0”) at the forward aspects. The hood was buckled rearward and upward and both front fenders were buckled rearward and outward. The impact resulted in slight roof buckling at both B-pillars. The left front and right front doors were displaced slightly rearward. The windshield was fractured from crash forces. The Collision Deformation Classification for the first tree impact was 12-FYE9-9, as the damage from the second impact overlapped the damage from the first impact. The CDC for the second tree impact was 12-FYEW-2. Six crush measurements were documented along the cross member behind the front bumper beam and were as follows: C1 = 0.0 cm C2 = 0.5 cm (0.2”), C3 = 38.0 cm (15.0”), C4 = 34.8 cm (13.7”), C5 = 15.1 cm (6.0”), C6 = 0.0 cm.

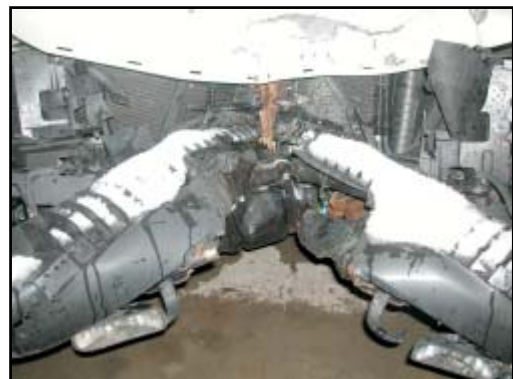
**Figure 5. Close-up of maximum crush and fractured bumper beam**

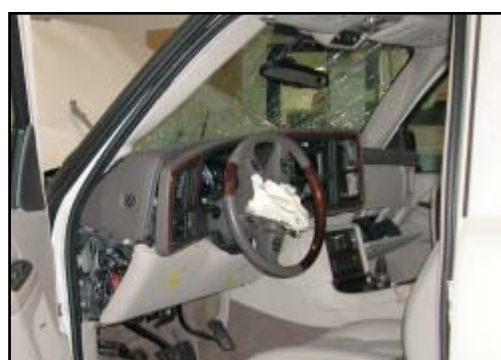
The 2004 Cadillac Escalade sustained moderate interior damage as a result of occupant contact and passenger compartment intrusion (**Figure 6**). Two diagonal scuff marks were present on the knee bolster from contact with the driver’s knees. The scuff mark from his left knee measured 3.8 x 3.8 cm (1.5 x 1.5”) and was located 19.1 cm (7.5”) left of the knee bolster centerline and 7.6 cm (3.0”) below the top of the knee bolster. The scuff mark from the right knee measured 5.1 x 3.8 cm (2.0 x 1.5”) and was located 7.6 cm (3.0”) to the right of the bolster centerline and 14.0 cm (5.5”) below the top of the bolster. The top aspect of the bolster was deformed in the area around the steering column and sustained a small fracture. The left and center instrument panel trim was displaced from crash forces. The driver loaded the steering wheel, which resulted in the forward displacement of the steering column and complete separation of the shear capsules. The shear capsule displacement measured 7.6 cm (3.0”). The driver’s toe pan sustained minor pocketing behind the accelerator pedal, and the accelerator pedal was deformed slightly upward and outboard. Passenger compartment intrusions were documented as follows:

**Figure 6. Left front view of interior damage**

<b>Position</b>	<b>Intruded Component</b>	<b>Magnitude of Intrusion</b>	<b>Direction</b>
FL	Left instrument panel	5.1 cm (2.0”)	Longitudinal
FL	Left toe pan	15.2 cm (6.0”)	Longitudinal
FR	Right instrument panel	8.3 cm (3.3”)	Longitudinal
FR	Right toe pan	11.4 cm (4.5”)	Longitudinal

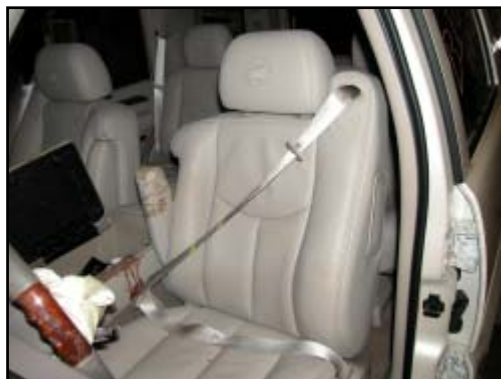
The 2004 Cadillac Escalade was configured with integrated manual 3-point lap and shoulder belts for the front seat positions. The driver's safety belt (**Figure 7**) was configured with a sliding latch plate and an Emergency Locking Retractor (ELR). The shoulder belt webbing retracted through a plastic guide located on the outboard aspect of the top of the seat back. At the time of the crash, the driver had two spring-loaded plastic clips positioned on each edge of the safety belt webbing against the plastic guide while the safety belt was worn. He stated that the clips were used to maintain approximately 5.1 – 7.6 cm (2 – 3") of slack in the shoulder belt while the safety belt was in use. The driver's belt was not restricted and was found in the stowed position at the time of the vehicle inspection. Minor cupping of the webbing was present on the lap belt 22.9 cm (9.0") above the plastic stop button from occupant loading. Two lateral creases were present on the webbing 48.3 cm (19.0") above the plastic stop button from probable loading against the latch plate. Body fluid (blood) was present on the shoulder belt webbing, and began 55.9 cm (22.0") above the stop button and extended up the webbing 41.9 cm (16.5"). The plastic guide was separated from the seat fabric.

**Figure 7. Driver's safety belt**

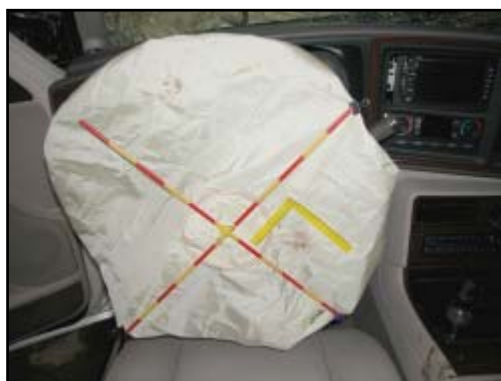
**Figure 8. Deployed driver's air bag**

quadrant of the air bag face. The transfer was located 3.8 cm (1.5”) above the horizontal centerline, measured 10.2 cm (4.0”) in height, began at the vertical centerline and extended 8.9 cm (3.5”) to the left.
