# INDIANA UNIVERSITY

## TRANSPORTATION RESEARCH CENTER

## ON-SITE CERTIFIED ADVANCED 208- COMPLIANT VEHICLE INVESTIGATION

CASE NUMBER - IN-04-010  
LOCATION - Texas  
VEHICLE - 2004 TOYOTA CAMRY  
CRASH DATE - March 2004

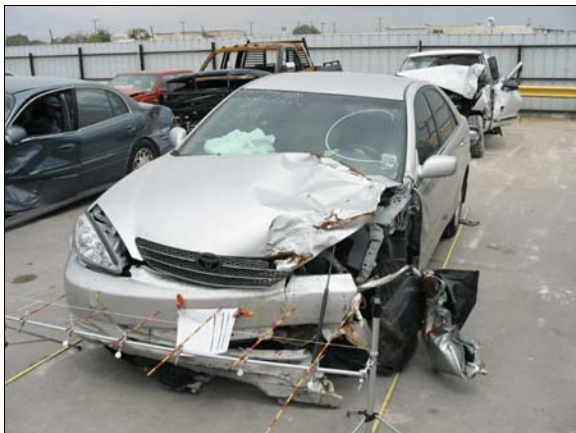
**Figure 4:** Case vehicle's front left damage and damage to left fender and wheel assembly from the impact with the Ford

**Crash:** The front left of the case vehicle (**Figure 4**) impacted the front left of the Ford (**Figure 5**) causing a stage one deployment of the case vehicle driver's air bag and a stage two deployment of the front right passenger air bag. As a result of the impact with the case vehicle, the Ford's counterclockwise rotation was accelerated, and the Ford entered the median and rolled over, driver side leading, one-and-one half times (six quarter turns).

**Exterior Damage:** The case vehicle's contact with the Ford involved the front bumper, hood, grille, left fender (**Figure 4** above), and the left front wheel (**Figure 6**). Direct damage began at the left front bumper corner and extended 121 centimeters (47.6 inches) along the bumper. Direct damage also extended 118 centimeters (46.5 inches) along the left fender, which was torn off. Residual maximum crush was measured as 37 centimeters (14.6 inches) occurring at C<sub>2</sub> (**Figure 7** below). The case vehicle's front bumper, bumper fascia, grille, radiator, left fender, left turn lamp/headlamp assemblies, left front wheel, and hood were directly damaged and crushed rearward. The table below shows the case vehicle's crush profile.

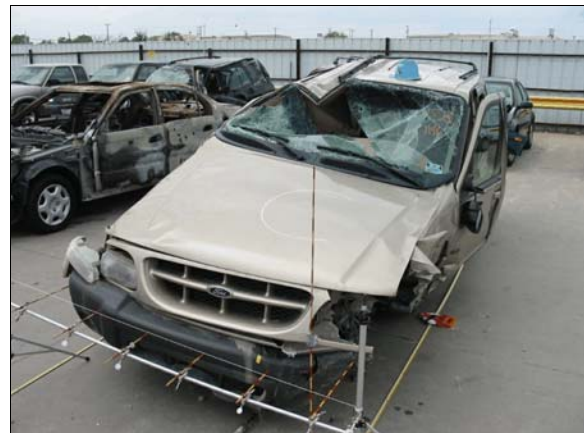
**Figure 5:** Ford's front left and left fender damage from impact with the case vehicle, and top damage due to the subsequent rollover.

**Exterior Damage:** The Ford's impact with the front of the case vehicle involved the front left of the Ford. The bumper, left headlamp/turn lamp assembly, grille and the left fender were directly contacted and crushed rearward. The direct damage began at the left corner of the front bumper and extended 49 centimeters across the bumper. The maximum residual crush was measured as 26 centimeters (10.2 inches) occurring at C<sub>1</sub>. The Ford's crush profile is shown in the table below.

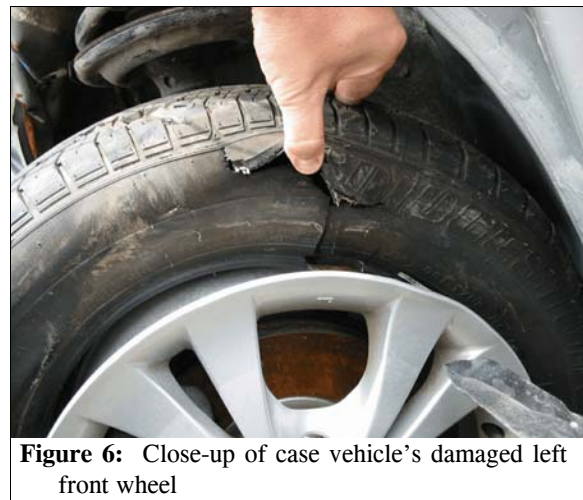
**Figure 6:** Close-up of case vehicle's damaged left front wheel

The case vehicle’s recommended tire size was: P205/65R15, and the vehicle was equipped with tires of this size.. The case vehicle’s left front tire was deflated and rotated outward as a result of the crash. The case vehicle’s tire data are shown in the table below.

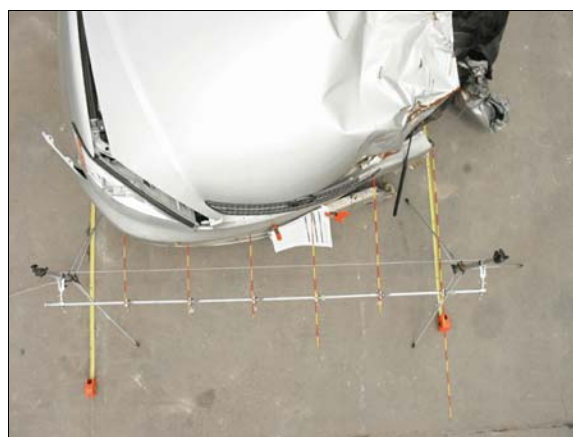
The wheelbase on the case vehicle’s left side was shortened 19 centimeters (7.5 inches) while the right side wheelbase was unaltered from the crash. There was induced damage to the hood, front bumper, and left front door. No other obvious induced damage or remote buckling was observed on the case vehicle.

**Figure 7:** Overhead view of case vehicle’s front crush profile, each increment on rods is 5 cm (2 in)

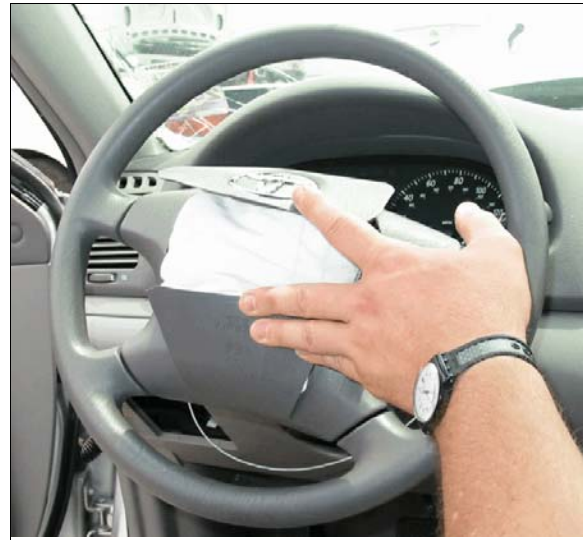
The case vehicle's driver air bag was located in the steering wheel hub. An inspection of the air bag module cover flaps (**Figure 8**) and the air bag fabric revealed that the cover flaps opened at the designated tear points. There was no evidence of damage during the deployment to the air bag or the cover flaps. The top cover flap was triangular in shape and was 16.5 centimeters (6.5 inches) in width at its widest point near the tear seam and 7 centimeters (2.8 inches) in height. The bottom cover flap was also triangular in shape and was 14 centimeters (5.5 inches) in width at its widest point near the tear seam and 8 centimeters (3.1) in height. The driver's air bag was designed with two tethers, each approximately 11 centimeters (4.3 inches) in width and had two vent ports, each approximately 3 centimeters (1.2 inches) in diameter, located at the 11 and 1 o'clock positions. The deployed driver's air bag (**Figure 9**) was round with a diameter of 65 centimeters (25.6 inches). An inspection of the driver's air bag fabric revealed eye and lip makeup near the center of the air bag (**Figure 10**). The distance between the mid-center of the driver's seat back as positioned at the time of the inspection (i.e., between forward-most and middle track position) and the front surface of the air bag's fabric at full excursion was 24 centimeters (9.4 inches).

**Figure 8:** Overview of driver's air bag module cover flaps

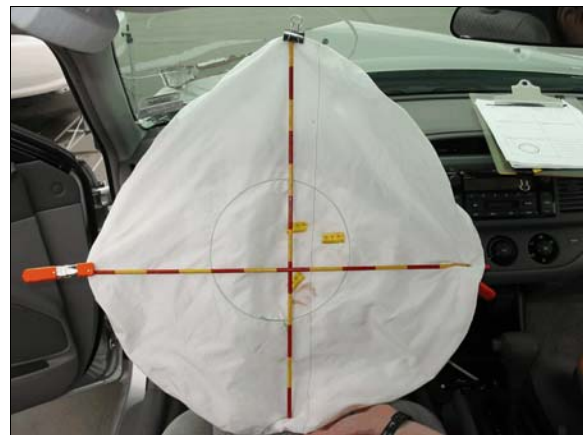
**Figure 9:** Case vehicle's deployed driver air bag, occupant contact evidence highlighted with yellow tape

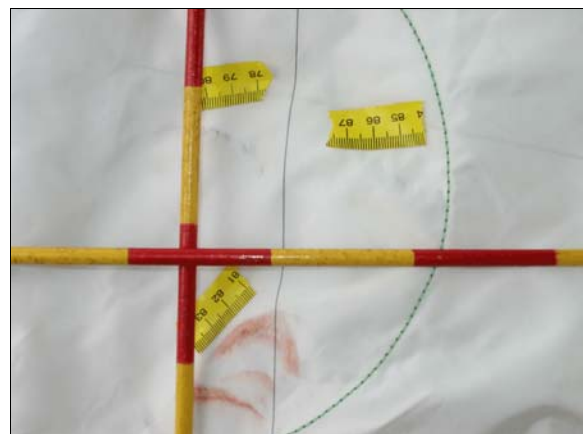
**Figure 10:** Close view of occupant contact evidence within center stitching of case vehicle's deployed driver air bag

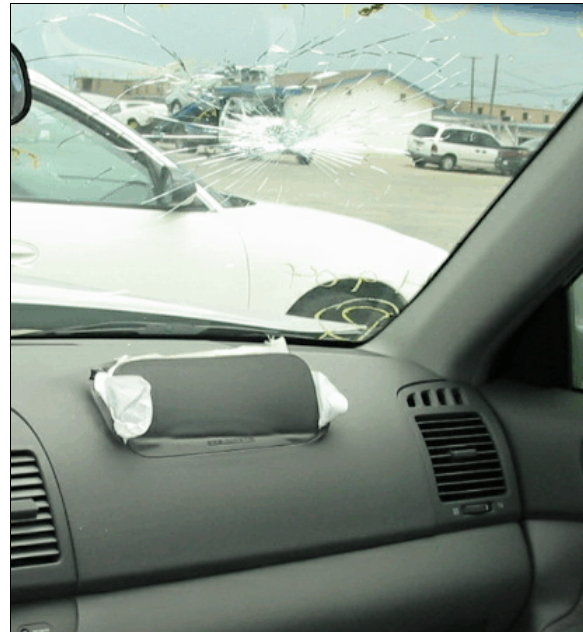
**Vehicle Interior:** Inspection of the case vehicle’s interior revealed occupant contact marks on the driver’s air bag. The right portion of the windshield was cracked due to contact by the deploying front right air bag. The case vehicle did not sustain any intrusion, and there was no evidence of compression of the energy absorbing steering column or deformation of the steering wheel.

The front right passenger's air bag was located in the top of the instrument panel (**Figure 11**). An inspection of the front right air bag module's cover flap and the air bag's fabric revealed that the cover flap opened at the designated tear points, and there was no evidence of damage during the deployment to the air bag or the cover flap. The air bag module cover flap was rectangular in shape and was 21 centimeters (8.3 inches) in width and 10 centimeters (3.9 inches) in height. The front right passenger's air bag was designed without any tethers. The front right air bag had two vent ports, each approximately 5.5 centimeters (2.2 inches) in diameter, located at the 9:30 and 2:30 clock positions. The deployed front right air bag (**Figure 12**) was rectangular with a height of approximately 60 centimeters (23.6 inches) and a width of approximately 44 centimeters (17.3 inches). Although some occupant contact with this air bag was likely, an inspection of the front right passenger air bag revealed no evidence of occupant contact. The distance between the mid-center of the passenger's seat back as positioned at the time of the inspection (i.e., between rear-most and middle track position) and the front surface of the air bag's fabric at full excursion was 24 centimeters (9.4 inches). The deployment of the front right passenger's air bag fractured the windshield (**Figure 11**).

**Figure 11:** Overview of location of front right air bag, air bag module flap and cracked windshield from deployment

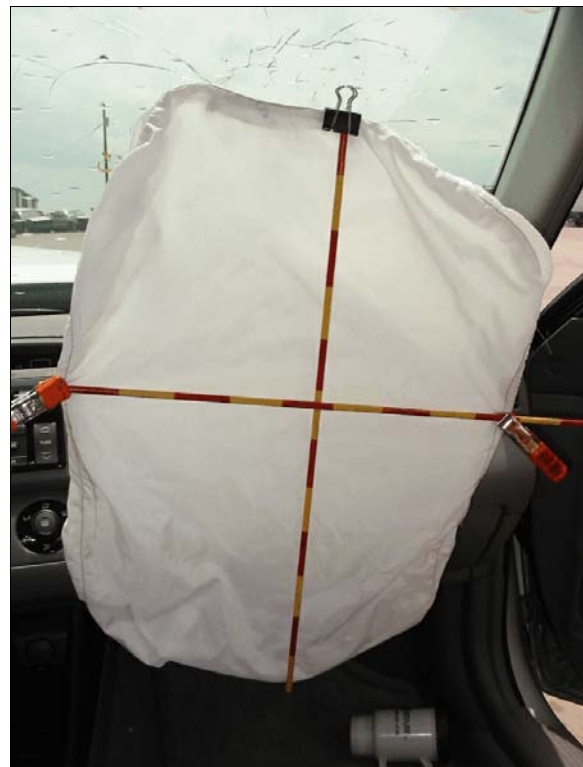
**Figure 12:** Front surface of case vehicle's deployed front right passenger air bag showing no obvious evidence of occupant contact

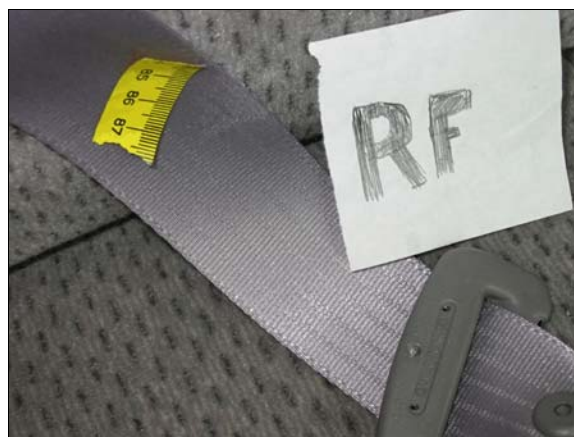
The case vehicle's front right passenger was restrained by his manual, three-point, lap-and-shoulder safety belt system. The safety belt system was equipped with a retractor-mounted pretensioner with force limiter housed within the B-pillar. Inspection of the front right passenger's seat belt webbing, "D"-ring, and latch plate revealed that the pretensioner had actuated. A length of belt webbing consistent with a restrained occupant was found withdrawn from the retractor. The webbing would not retract and was locked in this position. Furthermore, there were friction burns on the belt webbing (**Figure 13**) and "D"-ring indicating the front right passenger was restrained during the crash. In addition, the interviewee indicated that the front right passenger was wearing his safety belt.

**Figure 13:** Case vehicle's front right safety belt showing friction burns (indicated by yellow tape) on webbing

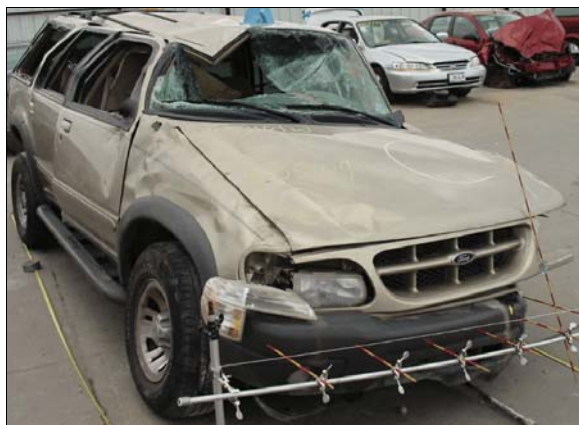
The rollover involved both sides and the top of the Ford (**Figures 14 and 15**). Direct damage involved the roof, the right side and the top of the left quarter panel and left front door. The area of maximum crush occurred to the roof, inboard of the right roof side rail. The maximum roof crush was approximately 23 centimeters (9.1 inches). Induced damage also involved the roof, and both sides of the Ford.

**Figure 14:** Front right view of rollover damage to case vehicle

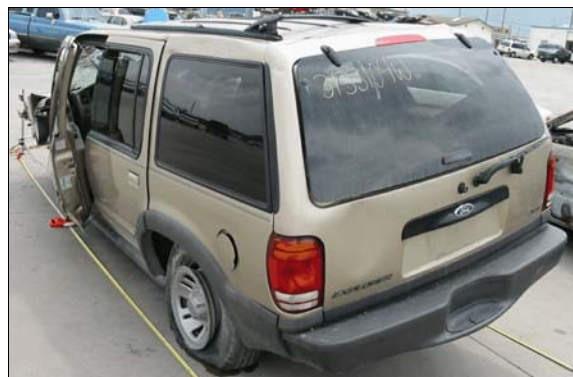
**Figure 15:** Back left view of damage to Ford
