Remote Passenger Air Bag Fatality Investigation / Vehicle to Vehicle
Dynamic Science, Inc. / Case Number: DS04010
1997 Ford Escort
New Mexico
January, 2004

1. Report No. DS04010		2. Government Accession No.		3. Recipient Catalog No.	
4. Title and Subtitle Remote Passenger Air Bag Fatality Investigation				5. Report Date December 17, 2004

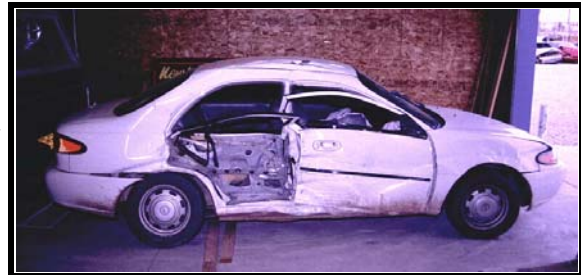
Figure 2. Right side, Ford Escort

Damage Description: Moderately Severe/ Right Side Impact: Primarily lateral displacement of the right side doors. Lateral deformation noted to the right A-pillar, B-Pillar and C-Pillar. Deformation was also noted to the right quarter-panel, and right roof side rail. The tempered right side glazing disintegrated due to the impact forces and the laminated windshield glazing was cracked due to the impact forces and the deployment of the front right passenger air bag.

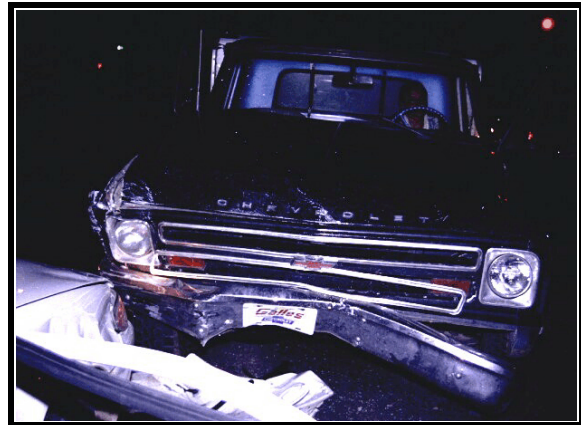
Figure 3. Front, Chevrolet pickup

Description: 1967 Chevrolet C20 series pickup
 VIN: CE247Zxxxxxx
 Odometer: Unknown
 Engine: Unknown, equipped with manual transmission
 Reported Defects: Unknown
 Cargo: None Reported
 Damage Description: Moderate Frontal Impact Damage:
 Longitudinal displacement to the front bumper, hood and radiator/grille area. Minor damage noted to the right fender and front, right headlight damaged.
 CDC: 11FZEW1
 Delta V:
 Total 15.0 km/h (9.3 mph)
 Longitudinal -14.1 km/h (-8.8 mph)
 Latitudinal 5.1 km/h (3.2 mph)
 Energy 49,695 joules
 (36,653 ft lbs)

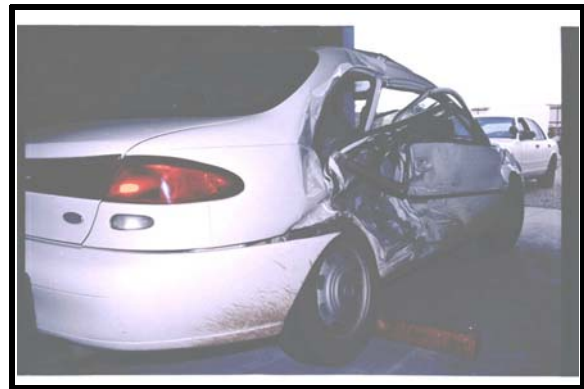
Figure 4. Right rear, Ford Escort

The Ford Escort sustained moderate interior damage from the impact with Chevrolet pickup. There was lateral intrusion to both right side seats from the front door, B pillar, and rear door. The glazing for both doors was disintegrated. There was damage to the right side of the windshield from the deploying front right passenger air bag.

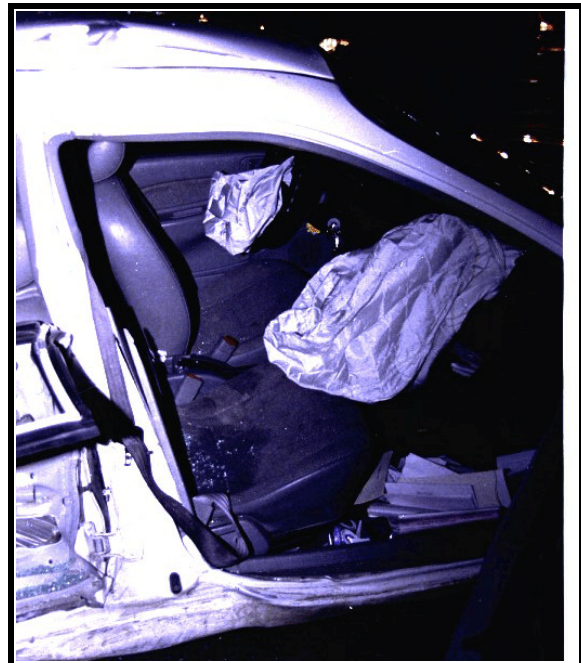
Figure 6. Front right passenger air bag, side view

The front, right passenger air bag was located on the instrument panel (mid-mount type). The module deployment door is rectangular in shape and equipped with a tear seam that is designed to allow the door to hinge outward during deployment. The nylon air bag is inflated with nitrogen after a chemical reaction of sodium azide and copper oxide combusts. The inflator unit is supported by a metal reaction housing unit. There was no noted residual damage to the air bag and the module cover deployment door opened at the designated tear point. The deployment door cover opened with enough force to break the laminated windshield in front of the front, right seated position. Blood stains were noted to the nylon air bag surface.

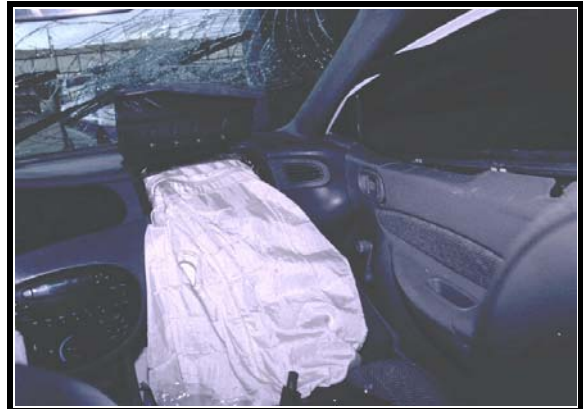
Figure 9. Front right passenger air bag, front view

The 7 month old female infant's face was significantly contacted by the deploying passenger air bag which resulted in numerous facial injuries. As a result of air bag contact, she sustained multiple upper left forehead abrasions measuring 0.6 cm (0.25 in) each, a left cheek abrasion 3.1

x 0.6 cm (1.25 x 0.25 in) partially patterned resembling a stitched seam, and a 3.8 x 2.5 cm (1.5 x 1 in) abrasion to right side of mouth.

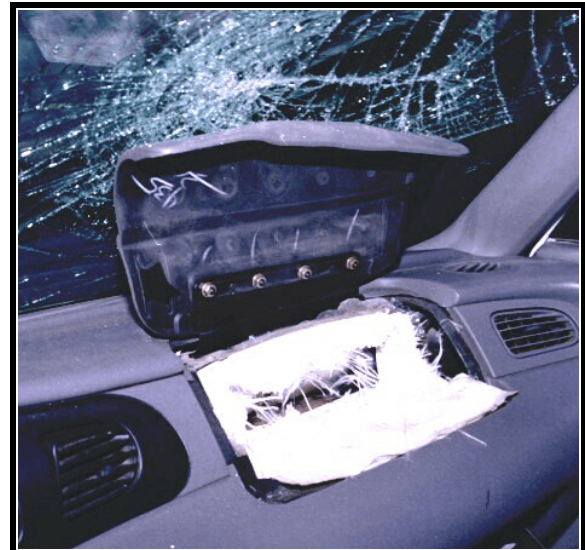
Figure 10. Front right passenger air bag module cover

3.8 x 2.5 cm (1.5 x 1 in) abrasion to right side of mouth	290202.1	Passenger air bag	Certain
	Skull fracture beginning on the right posterior portion of the anterior frontanelle extending laterally and posteriorly 8.0 cm (3.1 in)	150402.2	Passenger air bag module door cover	Probable
	Skull fracture begins at the left posterior anterior frontanelle and extends laterally and posteriorly 12.0 cm (4.7 in)	150402.2	Passenger air bag module door cover	Probable
	Brain laceration 11.0 x 2.0 cm (4.3 x 0.8 in) over the frontoparietal and partially onto the occipital lobe.	140688.4	Passenger air bag module door cover	Probable

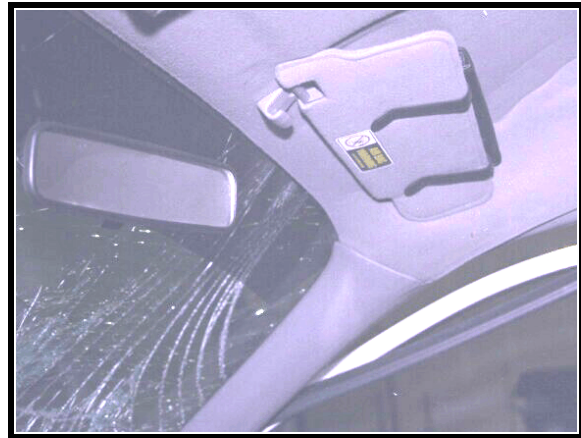
Figure 11. Dislodged sun visor and scuff to A pillar

The air bag deployment probably thrust the child in an upward trajectory and she may have contacted the roof panel, sun visor area. The sun visor was dislodged and there appear to be a vertical scuff along the A pillar (see Fig. 11). The driver removed the child from the car and placed the child in the arms of a motorist that had stopped to assist. The witness/motorist placed the injured infant on the center seat of his van. Paramedics that responded to the scene, removed the injured infant from the rear seat of the van and subsequently transported her to a hospital where she was pronounced deceased at 1915 hours (1 hour and 16 minutes post-impact).

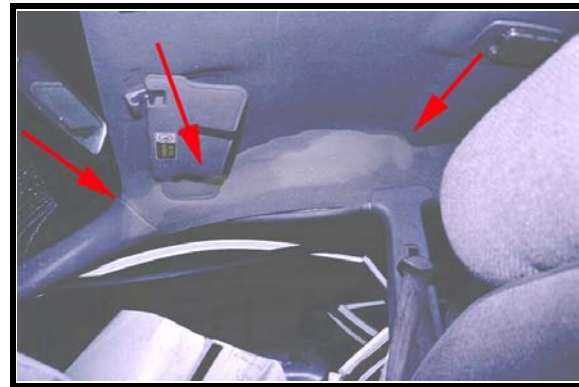
Figure 12. Scuff along roof side rail
