**GENERAL DYNAMICS ON-SITE SIDE IMPACT INFLATABLE OCCUPANT
PROTECTION INVESTIGATION**

GENERAL DYNAMICS CASE NO: CA04-015

VEHICLE: 2002 GMC YUKON

CRASH DATE: MARCH 2004

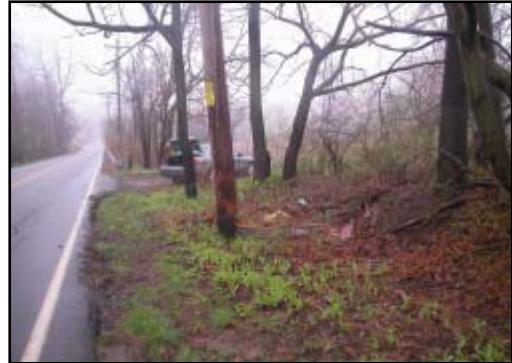
The GMC traveled on the roadside 3.2 meters (10.5 feet) south of the white fog line in a clockwise rotation and impacted a large utility pole (**Figure 3**) with the left passenger compartment area. The left rear door was separated from the vehicle during maximum engagement. The impact to the utility pole caused the pole to fracture at the point of impact, however, the pole did not topple to the ground. The deformed pole created tension to the

Figure 3. Impact area with the utility pole.

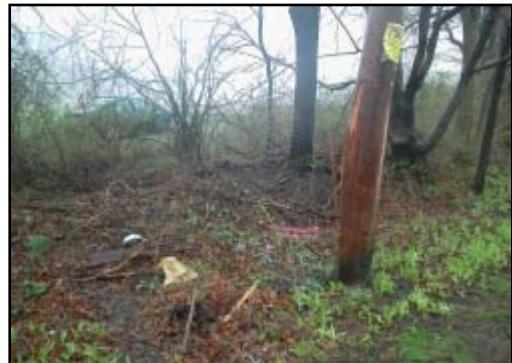
The impact area was rear of the center of gravity, which redirected the GMC in a counterclockwise rotation. The GMC rotated approximately 270 degrees to final rest and overrode downed branches and vegetation (**Figure 4**) that were located south of the struck utility pole. The GMC came to rest facing a northwest direction approximately 0.7 meters (2.3 feet) east of the utility pole.

Figure 4. Area of impact with the shrub.

The GMC sustained no residual damage as a result of overriding the downed branches and vegetation.

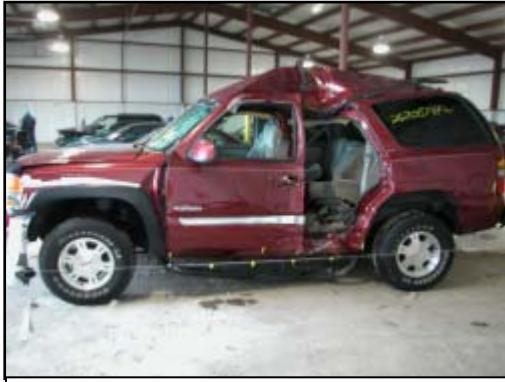
The first crush profile was documented at the sill level (**Figure 5**) due to the separation of the left rear door. The direct contact damage measured 130.0 cm (51.2") and began 52.0 cm (20.5") forward of the left rear axle. Six crush measurements were measured along the sill using a combined direct and induced damage width of 168.0 cm (66.1") and were as follows: C1 = 11.5 cm (4.5"), C2 = 36.0 cm (14.2"), C3 = 30.0 cm (11.8"), C4 = 21.0 cm (8.3"), C5 = 11.0 cm (4.3"), C6 = 8.0 cm (3.1").

Figure 5. Sill level crush profile.

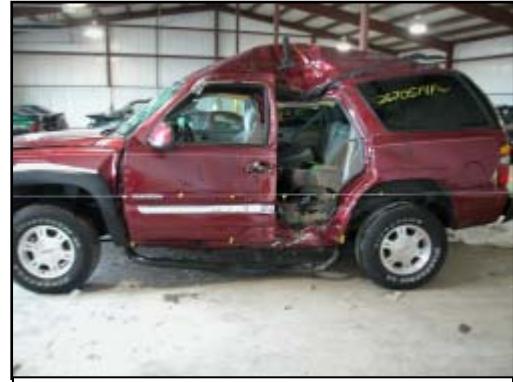
The second crush profile was measured along the mid-door level (**Figure 6**). The direct contact damage measured 78.0 cm (30.7") and began 88.0 cm (34.6") forward of the left rear axle and extended to 48.0 cm (18.9") forward of the rear edge of the left front door. Six crush measurements were recorded using a combined direct and induced damage width of 194.0 cm (76.4") and were as follows: C1 = 7.0 cm (2.8"), C2 = 5.0 cm (2.0"), C3 = 27.0 cm (10.6"), C4 = 18.2 cm (7.2"), C5 = 8.5 cm (3.3"), C6 = 0.0.

Figure 6. Mid-door crush profile.

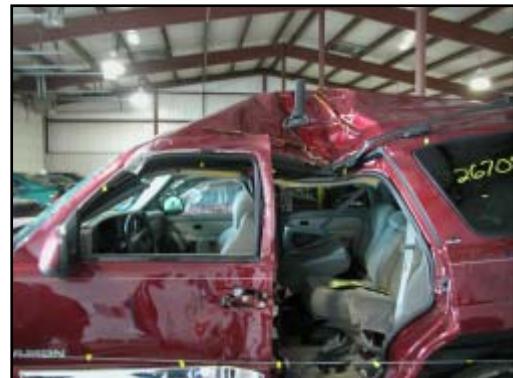
The third crush profile was measured along the roof side rail (**Figure 7**). The direct contact damage measured 78.0 cm (30.7") and began 88.0 cm (34.6") forward of the left rear axle and extended forward 48.0 cm (18.9"). The residual deformation was measured using a combined direct and induced damage width of 194.0 cm (76.4") and were as follows: C1 = 26.0 cm (10.2"), C2 = 50.0 cm (19.7"), C3 = 49.0 cm (19.3"), C4 = 25.0 cm (9.8"), C5 = 28.5 cm (11.2"), C6 = 5.5 cm (2.2"). The Collision Deformation Classification (CDC) for the utility pole impact was 09-LPAW-4.

Figure 7. Roof side rail crush profile.

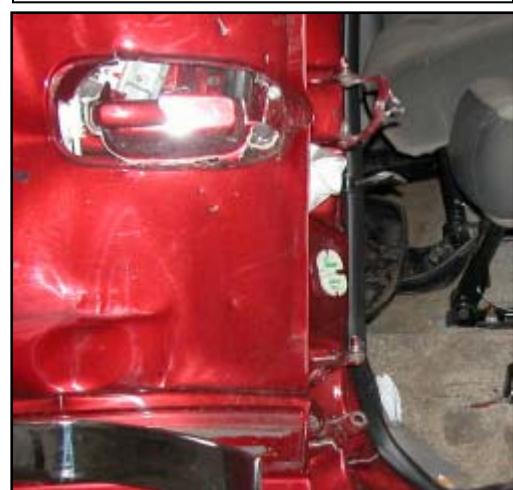
The GMC's windshield was fractured from the lateral deformation of the roof side rail and the left front and left rear glazing were disintegrated from contact with the utility pole. The remainder of the glazing remained intact. The front left door remained closed during the crash. The door would not close post-crash due body distortion and the latch was damaged from forcing the door open post-crash. The left rear door was separated at impact at the hinge points on the B-pillar (**Figure 8**). The right side doors and rear tailgate remained closed during the crash and operational post-crash.

Figure 8. Left rear door B-pillar mounted hinges. Torn during utility pole impact.

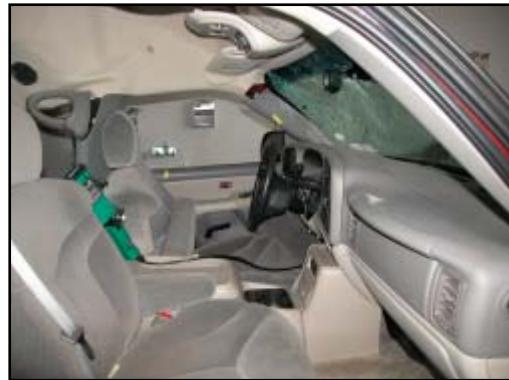
The 2002 GMC Yukon sustained moderate interior damage as a result of occupant contacts and passenger compartment intrusion. The driver's contacts consisted of a crack to upper left door panel from probable contact with the driver's left arm/shoulder. The left front door control panel (switches for power windows/locks) was displaced from probable contact with the driver's left thigh. A probable head contact was noted to the grab handle that was mounted above the B-pillar with body fluid noted on the handle. Two scuffmarks were noted to the knee bolster from probable contact with the driver's knees. A contact was noted to the left A-pillar plastic trim, which was evidenced by a scuff, scratches, and possible skin transfer. The front left head restraint contained a small spot of dried body fluid that may have resulted from a possible rebound contact from the driver's head. **Figure 9** is an overall view of the contact points. The passenger compartment intrusions are listed in the table below:

Figure 9. Overall view of contact points.

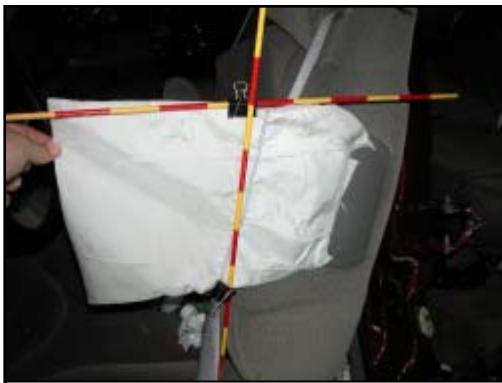
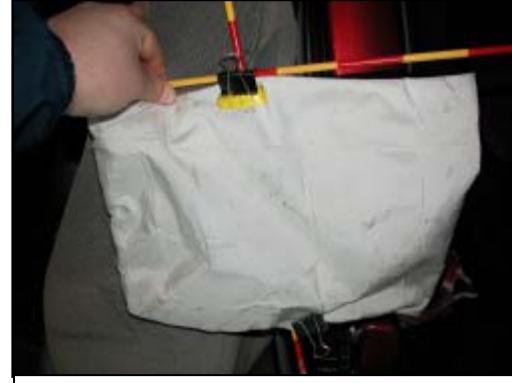
The 2002 GMC Yukon was equipped with seat back mounted side impact air bags for the front seating positions. The front left side impact air bag deployed as a result of the impact with the utility pole (**Figures 10 and 11**). A single rectangular cover flap that measured 16.0 cm (6.9") in height and 6.0 cm (2.4") wide concealed the air bag module. The air bag membrane measured 40.5 cm (15.9") from the forward edge in relation to the vehicle to the air bag module and was 24.1 cm (9.5") in height. There were several small cuts noted to the air bag membrane from

contact with the shattered side glazing; however, these were superficial and did not compromise the inflation of the air bag. A larger superficial laceration was noted to the air bag membrane that was located 17.0 cm-19.5 cm (6.7"-7.7") rear of the forward edge. There was no occupant contact evidence noted to the air bag; however, dirt was present on the air bag from post-crash handling. A single vertically oriented seam was documented on the outboard aspect of the air bag module that was located 23.5 cm (9.3") rear of the forward edge. The air bag contained no tethers or vent ports.

Figure 10. Outboard aspect of driver's side impact air bag.

Figure 11. Inboard aspect of driver's side impact air bag.

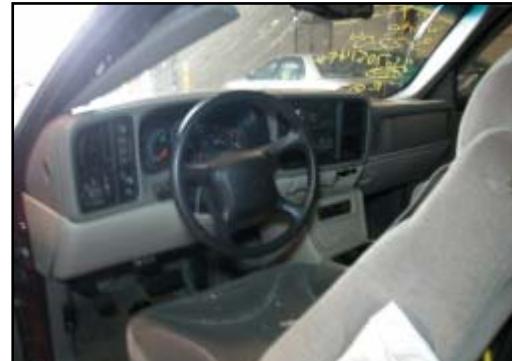
The 2002 GMC Yukon was equipped redesigned frontal air bags for the driver and front right passenger. The driver's frontal air bag was located in the center of the steering wheel hub. The front right air bag was mid-mounted on the front right instrument panel. The frontal air bags did not deploy in the subject crash (**Figure 12**).

Figure 12. Non-deployed frontal air bag system.

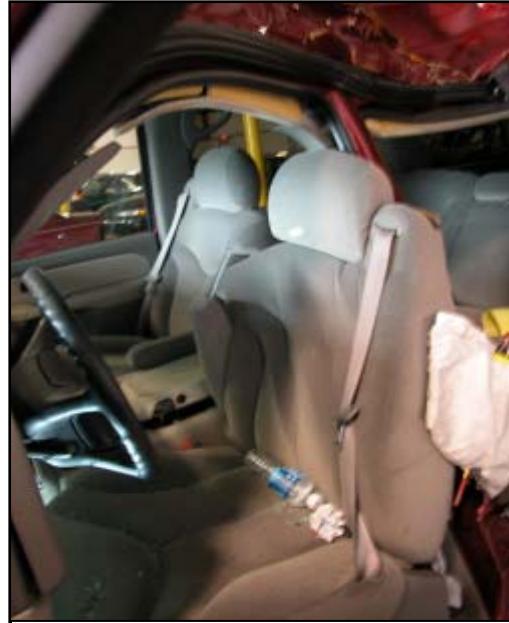
The 2002 GMC Yukon was equipped with integrated manual 3-point lap and shoulder safety belts for the front seating positions. The second row outboard positions were equipped with manual 3-point lap and shoulder safety belts and a center 2-point manual lap belt. The third row was equipped with integrated manual 3-point lap and shoulder safety belts. The driver's safety belt (**Figure 13**) was configured with a sliding latch plate, and an Emergency Locking Retractor (ELR). Historical usage evidence was noted to the driver's latch plate, which consisted of minor scratches. Although the driver stated to the SCI investigator that she used her lap and shoulder safety belt. There was no crash related usage evidence such as transfers or stretching on the driver's safety belt which indicated that the driver did not utilize her safety belt in the crash. Furthermore, the EDR data also indicated that the driver's safety belt switch circuit status was unbuckled.

Figure 13. Driver's integrated 3-point manual lap and shoulder safety belt.
