Child Safety Seat Fatality Investigation / Vehicle to Vehicle
Dynamic Science, Inc. / Case Number: DS04015
2004 Volkswagen Beetle
Oregon
July, 2004

1. Report No. DS04015	2. Government Accession No.	3. Recipient Catalog No.	
4. Title and Subtitle Child Safety Seat Fatality Investigation		5. Report Date April 18, 2005

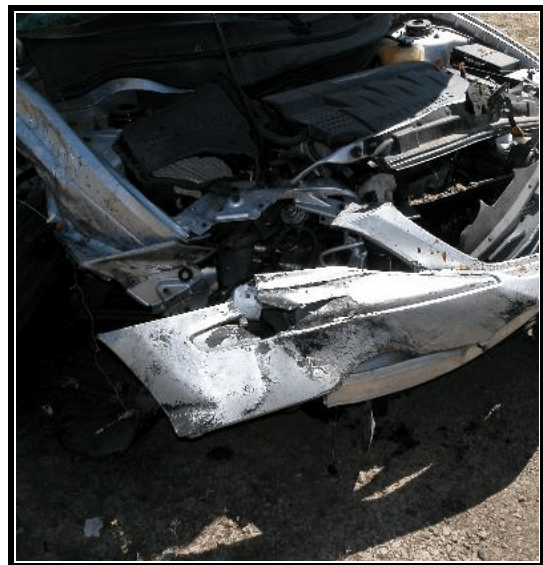
Figure 6. Contact damage from guardrail impact

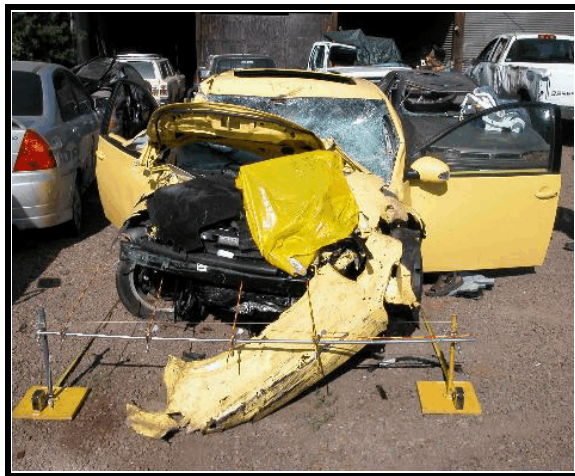
This vehicle sustained 150.0 cm (59.0 in) of direct contact to the front bumper corner from the impact with the right side Chrysler Pacifica. The residual crush measured along the bumper was as follows: C1=26.0 cm (10.2 in), C2=46.0 cm (18.1 in), C3=65.0 cm (25.6 in), C4=73.0 cm (28.7 in). The maximum crush was measured at C1. The principle direction of force was within the 11 o'clock sector and was an estimated 340 degrees. There was end shift to the right. The damaged components included the bumper fascia and reinforcement bar, hood, grille, and radiator. Both wheelbases were shortened; the left by 15.0 cm (5.9), the right by 51.0 cm (20.0 in). The front right door was jammed shut. The windshield was damaged and cracked. The front right window was disintegrated from impact forces.

Figure 8. Front, Volkswagen Beetle

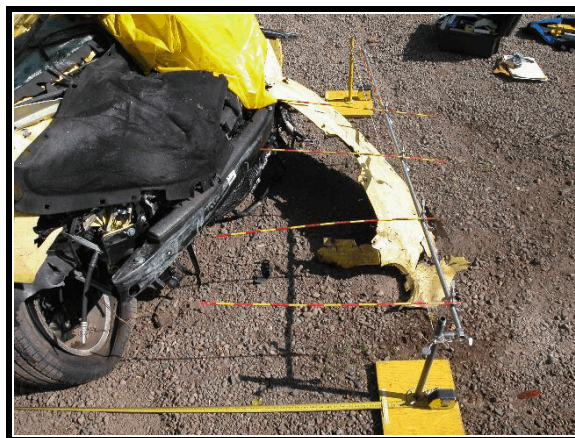
Figure 9. Right side view showing depth of crush

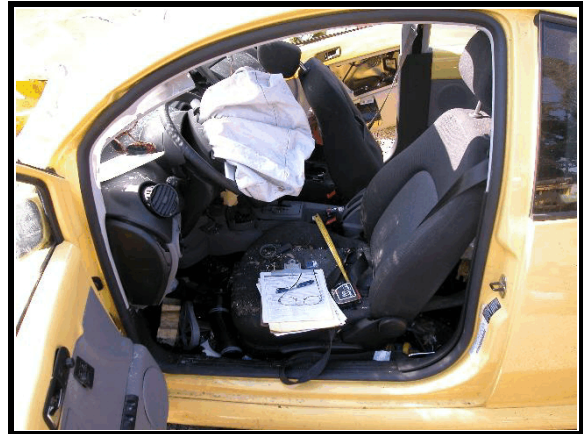
Interior damage to the Volkswagen Beetle was significant and was attributed to occupant contact and passenger compartment intrusion. The windshield sustained fracture damage from impact forces. The right side glass was disintegrated by impact forces. There was longitudinal intrusion to the driver's seated area from both the toe pan and instrument panel, with the maximum intrusion from the toe pan measuring 6.0 cm (2.3 in). There was longitudinal intrusion to the front left seat area from the instrument panel, the toe pan, the A pillar and the area forward of the A pillar. The maximum intrusion to the right front was to the A pillar and measured 20.0 cm (7.9 in). It appears that both front doors were initially jammed shut and had to be opened by rescue personnel. The steering wheel collapsed due to occupant loading and the rim was deformed 5.0 cm (1.9 in) forward.

Figure 10. Interior view from left side

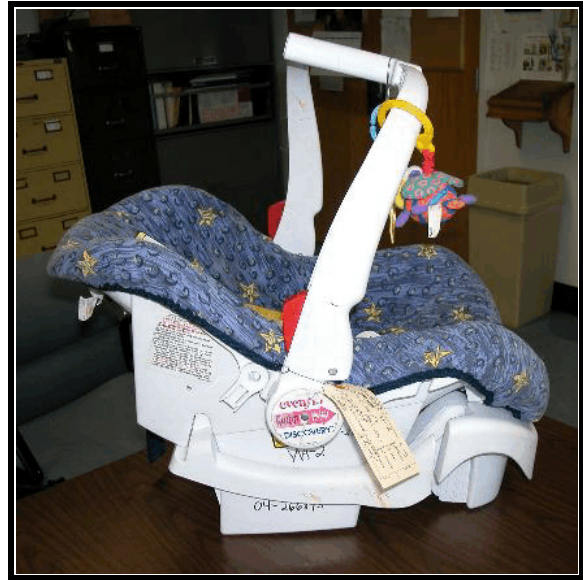
Figure 17. Side view, Evenflo Discovery infant seat

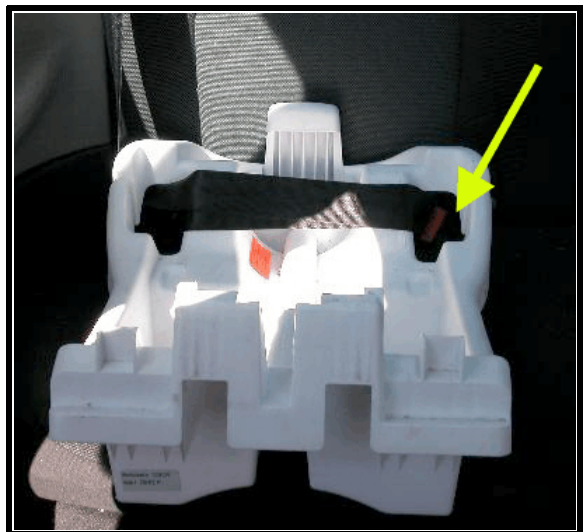
At impact, the child and infant seat responded to the 11 o'clock direction of force by moving forward and to the left. There are clear indications that the child was initially held in place by the infant seat harness. There were bilateral shoulder contusions/abrasions, most significantly on the right side of the child (see graphic images at the end of this report). The child's head engaged the interior of the infant seat. There are clear indications that the seat base and lap and shoulder belt sustained impact related loading (13.0 cm/5.1 in long, starting 36.0 cm/14.2 in from the button stop).

Figure 16. Infant seat base (arrow indicate area of loading to lap and shoulder belt)

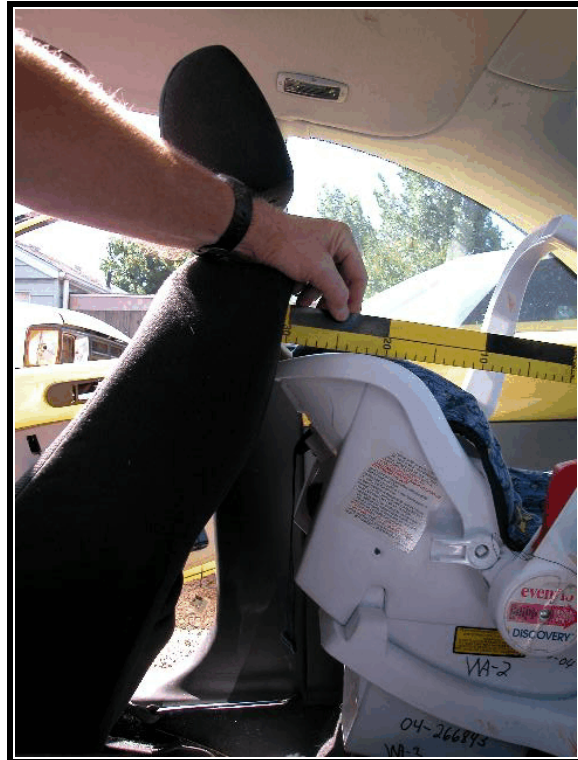
During the impact the infant seat and front right passenger seat back both traveled forward. The infant seat twisted clockwise and traveled forward approximately 13.0 cm (5.2 in). There was loading and compression to the infant seat, causing the fracture on the right side. At some point during the impact, the release handle was either in contact with the seat back (or possibly a diaper/bottle bag that was in the rear seat). As the impact terminated and the vehicle began a sharp clockwise rotation, the seat back and infant seat began to reconstitute. This movement between the two surfaces caused the release handle to move/rotate upward. At this point, the seat was released from the base. The continuing clockwise rotation caused the seat to come out of its base and pitch to the left where it came to rest upside down.

Figure 18. Distance between infant seat and vehicle seat back

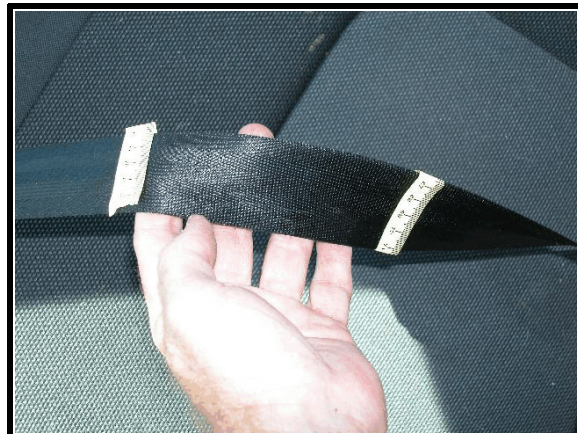
Figure 19. Loading to lap and shoulder belt at the right rear seat position

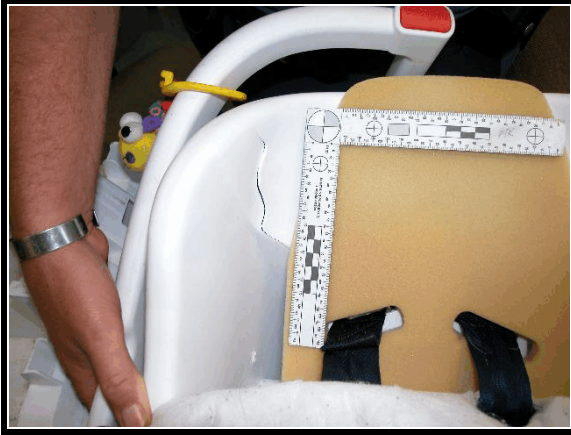
Figure 20. Fracture to infant seat back

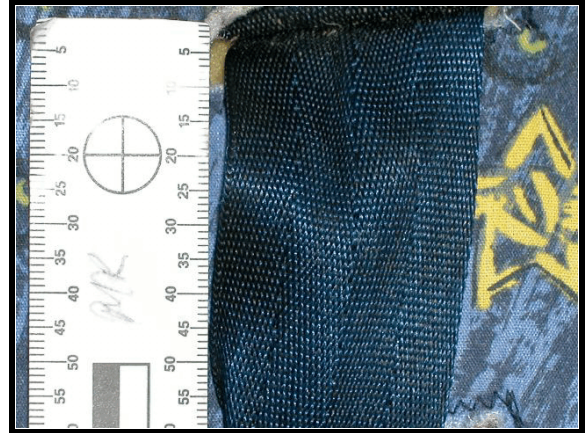
Figure 21. Skin transfer to right infant seat harness

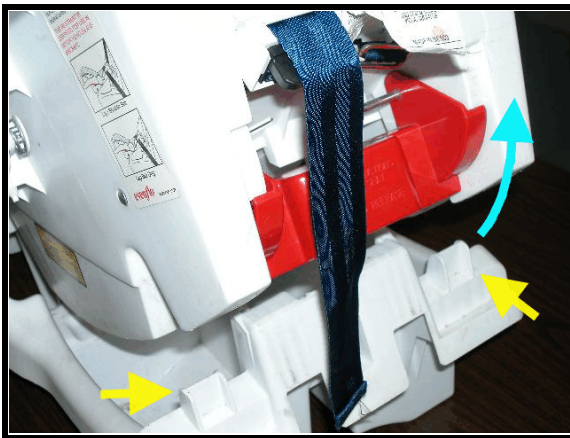
After the initial impact, the infant seat came out of the base. The infant was found upside down, in the infant seat, behind the driver's seat. The seat base was found in place, still anchored to the vehicle. There were no indications that the seat base/seat locking mechanism failed.

For the infant seat to come out of the base it would have been necessary for the release handle on the leading side of the infant seat to be rotated upward. The amount of movement and the force required for movement is minimal.

Figure 22. Seat release movement

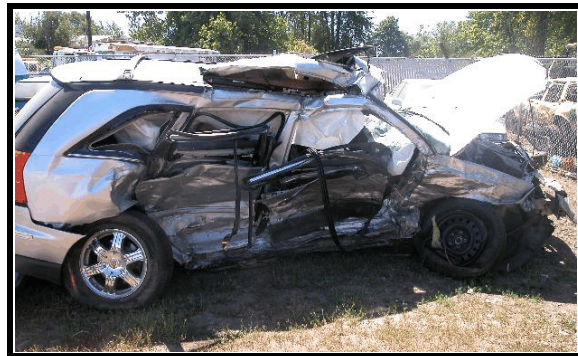
This vehicle sustained 277.0 cm (109.0 in) of direct contact to the right side from the impact with the front of the Volkswagen. The damage began at the right rear axle and extending forward. The residual crush measured at the mid door level was as follows: C1=0 cm (0 in), C2=64.0 cm (25.2 in), C3=78.0 cm (30.7 in), C4=79.0 cm (31.1 in), C5=45.0 cm (17.7 in), C6=0 cm (0 in). The maximum crush was measured at C4. The principle direction of force was within the 2 o'clock sector and was an estimated 70 degrees. All the glazing on the right side was disintegrated from impact forces. Both right side doors were jammed shut. The right side wheelbase was shortened by 45.0 cm (17.7 in). The windshield was damaged and cracked.

Figure 24. Right side, Chrysler Pacifica

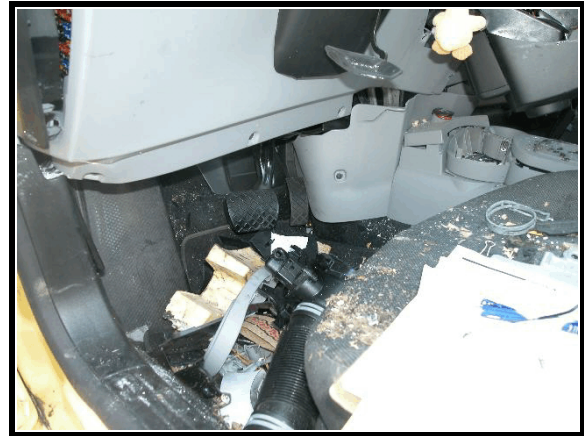
The 55-year-old female driver of the Volkswagen Beetle was seated in the fabric covered bucket seat in a normal, upright fashion. The seat was adjusted to the rear most track position. The seat back was slightly reclined. She was wearing the available lap and shoulder belt. Her right foot was on the brake, the left on floor. She reported that she did not take an evasive steering actions. Both hands were on the steering wheel. At impact with the Chrysler Pacifica, the frontal air bag deployed. The female driver exhibited a forward and slightly left trajectory in response to the 11 o'clock direction of the impact force. She loaded the safety belt—causing hip and torso contusions. She flexed forward and engaged the deployed air bag. Both of her knees and lower legs engaged the lower instrument panel—causing a right fibula fracture, lower leg abrasions, and an indirect loading type right femur fracture. The driver's right foot flexed laterally due to the braking and impact and she sustained an open fracture/dislocation to her right ankle.

Figure 29. Left lower instrument panel and foot controls

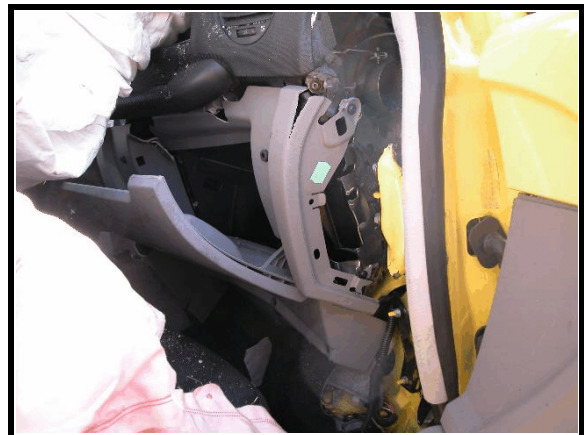
The 25-year-old female front right passenger was seated in the fabric covered bucket seat in a normal, upright fashion. The seat was adjusted to the rear most track position. The seat back was slightly reclined. She was wearing the available lap and shoulder belt. Both of her feet were likely on the floor. At impact with the Chrysler Pacifica, the frontal and right side air bags deployed. This female occupant exhibited a forward and slightly left trajectory in response to the 11 o'clock direction of the impact force. She loaded the safety belt—causing right side rib fractures and a pulmonary contusion from contact to the shoulder belt. Her right knee contacted the glove box door—causing a knee laceration and indirect loading to the right acetabulum causing dislocation of the right femur. This same motion caused a full thickness tear through the right abductor muscle.

Figure 30. Contact to glove box door

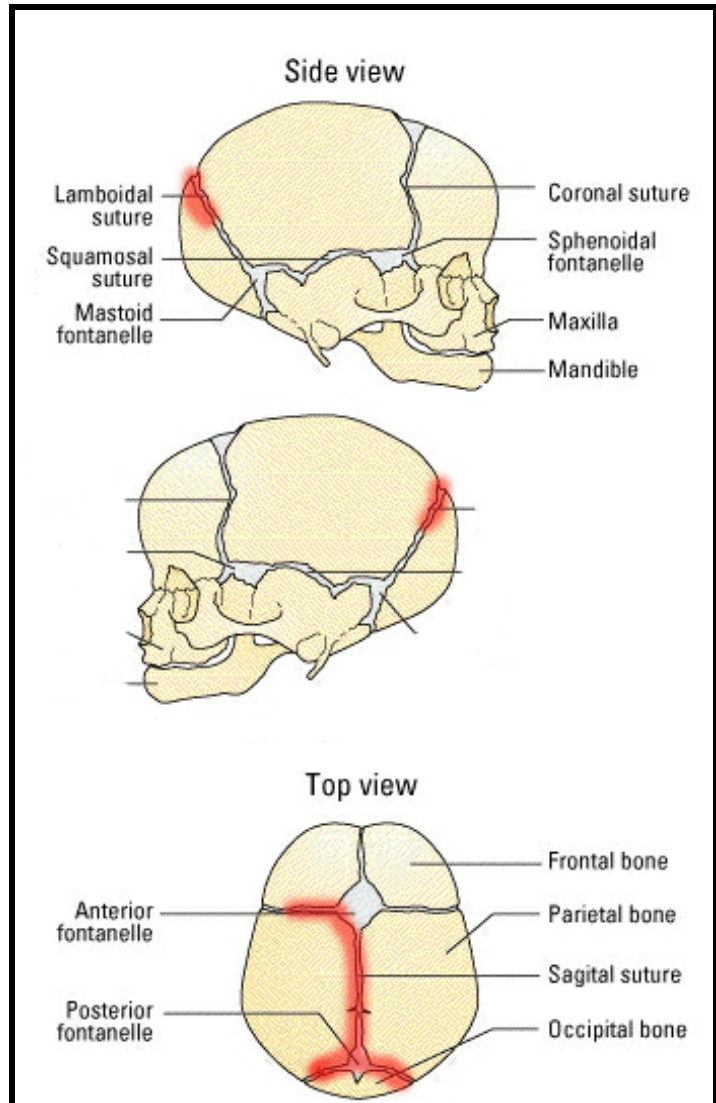
The 8-month-old male rear right seat occupant had been placed in an Evenflo Discovery rear-facing 3-point infant seat. The child was properly restrained with the carrying handle left in the up position. The infant seat was designed with a detachable stay-in-vehicle base. The base was anchored to the vehicle using the available lap and shoulder belt. At impact, the child and infant seat responded to the 11 o'clock direction of force by moving forward and to the left. There are clear indications that the child was initially held in place by the infant seat harness. There were bilateral shoulder contusions/abrasions, most significantly on the right side. He engaged the shoulder harness on the right side—causing a right side clavicle fracture. The child's head engaged and loaded the interior of the infant seat—causing the skull fractures and brain injuries. The skull injuries appear to be loading type injuries that formed along the skull sutures. The child seat was being reinforced by the front right seat back. The plastic shell of the child seat was fractured due to contact with the front seat back.

Figure 31. Fracture lines along sutures (fractures in red)
