**CALSPAN ON-SITE CERTIFIED ADVANCED 208-COMPLIANT  
VEHICLE CRASH INVESTIGATION**

**SCI CASE NO: CA04-016**

**VEHICLE: 2004 CHEVROLET SILVERADO PICK-UP TRUCK  
LOCATION: NORTH CAROLINA  
CRASH DATE: MARCH 2004**

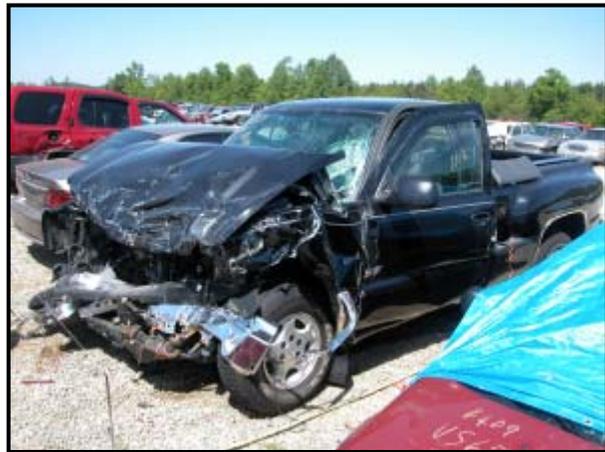
This investigation focused on the performance of the Certified Advanced Compliant (CAC) occupant protection system in a 2004 Chevrolet C1500 Silverado pick-up truck, **Figure 1**. This advanced occupant protection system was comprised of dual-stage frontal air bags, seat track position sensors for both front seats, front safety belt buckle switches and a front right occupant detection sensor. The manufacturer certified that this advanced system met the requirements of the advanced Federal Motor Vehicle Safety Standard No. 208. The vehicle's Sensing and Diagnostic control Module (SDM) tailored the deployment of the frontal air bags based on the crash severity and input from these sensors. The SDM had Event Data Recorder (EDR) capabilities that captured pre-crash and crash data related to the event. The EDR recorded a deployment event that was downloaded during the inspection and was used as a supplement to the on-site investigation. The Chevrolet was involved in a head-on collision with a 1983 Ford F250 pick-up truck. The driver bag in the Chevrolet deployed as a result of the crash. The 50-year old restrained male driver of the Chevrolet sustained multiple injuries and was transported to a medical center for treatment. The 31 year old unrestrained driver of the Ford was fatally injured in the crash.

**Figure 1: Front left oblique view of the subject vehicle.**

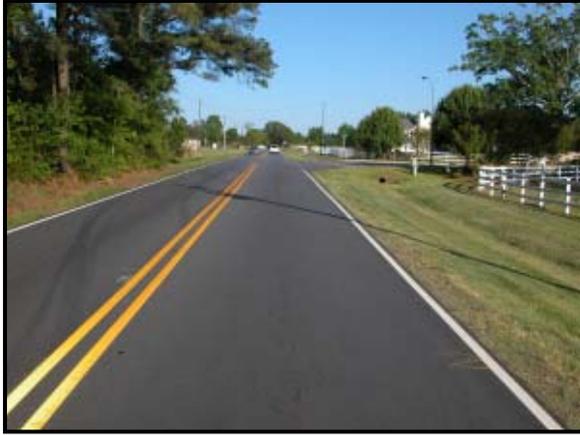
orange paint. The posted speed limit was 89 km/h (55 mph). **Figure 2** is an eastbound trajectory view at the crash site 61 m (200 ft) from the point of impact. **Figure 3** is an eastward view of the point of impact and the final rest positions of the vehicles.

**Figure 2: Eastbound trajectory view 61 m (200 ft) from the point of impact.**

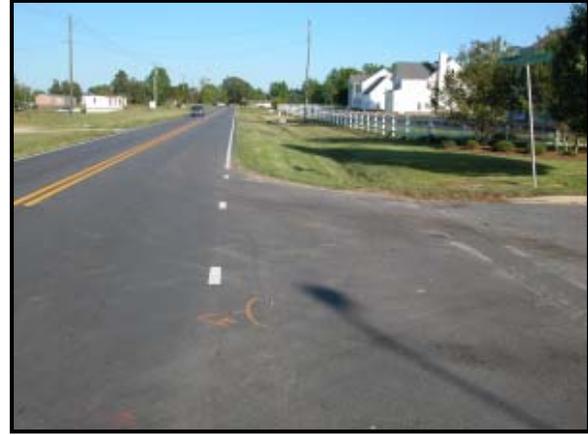
**Figure 3: Point of impact and final rest of the vehicles in the mouth of the intersection.**

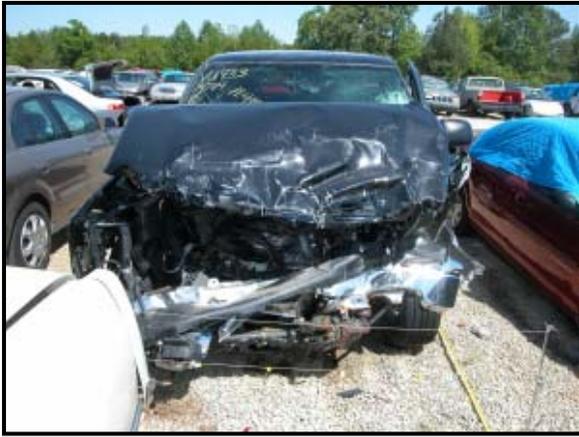
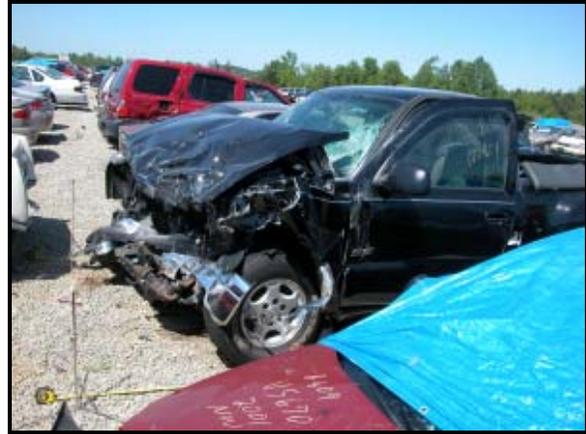
**Figures 4 and 5** are the front and left lateral views of the Chevrolet. The front plane of the Chevrolet sustained a combined width of direct contact and induced damage that extended across the vehicle's 167.6 cm (66.0 in) front end width. The direct contact damage began 46 cm (18 in) right of center and extended 122 cm (48 in) to the left front corner. The direct contact began immediately outboard of the right frame rail. The damaged components included the front bumper, center grille, headlamp assemblies, hood and left front fender. The direct contact of the surface of the hood extended 61 cm (24 in) rearward of the hood face. The damage profile was biased to the left side. The residual crush was measured along the front bumper was as follows: C1 = 70 cm (27.6 in), C2 = 58 cm (22.8.in), C3 = 52 cm (20.5 in), C4 = 47 cm (18.5 in), C5 = 32 cm (12.6 in), C6 = 20 cm (7.9 in). The maximum crush was located at C1, the left front bumper corner. The left sill buckled 23 cm (9 in) rearward of the A-pillar. The left wheelbase was reduced 20 cm (8.0 in). The left front tire was displaced rearward to the aft aspect of the wheel opening and was restricted. The right wheelbase was reduced 4 cm (1.5 in). The lower left aspect of the windshield was fractured from the exterior impact force. The left door was jammed closed by the impact. It was opened by the emergency responders. There was evidence of extrication at the door latch. There was cab-to-bed contact on the left side due to the compressive force of impact. The Collision Deformation Classification (CDC) was 12-FYEW-3.

**Figure 4: Front view of the Chevrolet.**

**Figure 5: Left lateral view.**

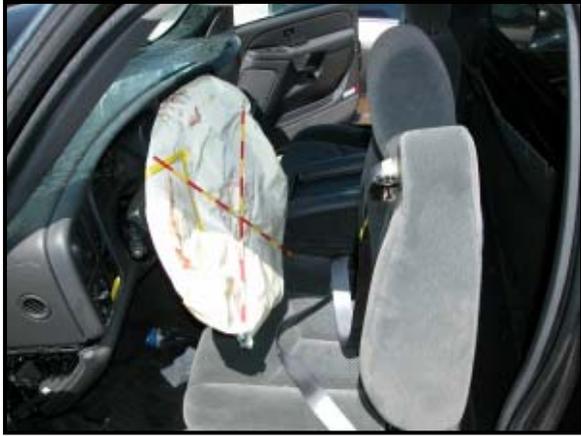
**Figure 6** is a left interior view of the Chevrolet. The interior damage to the Chevrolet consisted of the deployment of the driver air bag, the driver interior contacts, and minor intrusion. The left corner of the instrument panel intruded rearward 4 cm (1.5 in). The intrusion of the outboard aspect of the toe pan measured 5 cm (2 in).

The 4-spoke steering wheel was rotated 80 degrees clockwise at inspection. The tilt adjustment was in the center position. There was no deformation of the steering wheel rim. There was complete shear capsule separation estimated at 5 cm (2 in). The compressed steering column was captured by the deformed metal backer located behind the driver knee bolster, **Figure 7**. The rigid plastic knee bolster exhibited a 5 cm (2 in) diameter contact scuff mark on the steering wheel centerline. The bolster panel compressed forward 9 cm (3.5 in) as evidenced by the deformation of the metal backer located behind the panel. This deformation resulted from contact with the driver's lower extremities. The upper left aspect of the instrument panel, immediately adjacent to HVAC vent, exhibited residual blood evidence from a left upper extremity contact. There were no other identified occupant contacts to the interior.

Figure 6: Left front interior view.

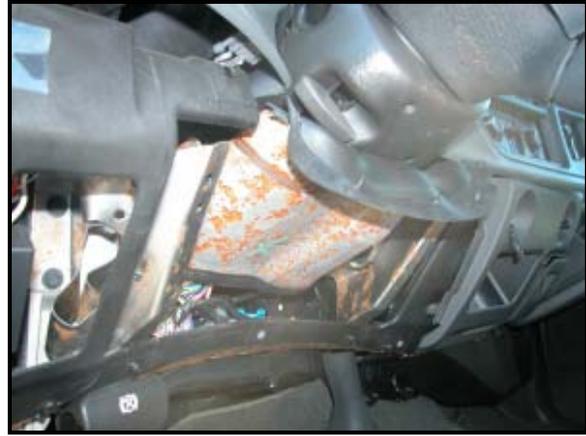
Figure 7: Deformation of the metal backer behind the knee bolster.

The 50 year old driver was seated in a rear track position in a presumed upright posture. He was restrained by the vehicle's integrated three-point lap and shoulder belt system. Upon impact with the Ford, the manual restraint's ELR retractor locked and the CAC advanced driver air bag deployed. The driver initiated a forward trajectory in response to the 12 o'clock direction of the impact force and loaded the locked belt system. The driver's hands were displaced from the steering wheel rim by the force of the crash and impacted the instrument panel forward of his seated position. The contact of his upper extremities with the instrument panel resulted in the identified fractures. The driver loaded the belt system with his torso and pelvis and as the driver rode down the force of the impact, this load was transferred into the seat back through the integrated belt system. The driver's seat back deflected forward damaging the recline mechanism. The driver's right lower extremity impacted and deformed the knee bolster and its metal backer forward. This contact resulted in the right tibia plateau fracture and fibula fracture.

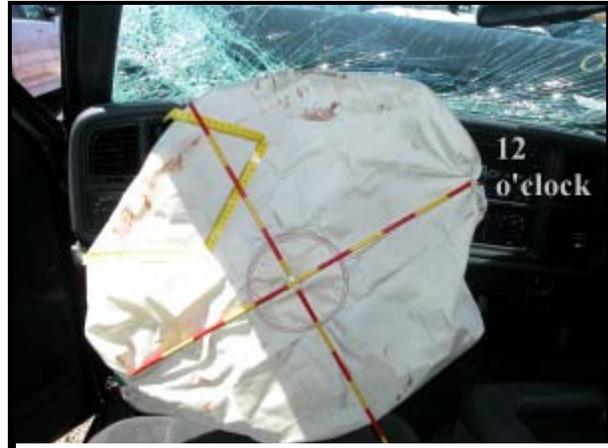
The driver air bag, **Figure 8**, deployed from an I-configuration module located in the center hub of the steering wheel rim. The symmetrical cover flaps measured 8 cm x 11 cm (3 in x 4.5 in), width by height, respectively. The flaps opened at the designed tear seams during the deployment sequence and were not damaged. There was no evidence of occupant contact. The deployed driver air bag measured 61 cm (24 in) in diameter. The bag was tethered by two 10 cm

(4 in) wide straps in the 3/9 o'clock sectors and was vented by two 3 cm (1.2 in) diameter ports located in the 11/1 o'clock sectors. The 8 through 9 o'clock sectors of the air bag revealed evidence of an expansion scuff. The face of the bag was abraded over a radial length of 17 cm (6.5 in) measured from the perimeter seam. The air bag was spattered with post-crash blood evidence.

**Figure 8: Driver air bag.**

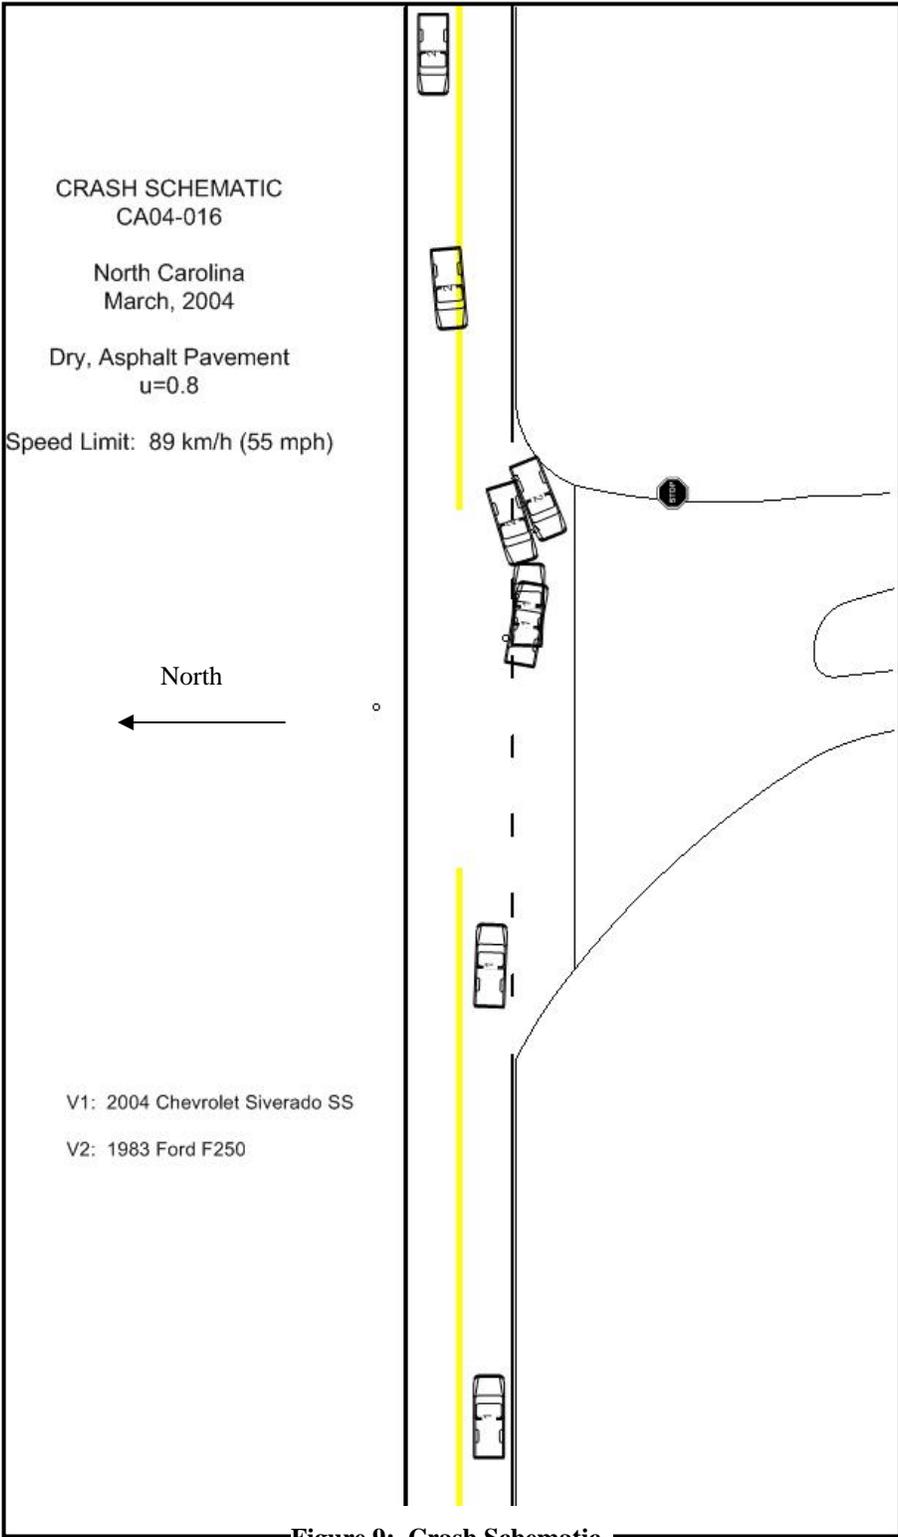
Figure 9: Crash Schematic

The driver of the Chevrolet steered his vehicle to the right in an attempt to avoid the Ford as it encroached into his lane and began to brake. The EDR reported the Chevrolet's brakes were activated two seconds (T-2) prior to AE. There was a corresponding reduction in Engine RPM, and Percent Throttle. The speed of the Chevrolet reduced to 53 km/h (33 mph) one second (T-1) prior to AE. The right steer maneuver positioned the Ford in the mouth of the intersection. Coincident to this, the Ford continued its errant trajectory through the eastbound traffic lane and also entered the mouth of the intersection. Due to the speeds of the respective vehicles and the separation distance, the Chevrolet driver's avoidance maneuver directed his vehicle into the impact. A schematic of the crash is attached to the end of this report as **Figure 9**.

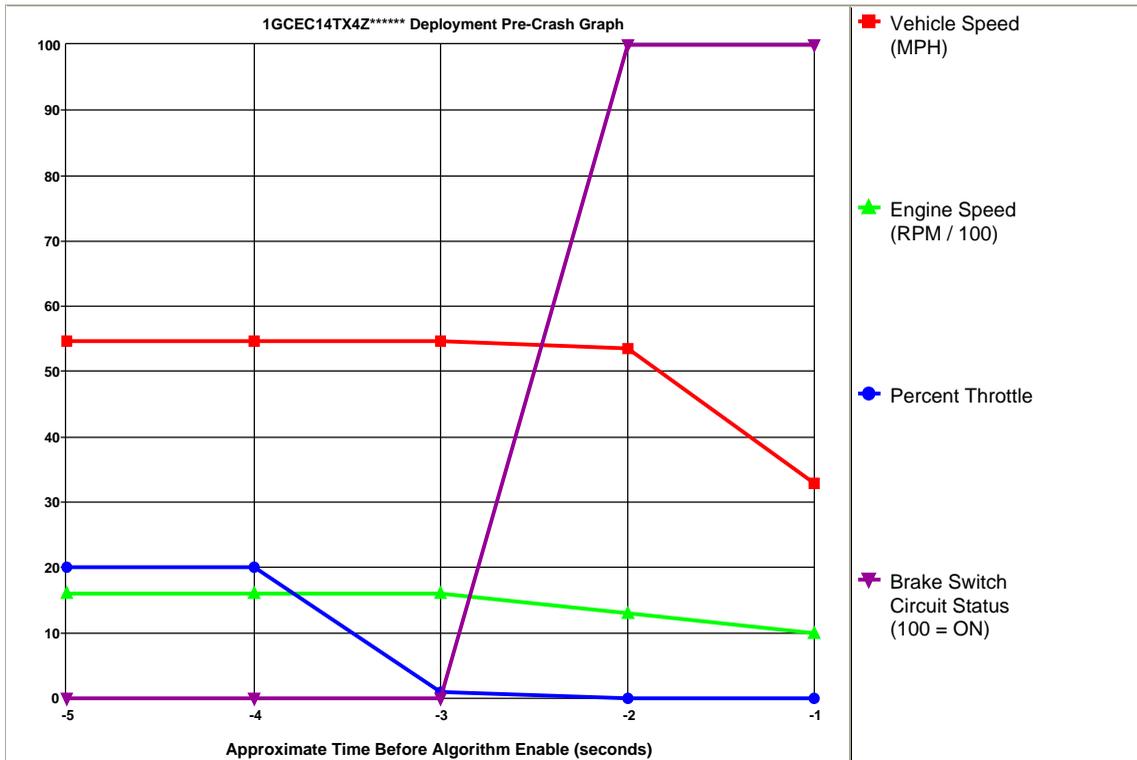
Seconds Before AE	Vehicle Speed (MPH)	Engine Speed (RPM)	Percent Throttle	Brake Switch Circuit Status
-5	55	1600	20	OFF
-4	55	1600	20	OFF
-3	55	1600	1	OFF
-2	53	1344	0	ON
-1	33	960	0	ON

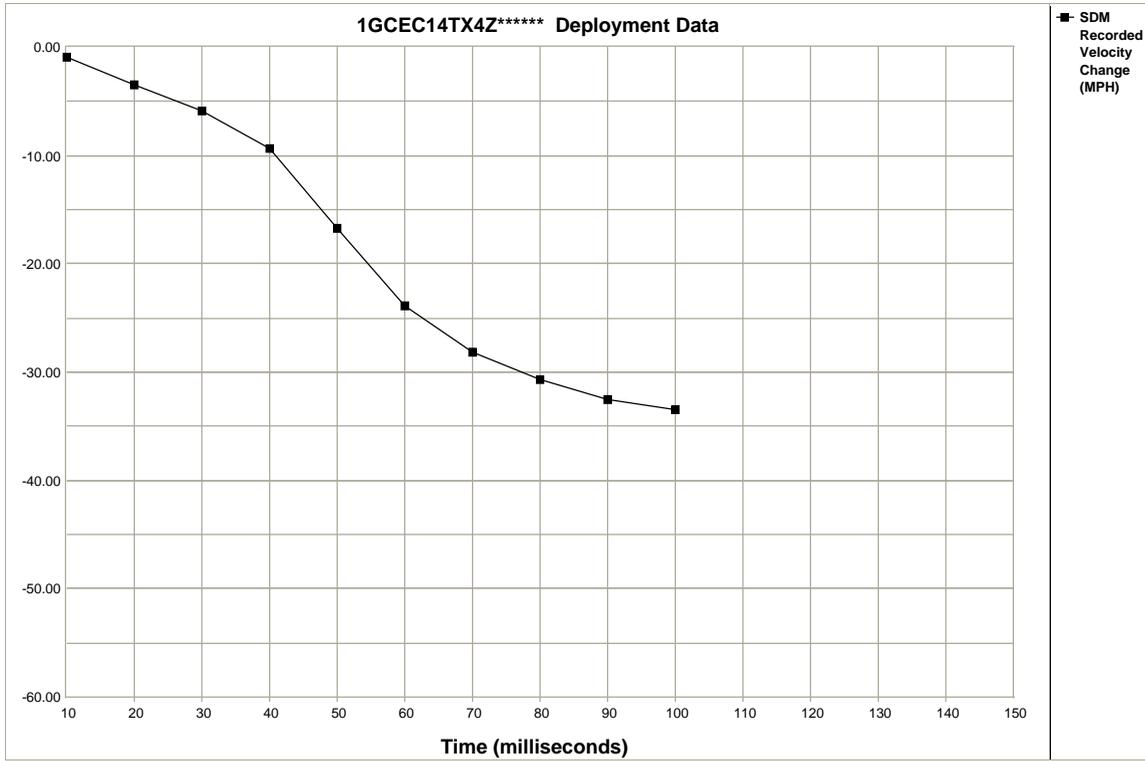
Time (milliseconds)	10	20	30	40	50	60	70	80	90	100	110	120	130	140	150
Recorded Velocity Change (MPH)	-0.93	-3.41	-5.89	-9.30	-16.74	-23.87	-28.21	-30.69	-32.55	-33.48	N/A	N/A	N/A	N/A	N/A

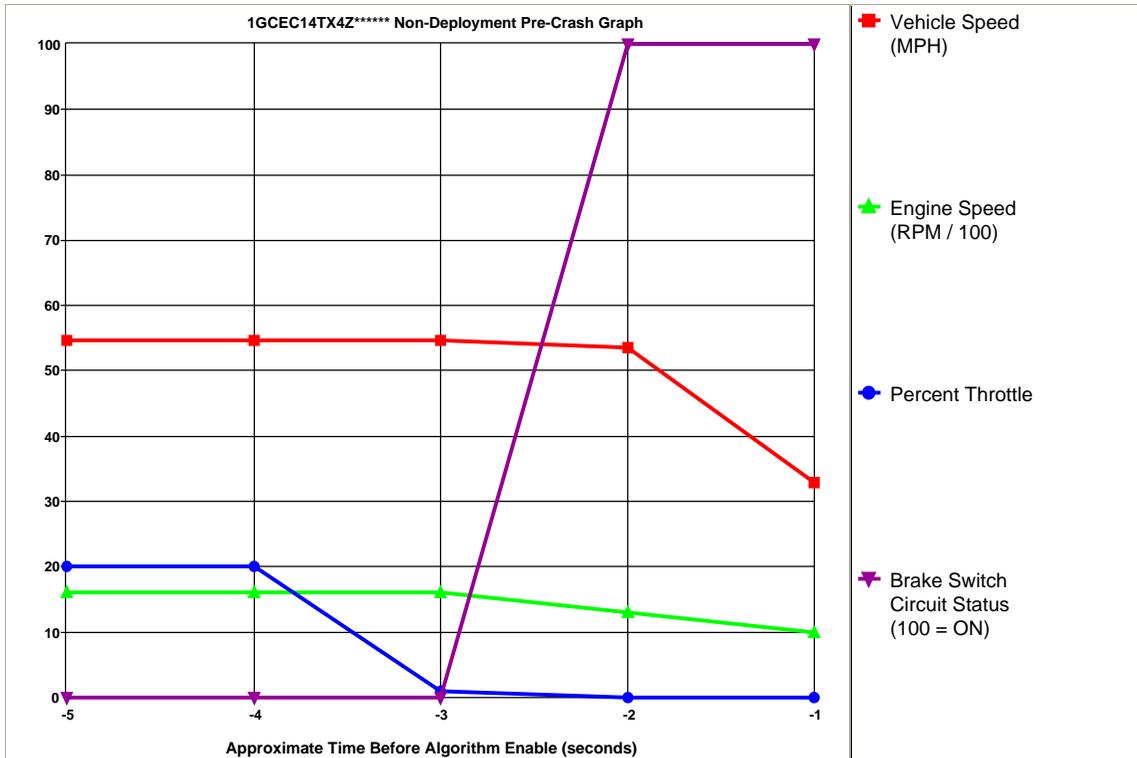
Seconds Before AE	Vehicle Speed (MPH)	Engine Speed (RPM)	Percent Throttle	Brake Switch Circuit Status
-5	55	1600	20	OFF
-4	55	1600	20	OFF
-3	55	1600	1	OFF
-2	53	1344	0	ON
-1	33	960	0	ON

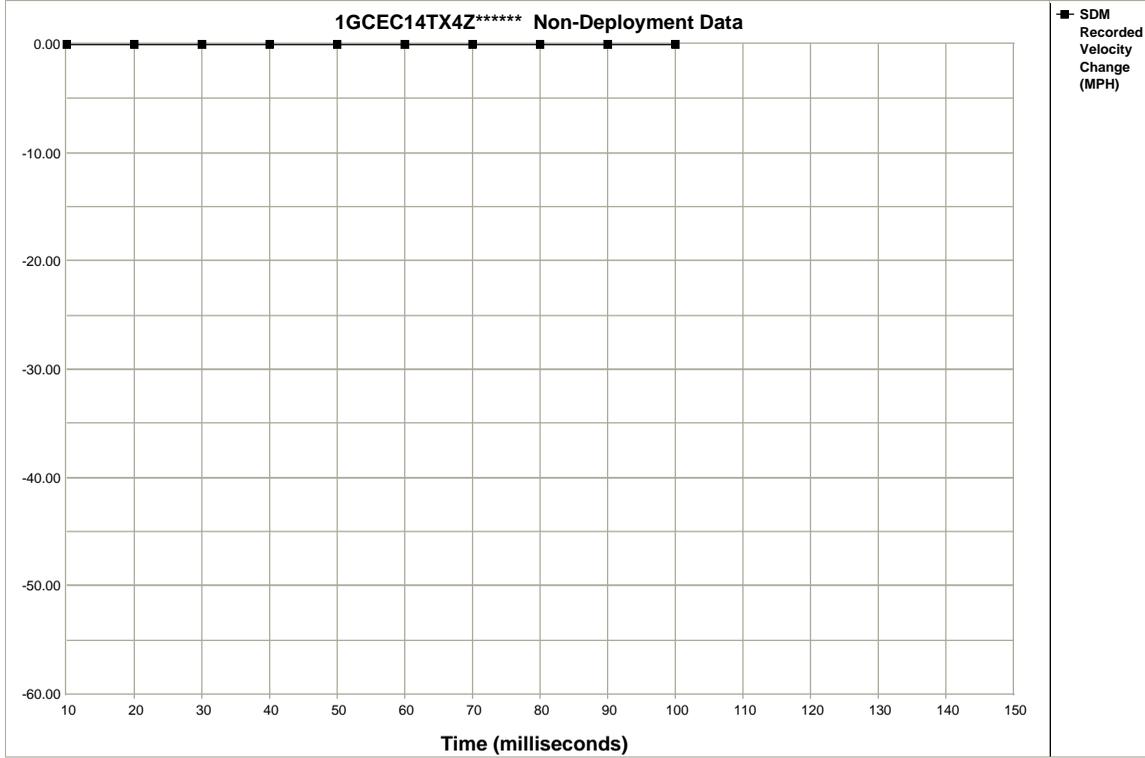
Time (milliseconds)	10	20	30	40	50	60	70	80	90	100	110	120	130	140	150
Recorded Velocity Change (MPH)	0.00	0.00	0.00	0.00	0.00	0.00	0.00	0.00	0.00	0.00	N/A	N/A	N/A	N/A	N/A
