Ford Safety Canopy/Child Safety Seat Investigation /Rollover  
Dynamic Science, Inc. / Case Number: DS04016  
2003 Ford Expedition  
California  
July, 2004

1. Report No. DS04016	2. Government Accession No.		3. Recipient Catalog No.	
4. Title and Subtitle Ford Safety Canopy/Child Safety Seat Investigation			5. Report Date April 6, 2006

**Dynamic Science, Inc.**  
**Crash Investigation**  
**Case Number: DS04016**

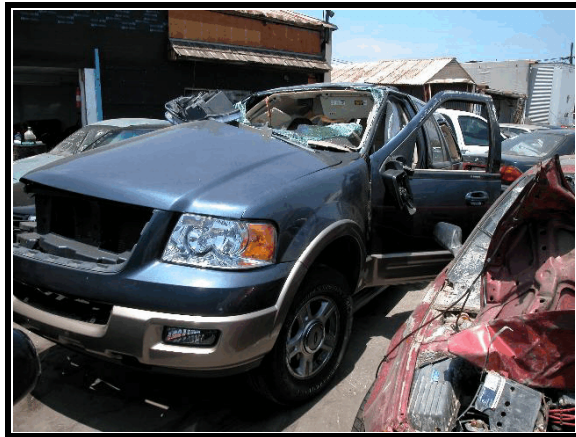
Figure 1. Front left, Ford Expedition

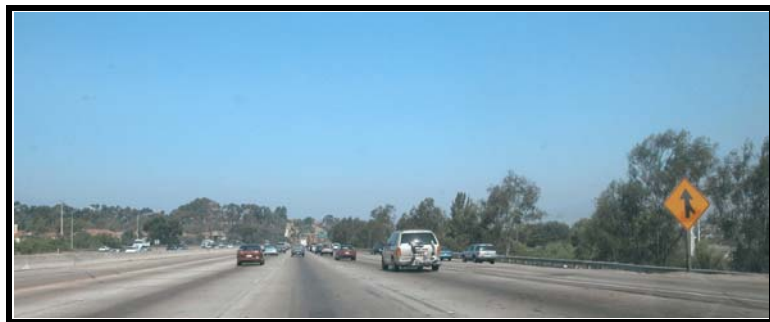
Figure 2. Overview of crash scene - north

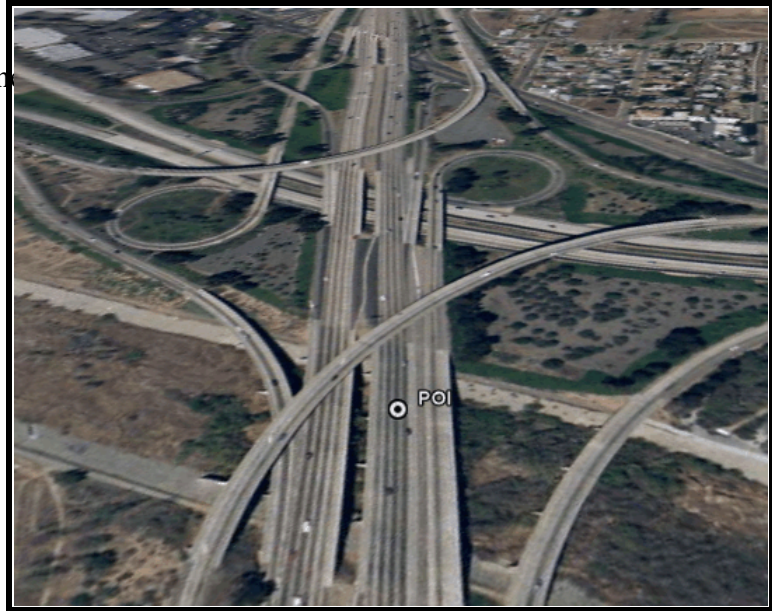
**Figure 3.** Overview of roadway—looking toward the north

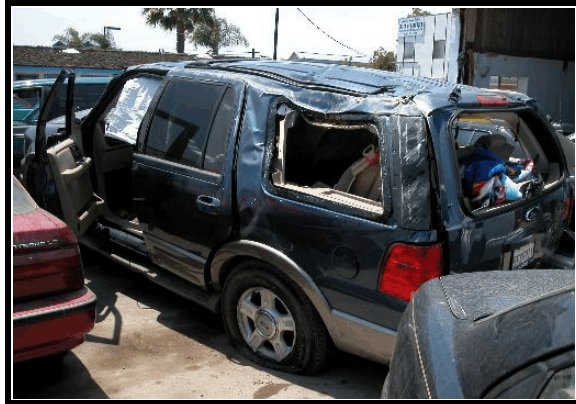
Figure 4. Left rear, Ford Expedition

Damage Description: Rollover damage on all planes. Windshield cracked. Side glass and backlight disintegrated. Right front tire missing. Left rear and right rear tires flattened with rim damage. Rim damage to front left.

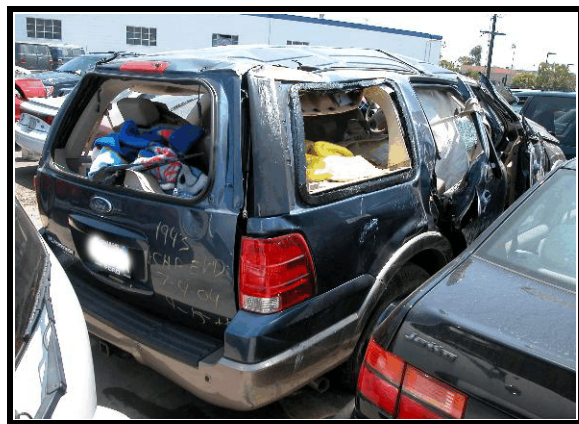
Figure 5. Right rear, Ford Expedition

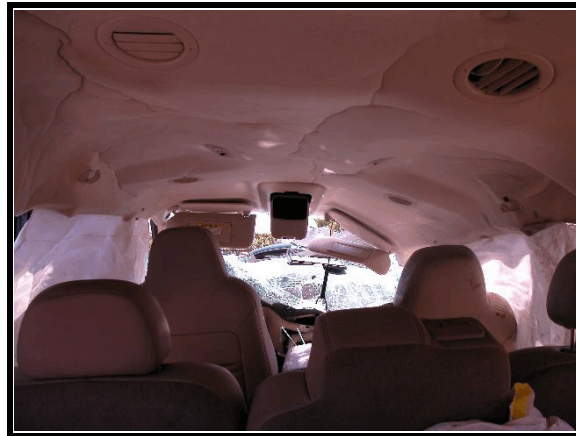
**Figure 6.** Overview of vehicle interior

The 2003 Ford Expedition sustained moderate interior damage as a result of passenger compartment intrusion and occupant contacts. The left and right A pillars, windshield header, B pillar, roof and both roof rails intruded into the passenger compartment. The glazing was disintegrated for all right side positions, the backlight, and the front and rear left side positions. The windshield was cracked. Both right side doors were jammed shut. Both side curtains deployed during the rollover sequence. The entire instrument panel was shifted. There were blood patterns found on the left side of the right front seat, on the right side air curtain, on the right roof rail, on the front of the third row right seat, and on the child seats. Strands of hair were found embedded in the remaining side glass at the third row right seat position.

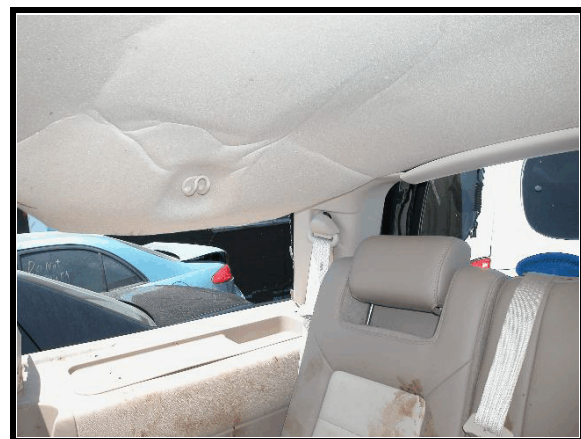
**Figure 7.** Third row, right side, area of ejection

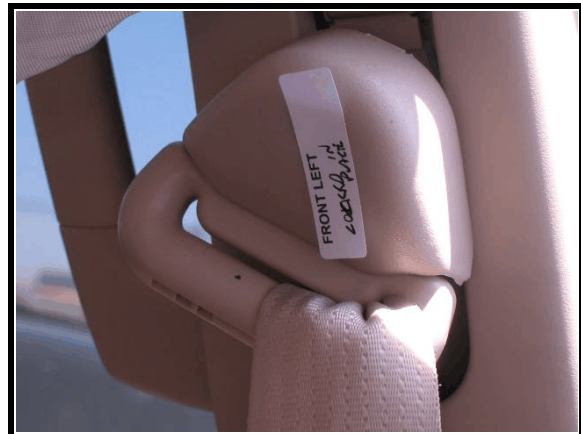
**Figure 8.** Driver's seat belt, webbing locked in D ring

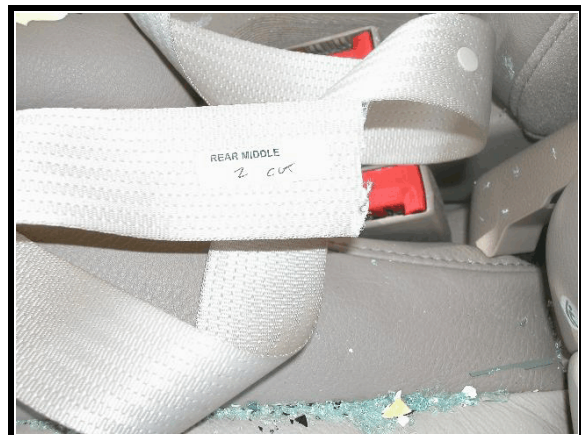
**Figure 9.** Second row, center, seat belt cut

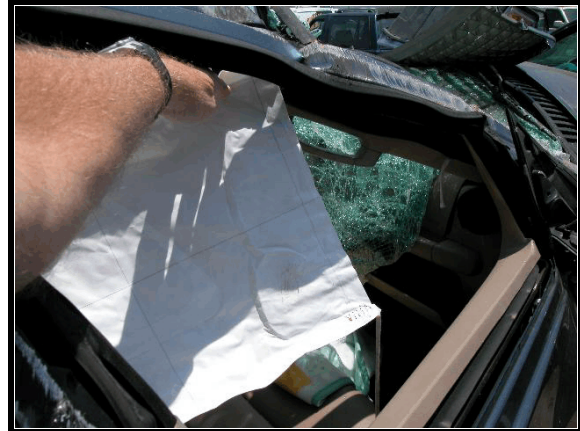
There was no damage or occupant contacts found on the left curtain. On the right side curtain there were road abrasions to the exterior of the curtain within the confines of the front right glass area. The front tether and portions of the curtain had been cut during extrication efforts. There was blood found on the inside of the curtain from the B pillar rearward.

**Figure 10.** Road abrasions to front right portion of side curtain

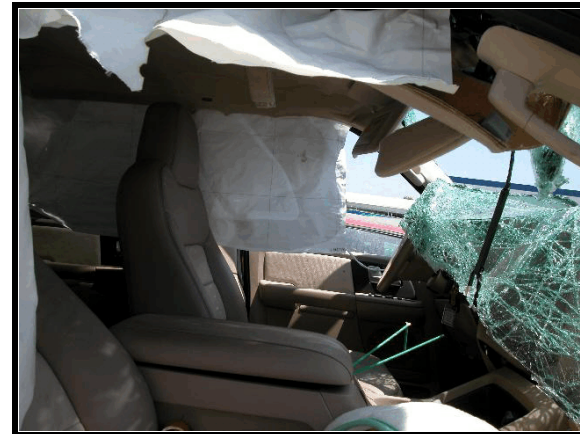
**Figure 11.** Left front interior view of side air curtain

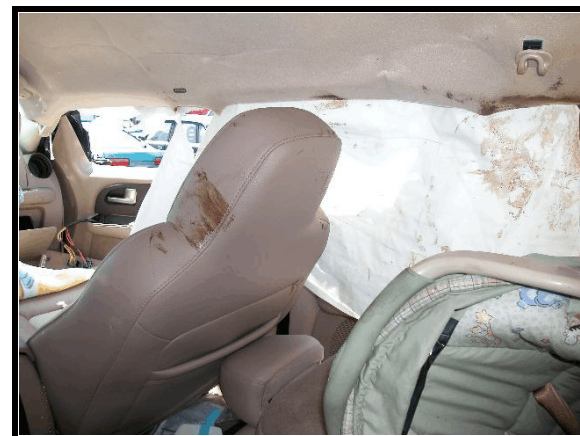
**Figure 12.** Blood pattern to right interior side curtain

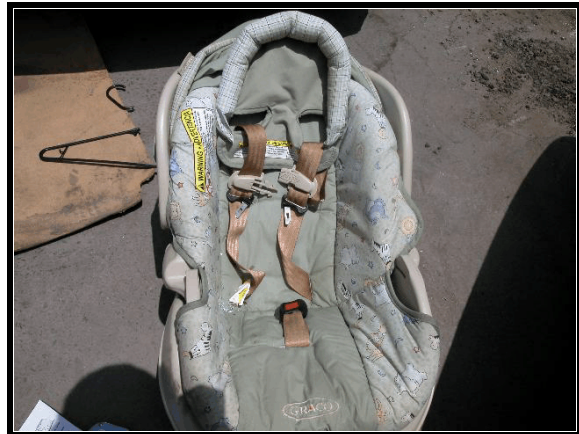
The 4-month-old male second row middle seat occupant (05) was seated in a Graco Snug Ride Model 7446 STA infant safety seat (Mfg. date 11/25/03). He was not using the child seat harness. The manufacturer recommends that the infant car seat is to be used rear-facing only and is for infants up to 9 kg (20 lbs) and less than 66 cm (26 in) tall. The seat is designed with a stay-in-vehicle base. The seat is equipped with a lower anchorage attachment. According to EMS personnel, the seat base had been tightly anchored to the vehicle using the available lap and shoulder belt and the child seat was still attached to the seat base. The belt was equipped with a switchable retractor but it is not known if the belt was in the automatic locking or emergency locking mode. Emergency personnel found it necessary to cut the seat belt in order to extricate other occupants.

The child in this seat was ejected and fatally injured. The child seat and seat base remained in the vehicle.

**Figure 13.** Graco Snug Ride infant safety seat, second row middle seat position

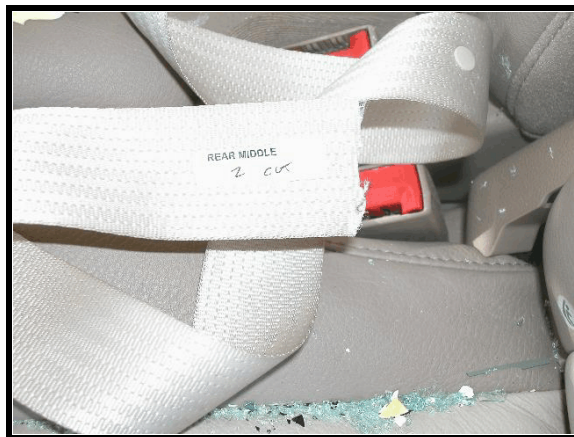
**Figure 14.** Second row, center, seat belt cut

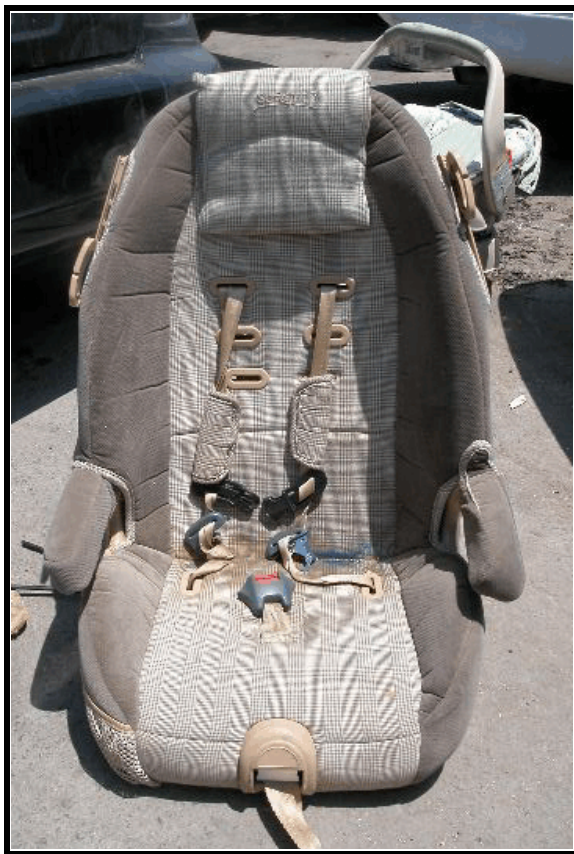
The 1-year-old female third row middle seat occupant was seated in a forward facing Dorel Safety 1<sup>st</sup> Vantage Point child safety seat (Mfg. date 12/17/2001). The Vantage Point 02-460 is designed for children from 10-45 kg (22-100 lbs). For children 10-18 kg (22-40 lbs), the 5-point harness adjusts with a front pull adjust system. The harness has 3 height positions to adapt to the child's growth. The harness was found in the top most position at the time of inspection. With the harness removed, the seat converts to a belt-positioning booster for children 14-45 kg (30-100 lbs). Five-position belt guides on both sides help provide shoulder belt fit. The child seat was anchored to the vehicle seat. Apparently there was too much slack which allowed the child seat to rotate during the crash. The child was using the internal 5-point harness. It is not known if the harness was being used properly. There was some loading to the left arm rest and it was deformed outward. There was also blood found on the base of the seat on the right side.

**Figure 15.** Dorel Safety 1<sup>st</sup> child safety seat, front view

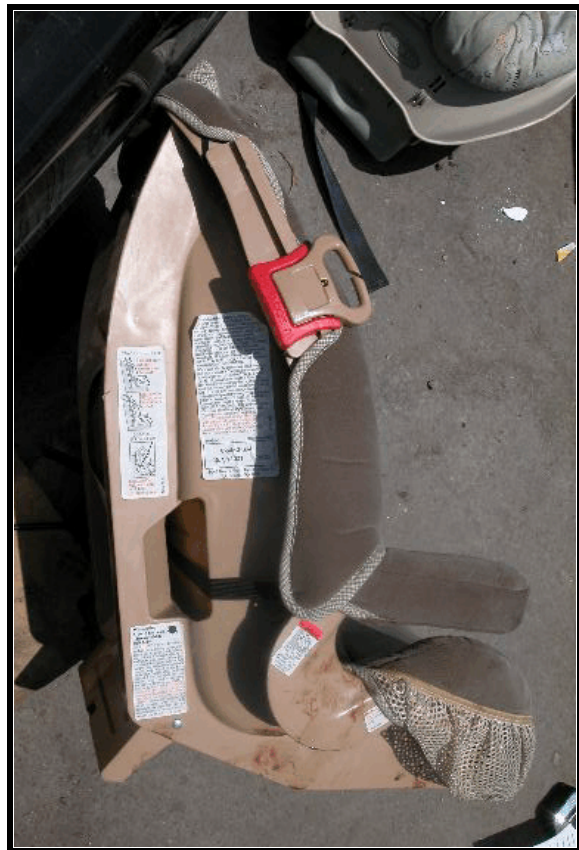
**Figure 16.** Dorel Safety 1<sup>st</sup> child safety seat, side view
