## REMOTE AIR BAG DEPLOYMENT REPORT

CASE NUMBER - IN-04-017

VEHICLE - 1997 Mercury Mountaineer

| 4. Title and Subtitle<br>Remote Child Air Bag-Related Fatality Investigation<br>Vehicle - 1997 Mercury Mountaineer<br>Location - Arkansas | | | 5. Report Date:<br>March 15, 2005 | | |

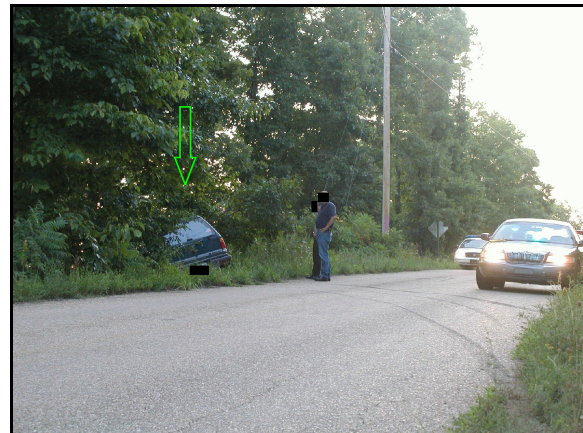
The case vehicle was traveling eastward in the eastbound lane of a two-lane county road and intended to continue straight ahead. It was dark (i.e., not yet dawn and not lighted) and the weather was clear. The roadway was straight and level, the asphalt surface was dry and free of defects with very faded double yellow painted lines separating the east and westbound lanes, no edge lines, no shoulders and no posted speed limit. A loose object (wooden sawhorse) fell out of an eastbound pickup truck that was ahead of the case vehicle. The case vehicle's driver steered to the right and probably braked, successfully avoiding the loose object. The case vehicle went off the right (south) side of the roadway and the driver steered sharply left. The case vehicle re-entered the roadway in a counterclockwise yaw, traveled obliquely across the roadway leaving critical curve scuffs and continued off the north (left) edge. The crash occurred on the roadside, a short distance off the north (left) road edge (Figure 1).

**Figure 1:** East-west roadway at crash site, showing critical curve scuffs leading to north road edge departure and case vehicle's back (arrow) at final rest (case photo #02)

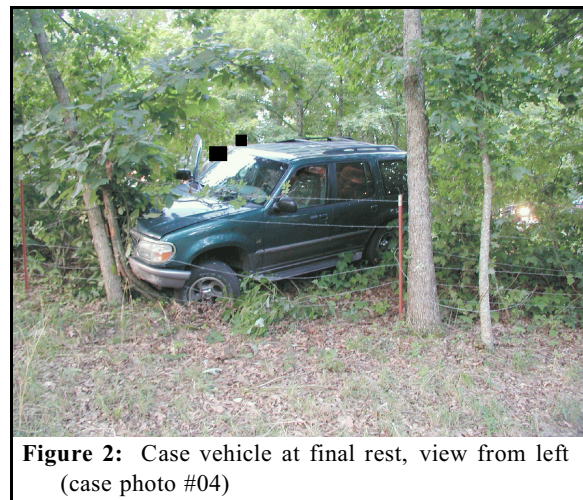
**Figure 2:** Case vehicle at final rest, view from left (case photo #04)

centimeters [4 inches] in diameter and it was approximately 0.5 meters [20 inches] south of the fence and larger tree. Two out of six strands of the barbed wire fence were broken (i.e., the case vehicle did not penetrate through the fence). The larger tree had a diameter of approximately 20 centimeters [8 inches] and was immediately adjacent to the inside edge of the fence. The roadside terrain sloped downhill from the road surface. At final rest, the case vehicle was heading north on the downhill slope, tilted to its left, with its front against the smaller tree and the barbed wire strands entangled in its grille and left headlamp assembly (**Figures 2 and 3**).

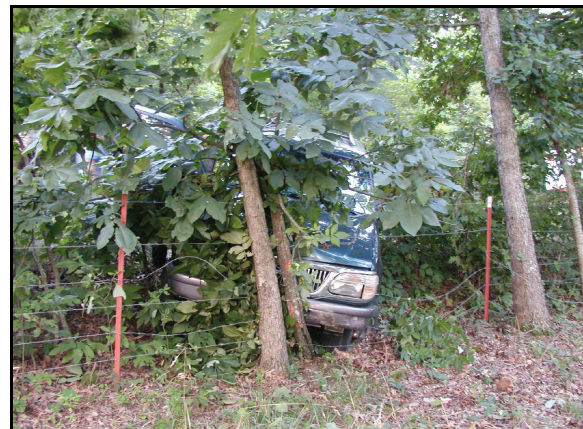
**Figure 3:** Case vehicle at final rest, view from front (case photo #09)

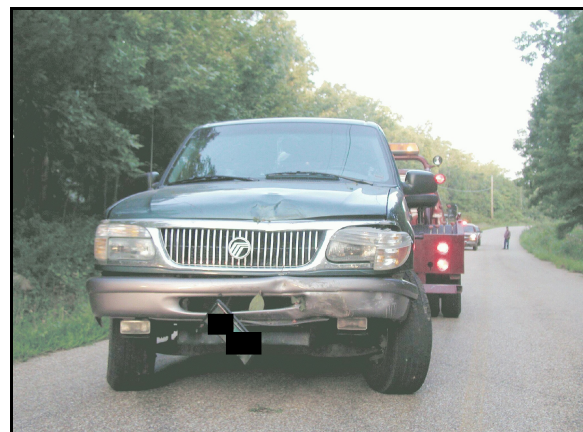
The case vehicle sustained dents and scrapes on the left half of the front bumper and at the center of the grille and hood (**Figure 4**). The hood was slightly deformed and the left headlamp/turn signal assembly was slightly displaced. It appears that the left front suspension/steering assembly may have been slightly damaged, but this cannot be confirmed with the available documentation. None of the tires were deflated or restricted. There was spider web cracking low on the windshield directly above the front right air bag module and no other glazing damage.

The CDC was estimated from the available photographs as **12-FYEW-1 (0)**. Because the case vehicle's impact involved objects that yielded, this collision is out of scope for the WinSMASH reconstruction program. This was a crash of low severity (14-23 km.p.h. [9-14 m.p.h.]) for the case vehicle.

**Figure 4:** Case vehicle's front (case photo #11)

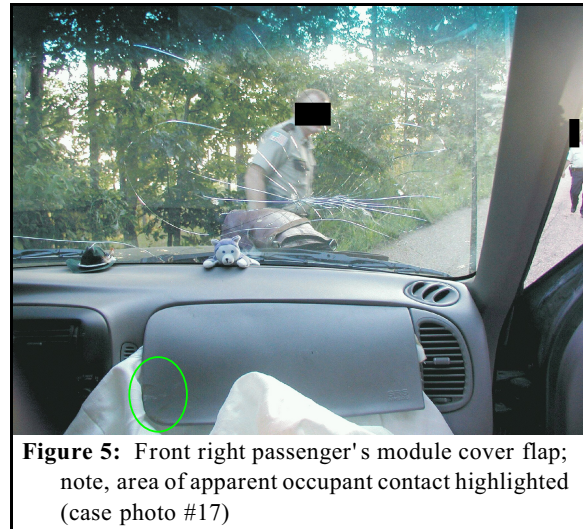
The front right passenger's air bag module was located in the front of the instrument panel, with a single cover flap (**Figure 5**). The available photographs show only a small portion of the air bag fabric and do not provide any closeup views of any air bag system components. There is an area of slight deformation with smudges of what appears to be blood and/or other tissue at the left lower corner of the module cover flap. There is an area of focal cracking low in the windshield that is probably a result of the air bag cover flap striking the glazing. There were particles of sputum on the windshield in the area directly in front of the passenger's seat area.
