Ford Safety Canopy Investigation/Vehicle Rollover  
Dynamic Science, Inc. / Case Number: DS04017  
2004 Ford Expedition  
New Mexico  
June 2004

1. Report No. DS04017	2. Government Accession No.		3. Recipient Catalog No.	
4. Title and Subtitle Ford Safety Canopy Investigation		5. Report Date April 20, 2006

**Dynamic Science, Inc.**  
**Crash Investigation**  
**Case Number: DS04017**

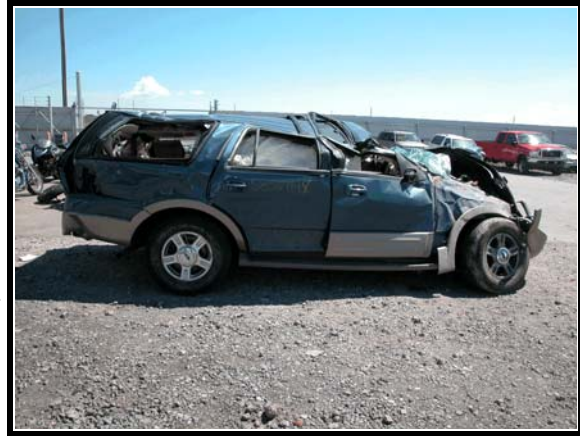
**Figure 8.** Right side of case vehicle

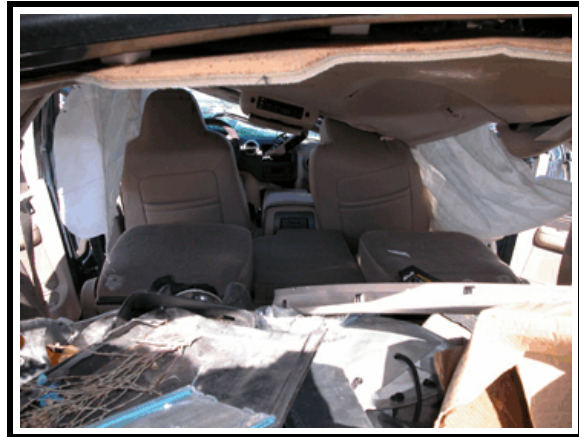
Figure 9. Roof intrusion

In the front left seating area, there was vertical roof and windshield header intrusion. In the front row center area, there was longitudinal intrusion of the center instrument panel. In the front right seating position, there was vertical roof, A pillar and roof side rail intrusion. The maximum intrusion was to the roof rail and was estimated at 33.0 cm (13.0 in). The front right integral head restraint and seat back were deformed due to the vertical intrusion. In the second row left seating location there was vertical roof, B and C pillar intrusion. In the second row center seating position, there was vertical roof intrusion. In the second row right seating position, there was vertical B and C pillar, roof, and roof rail intrusion. In the third row left and right seating positions there was vertical D pillar and roof intrusion. The amount of individual component intrusion is not known.

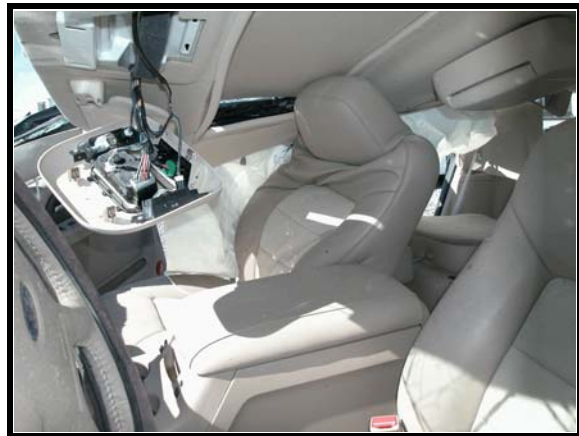
The front seating positions in the 2004 Ford Expedition Eddie Bauer were configured with leather covered bucket seats with integral head restraints. The driver's head restraint was undamaged but the front right head restraint was deformed by vertical roof intrusion. The bucket seats have adjustable seat tracks and seat back cushions.

Figure 10. Front right head restraint and seat back damage

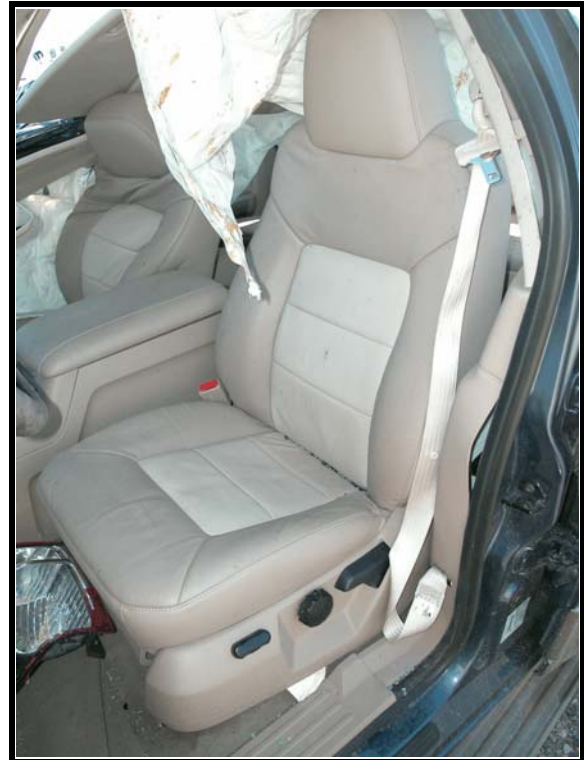
The 2004 Ford Expedition Eddie Bauer was configured with manual 3-point lap and shoulder belts for each of the eight seating positions. Both front seat belts were equipped with pretensioners with load limiters and seat belt height adjusters. It is not known whether or not the front seat belt pretensioners actuated during the crash. The driver and front right passenger seat belt height adjusters were in the full down position. The driver's safety belt was configured with

**Figure 11.** Driver's seat belt

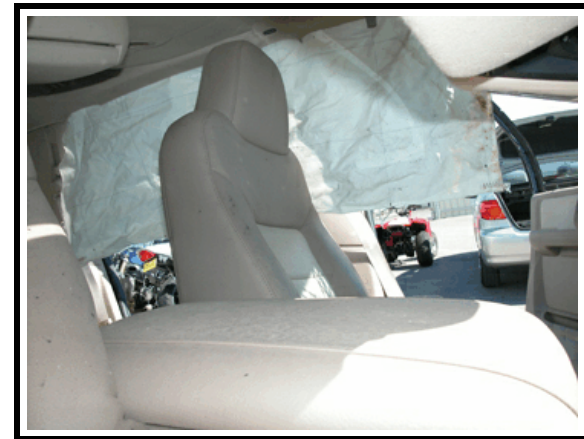
**Figure 12.** Driver's side curtain

Both the left and right canopy side curtains deployed during the crash. The curtains deployed downward from the roof side rails. The curtains were rectangular in shape and measured 139.0 cm (54.7 in) wide by 50.0 cm (19.7 in) high. They are attached to the A pillar by a single 47.0 cm (18.5 in) tether and to the C pillar by a 11.0 cm (4.3 in) tether. Both side windows are essentially covered by the deployed air bag.

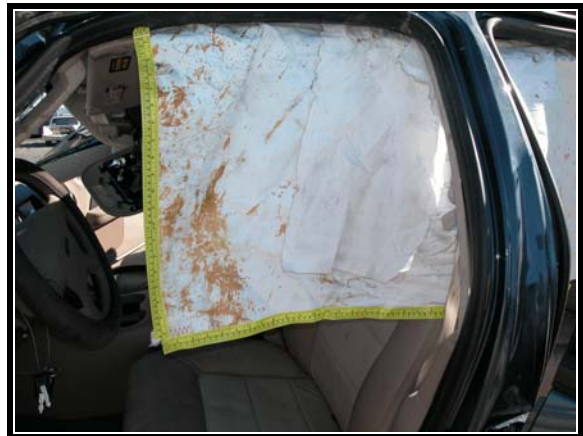
There was no damage or occupant contacts found on the left curtain. The exterior side of the curtain was peppered with dirt marks from the dirt area on the right side of the roadway. On the right side curtain there were module cover transfers on the exterior side of the curtain. The front tethers on both side curtains were cut. The left rear tether had also been cut.

**Figure 13.** Driver's side curtain - Dirt on bag

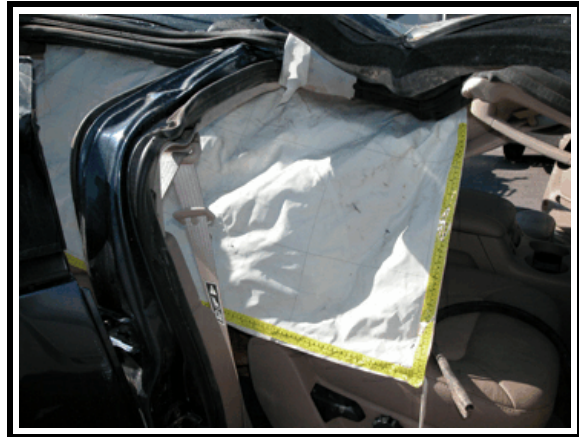
**Figure 14.** Front right side curtain

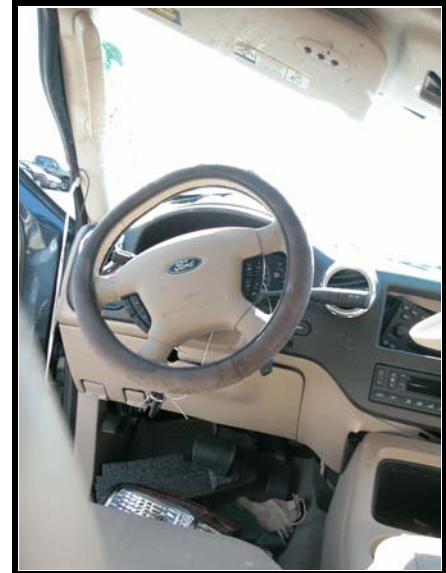
The 48-year-old male driver appears to have been seated in an upright posture in the leather covered bucket seat and was restrained by the available 3-point manual lap and shoulder belt. The shoulder belt anchorage was in the full down position. The seat was adjusted to between the center and rearward most track position. The seat back was reclined at a 105 degree angle. The seat bottom angle is unknown. The driver was asleep when the case vehicle drifted off the left side of the freeway. The driver woke up as the vehicle was in the depressed dirt center median and he tried to get the vehicle back onto the roadway by steering right. While steering right, he overcorrected and lost control of the vehicle. The Ford Expedition went into a clockwise yaw, causing the restrained driver to pitch to his left. The vehicle's left tires made contact with the asphalt shoulder, causing the vehicle to tip and begin to rollover to the left. The Expedition continued rolling across both eastbound lanes, the right shoulder area, and then onto the right dirt area off the roadway's edge. The vehicle rolled twelve quarter turns before coming to final rest on all four wheels, facing southwest. During the rollover event, it is likely that the restrained male driver pitched right and left within his seating area, but very little evidence of occupant contact was found. During the rollover event, the driver's side curtain air bag deployed. It is likely that the driver's upper left torso and head contacted the deployed curtain, but no evidence of occupant contact was found.

Figure 15. Driver's seating area
