**CALSPAN ON-SITE CERTIFIED ADVANCED 208-COMPLIANT
VEHICLE CRASH INVESTIGATION**

SCI CASE NO: CA04-017

**VEHICLE: 2004 HONDA ACCORD
LOCATION: NORTH CAROLINA
CRASH DATE: MARCH 2004**

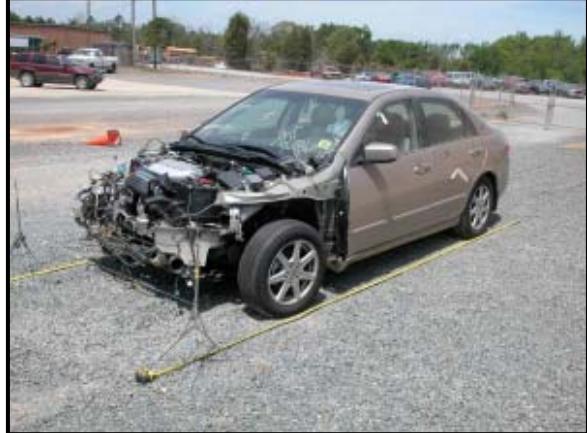
This on-site investigative effort focused on the performance of the Certified Advanced 208-Compliant safety system in a 2004 Honda Accord and the injury sources for the 46 year old restrained female driver. **Figure 1** is a left front view of the Honda. The Honda's CAC system was comprised of dual-stage frontal air bags, seat track position sensors for both front seats, front safety belt buckle switches, front safety belt retractor pretensioners and a front right occupant detection sensor. The frontal air bag system was certified by the manufacturer to have met the advanced air bag requirements of Federal Motor Vehicle Safety Standard 208. The Honda's Air

Figure 1: Left front oblique view of the Honda.

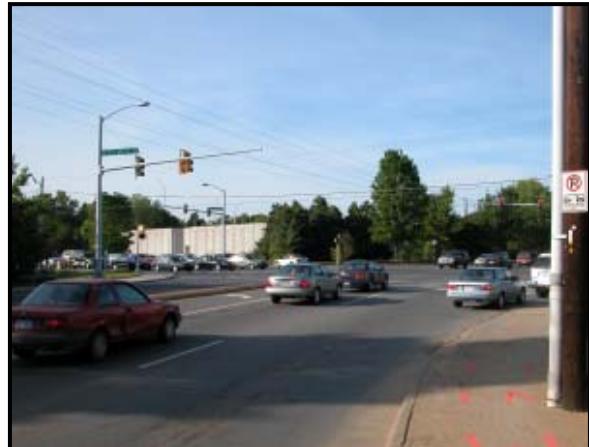
Figure 2: Northeast trajectory view of the Honda approaching the intersection.

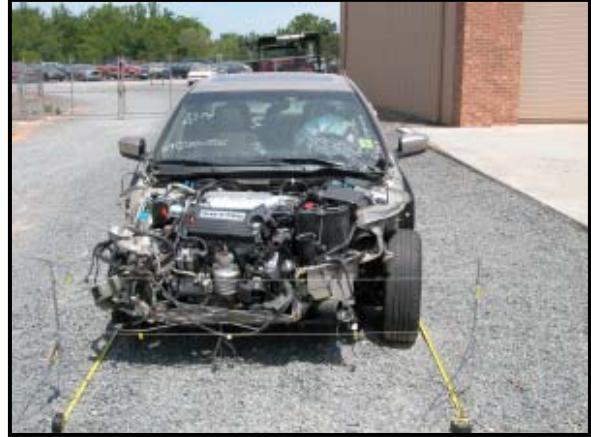
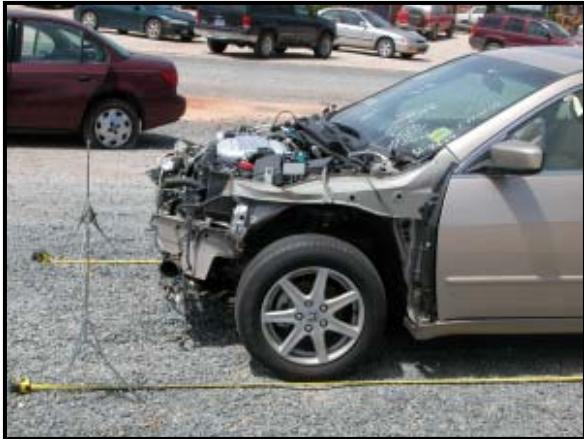
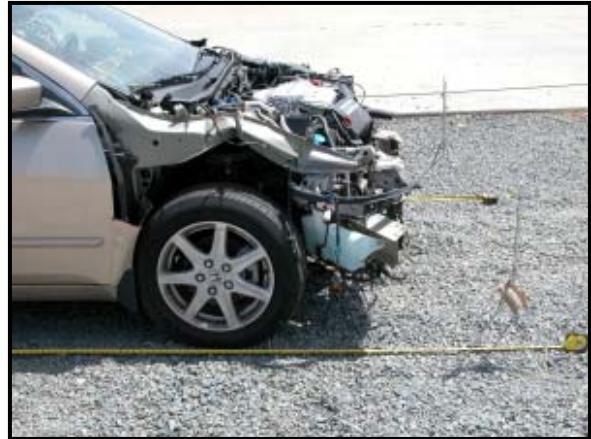
Figures 3 through 5 are the front, left lateral and right lateral views of the Honda. The damaged vehicle had been dismantled prior to the SCI inspection for the purposes of insurance damage estimation. The front bumper fascia, bumper reinforcement bar, hood, and front fenders were removed from the vehicle and missing. The absence of these components hampered documentation of the vehicle's frontal damage per SCI protocol. Through the inspection of the exposed components (sub-frame and engine compartment), it was determined that the direct contact damage extended across the entire 152 cm (60 in) frontal end width of the Honda. The frontal crush was documented at the exposed ends of the vehicle's sub-frame and across the engine cradle. The deformation of the left end of the sub-frame measured 20 cm (7.8 in) longitudinal. It was deflected (shifted) to the right 25 cm (9.7 in). The right sub-frame was deformed 30 cm (11.9 in) longitudinally and 29 cm (11.5 in) to the right. The center of the engine cradle was displaced 8 cm (3 in) rearward. The right wheelbase was reduced 10 cm (3.8

in). The right front tire was restricted due to its contact with the trailing edge of the wheel house. The left wheelbase lengthened 6 cm (2.3 in) due to distortion of the vehicle. The windshield was not damaged. There was no damage to the side glazing and all the doors remained operational. The Collision Deformation Classification (CDC) of the Honda was 70-FDEW2. The 10 o'clock direction of force was incremented by 60 to reflect the right end shift of the vehicle.

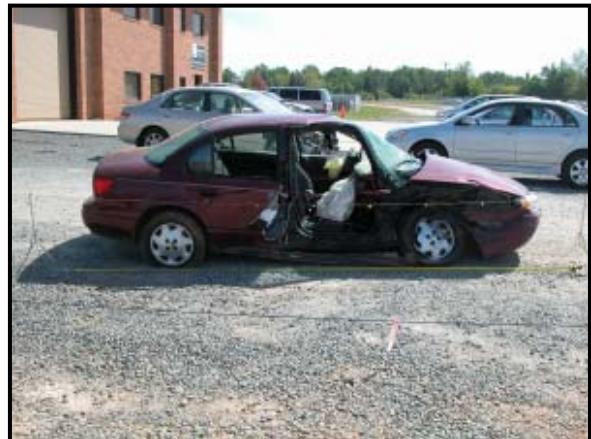
Figure 6 is a right side view of the Saturn. The vehicle's right plane sustained 222 cm (87.5 in) of direct contact damage that began at the right front bumper corner and extended to right B-pillar. The induced damage extended an additional 21 cm (8.3 in) onto the right rear door panel. The total length of the direct and induced damage measured 243 cm (95.8 in). The force of the side impact caused the vehicle to bow to the right. The bowing of the Saturn's front structure measured 13 cm (5.1 in) with reference to the vehicle's center line. The residual crush (inclusive of a 6 cm (2.5 in) average bowing factor) was as follows: C1 = 6 cm (2.5 in), C2 = 24 cm (9.4 in), C3 = 26 cm (10.2 in), C4 = 21 cm (8.1 in), C5 = 20 cm (7.9 in), C6 = 6 cm (2.5 in). The front right door was removed by the

Figure 6: Right side view of the Saturn.

fire department personnel and was missing. The rear right door compressed rearward into the C-pillar and was jammed shut. The left doors were operational. The right wheelbase was reduced 23 cm (9.1 in) due to the vehicle's bowing. The left wheelbase lengthened 6 cm (2.1 in). The CDC of the Saturn was 01-RYEW3.

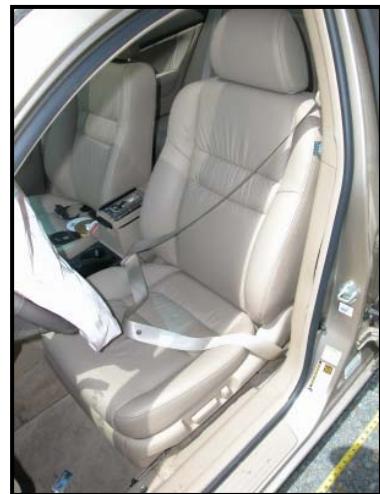
The driver's manual restraint consisted of continuous loop webbing, a sliding latch plate, an adjustable D-ring and an Emergency Locking Retractor located in the base of the B-pillar. **Figure 7** is a view of the driver seat and restraint. The retractor was equipped with a pretensioner that fired as a result of the crash. Upon initial inspection, the webbing was found extended from the retractor and the retractor was locked. The length of the extended webbing measured 173 cm (68.2 in). Examination of the webbing was unremarkable for crash related evidence. The D-ring was adjusted to the full down position. The surface of the D-ring was not abraded. Inspection of the latch plate revealed usage indicators consistent with the vehicle's age. The friction surface of the latch plate hardware was not abraded. The driver was restrained at the time of the crash. The locked and extended condition of the webbing was consistent with the use of the restraint at the time of the crash. The downloaded EDR data indicated the driver was restrained as well.

Figure 7: Driver seat and safety belt.

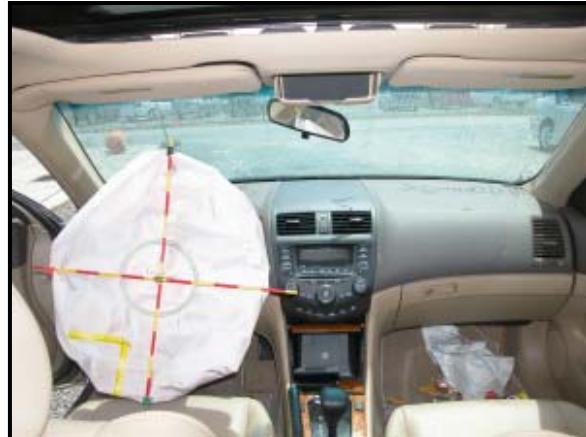
The driver air bag, **Figure 8**, deployed as a result of the frontal crash. The driver air bag was housed in the center hub of the steering wheel in the typical manner. The air bag deployed from the H-configuration module as designed. There was no occupant contact to the flaps. The air bag measured 57 cm (22.5 in) in diameter in its deflated state. It was vented by two 5 cm (1.8 in) diameter ports located in the 11/1 o'clock sectors on the back side of the bag and it was tethered by two 6 cm (2.3 in) wide straps in the 12/6 o'clock sector. The excursion of the face of the bag measured 24 cm (9.5 in) from the module. A 5 x 6 cm (1.8 x 2.5 in) patterned deployment scuff was identified in the 4'oclock sector of the air bag. Note: the steering wheel was rotated 90 degrees clockwise. There was no other evidence on the driver air bag.

Figure 8: Front interior and driver air bag.

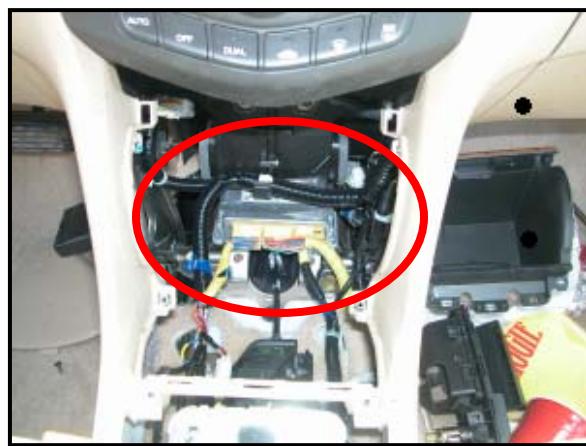
The Air bag Control Module (ACM) in the Honda had the capability to record crash event data. A secondary focus of this investigation involved removing the ACM from the Honda. The module was located under the center instrument panel, **Figure 9**. The ACM was forwarded to the NHTSA which in-turn forwarded the module to Honda in order to retrieve the EDR data. Upon analysis, Honda forwarded a text report of the data recorded at the time of the crash to the NHTSA. The text data is summarized below.

Figure 9: ACM location.
