On scene Investigation / Vehicle to Vehicle
Dynamic Science, Inc. / Case Number: DS04018
1996 Dodge Grand Caravan
California
May, 2004

1. Report No. DS04018	2. Government Accession No.		3. Recipient Catalog No.	
4. Title and Subtitle On Scene Passenger Air Bag Serious Injury Investigation			5. Report Date March 18, 2005

Description: This on-scene investigation focused on the performance of the front right passenger air bag in a 1996 Dodge Grand Caravan and its interaction with a 9-year-old male seated in the front right seating position. This was a four-vehicle chain reaction type crash with this vehicle being involved in the first impact. At impact, the front right passenger bag deployed and came into contact with the front right occupant's face. He sustained a concussive head injury with loss of consciousness, a small left subdural hematoma, and a right ethmoid sinus fracture. He was transported by air ambulance to an area children's trauma center where he arrived with a Glasgow Coma Scale (GCS) score of 5 and was hospitalized for a total of 62 days.

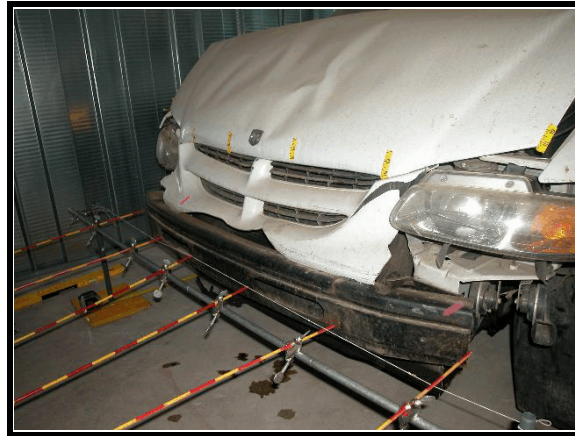
Figure 2. Front left, Dodge Caravan

Damage Description:	Minor front end damage. Fascia off.	
CDC:	12FDEW1	
Delta V:	Total	30.3 km/h (18.8 mph)
	Longitudinal	-30.3 km/h (-18.8 mph)
	Latitudinal	0 km/h (0 mph)
	Energy	26,073 joules (19,230 ft-lbs)

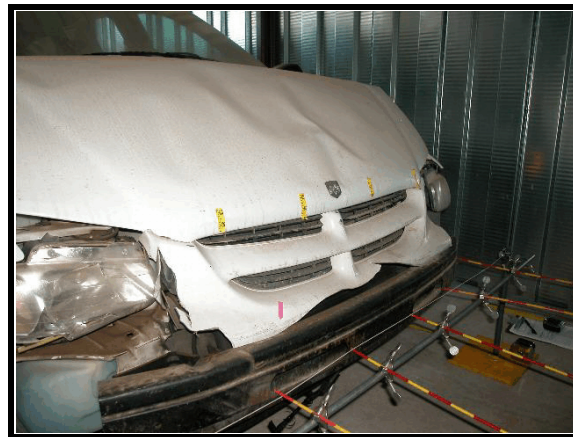
Figure 3. Front right, Dodge Caravan

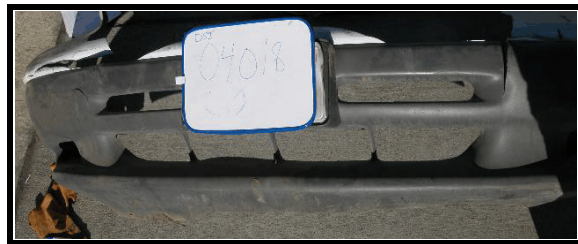
The case vehicle sustained 180.0 cm (70.9 in) of direct contact to the front bumper fascia from the initial impact. The residual crush measured along the bumper was as follows: C1=7.4 cm (2.9 in), C2=13.0 cm (5.1 in), C3=15.0 cm (5.9 in), C4=15.0 cm (5.9 in), C5=12.0 cm (4.7 in), C6=7.0 cm (2.8 in). The maximum crush was at C4. The principle direction of force was within the 12 o'clock sector and was an estimated 0 degrees. The damaged components included the bumper fascia and reinforcement bar.

Figure 4. Front bumper fascia

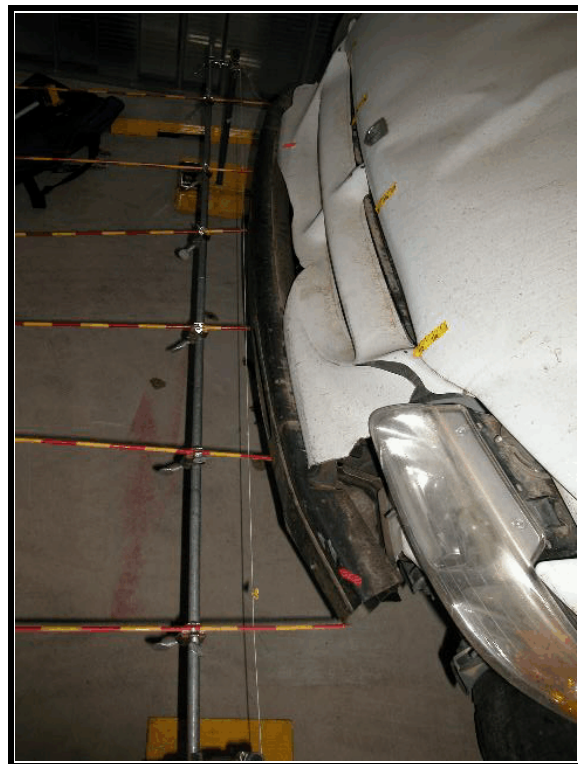
Figure 5. Front bumper measurements

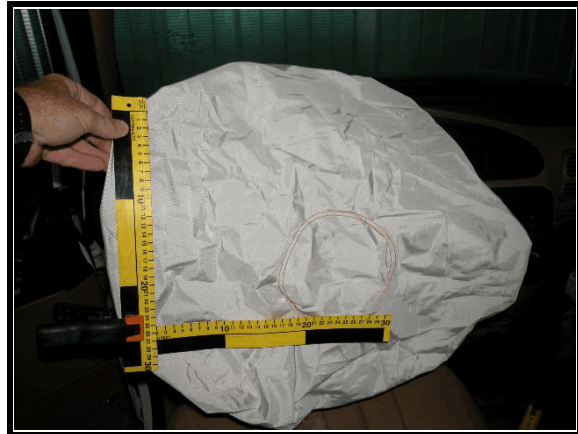
The Dodge Grand Caravan was equipped with dual front air bags that deployed at impact with the Lexus. The driver's air bag module was mounted in the center of the steering wheel and had an H configuration. The top cover measured 2.5 cm (0.9 in) high by 17.5 cm (6.9 in) wide. The bottom cover measured 7.5 cm (2.9 in) high by 17.5 cm (6.9 in) wide. The air bag was circular in shape and measured 64.0 cm (25.2 in) in its deflated state. There was a single tether. The bag was internally vented. There was a single scuff roughly in the center of the face of the air bag. There was no damage to the module cover or the air bag itself.

Figure 7. Face of driver's air bag

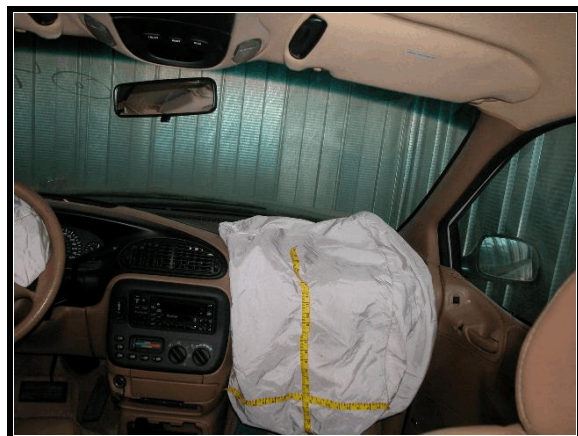
The front right passenger air bag module was a mid mount design which incorporated a horizontally oriented dual flap tear seam with an H configuration. The top cover measured 3.5 cm (1.4 in) high by 29.0 cm (11.4 in) wide. The bottom cover measured 7.0 cm (2.8 in) high by 29.0 cm (11.4 in) wide. The air bag was vaguely rectangular in shape. It measured 45.0 cm (17.7 in) wide seam to seam, 36.0 cm (14.2 in) wide near the base, and 80.0 cm (31.5 in) high in its deflated state. The air bag had a maximum excursion of 64.0 cm (25.2 in) which placed the air bag 11.0 cm (4.3 in) from the seat back as positioned at the time of impact. There were no tethers or vent ports. The module covers were undamaged. The air bag face exhibited a skin contact which measured 23.0 cm (9.1 in) high by 2.0-4.0 cm (0.8-1.6 in) wide. It was located 24.0 cm (9.5 in) to the right of the left seam and 45.0 cm (17.7 in) from the top edge.

Figure 8. Front view, passenger air bag

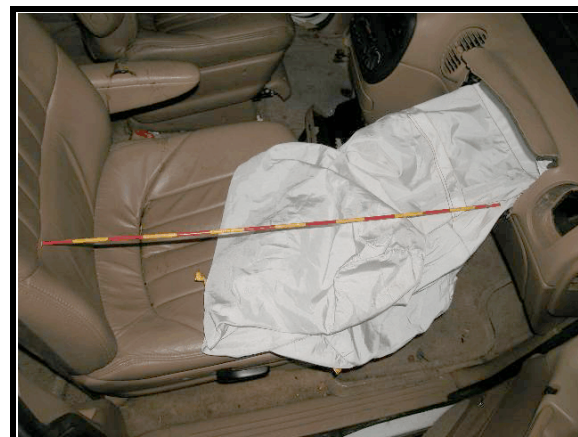
Figure 9. Side view, passenger air bag

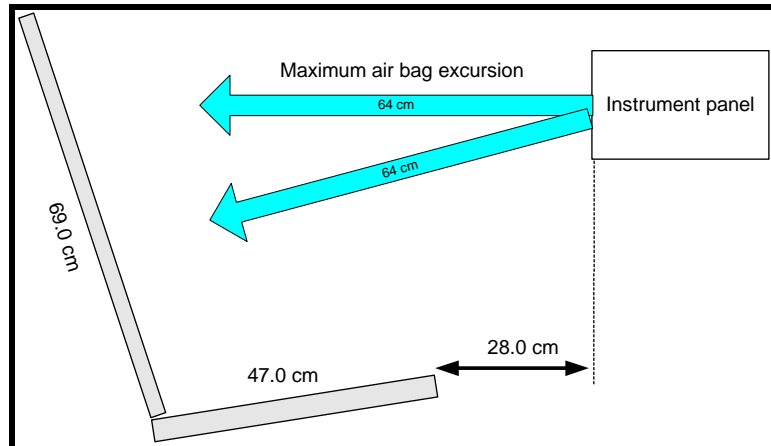
Figure 10. Overview of front right passenger air bag deployment range

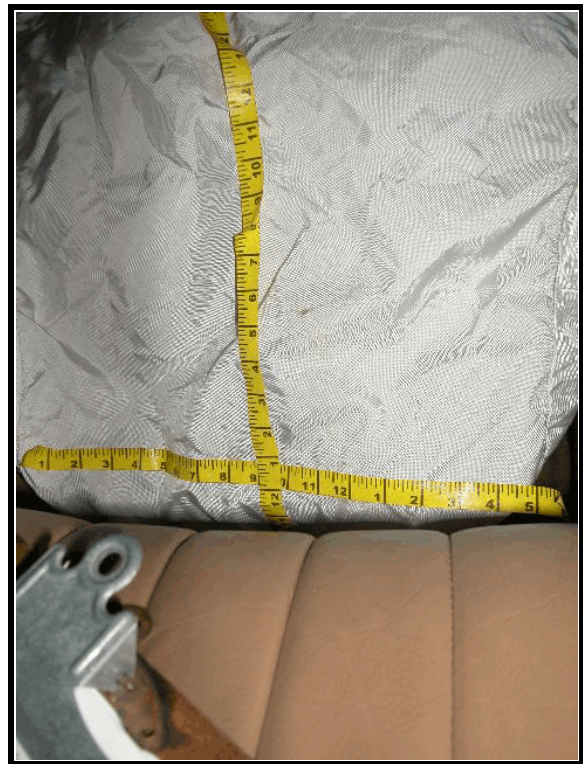
The 9-year-old male (152 cm/60 in, 39 kg/85 lbs) front right occupant of the Caravan was seated in a normal, upright fashion. At the time of the vehicle inspection the leather covered bucket seat was adjusted to the full rearward track position—28.0 cm (10.7 in) from the front of the seat bottom to the face of the instrument panel. The seat back was found to be at 73 degree angle from horizontal. The seat bottom was 10 degrees from horizontal. He was wearing the available 3-point manual lap and shoulder belt. The shoulder belt anchorage adjustment was in the full down position. Prior to impact, the driver began braking. This occupant pitched forward and likely began to load the shoulder harness. As the impact occurred, the front right passenger air bag deployed and this occupant contacted the front of the air bag with his face. It appears likely that the occupant contacted the air bag while it was still deploying—as evidenced by the 23.0 cm (9.0 in) long contact streak. This contact likely caused the brain injuries (temporal) and the soft tissue injuries to his face. He was likely forced back into the seat back but there was no indication of any contact to the seat back or any other structures behind this occupant. He was rendered unconscious and came to rest in this seat belt with his head/face leaning to the left (as evidenced by the blood drip pattern down the left side of the seat). It is not clear how this occupant was removed from the vehicle. At some point post-crash he was transported by helicopter to children's trauma center. He sustained a concussive head injury with loss of consciousness, a small left subdural hematoma, and a right ethmoid sinus fracture.

Figure 11. Overview of passenger air bag face

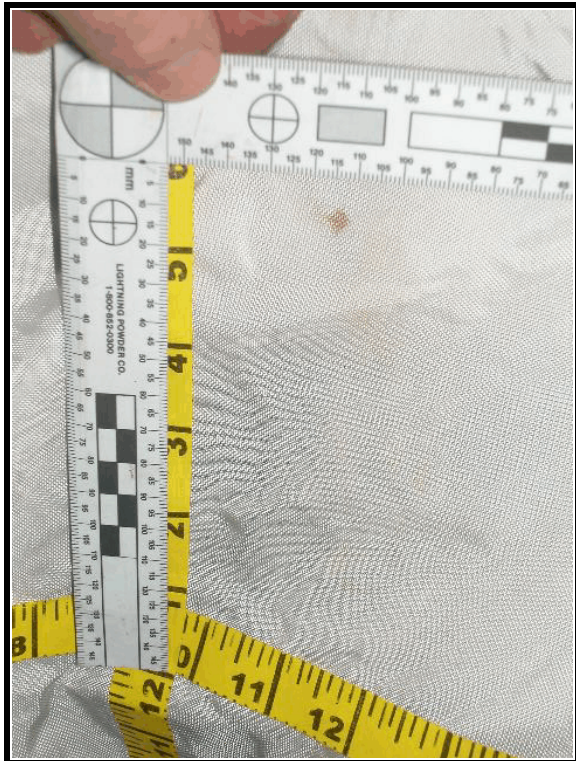
Figure 12. Skin contact to face of passenger air bag

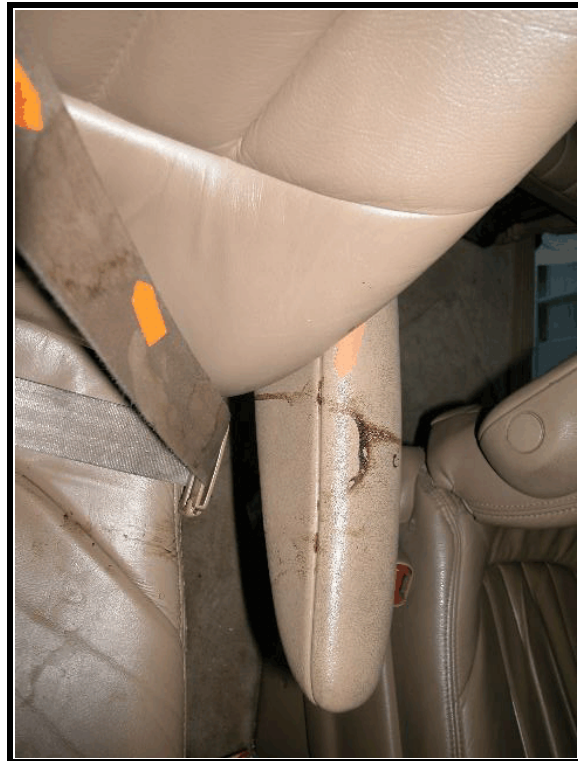
¹Restraint usage was determined by blood splatter location which indicated that the seat belt was in the proper position prior to the crash. Age darkened stains on the belt were tested and were identified as blood using a presumptive blood test.

Figure 13. Blood spill pattern to shoulder harness and left arm rest (front right seat)

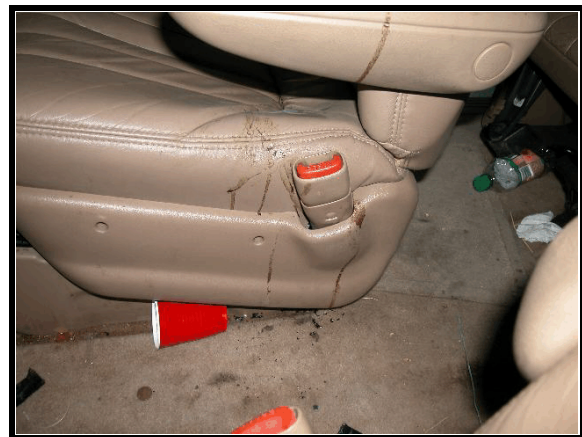
Figure 14. Blood spill pattern down left side of front right seat
