**CALSPAN ON-SITE CERTIFIED ADVANCED 208-COMPLIANT  
VEHICLE CRASH INVESTIGATION**

**CASE NO: CA04-018**

**VEHICLE: 2003 ACURA MDX**

**CRASH DATE: MARCH 2004**

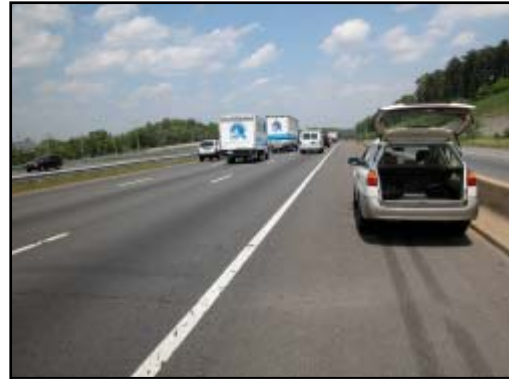
The unrestrained 30-year-old female driver of the 2003 Acura MDX was operating the vehicle northbound on the outboard lane of the three-lane interstate roadway (**Figure 2**). As the driver continued northbound, she initiated a rapid left-right steering maneuver to avoid a bucket that was in the travel lane. As a result of the right counter steer maneuver, the vehicle initiated a clockwise rotation and departed the east road edge. The Acura traversed the east shoulder in a CW yaw and struck the concrete Jersey barrier.

**Figure 2. Acura's northbound travel.**

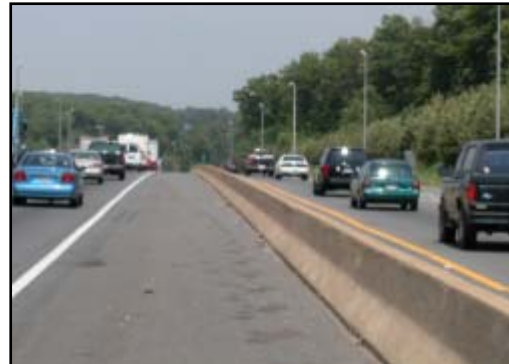
The initial contact involved the front right aspect of the Acura against the concrete Jersey barrier (**Figure 3**). The offset right engagement in combination with the pre-crash CW yaw, allowed the vehicle to continue to rotate CW and engage the barrier with the full width of the frontal plane. The resultant direction of force was 11 o'clock.

**Figure 3. Area of impact between the Acura and the Jersey barrier.**

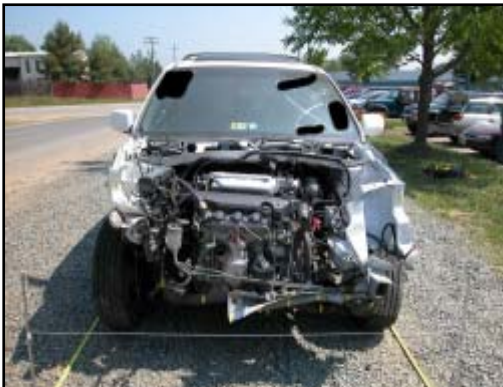
The Acura sustained moderate severity damage as a result of the impact with concrete Jersey barrier (**Figures 4 and 5**). The impact involved the full frontal area of the Acura; however, the frontal components were removed and the right frame rail was cut by a repair facility to assess the damage. The damaged components were not with the vehicle at the time of the SCI investigation. As a result, the length of the direct contact damage could not be determined. The SCI investigator documented two crush profiles to the remaining structure of the vehicle. The first profile was measured at the lower cross member, which was bolted to the frame rails. The right side of the cross member was disconnected during the post-crash damage assessment. The maximum crush measured 14 cm (5.6”) and was located at crush measurement three. Six equidistant crush measurements were documented at this level using a combined direct and induced damaged width of 80 cm (31.5”), and were as follows: C1 = 7 cm (2.8”), C2 = 12 cm (4.5”), C3 = 14 cm (5.6”), C4 = 13 cm (5.1”), C5 = 11 cm (4.3”), C6 = 9 cm (3.5”).

**Figure 4. Frontal damage to the 2003 Acura MDX.**

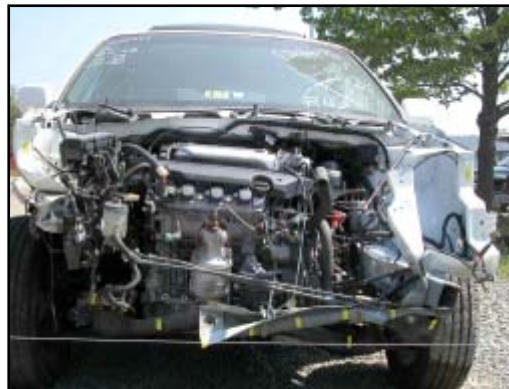
The second crush profile was documented at the lower engine cradle. The maximum crush measured 21 cm (8.1”) at the front right aspect of the cradle assembly. The residual crush was measured using a combined direct and induced damaged width of 107 cm (42.0”). The profile was as follows: C1 = 14 cm (5.5”), C2 = 6 cm (2.5”), C3 = 5 cm (1.8”), C4 = 5 cm (1.8”), C5 = 6 cm (2.5”), C6 = 21 cm (8.1”). This crush profile yielded the greatest depth of crush and was used to calculate the delta V. The Collision Deformation Classification (CDC) for this impact was 11-FDEW-1.

The SCI investigator also documented crush to the upper and lower aspects of the left and right fender supports. The lower left fender crush measured 3 cm (1.2”) and the upper measured 5 cm (2.0”). The lower right fender crush measured 9 cm (3.5”) and the upper measured 8 cm (3.0”).

**Figure 5. Close-up view of the two crush profiles documented for this impact.**

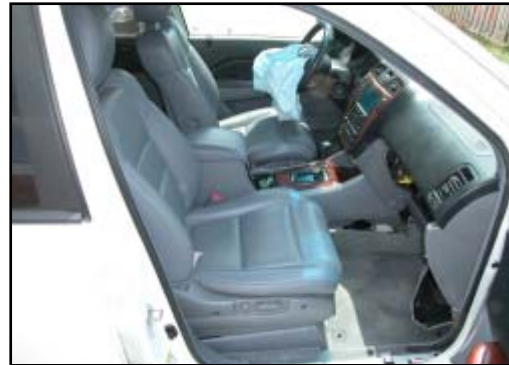
The interior of the 2003 Acura MDX sustained minor severity damage as a result of passenger compartment intrusion. The front right toe pan intruded longitudinally 3 cm (1.0”) as result of the front right tire displacement rearward into the front cowl. There was no occupant contact points noted to the interior components. **Figure 6** is a lateral view across the interior of the Acura.

**Figure 6. Lateral view across the interior of the Acura.**

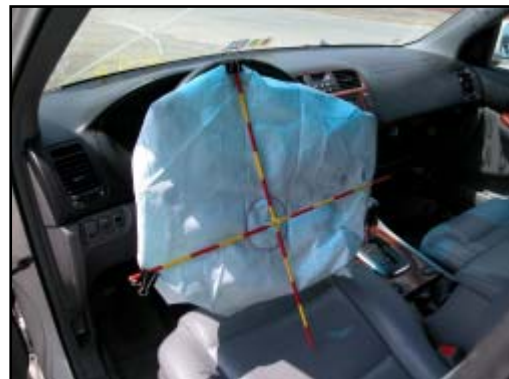
In the subject crash, the driver’s frontal air bag deployed at impact with the concrete Jersey barrier. The driver’s air bag module was located within the center of the steering wheel hub (**Figure 7**). Two H-configuration cover flaps concealed the air bag. The top cover flap measured 16 cm (6.2”) in width and 5 cm (2.0”) in height. The lower cover flap measured 16 cm (6.2”) in width at the top tear seam and 7 cm (2.8”) at the lower hinge point. The lower flap measured 8 cm (3.2”) in height. The air bag membrane measured 58 cm (23.0”) in diameter in its deflated state. No driver contacts were present on the air bag membrane; however, dirt was present from post-crash manipulation within the vehicle. The air bag contained two 4 cm (1.5”) diameter vent ports that were centered 17 cm (6.5”) forward of the peripheral seam. A 10 cm (3.9”) diameter tether reinforcement stitching was located on the center face of the air bag. The air bag contained two 6 cm (2.5”) wide band tethers that were located at the 12 and 6 o’clock positions.

**Figure 7. Deployed driver's frontal air bag.**

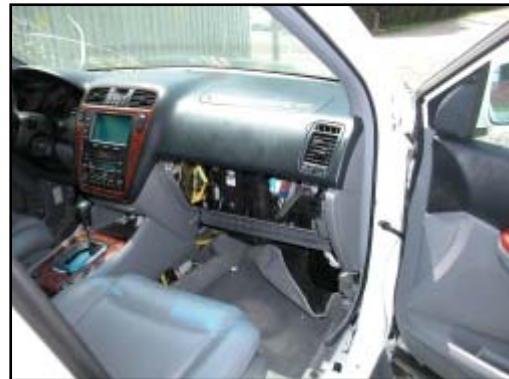
The front right passenger air bag was a top-mount design in the right instrument panel (**Figure 8**). The front right seating position was not occupied during the crash, therefore the air bag control module did not warrant the deployment of the front right air bag.

**Figure 8. Non-deployed front right air bag.**

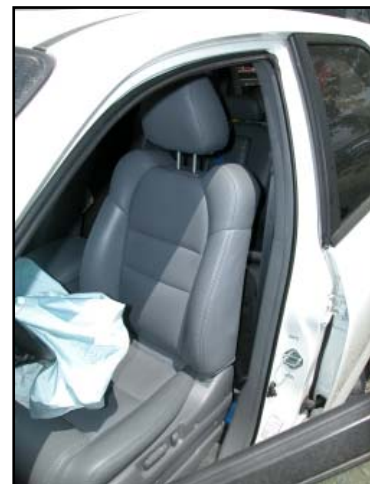
**Figure 9. Driver's seat.  
Note: The safety belt is taut against the B-pillar.**

The driver was not restrained by the safety belt in the subject crash. The belt webbing was cinched taut against the B-pillar due to the fired status of the retractor pretensioner (**Figure 9**).
