ON-SITE CERTIFIED ADVANCED 208- COMPLIANT VEHICLE INVESTIGATION

CASE NUMBER - IN-04-019

VEHICLE - 2003 GMC SIERRA, EXTENDED CAB

CRASH DATE - May 2004

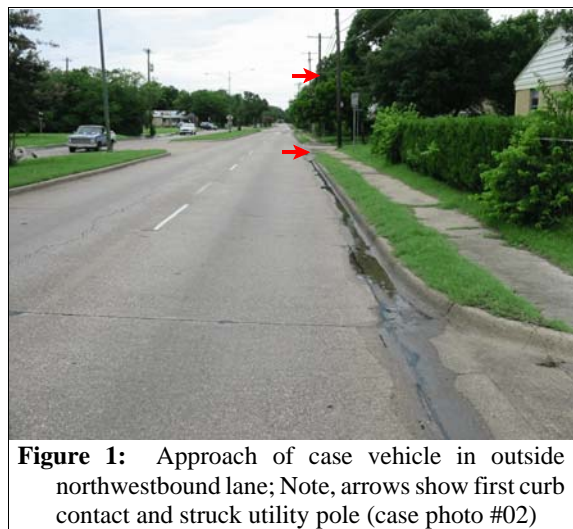
Figure 1: Approach of case vehicle in outside northwestbound lane; Note, arrows show first curb contact and struck utility pole (case photo #02)

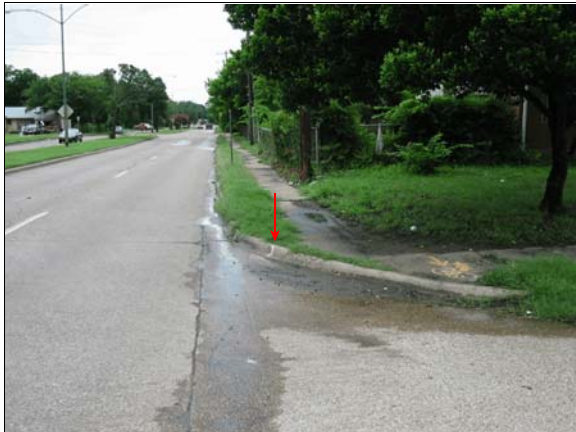
Figure 2: Approach of the case vehicle to impact with the utility pole; Note, arrow shows tire scuff on curb; at white chalk mark, not the broad scuff (case photo #04)

Crash: The case vehicle traveled over the curb and sidewalk (**Figure 2** above) on the north side of the roadway and the front right corner of the case vehicle (**Figure 3**) impacted a wooden utility pole (**Figure 4**) causing the case vehicle's driver air bag to deploy. The case vehicle's front right air bag did not deploy because there was no front right occupant in the case vehicle.

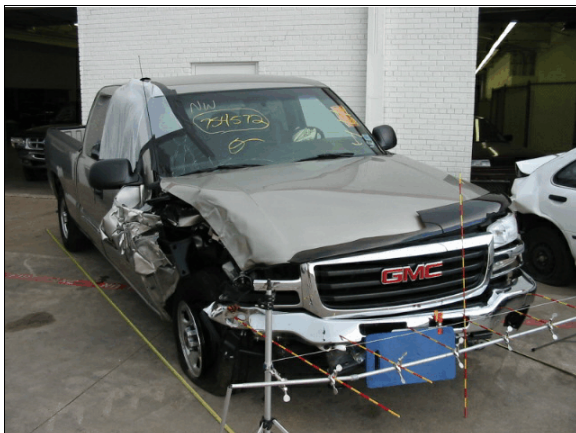
Figure 3: Overview of the damage [each stripe on rods is 5 cm (2 in)] to the right corner of the front bumper, hood, right fender and right front wheel (case photo #21)

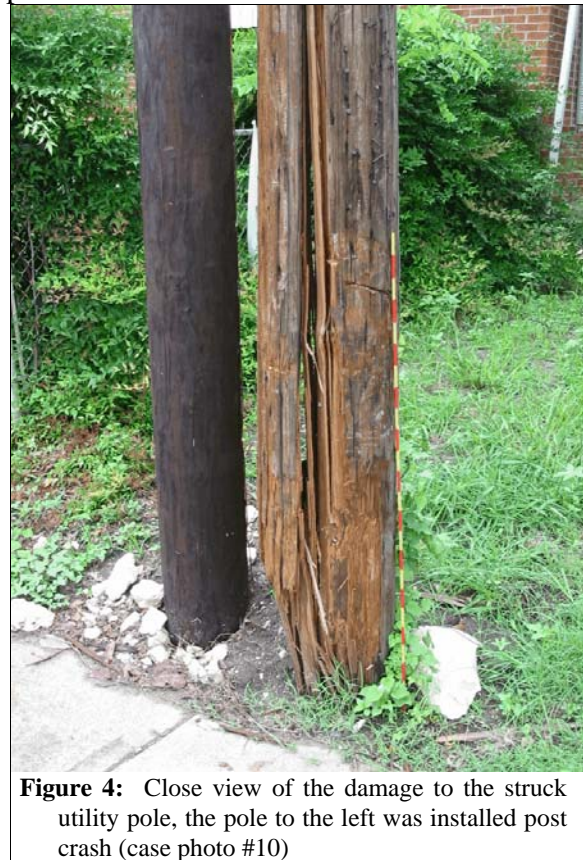
Figure 4: Close view of the damage to the struck utility pole, the pole to the left was installed post crash (case photo #10)

Post-Crash: As a result of the impact, the case vehicle fractured the utility pole, but did not break it off its base, rotated clockwise a few degrees, traveled several feet and came to final rest against the utility pole facing northwest. The final rest position of the case vehicle was not indicated on the police crash report, but this contractor's interview with the owner of the property where the crash occurred indicated that the case vehicle was still in contact with the utility pole at final rest.

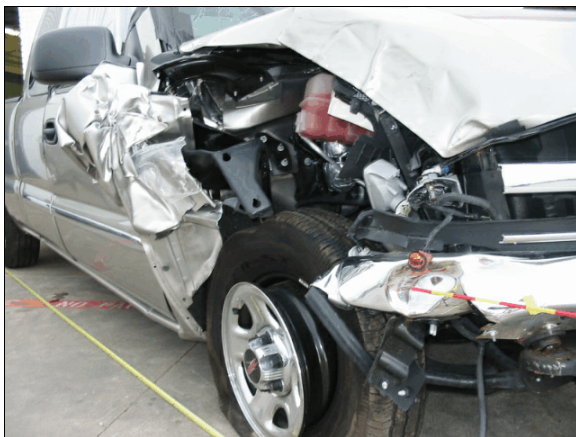
Exterior Damage: The case vehicle's impact with the utility pole involved the right corner of the front bumper, grille and the hood, as well as the right headlamp/ turn lamp assembly (**Figure 5**). As the impact progressed, the utility pole engaged the right fender and the right front wheel. The right front wheel was crushed rearward into the back of the wheelhouse, which buckled the cowl, fractured the windshield and deformed the right front door. The right fender was crushed back nearly to the base of the windshield.

Figure 5: Close view of damage to right corner of front bumper, the hood, right fender and right front wheel (case photo #23)

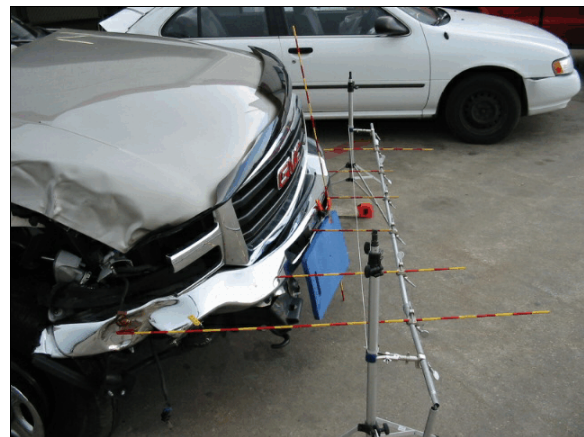
The direct damage began at the right corner of the front bumper and extended 13 centimeters (5.1 inches) along the bumper. Crush measurements were taken at the bumper and maximum crush was measured as 42 centimeters (16.5 inches) occurring at C_6 (**Figure 6**). A second level of crush was measured above the bumper at C_6 due to the crush of the right fender. The measured crush at this level was 134 centimeters (52.8 inches). The average crush at C_6 was then calculated as 88 centimeters (34.6 inches). The table below shows the case vehicle's final crush profile

Figure 6: Right side view of crush profile to case vehicle's front bumper prior to adjustment of baseline placement (case photo #20)

The case vehicle’s wheelbase was reduced 14 centimeters (16.5 inches) on the right side and extended 5 centimeters (2 inches) on the left side. Induced damage involved the front bumper, grille, hood, windshield, right fender and right front door..

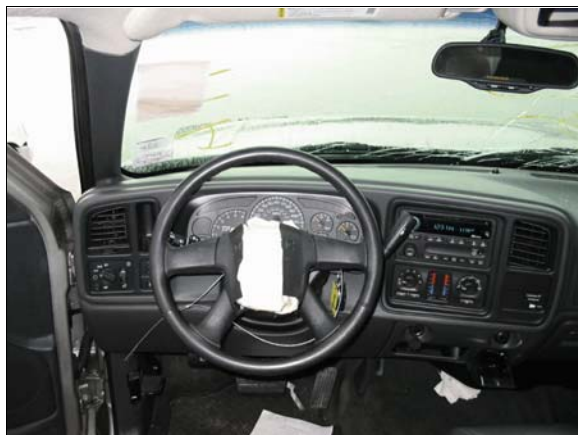
Vehicle Interior: Inspection of the case vehicle’s interior revealed no evidence of occupant contact to any interior surfaces or components (**Figure 7**). There were a few dark smears on the driver’s air bag, but these did not appear to be related to occupant contact. In addition, there was no evidence of compression of the energy absorbing steering column, and no deformation of the steering wheel rim was observed (**Figure 8**).

Figure 7: Overview of steering wheel, air bag module flaps and left instrument panel (case photo #28)

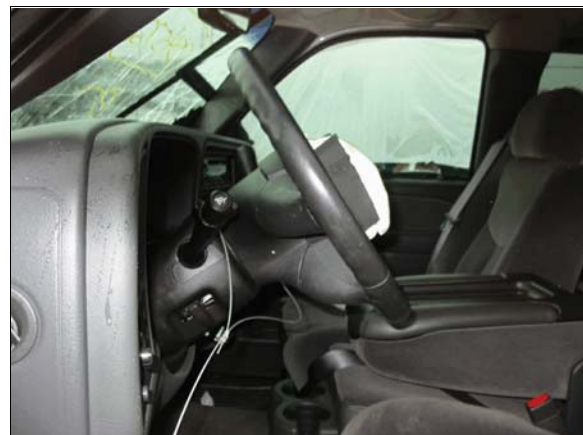
Figure 8: The case vehicle’s steering wheel and steering column (case photo #27)

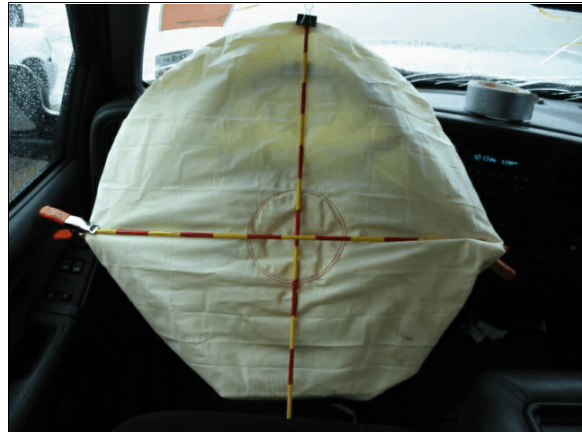
The case vehicle's driver air bag was located in the steering wheel hub. An inspection of the air bag module cover flaps and the air bag fabric revealed that the cover flaps opened at the designated tear points. There was no evidence of damage during the deployment to the air bag module cover flaps or the air bag. The deployed driver's air bag (**Figure 9**) was round with a diameter of approximately 64 centimeters (25.2 inches). The air bag was designed with two tethers, each approximately 12 centimeters (4.7 inches) in width and had two vent ports (**Figure 10**), each approximately 3 centimeters (1.2 inches) in diameter, located at the 11 and 1 o'clock positions. The module cover (**Figure 7** above) consisted of asymmetrical "I"-configuration cover flaps constructed of medium weight, pliable vinyl. Each flap was 14.5 centimeters (5.7 inches) in width at the top, 10 centimeters (3.9 inches) in width at the bottom and 12 centimeters (4.7 inches) in height along the center tear seam. The distance between the mid-center of the driver's seat back, as positioned at the time of the vehicle inspection, and the front surface of the air bag fabric at full excursion was 45 centimeters (17.7 inches). Inspection of the air bag fabric revealed no evidence of occupant contact. There were a few dark smears on the air bag, but they appeared to be due to post-impact handling of the air bag.

Figure 9: Case vehicle's driver air bag (case photo #29)

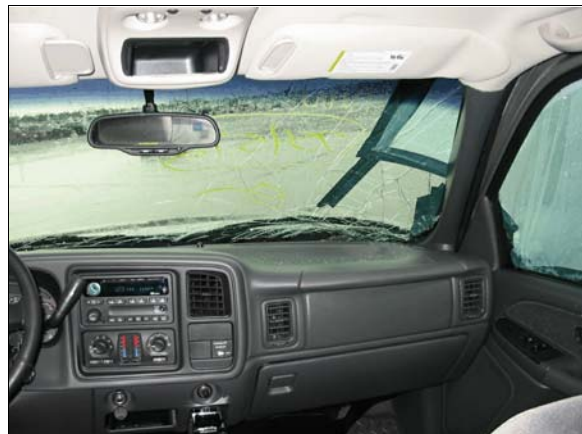
Figure 11: Overview of the right instrument panel and location of front right air bag (case photo #40)

The front right passenger air bag was located in the middle of the instrument panel (**Figure 11** above). It was equipped with an air bag suppression switch that was set to the “Auto” position (**Figure 12**). The deployment of the front right air bag was properly suppressed by the case vehicle’s advanced occupant protection system because there was no front right passenger in the case vehicle at the time of the crash.

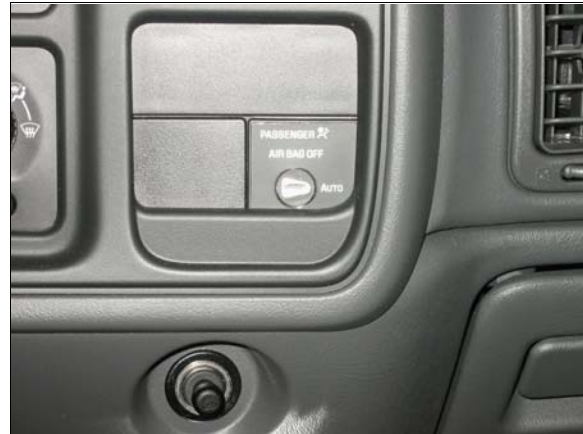
Figure 12: Case vehicle’s front right air bag suppression switch (case photo #39)

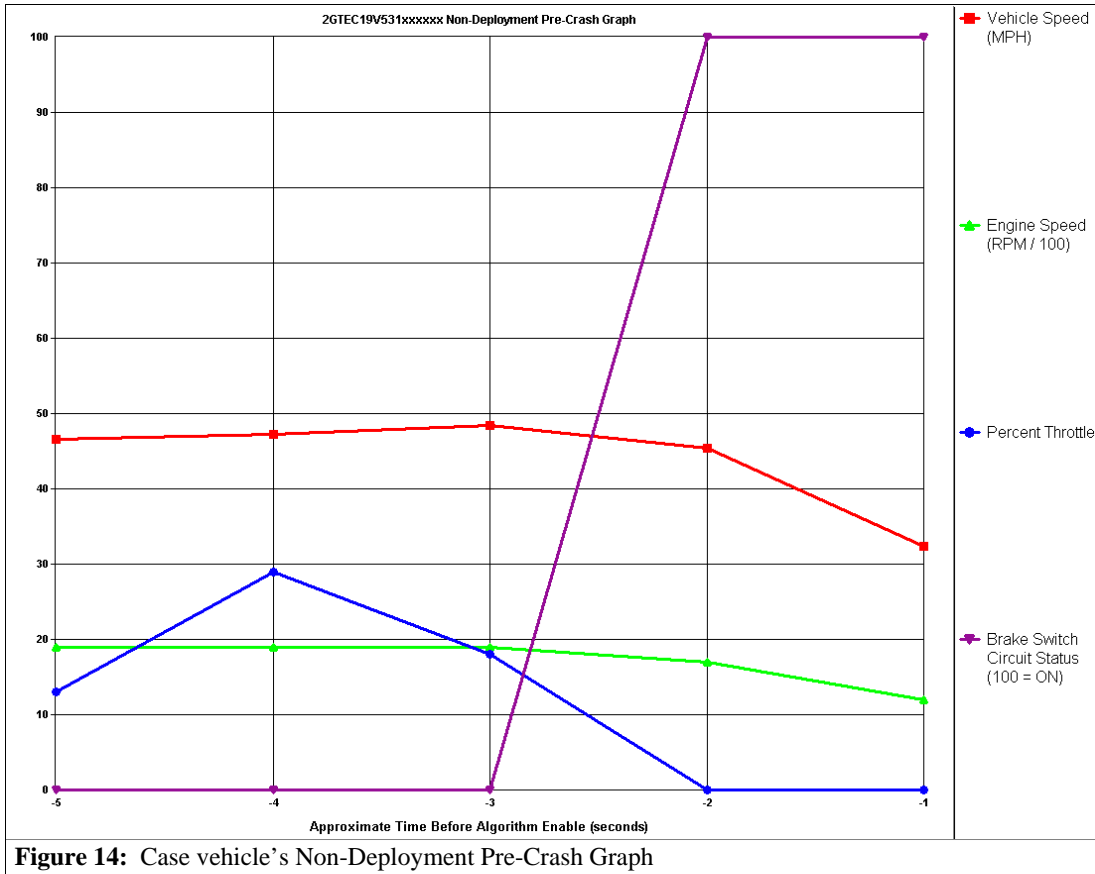
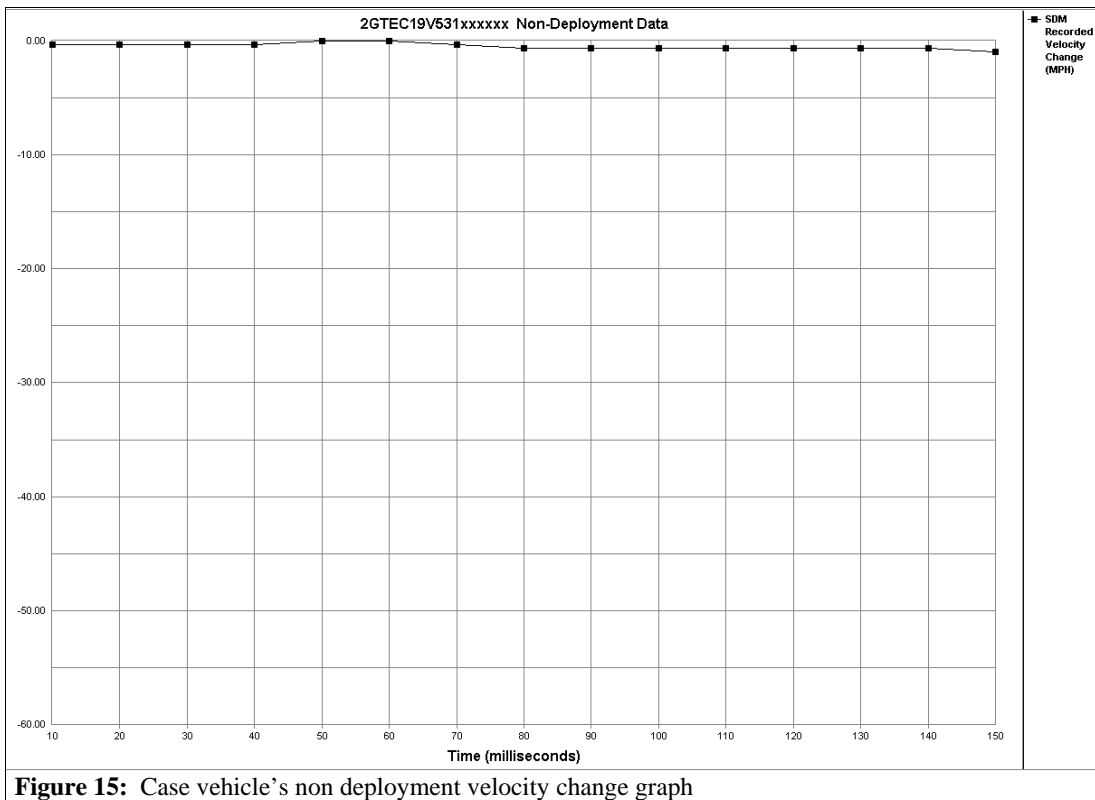
Figure 13: Case vehicle's System Status at Non-Deployment report

The download of the case vehicle’s EDR was done during the vehicle inspection via connection to the case vehicle’s diagnostic link connector. The EDR reports for the downloaded data are presented at the end of this report (**Figures 13-18**). The downloaded data indicated that a non-deployment event and deployment event were recorded. In addition, the data indicated there were one or more associated events that were not recorded. The system status reports for the non-deployment event (**Figure 13** below) and deployment event (**Figure 16** below) show that both events occurred during this crash because they occurred 0.6 seconds apart and were both recorded on the same ignition cycle. The system status reports also show that the SIR warning lamp was recorded as off and the driver’s seat belt switch circuit was recorded as buckled. In addition, the maximum SDM recorded velocity change (Delta V) was recorded as -2.0 km.p.h. (-1.24 m.p.h.) for the non-deployment event occurring 157.5 milliseconds (0.1575 seconds) after algorithm enable, and 20.7 km.p.h. (-12.84 m.p.h.) for the deployment event occurring 217.5 milliseconds (0.2175 seconds) after algorithm enable. Lastly, the pre-crash data indicate that the case vehicle was traveling 75.6 km.p.h. (47 mph) five seconds prior to algorithm enable, and the brake switch circuit was recorded as on for two seconds prior to algorithm enable.
