**CALSPAN ON-SITE CERTIFIED ADVANCED 208-COMPLIANT
VEHICLE CRASH INVESTIGATION**

CASE NO: CA04-021

VEHICLE: 2004 FORD TAURUS

LOCATION: WEST VIRGINIA

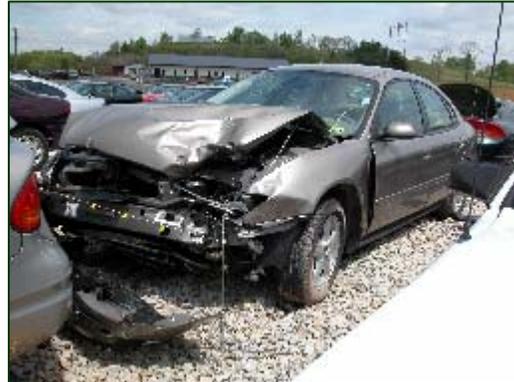
Figure 1. Front three-quarter view of the 2004 Ford Taurus.

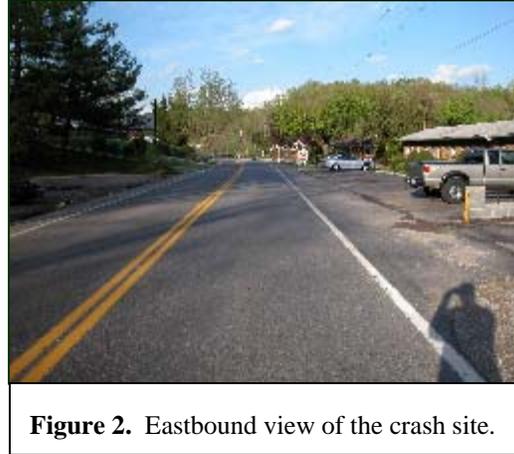
Figure 2. Eastbound view of the crash site.

The Chevrolet Lumina was traveling westbound exiting a right curve that transitioned onto the straight segment of road. At this location, the road surface was level. There were no defects in the asphalt road surface and the speed limit was posted at 89 km/h (55 mph). **Figure 2** is an eastbound view of the crash site. The crash schematic is attached as **Figure 13**, Page 10 of this report.

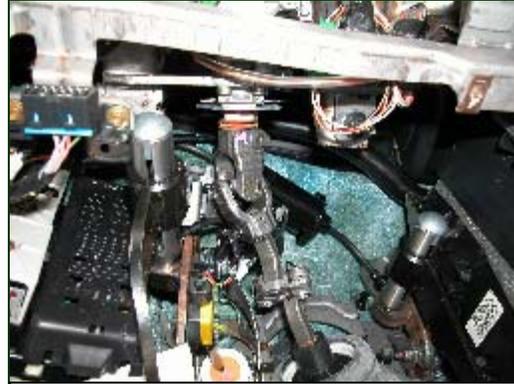
forward in the armrest/console position. The driver and right passenger positions were equipped with adjustable head restraints and reclining seat backs. Both front head restraints were adjusted to the up-position, 8 cm (3.25") above the top surface of the seat backs. The driver's seat was power-adjustable. The rear seat was a three-passenger bench seat with forward folding seat backs. The 60/40 passenger side wide seat backs were upright and locked at the time of the crash. There were no rear head restraints. The rear seat was equipped with LATCH (Lower Anchorages and Tethers for Children). The Taurus was also equipped with adjustable pedals. The adjustment switch was mounted on the horizontal surface of the left instrument panel immediately below the instrument cluster, left of the steering assembly. The brake pedal pad was embossed with ADJUSTABLE. At the time of the SCI inspection, the pedals were adjusted 4 cm (1.4") forward of the full rear position (**Figure 3**). In this position, the pedals were adjusted rearward, toward the driver.

Figure 3. Adjustable pedal jackscrews.

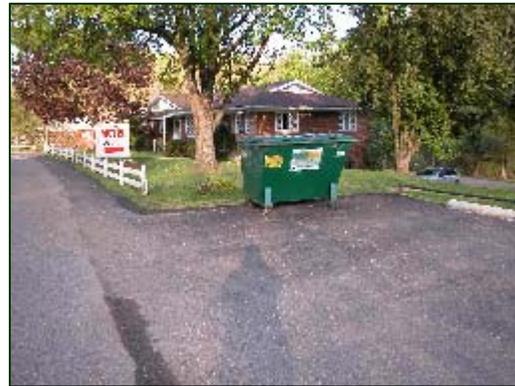
The Taurus was deflected to its right where it traversed the shoulder and entered the paved parking lot at the south road edge. The Taurus traversed the east edge of the lot and impacted a portable trash dumpster (**Figure 4**) that was mounted on casters. The center front area of the Taurus impacted the dumpster which deformed the front bumper fascia and hood edge. The 12 o'clock direction of force impact displaced the dumpster rearward. The back casters engaged asphalt curbing around the parking lot which tripped the dumpster onto its back side.

Figure 4. Struck trash dumpster and final rest position of the Taurus.

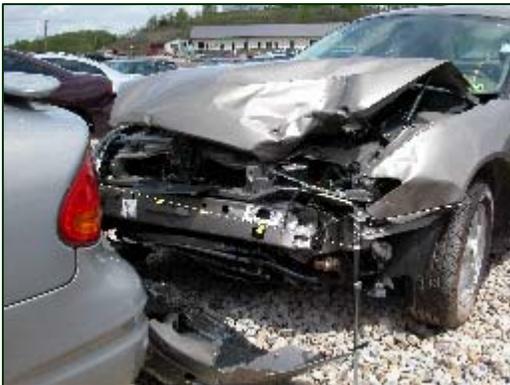
The Ford Taurus sustained moderate severity frontal damage (**Figure 5**) from the head-on crash sequence with the 1990 Chevrolet Lumina. The direct contact damage began on the bumper fascia, 51 cm (20.25") right of center and extended 125.1 cm (49.25") to the left bumper corner. Maximum crush measured 19 cm (7.5") and was located at the left corner of the bumper beam. The impact fractured the bumper fascia and the underlying Styrofoam filler panel, and deformed the full width of the bumper beam resulting in a combined induced and direct contact damage length of 131 cm (51.75"). The crush profile (**Figure 6**) was documented at the level of the bumper beam and was as follows: C1 = 19 cm (7.5"), C2 = 17 cm (6.625"), C3 = 11 cm (4.5"), C4 = 8 cm (3.0"), C5 = 4 cm (1.75"), C6 = 1 cm (0.25"). Components damaged by the impact included the front bumper fascia, filler panel, grille, hood, both front headlamp assemblies, both front fenders, the composite radiator support panel, radiator, air conditioning condenser, and the front frame rails. The Collision Deformation Classification (CDC) for this event was 12-FYEW-1.

Figure 5. Frontal damage to the Ford Taurus.

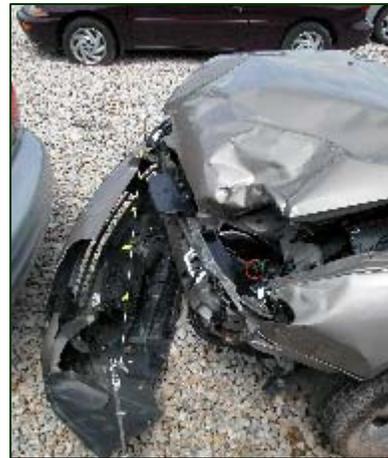
Figure 6. Lateral view documenting the depth of crush to the bumper beam.

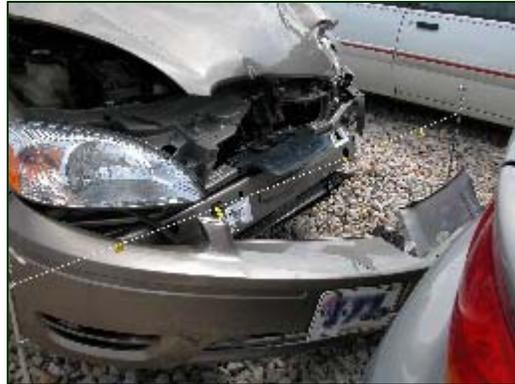
Following the initial impact, the center front of the Taurus impacted the portable trash dumpster. The minor severity impact produced green paint transfers to the damaged bumper fascia and hood (**Figure 7**). The paint transfer on the bumper fascia began at the vehicle's centerline and extended 5 cm (1.9") to the right. The diagonally oriented transfer pattern extended onto the hood face and was located 17-22 cm (6.75-8.5") right of the centerline. A 2 cm (0.75") deep dent was associated with the hood face contact with corner of the dumpster. The CDC for this event was 12-FCEN-1.

Figure 7. Green paint transfers from the dumpster impact.

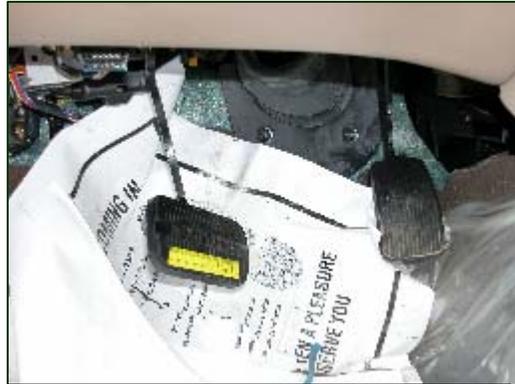
The interior of the Ford Taurus sustained minor severity damage that was attributed to occupant loading. There was no damage associated with exterior deformation or intrusion of the passenger compartment. The large stature driver applied a heavy braking force pre-crash with his right foot. The placement of his foot against the right aspect of the brake pedal at impact resulted in loading induced deformation of the pedal (**Figure 8**). The right aspect of the pedal was rotated approximately 7.6 cm (3.0") forward. There was no bending noted to the brake pedal arm.

Figure 8. Deformed brake pedal from driver loading.

His right foot loaded the brake pedal, which rotated the right aspect of the pedal plate forward. The driver did not sustain injury of the leg and denied pain of the foot and ankle.

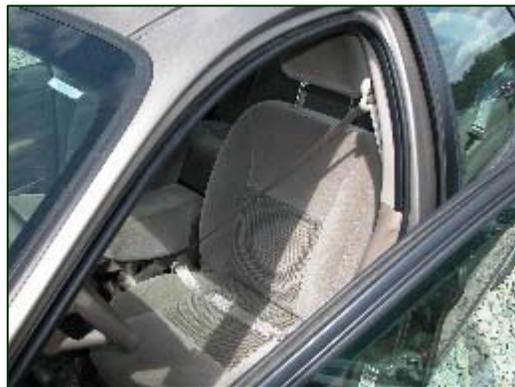
The front 3-point lap and shoulder belt systems consisted of continuous loop webbing with sliding latch plates and adjustable D-rings (**Figure 9**). The driver's D-ring was adjusted to the full-up position and the front right D-ring was adjusted 4 cm (1.75") below the full-up position. Both D-rings were designed with a series of detents over an 8 cm (3.25") vertical adjustment range.

Figure 9. Driver's manual belt system.

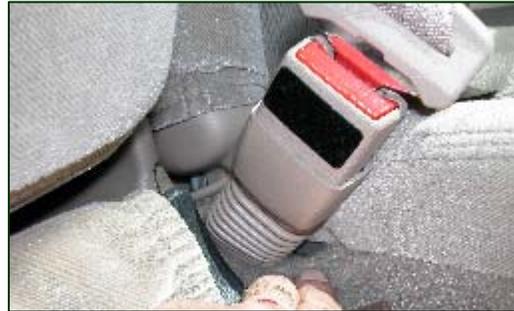
mode for both ELR and Automatic Locking Retractor (ALR) functions. The front seat retractors were equipped with load limiters that consisted of a torsion bar axle within the retractor. Both front buckle assemblies were equipped with pretensioners and buckle switches. The vehicle's RCM detected a threshold level crash and fired the driver's pretensioner (**Figure 10**). The front right seat was not occupied; therefore, the pretensioner did not fire. Measurements of the fired and non-fired pretensioner barrels indicated the driver's pretensioner travel was 5 cm (1.8"). Although the driver was restrained by the manual belt system, there was no loading evidence to the belt webbing or hardware components.

Figure 10. Fired driver's buckle pretensioner.

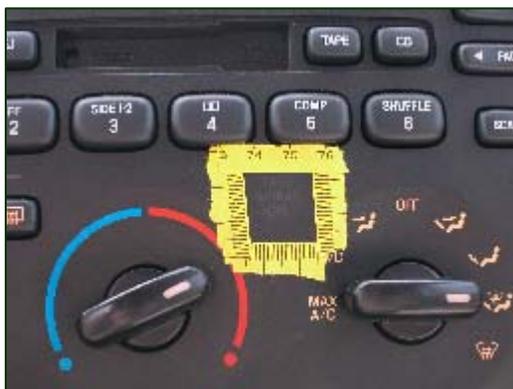
The 2004 Ford Taurus was equipped with a Certified Advanced 208-Complaint (CAC) frontal air bag system that consisted of dual stage air bags for the driver and front right positions, seat track positioning sensors, a front right occupant presence system, and safety belt buckle switches with pretensioners. The system was controlled and monitored by a Restraints Control Module (RCM) that was located on the center front tunnel of the Taurus, below the center instrument panel. A single satellite sensor was mounted to the hood latch bracket at the mid point of the vehicle. This sensor was positioned approximately 5 cm (2") above the front bumper beam. The passenger air bag activation status indicator (**Figure 11**) was located in the center mid instrument panel.

Figure 11. Passenger Air Bag ON/OFF status indicator lamp.

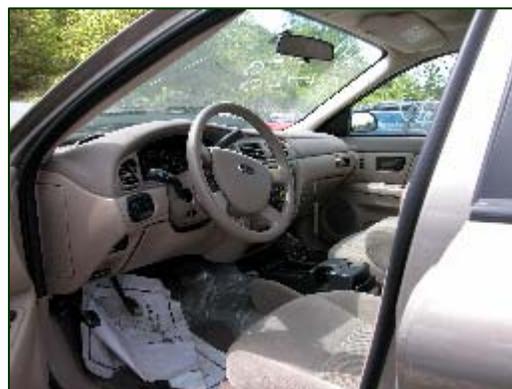
Figure 12. View of the non-deployed CAC frontal air bag system.

The driver's air bag was concealed in a module that was mounted within the four-spoke steering wheel rim (**Figure 12**). The spoke locations were positioned at the 3/9 and 5/7 o'clock positions. The non-deployed air bag was concealed by what appeared to be a single D-shaped cover flap. There was no contact evidence to the module cover.

The front right passenger air bag was a top mount design with the leading edge of the single cover flap extending onto the mid instrument panel (**Figure 12**). The forward hinged front right air bag cover flap measured 45 cm (17.75") in width and 33 cm (13.0") in depth. There was no damage or contact evidence to the cover flap.
