ON-SITE POTENTIAL SAFETY RELATED DEFECT INVESTIGATION

CASE NUMBER - IN-04-022

VEHICLE - 2003 SATURN VUE

CRASH DATE - April 2004

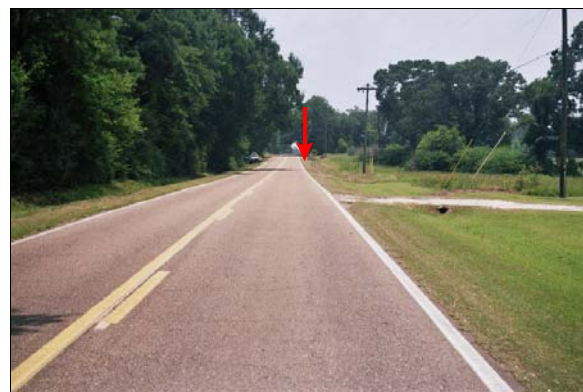
Figure 1: Approach of case vehicle in southeast bound lane, arrow shows area of rollover

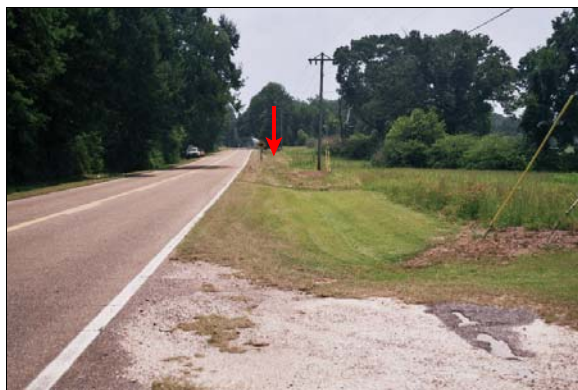
Figure 2: View southeast, case vehicle departed right side of roadway between driveway and utility pole, arrow shows case vehicle's area of final rest

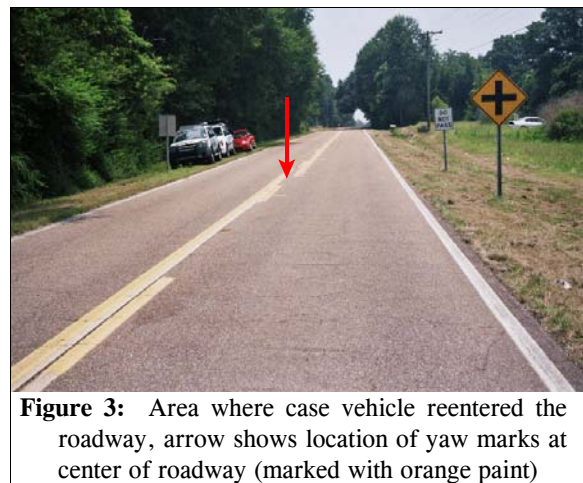
Figure 3: Area where case vehicle reentered the roadway, arrow shows location of yaw marks at center of roadway (marked with orange paint)

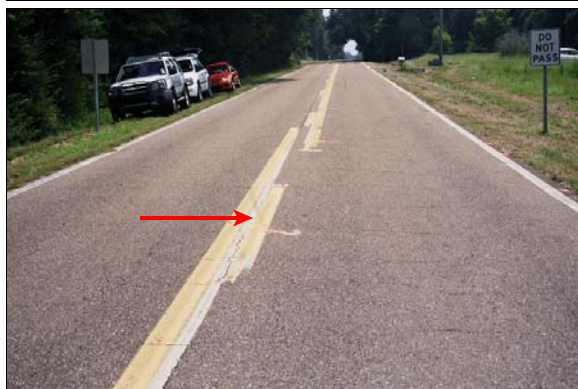
Figure 4: View southeast to case vehicle's yaw path, paint marks on center of roadway show yaw marks, arrow shows left rear yaw mark on centerline and no passing line

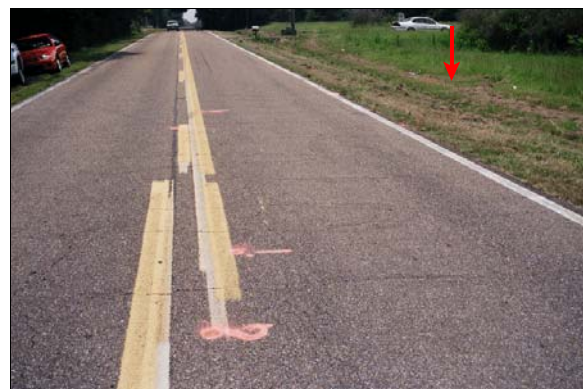
Figure 5: Case vehicle's left front yaw mark in foreground between paint dots, right rear yaw mark in background between paint marks, arrow shows area of case vehicle's final rest

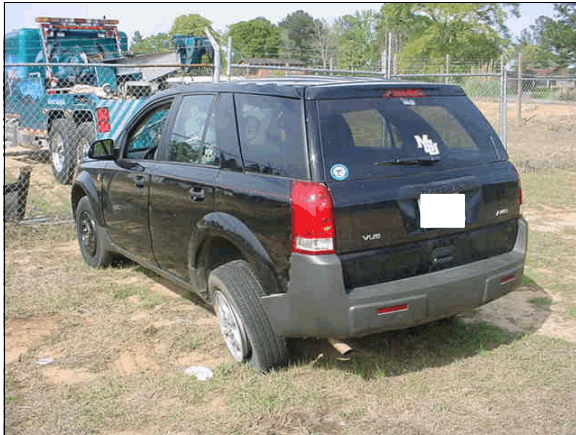
Figure 6: Insurance photo of case vehicle in tow lot showing condition of left rear wheel, spare tire mounted on left front

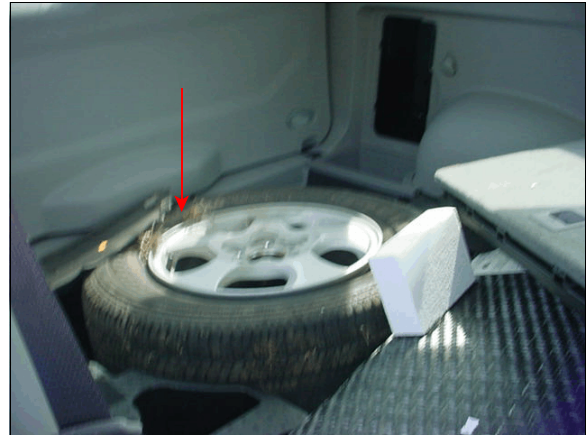
Figure 7: Insurance photo showing left front wheel in case vehicle's spare tire compartment, arrow shows grass jammed in bead

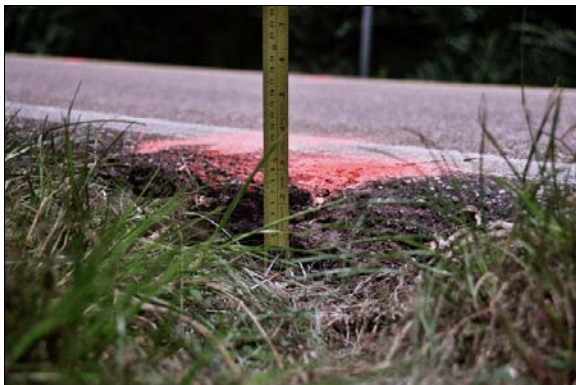
Crash: The case vehicle departed the south edge of the roadway and the left rear and left front tires loaded into the ground and tripped the vehicle causing it to roll over driver side leading. The interaction of the tires with the ground created divots in the ground beginning at the edge of the pavement, broke the beads on both tires and jammed grass in the bead of the left front tire (Figures 6 and 7). The passage of time since the crash combined with heavy rains and mowing of the roadway shoulder had caused the ground divots to dissipate; however, remnants of the divots still remained at the edge of the pavement (Figures 8 and 9).

Figure 8: Remnants of divot from case vehicle's left front wheel, tape measure at bottom of divot

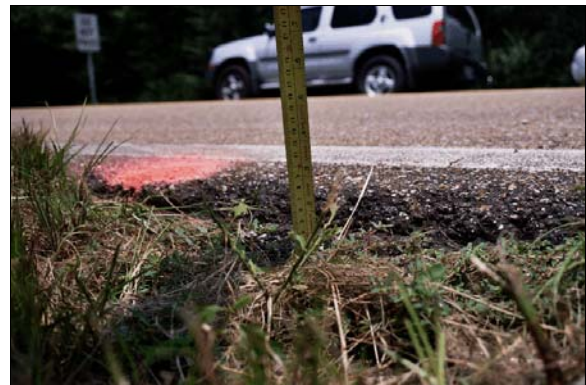
Figure 9: Remnants of divot from case vehicle's left rear wheel, tape measure at bottom of divot

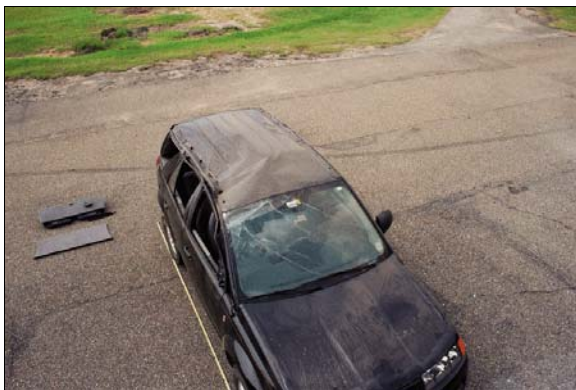
Figure 10: Top view of the crush to case vehicle's roof, roof side rails and right windshield header

As the case vehicle rolled over, the left roof side rail sustained a minor ground impact during the first quarter roll, and the right roof side rail sustained a hard ground impact during the second quarter roll (**Figures 10 and 11** above). The impact to the right roof side rail was the most severe and caused the most damage to the vehicle. As the case vehicle continued over into its third quarter roll, the right side sustained a minor ground impact that broke off the right side view mirror and scratched the right C-pillar. As the case vehicle was completing its third quarter roll, the sidewalls of the right side tires impacted the ground and grass was jammed in the beads of both tires (**Figures 12 and 13**). The case vehicle then landed on its wheels completing one full rollover.

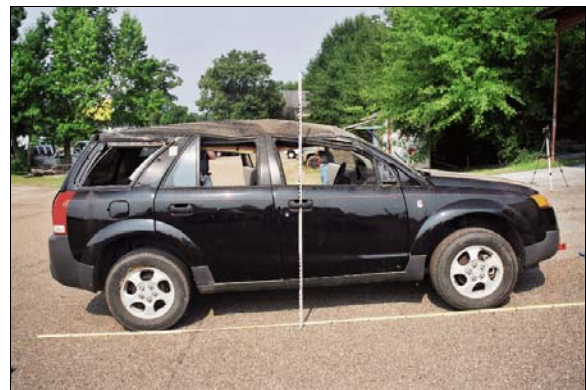
Figure 11: Overview of right roof side rail crush, vertical scale increments in tenths of foot

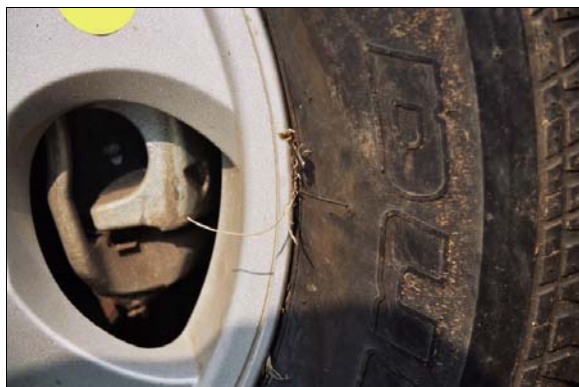
Figure 12: Grass jammed in bead of case vehicle's right front tire

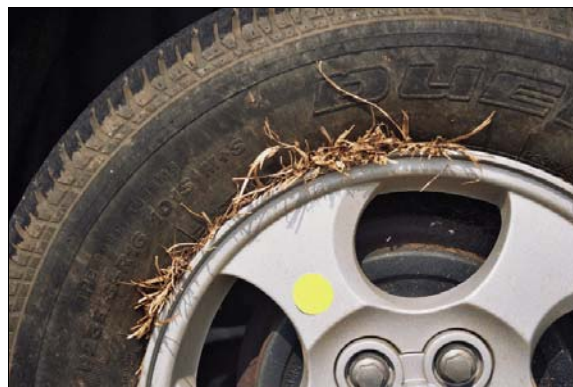
Figure 13: Grass jammed in bead of case vehicle's right rear tire

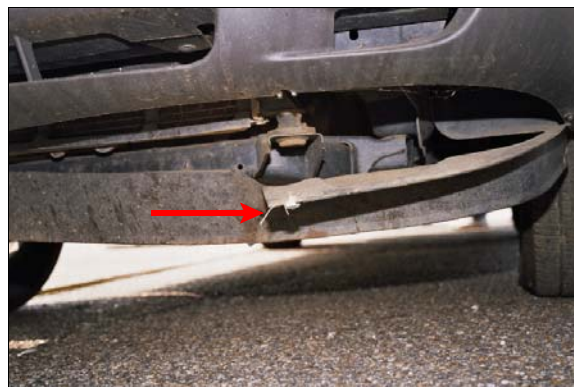
Exterior Damage: The case vehicle sustained minor direct damage to the left portion of the air scoop below the front bumper. The impact dislocated the left corner of the scoop from one of its mounts and deposited grass in the mounting screw (Figure 15). This impact most likely occurred during the initial tripping phase of the rollover due to loading of the case vehicle's front suspension from the yaw and the left front wheel loading into the ground. The rollover directly damaged the roof, both roof side rails and the right upper portion of the windshield (Figures 16 and 17). The most severe damage during the rollover occurred to the right roof side rail. The maximum crush was approximately 20 centimeters (8 inches) occurring approximately 15 centimeters (6 inches) forward of the B-pillar. In addition, the right side view mirror was broken off, and there were a few scratches to the right C-pillar. Induced damage involved the right side doors; and the right front, right rear and right quarter windows were broken out. The case vehicle's wheelbase was reduced approximately 1 centimeter (0.4 inches) on the right side and 2 centimeters (0.8 inches) on the left side.

Figure 15: Damage to the left portion of case vehicle's front air scoop, blade of grass in mounting screw at center of photo

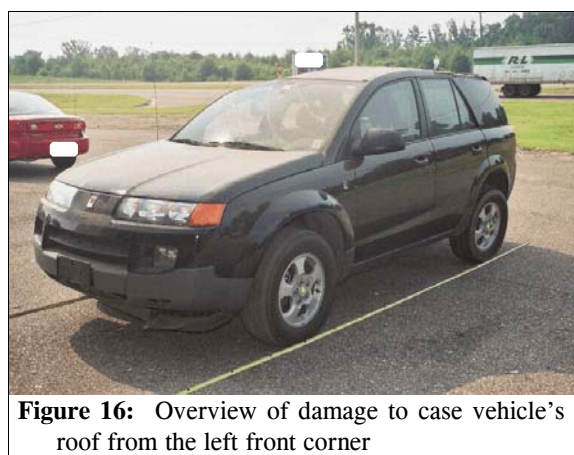
Figure 16: Overview of damage to case vehicle's roof from the left front corner

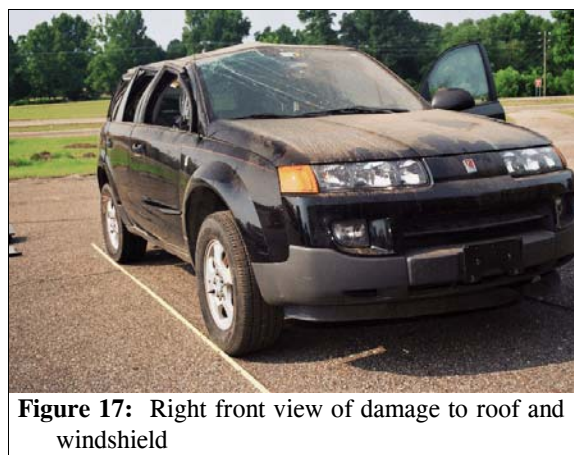
Figure 17: Right front view of damage to roof and windshield

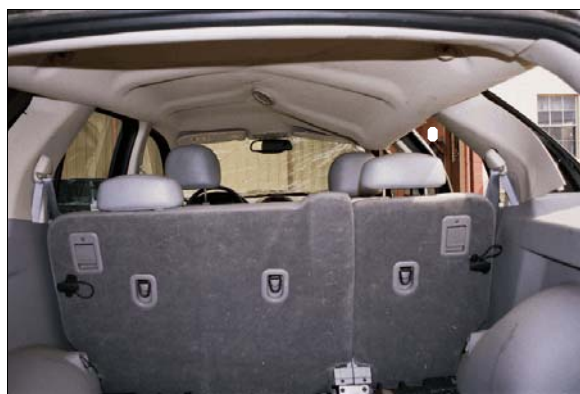
Vehicle Interior: Inspection of the case vehicle’s interior revealed no evidence of occupant contact to any interior surfaces or components. Numerous passenger compartment intrusions were observed and documented involving primarily the front right and back right seat positions. The most severe intrusions into these seat areas involved vertical intrusion of the roof of approximately 19 centimeters (7.5 inches), and approximately 9 centimeters (3.5 inches) of vertical and lateral intrusion of the roof side rail (**Figure 18**). In addition, there was lateral intrusion of the C-pillar and D-pillar of about 4 centimeters (1.6 inches). Lastly, there was no evidence of compression of the energy absorbing steering column, and no deformation of the steering wheel rim was observed (**Figure 19**).

Figure 18: Intrusion of case vehicle’s roof, right roof side rail and right B and C pillars

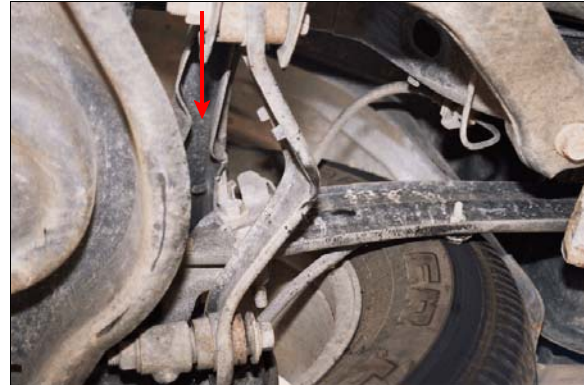
The case vehicle's driver stated in the Auto Safety Hotline, Vehicle Owner's Questionnaire and in her interview that after she steered the case vehicle back onto the roadway, the rear end fish-tailed slightly and the left rear wheel bent underneath the case vehicle causing it to rollover on the roadway passenger side first. This contractor's inspection of the case vehicle revealed that the left rear toe control link was badly bent; the upper control arm was bent, but to a lesser degree, the tire had contacted the trailing arm (Figure 20) and also contacted the front of its wheel house (Figure 21). In addition, the left rear wheel was observed to be angled in at the bottom about 10 degrees (Figure 22) and angled to the right, also about 10 degrees (Figure 23 below). The evidence on the vehicle and at the crash site does not support this damage occurring while the case vehicle was on the roadway during its clockwise yaw. The damage to these components most likely occurred as the left rear wheel departed the pavement and loaded into the ground. The remains of a divot with mounded-up soil was found at the edge of the pavement where the left rear wheel departed (Figure 9 above). In addition, no rim gouges were found in the roadway pavement and no abrasions were found on the left rear rim or tire sidewall. The surface of the outer treads of the left rear tire were also abraded (Figure 23 below) consistent with the yaw tire marks that were observed on the roadway centerline, no-passing line and southwest edge line, indicating the tire was rotating and not debedded while the case vehicle was on the roadway. Based on the evidence, this contractor concludes the following: This crash was a soil-tripped, driver side leading rollover that occurred as the case vehicle departed the south edge of the pavement. The damage to the left rear suspension most likely occurred during the rollover sequence

Figure 20: Left rear wheel contacting trailing arm, toe link bent in V-shape, arrow points to bent upper control arm

as the left rear wheel loaded into the ground as the case vehicle departed the edge of the roadway. The evidence does not support this damage occurring on the roadway during the case vehicle's steering maneuver and subsequent yaw.

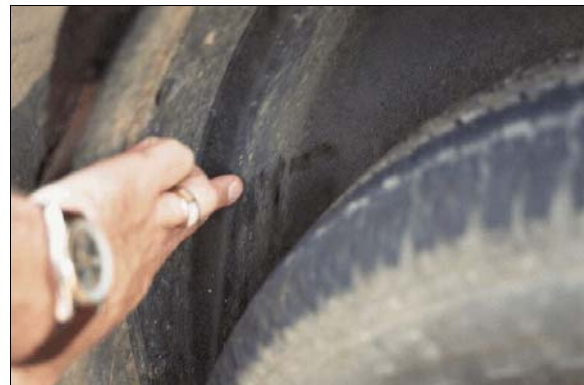
Figure 21: Scuff at front of left rear wheel house from contact by left rear tire

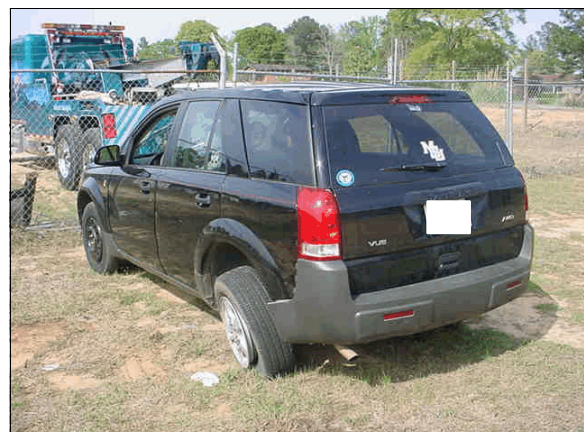
Figure 22: Insurance photo of case vehicle in tow lot showing condition of left rear wheel

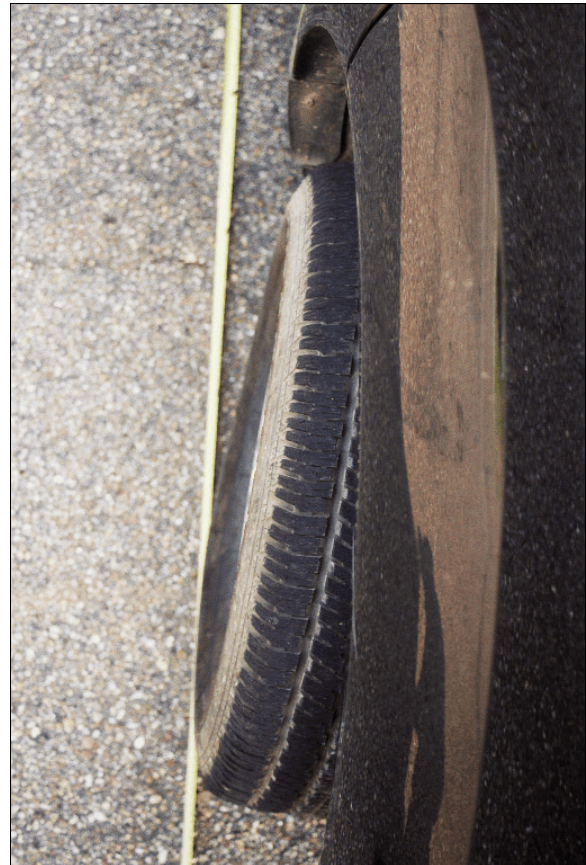
Figure 23: Top view of case vehicle's left rear wheel showing it angled to the right, outer treads abraded
